MINERALS PROGRAM INSPECTION REPORT
PHONE: (303) 866-3567

MINE NAME: Idarado Mining Co	MINE/PROSPECTING ID#: M-1977-403-HR	MINERAL: Lead, zinc, copper, c gold	COUNTY: San Miguel
INSPECTION TYPE: Monitoring	INSPECTOR(S): Lucas J. West	INSP. DATE: March 27, 2018	INSP. TIME: 08:00
OPERATOR: Idarado Mining Company	OPERATOR REPRESENTATIVE: Mark Parker, Larry Fiske	TYPE OF OPERATION: 112d-3 - Designated Mining Operation	
REASON FOR INSPECTION: Normal I&E Program	BOND CALCULATION TYPE: None	BOND AMOUNT: \$226,600.00	
DATE OF COMPLAINT: NA	POST INSP. CONTACTS: None	JOINT INSP. AGENCY: None	
WEATHER: Clear	INSPECTOR'S SIGNATURE:

SIGNATURE DATE: March 30, 2018

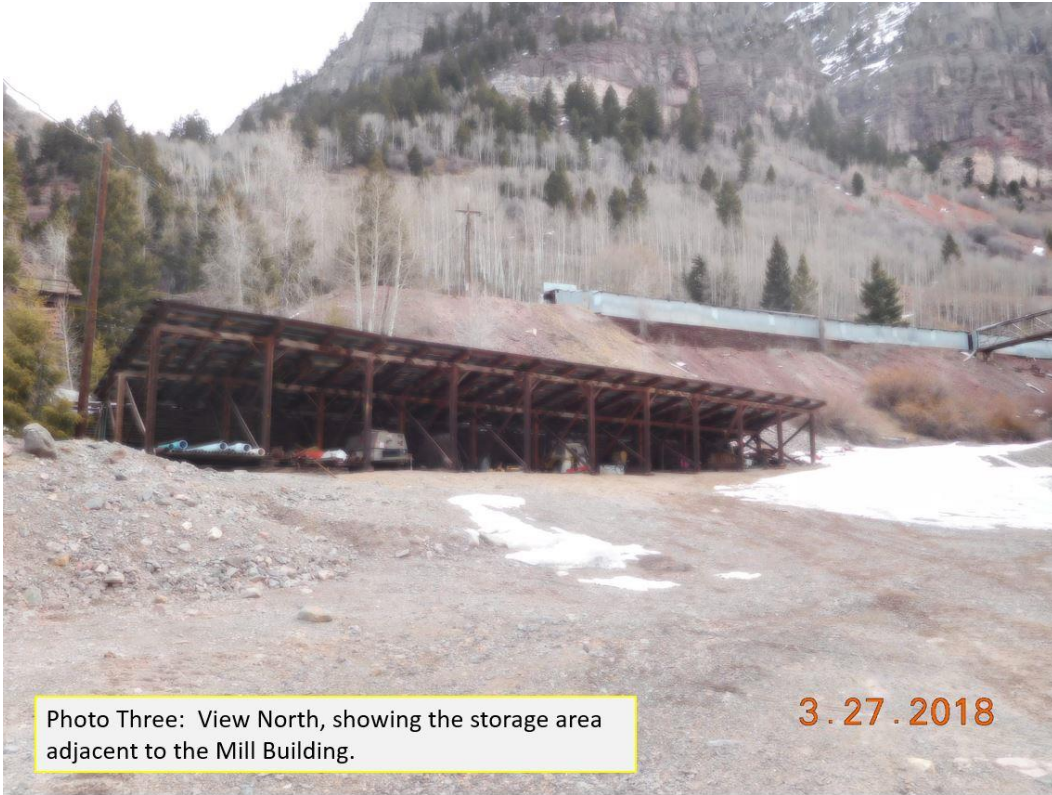
Photo Three: View North, showing the storage area adjacent to the Mill Building.

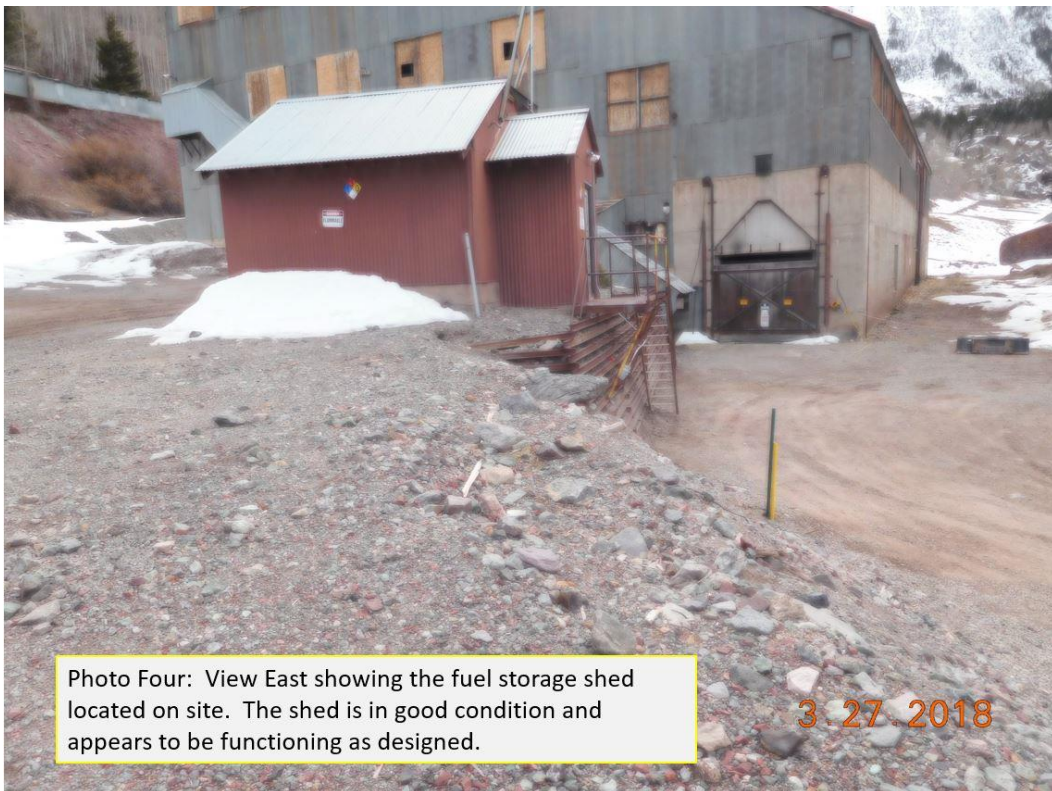
Photo Four: View East showing the fuel storage shed located on site. The shed is in good condition and appears to be functioning as designed.

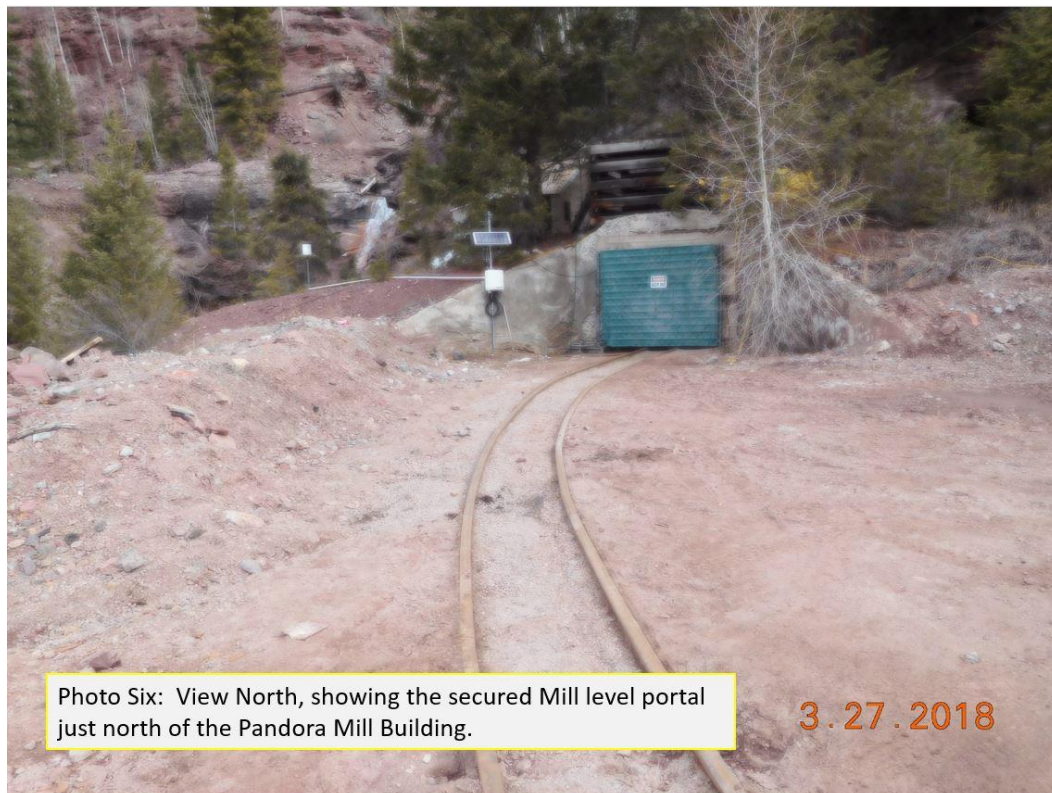
The Mill level portal was secured after the underground tour to prevent unauthorized entry, the closure can be seen in Photo Six. The locomotive shop and secondary train shed are located adjacent to the mill level portal. All of the buildings in this area were secured, and in good condition. They show no signs of vandalism or attempted unauthorized entry. The infiltration ponds were not filled during the time of the inspection, during the winter months the water is infiltrated through the infiltration ditch as part of the Consent Decree and Remedial Action Plan established by CDPHE.
