MINERALS PROGRAM INSPECTION REPORT

MINE NAME: Spor Pit	MINE/PROSPECTING ID#: M-1995-038	MINERAL: Gravel	COUNTY: San Miguel
INSPECTION TYPE: Monitoring	INSPECTOR(S): Lucas J. West	INSP. DATE: March 27, 2018	INSP. TIME: 15:45
OPERATOR: Mountain View Enterprises Limited Liability	OPERATOR REPRESENTATIVE: Chancy Marolf	TYPE OF OPERATION: 110c - Construction Limited Impact

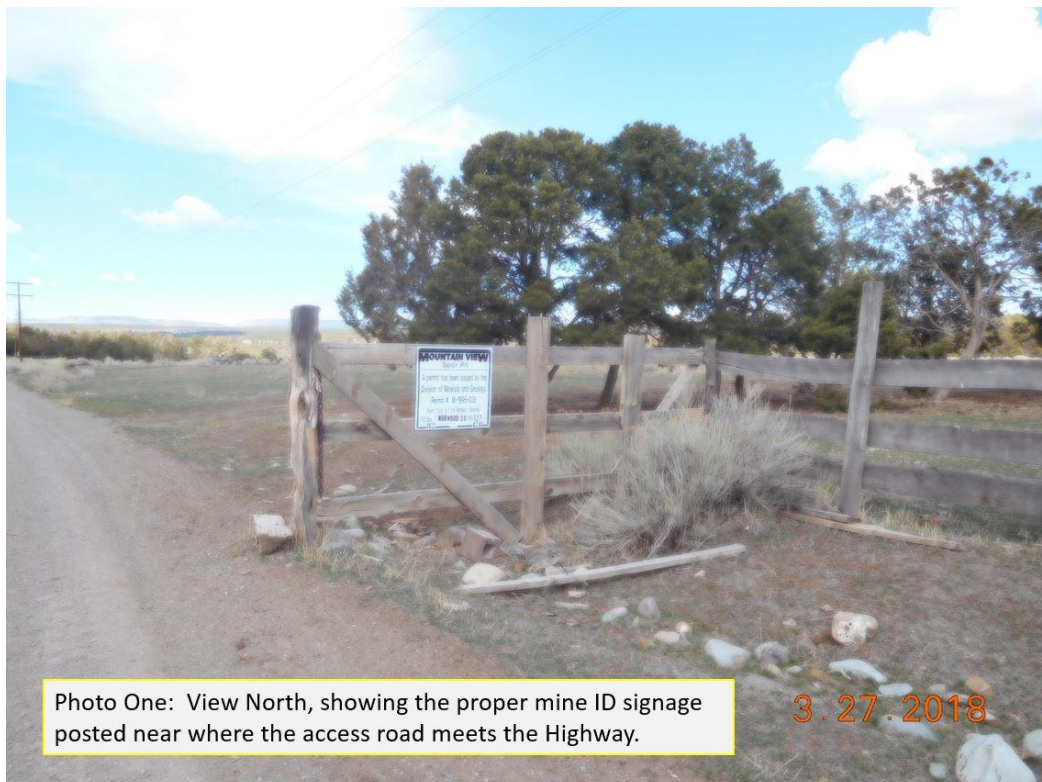
Photo One: View North, showing the proper mine ID signage posted near where the access road meets the Highway.

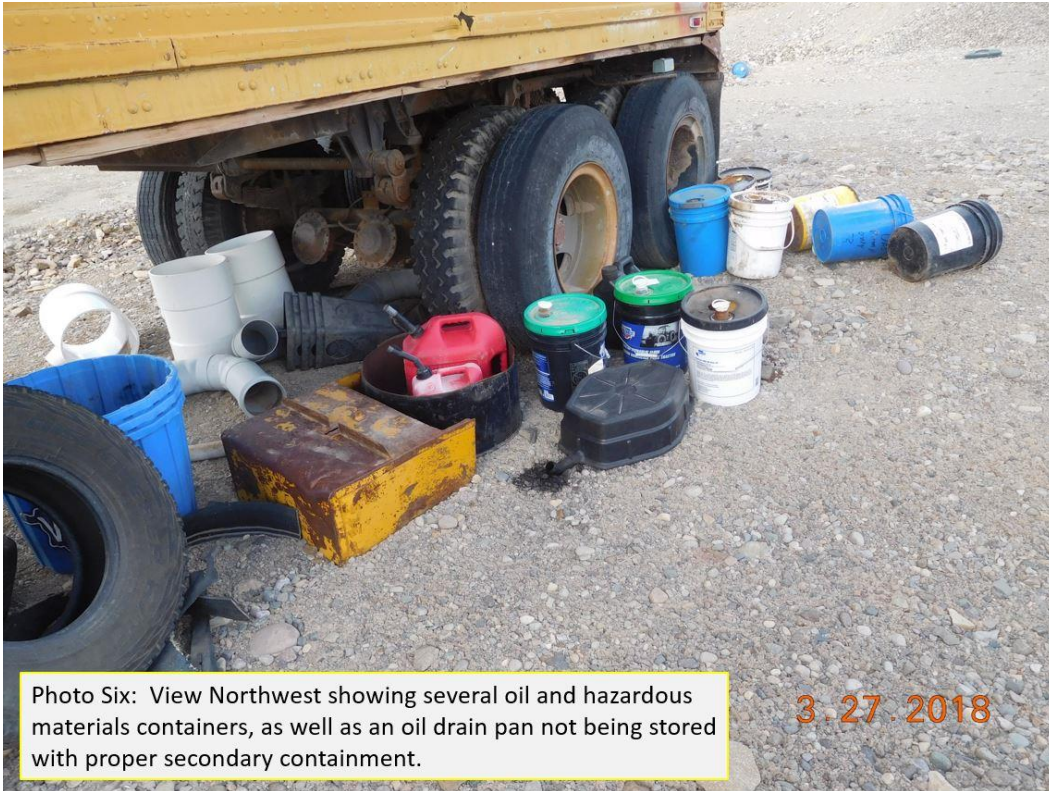
Photo Six: View Northwest showing several oil and hazardous materials containers, as well as an oil drain pan not being stored with proper secondary containment.

Also, petroleum and any hazardous materials on site for any period of time shall have appropriate secondary containment. The site will also have to comply with all applicable SPCC requirements. Please supply photo documentation that any and all fuel or hazardous materials containers are stored properly - including applicable secondary containment structures by the corrective action date. Note that secondary containment structures shall consist of an impermeable containment which could contain all contents of the tanks and various containers (when full) plus 10% of the total capacity. Several options for proper storage were discussed with the Operator during the inspection.

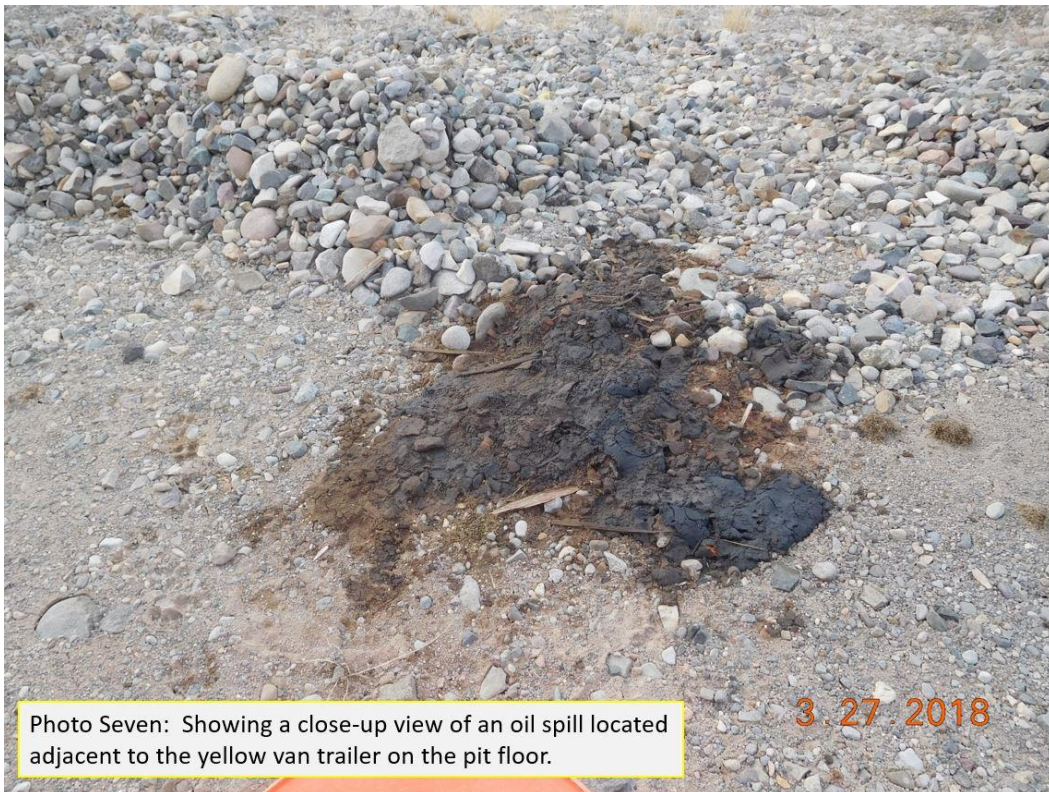
A problem was identified during the inspection that was discussed on site with the Operator. Multiple oil spills have occurred at the site which has impacted soils and improper storage and containment of fuels and/or other hazardous materials was present on site. Adjacent to the van trailer located on the pit floor, several small oil spills were observed, in addition to several containers of oil, and hydraulic fluid not being stored with appropriate secondary containment. The containers and spill in this area can be seen in Photos Six and Seven. Similarly, in the area being used as a storage area, two other spills were observed. A large spill was observed near the 55 gallon blue plastic drum of an unknown substance. This container was also being stored without proper secondary containment. The drum and spill can be seen in Photo Eight. Observations were also made near the tongue of the low-boy trailer in the area, which are consistent with a hydraulic fluid leak from the trailer that will need to be cleaned up. This spill can be seen in Photo Nine.

Photo Seven: Showing a close-up view of an oil spill located adjacent to the yellow van trailer on the pit floor.

The operator needs to remediate the various spills and submit a final report to the Division containing at least the following information:

- 1.) A description of how the spill was cleaned up containing at a minimum, volumes removed, locations of removal area, disposal method and photo documentation.

2.) Evidence in the form of a receipt that the contaminated soil was disposed of by an approved method (such as sent to an approved landfill, land farming, recycling center, etc.).
