**COLORADO**Division of Reclamation,
Mining and Safety

MINERALS PROGRAM INSPECTION REPORT**PHONE: (303) 866-3567**

MINE NAME: Parsons Mine	MINE/PROSPECTING ID#: M-2009-082	MINERAL: Sand and gravel	COUNTY: Weld
INSPECTION TYPE: Monitoring	INSPECTOR(S): Peter S. Hays	INSP. DATE: March 8, 2018	INSP. TIME: 10:30
OPERATOR: Martin Marietta Materials, Inc.	OPERATOR REPRESENTATIVE: Julie Mikulas	TYPE OF OPERATION: 112c - Construction Regular Operation

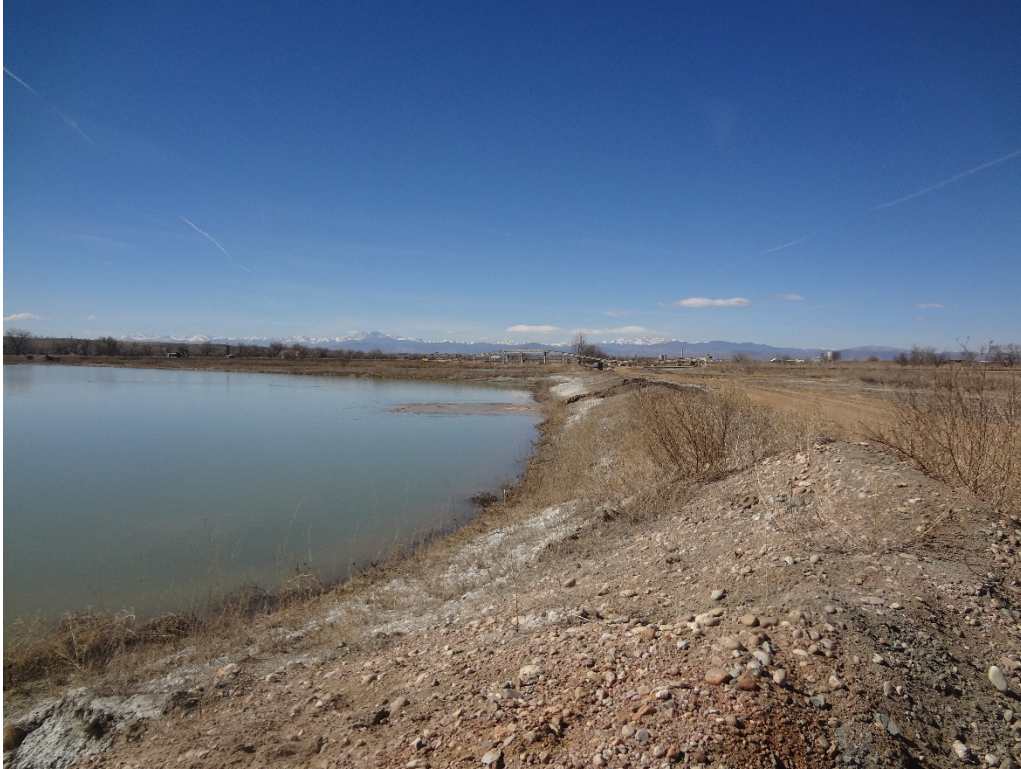
View of the sedimentation pond from northeast corner of the pond looking west

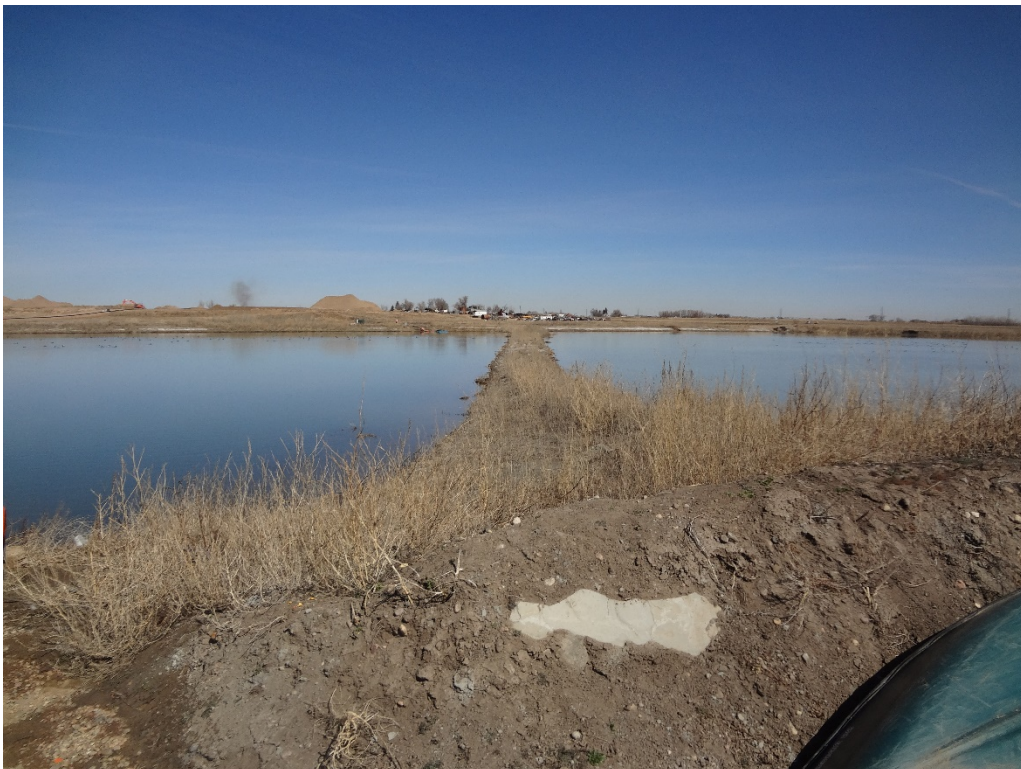
View of the dividing berm between the sedimentation pond and fresh water pond looking north

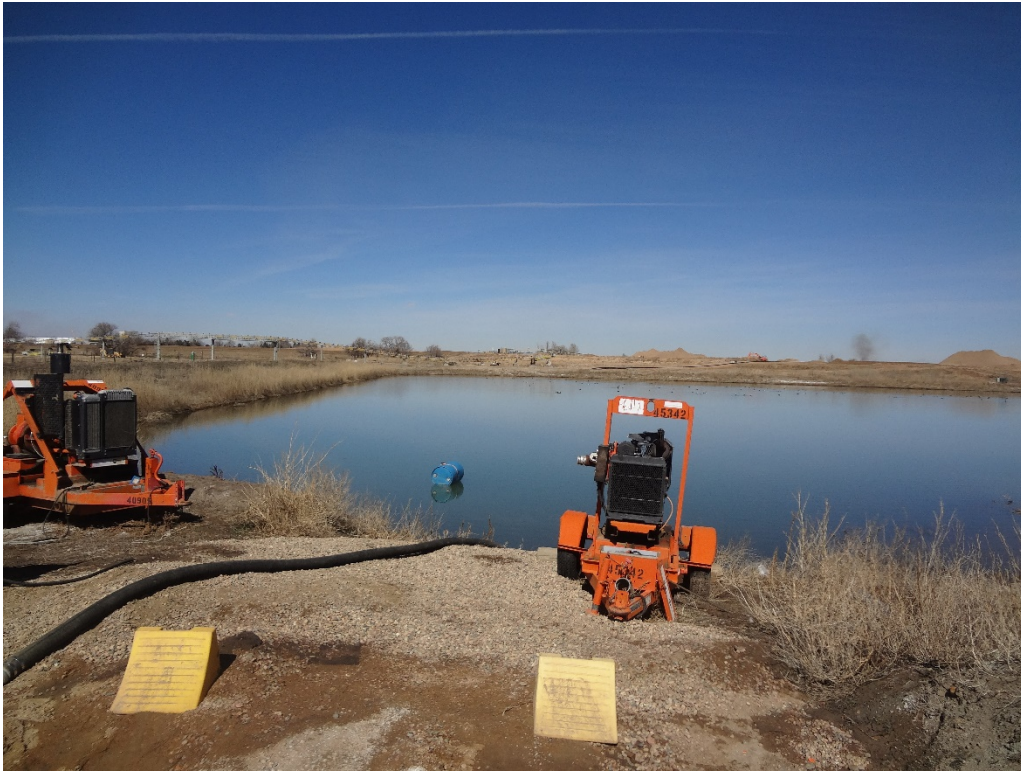
View of dewatering pump and water truck pump located in the southwest corner of the fresh water pond

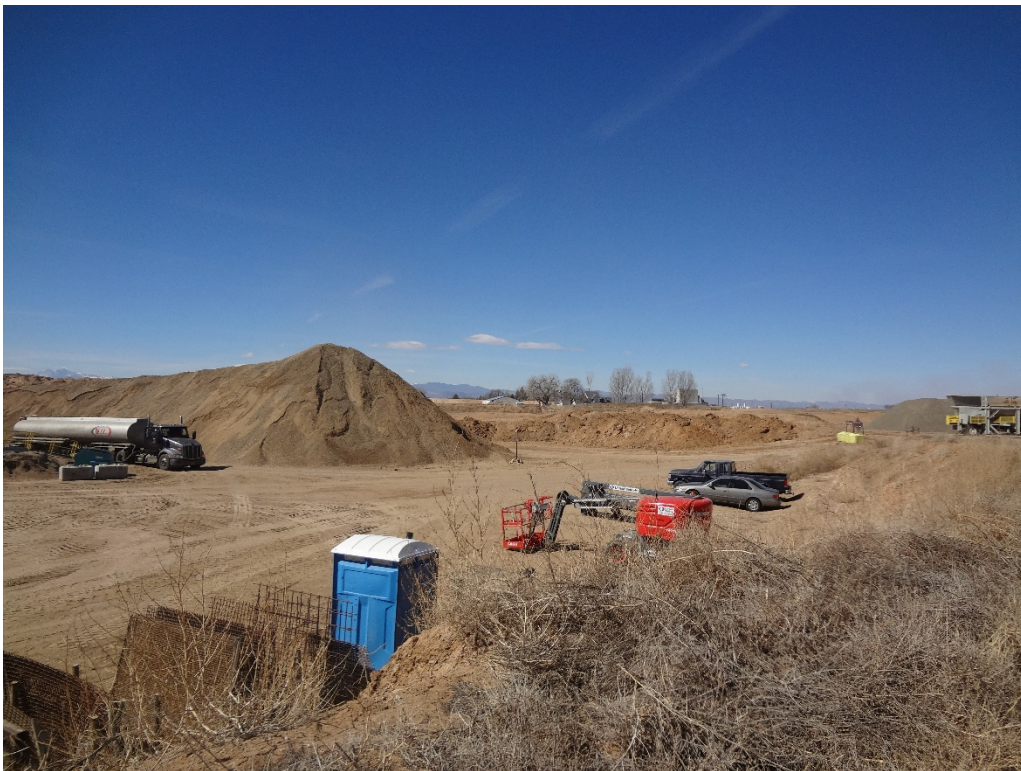
View of the mining activity looking northwest from the mine office area

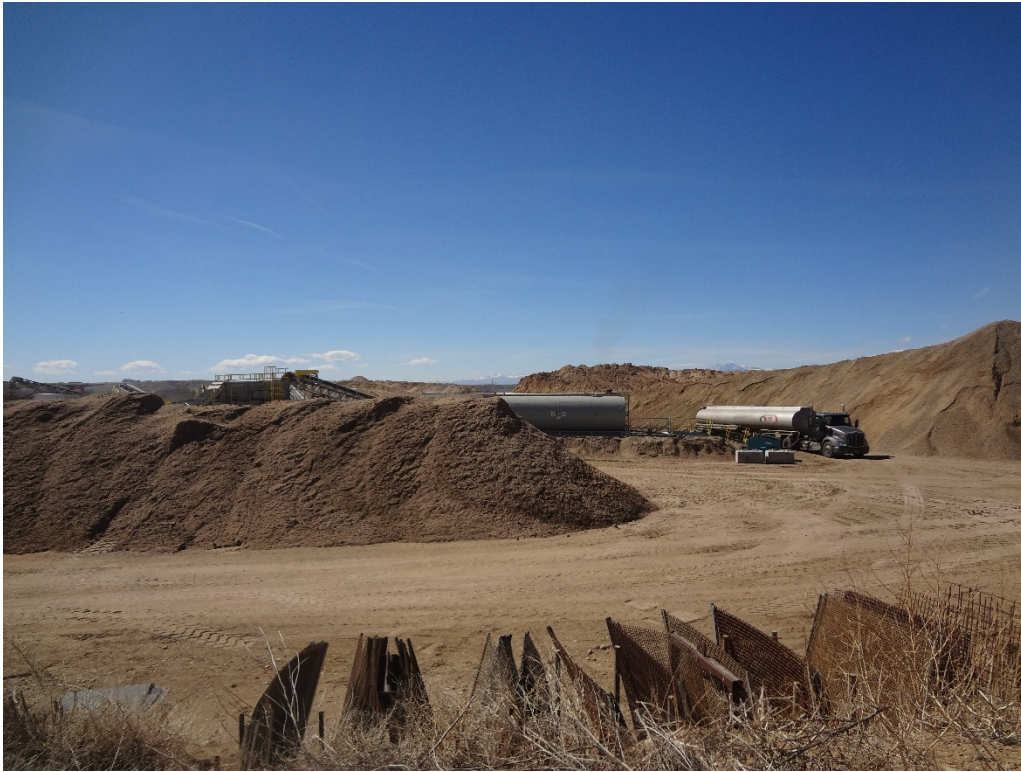
View of the mining activity looking west from the mine office area

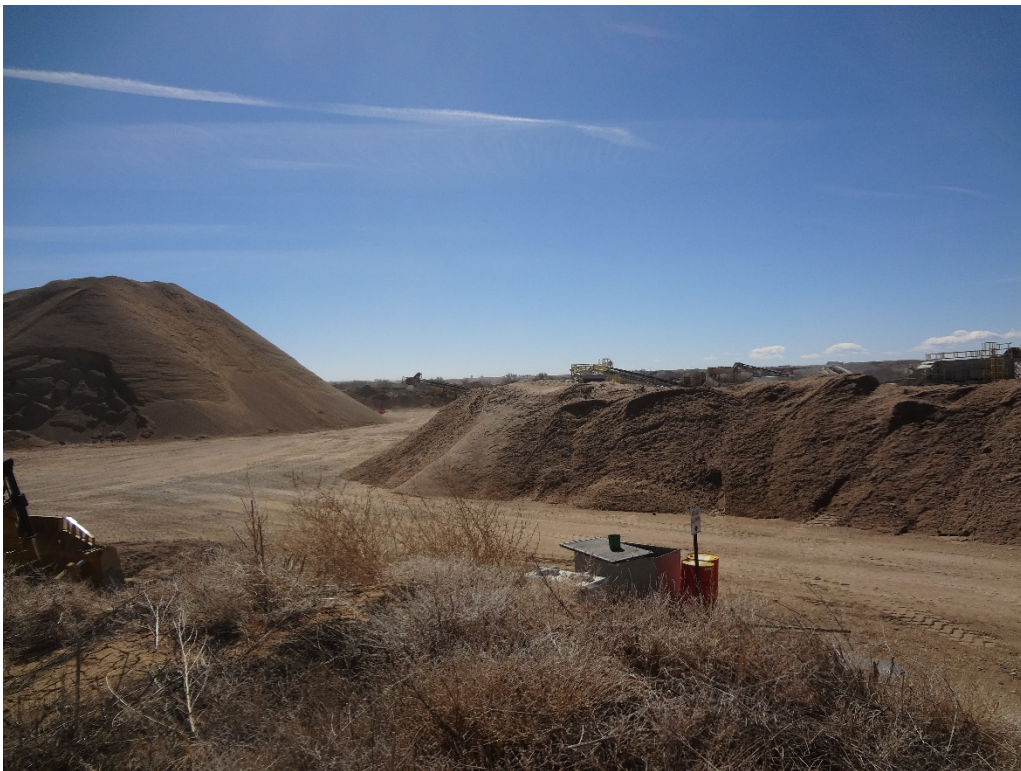
View of the mining activity looking southwest from the mine office area

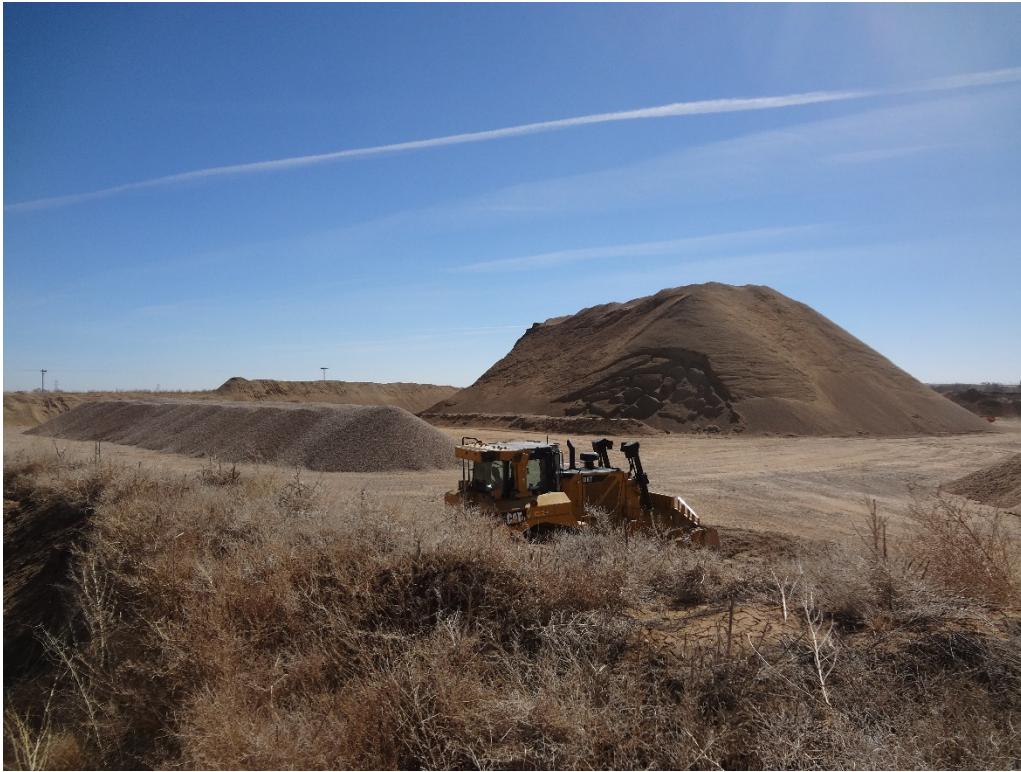
View of the mining activity looking south from the mine office area

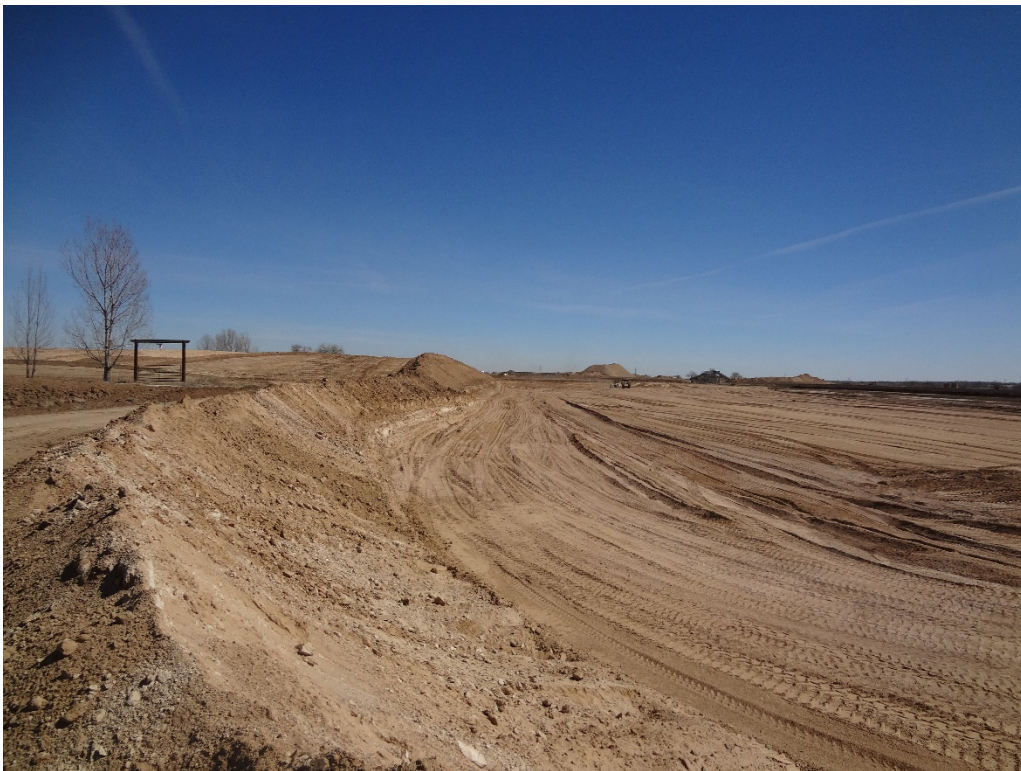
View of Stage 2 from the northwest corner of the stage looking east

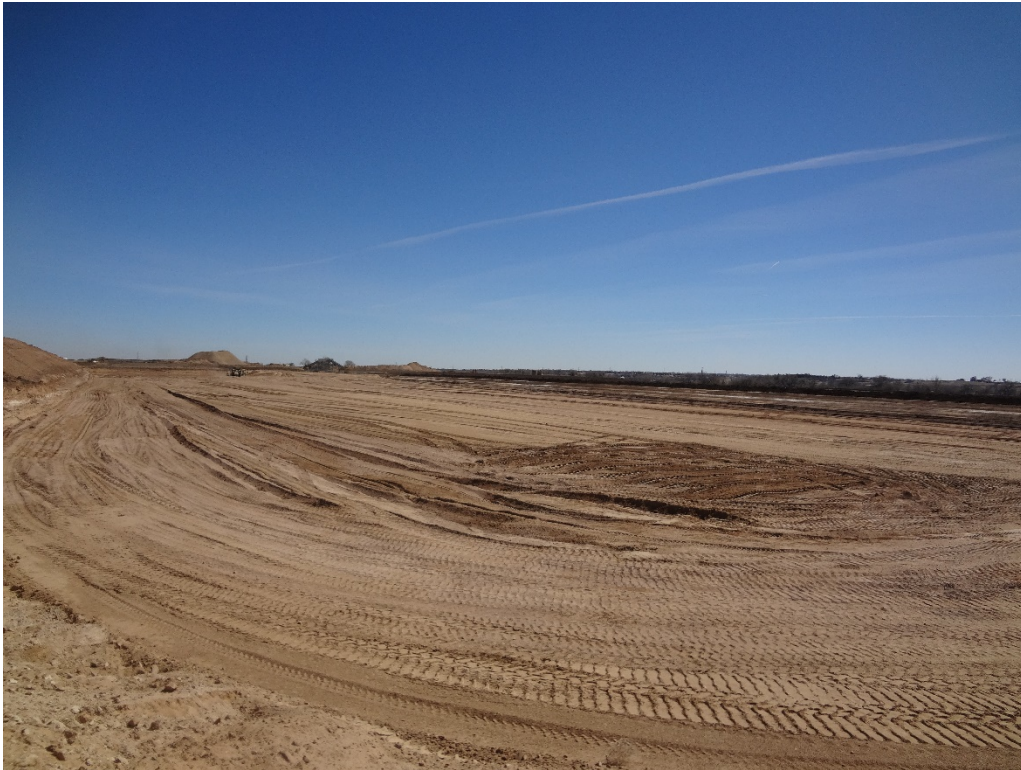
View of Stage 2 from the northwest corner of the stage looking southwest

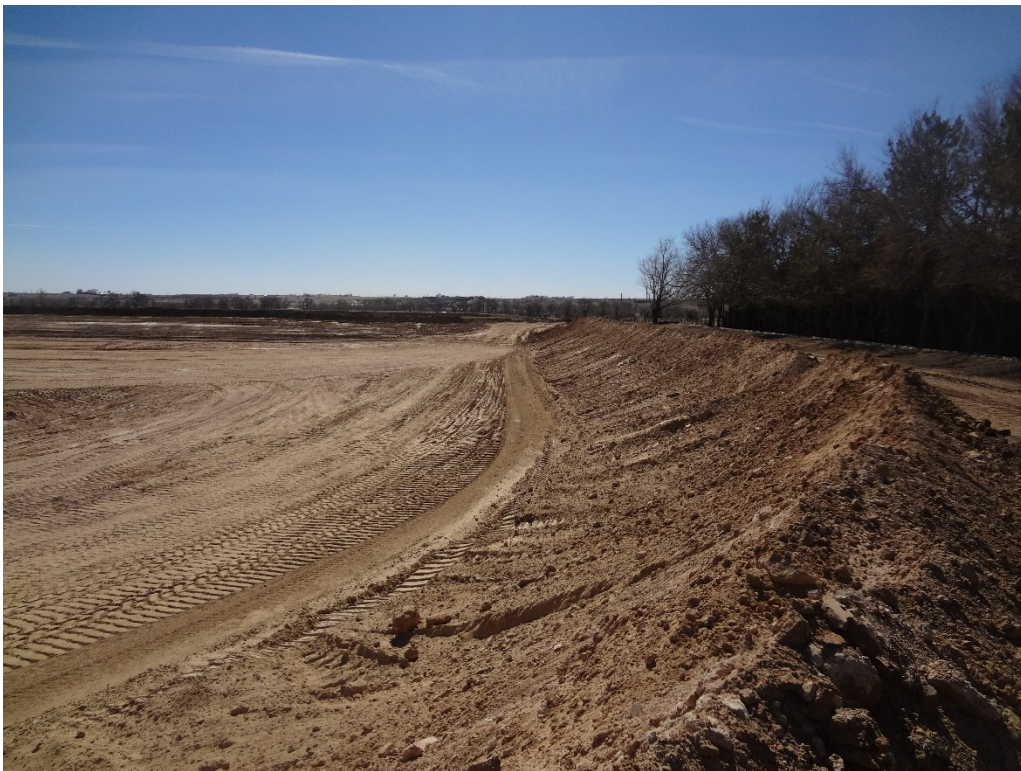
View of Stage 2 from the northwest corner of the stage looking south

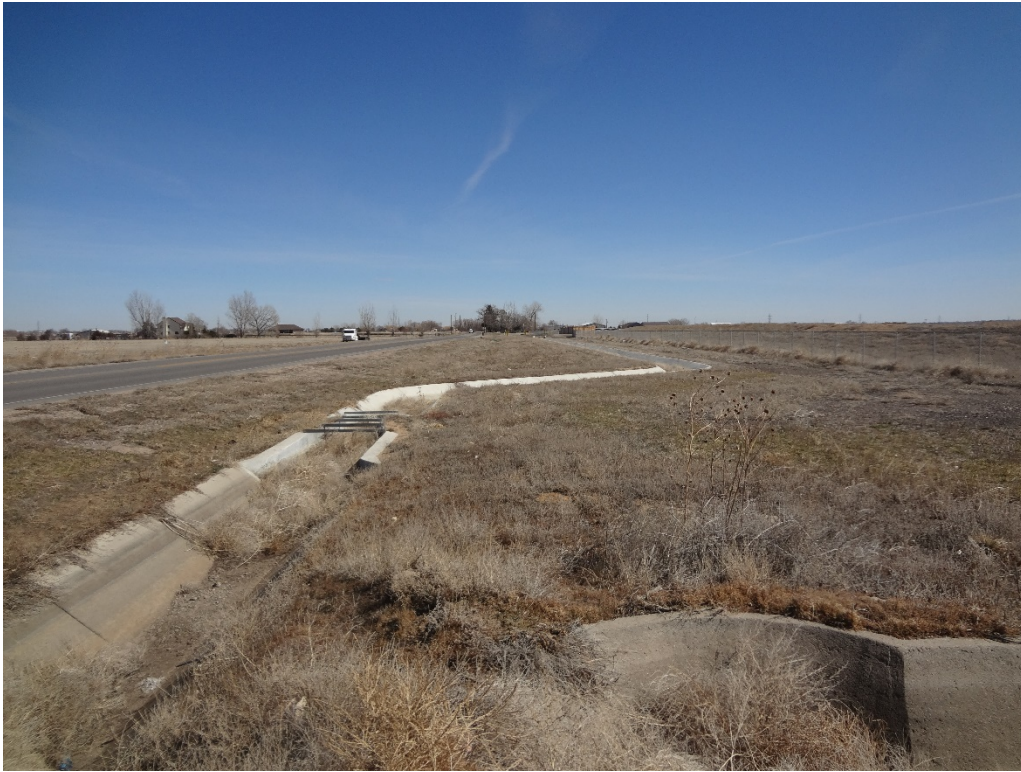
PROBLEM: The Division does not have a copy of the signed ditch location agreement between the Whitney Ditch Company and Martin Marietta Materials, Inc. for the relocation of the Whitney Ditch along the north edge of the property boundary.

The Whitney Ditch relocation is complete. The ditch relocation was required to install an acceleration / deceleration lane in CR 64.5. The ditch was moved to the south and constructed as a concrete lined trapezoidal channel. As cited as a problem, the Division does not have a copy of the signed ditch location agreement between the Whitney Ditch Company and Martin Marietta Materials, Inc. The Operator is required to provide the Division with a copy of the agreement by the corrective action date.

View of relocated Whitney Ditch from CR 64.5 looking east

CORRECTIVE ACTIONS: The Operator shall provide the Division with a copy of the ditch relocation agreement by the corrective action date.
