MINERALS PROGRAM INSPECTION REPORT

MINE NAME: Higgins Pit II	MINE/PROSPECTING ID#: M-2012-013	MINERAL: Borrow material	COUNTY: Lincoln
INSPECTION TYPE: Monitoring	INSPECTOR(S): Timothy A. Cazier	INSP. DATE: August 24, 2017	INSP. TIME: 10:45
OPERATOR: Smithburg Family Partnership, LLLP	OPERATOR REPRESENTATIVE: None	TYPE OF OPERATION: 112c - Construction Regular Operation	
REASON FOR INSPECTION: Normal I&E Program	BOND CALCULATION TYPE: Partial Bond	BOND AMOUNT: \$106,380.00	
DATE OF COMPLAINT: NA	POST INSP. CONTACTS: None	JOINT INSP. AGENCY: None	
WEATHER: Cloudy	INSPECTOR'S SIGNATURE:

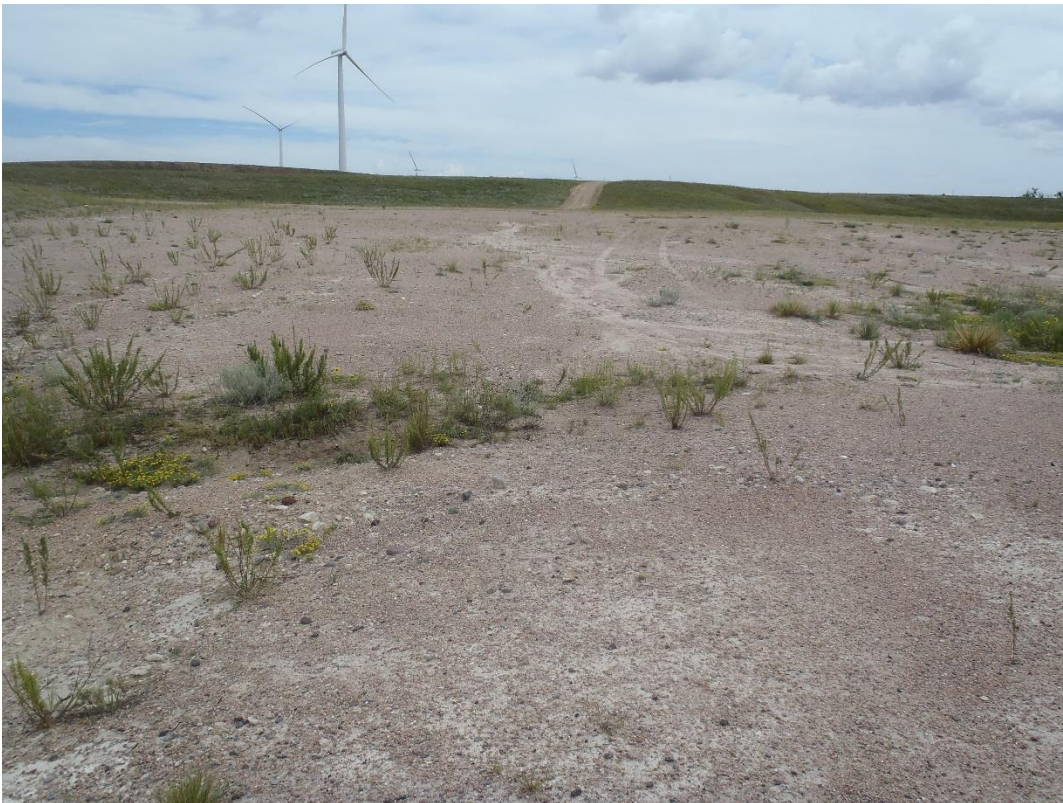
Gen. Compliance with Mine Plan: The operation appeared to be in compliance with the approved mine plan. The active area appeared to be on the west end (see **Photos 1** and **2**) Google Earth was used to measure the disturbed area, which was estimated to be approximately 34 acres, based on 2014 satellite imagery. The maximum allowed disturbed are is 52.66 acres.

Photo 1. Active area (west end, looking NE).

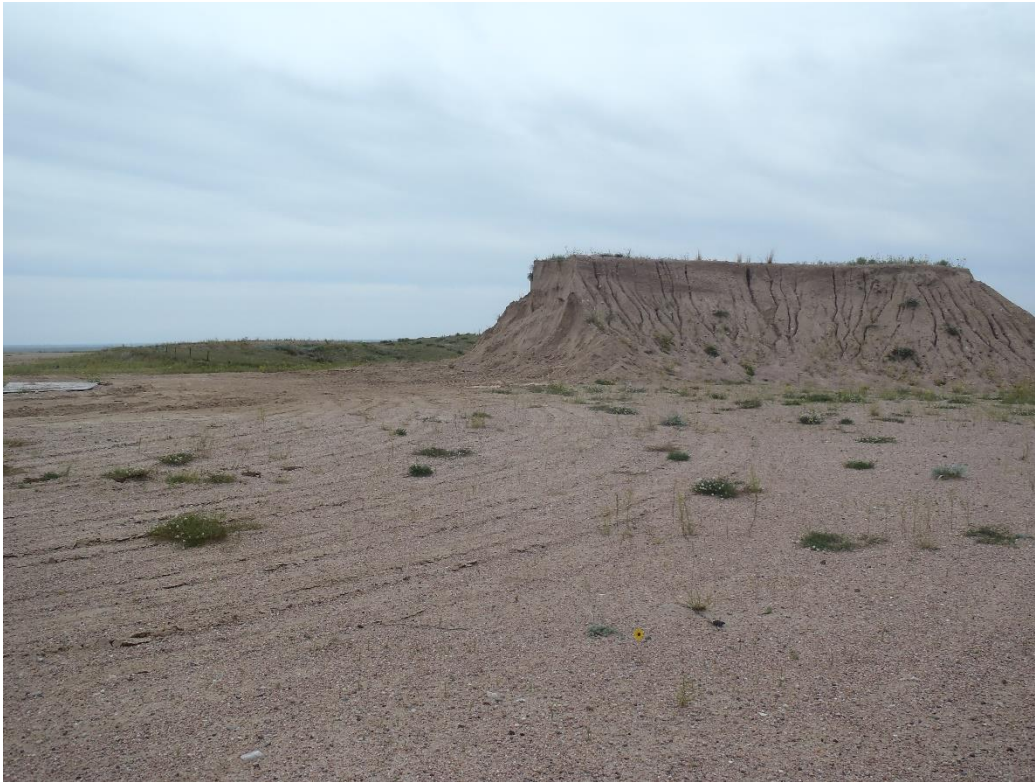
Photo 2. Active area (west end, looking SW; note product stockpile).

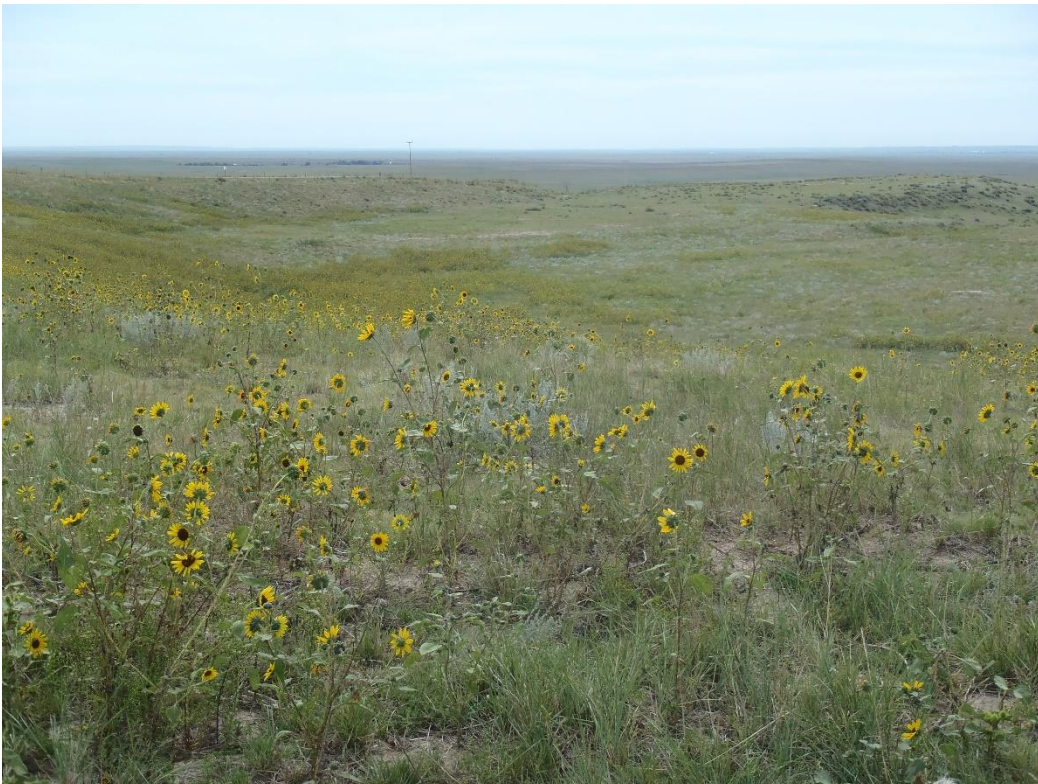
Reclamation Success: The east end appeared to be graded to 3H:1V, and is likely adequate for release. Much of the cover was sunflower, so a final assessment of vegetation establishment should wait.

Revegetation: The east end appeared to be revegetating well (see **Photos 3** and **4**). No noxious weeds were observed.

Photo 3. Reclaimed east end (looking SE).

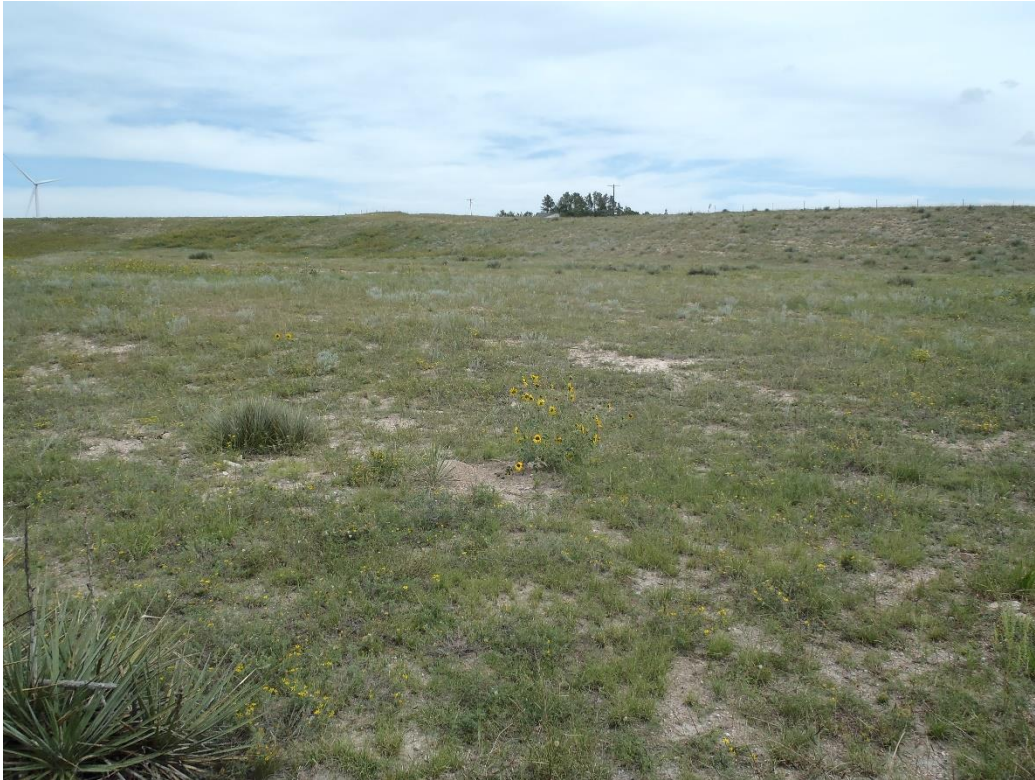
Photo 4. Reclaimed east end (looking NW).

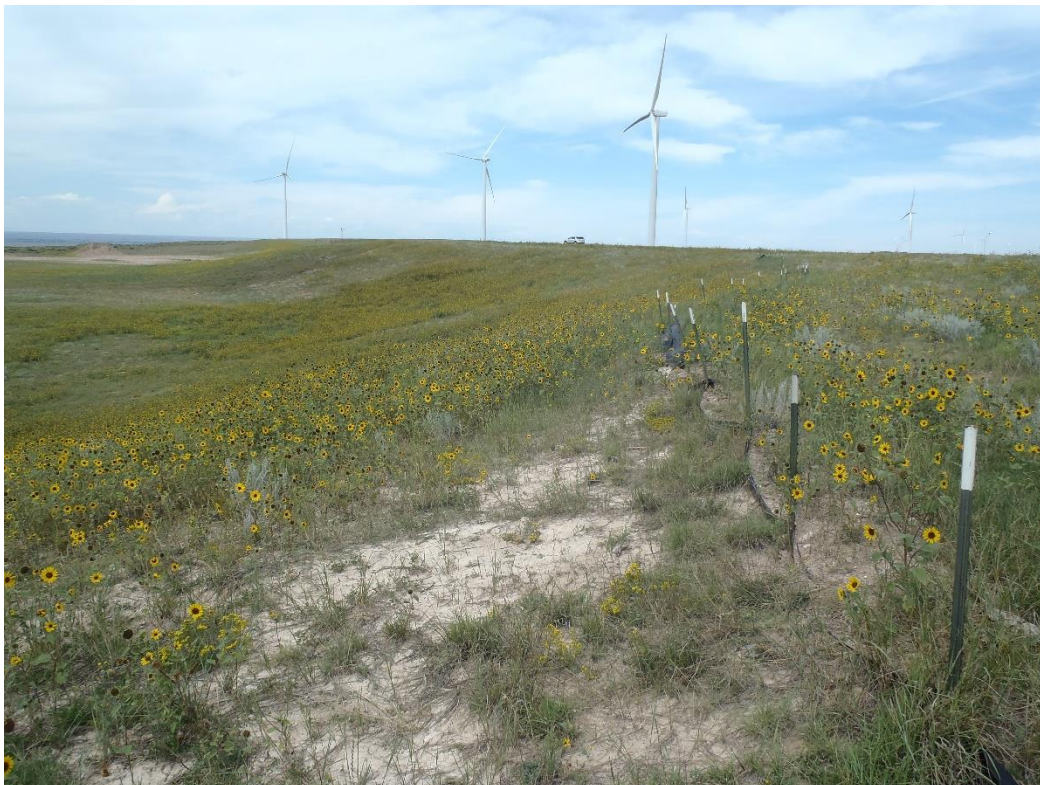
Sediment Control: No erosion problems were observed and no BMPs were needed at the time of the inspection. The silt fence on the crest of the eastern end of the highwall was failing (see **Photo 5**), but not needed with the vegetation at the time.

Photo 5. Failing silt fence on crest of eastern end of highwall (looking WNW).

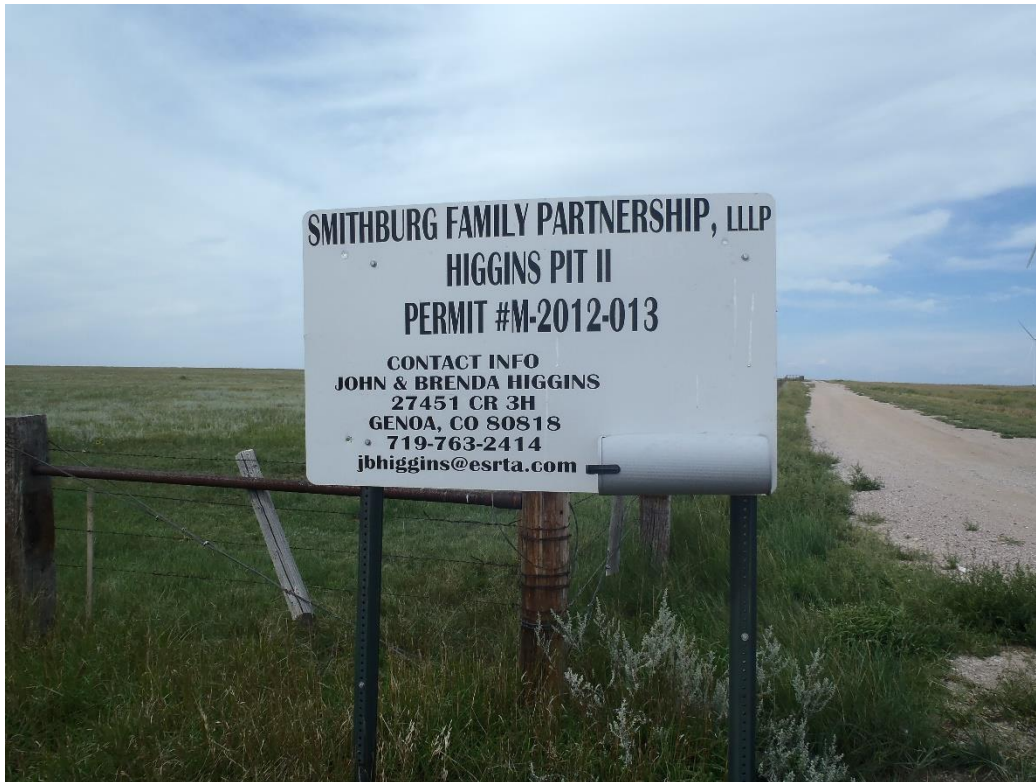
Signs and Markers: The permit sign was properly posted (see **Photo 6**). A fence clearly marked some boundary, but without a site representative available to clarify if the fence had been adjusted for the 2013 acreage release, it was uncertain whether or not the boundary was appropriately marked at the time of the inspection.

Photo 6. Permit sign at entrance.

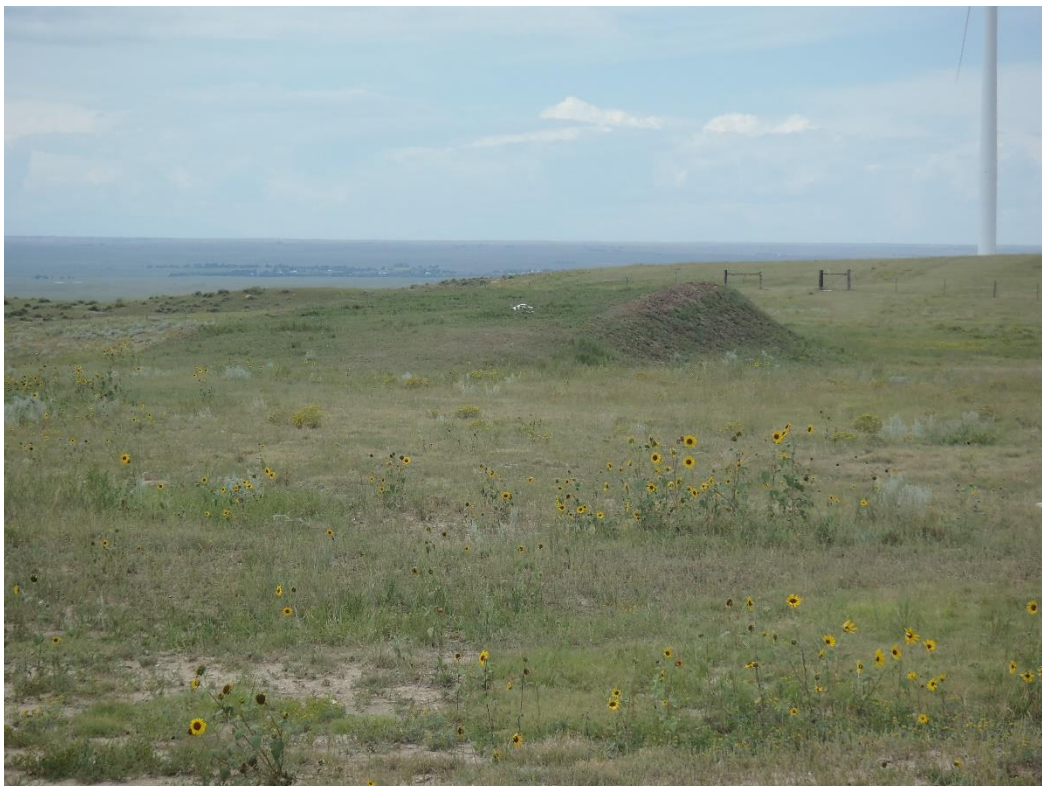
Topsoil: What appeared to be a topsoil stockpile (see **Photo 7**) was observed near two crossed T-posts on the north side of the site above the excavated area. It was vegetated and stable.

Photo 7. Probable topsoil stockpile (north side of west end, looking west).
