MINERALS PROGRAM INSPECTION REPORT
PHONE: (303) 866-3567

MINE NAME: Blue Pit	MINE/PROSPECTING ID#: M-1981-207	MINERAL: Sand and gravel	COUNTY: Garfield
INSPECTION TYPE: Monitoring	INSPECTOR(S): Amy C. Yeldell	INSP. DATE: March 28, 2018	INSP. TIME: 09:30
OPERATOR: Western Slope Materials, LLC	OPERATOR REPRESENTATIVE: Sean Mello	TYPE OF OPERATION: 112c - Construction Regular Operation	
REASON FOR INSPECTION: Normal I&E Program	BOND CALCULATION TYPE: Complete Bond	BOND AMOUNT: \$2,181,971.00	
DATE OF COMPLAINT: NA	POST INSP. CONTACTS: None	JOINT INSP. AGENCY: None	
WEATHER: Cloudy	INSPECTOR'S SIGNATURE:

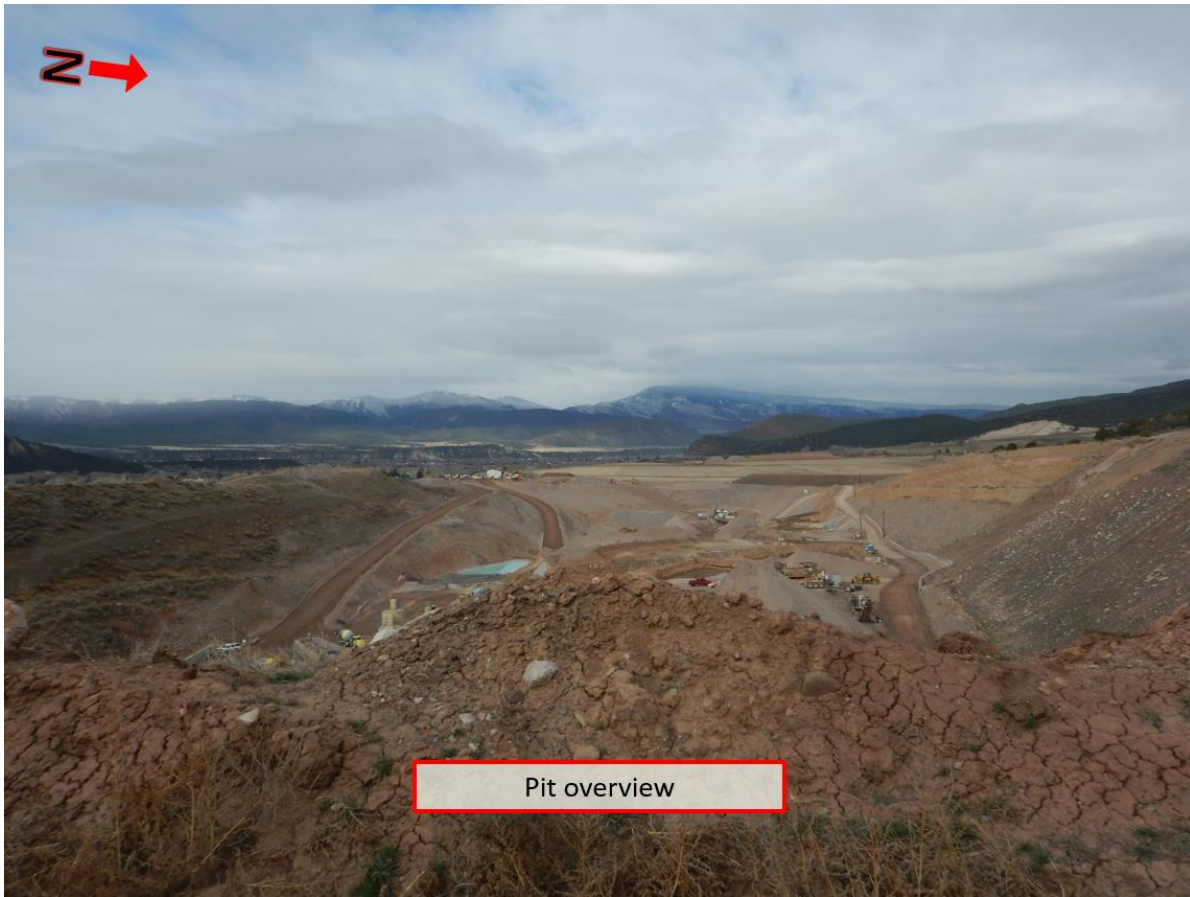
Pit overview

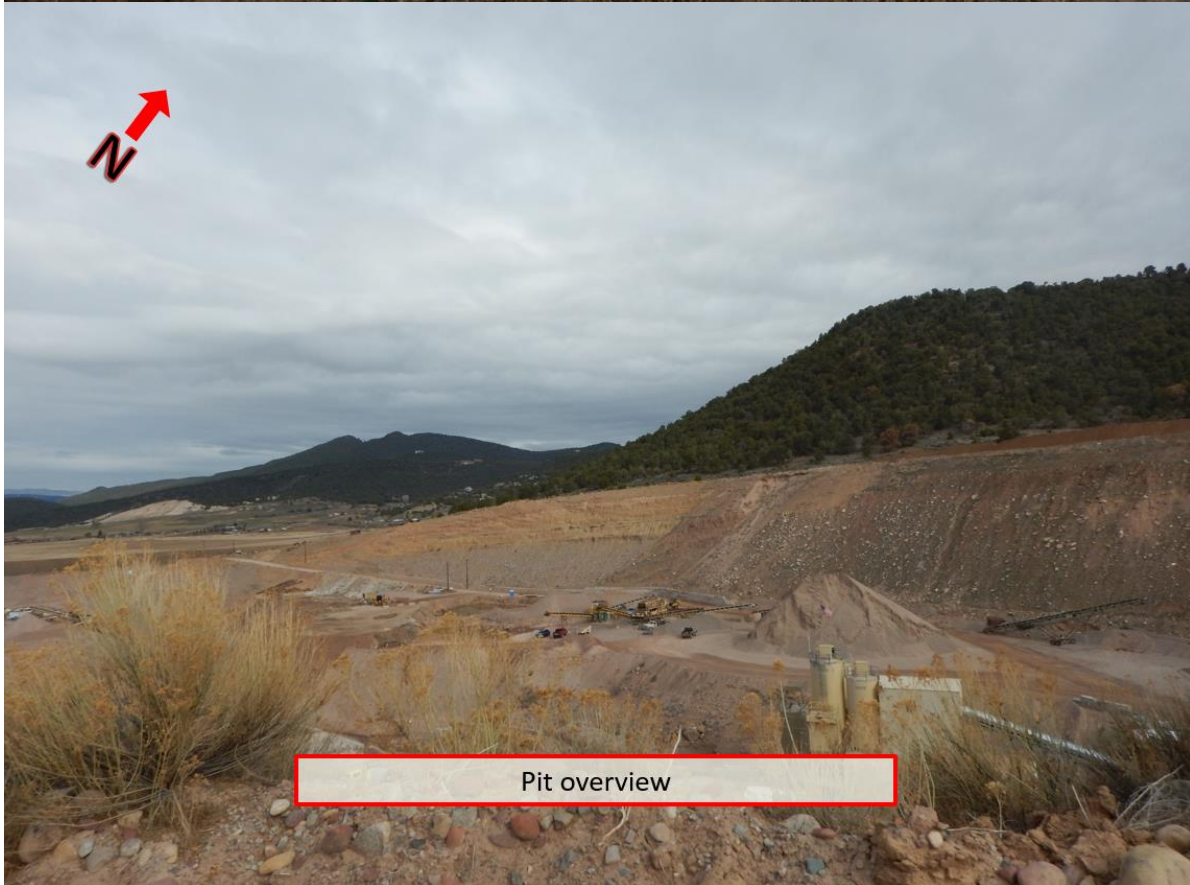
Pit overview

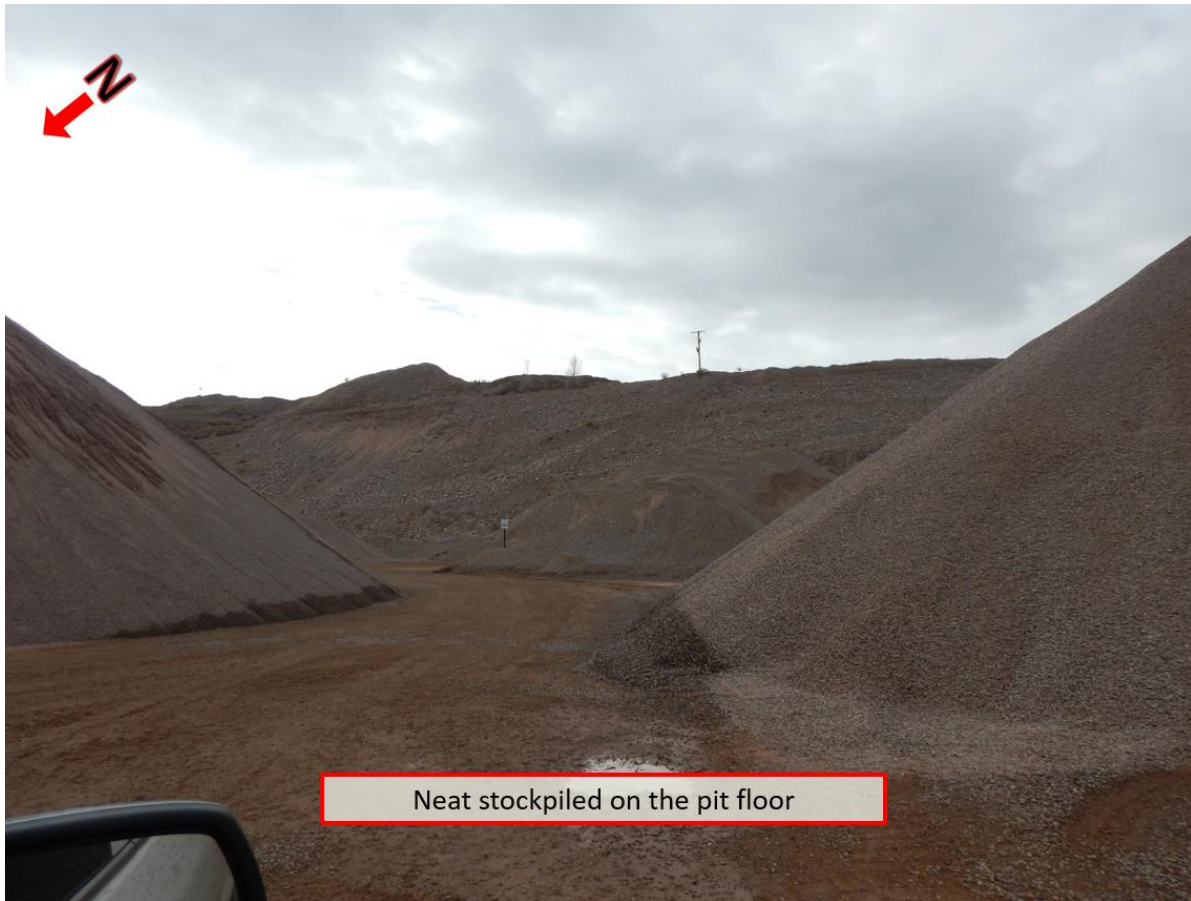
Neat stockpiled on the pit floor

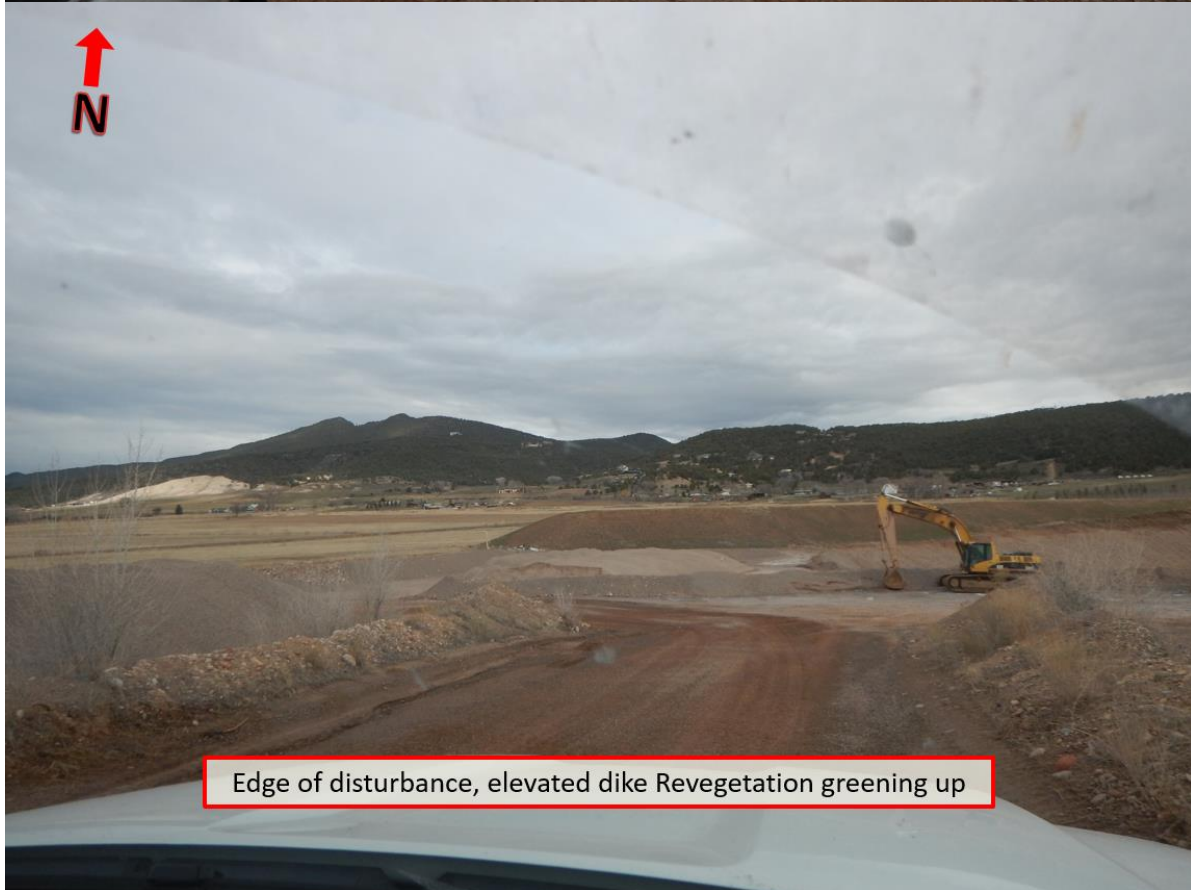
Edge of disturbance, elevated dike Revegetation greening up
