**MINERALS PROGRAM INSPECTION REPORT**  
**PHONE: (303) 866-3567**

<b>MINE NAME:</b> Carnation Mine	<b>MINE/PROSPECTING ID#:</b> M-1977-416	<b>MINERAL:</b> Uranium and vanadium	<b>COUNTY:</b> San Miguel
<b>INSPECTION TYPE:</b> Monitoring	<b>INSPECTOR(S):</b> Lucas J. West, Russ Means	<b>INSP. DATE:</b> March 28, 2018	<b>INSP. TIME:</b> 10:11
<b>OPERATOR:</b> Pinon Ridge Mining LLC	<b>OPERATOR REPRESENTATIVE:</b> George Glasier, Mike Rutter	<b>TYPE OF OPERATION:</b> 110d - Designated Limited Impact	
<b>REASON FOR INSPECTION:</b> Normal I&E Program	<b>BOND CALCULATION TYPE:</b> Complete Bond	<b>BOND AMOUNT:</b> \$22,468.00	
<b>DATE OF COMPLAINT:</b> NA	<b>POST INSP. CONTACTS:</b> None	<b>JOINT INSP. AGENCY:</b> None	
<b>WEATHER:</b> Clear	<b>INSPECTOR'S SIGNATURE:</b>

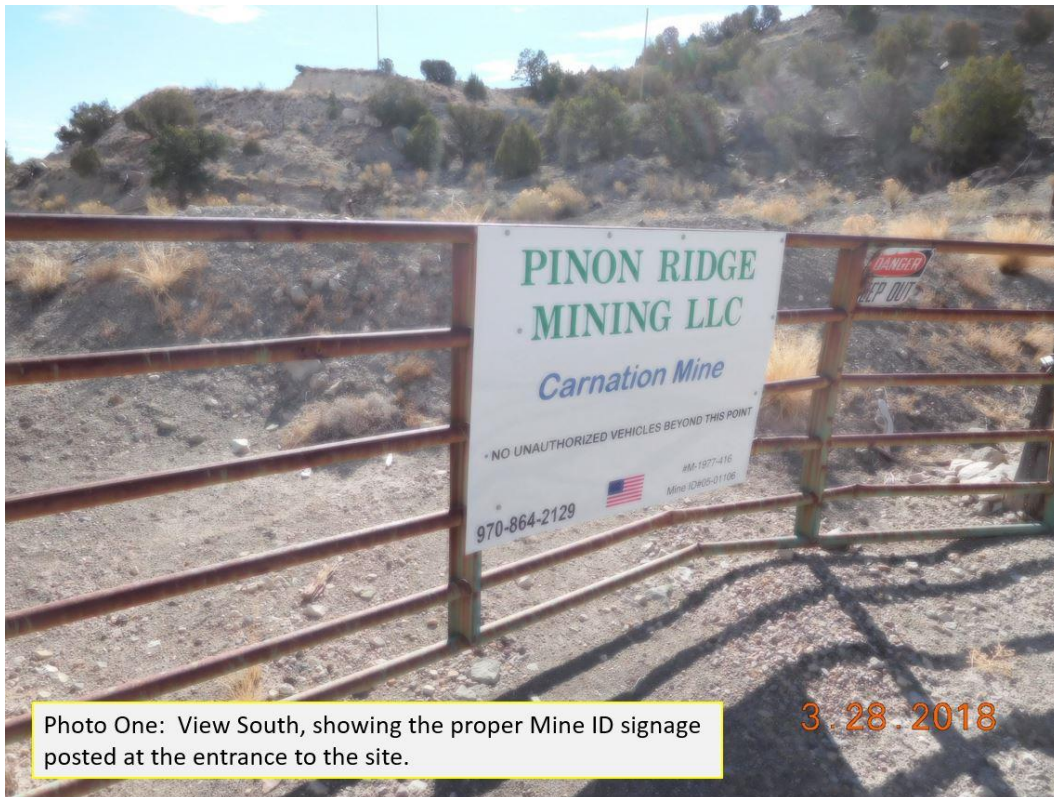
As seen in Photo One, the permit ID sign was observed at the entrance to the site. The permit boundary markers were also observed and all disturbances were confined within the permitted area. Evidence that the diversion ditches and storm water control devices are functioning as designed and no significant erosion was observed throughout the site. The lower permit area was also in good condition with no signs of significant erosion. The lower area has begun to revegetate itself and appears to be in good condition.

Photo One: View South, showing the proper Mine ID signage posted at the entrance to the site.

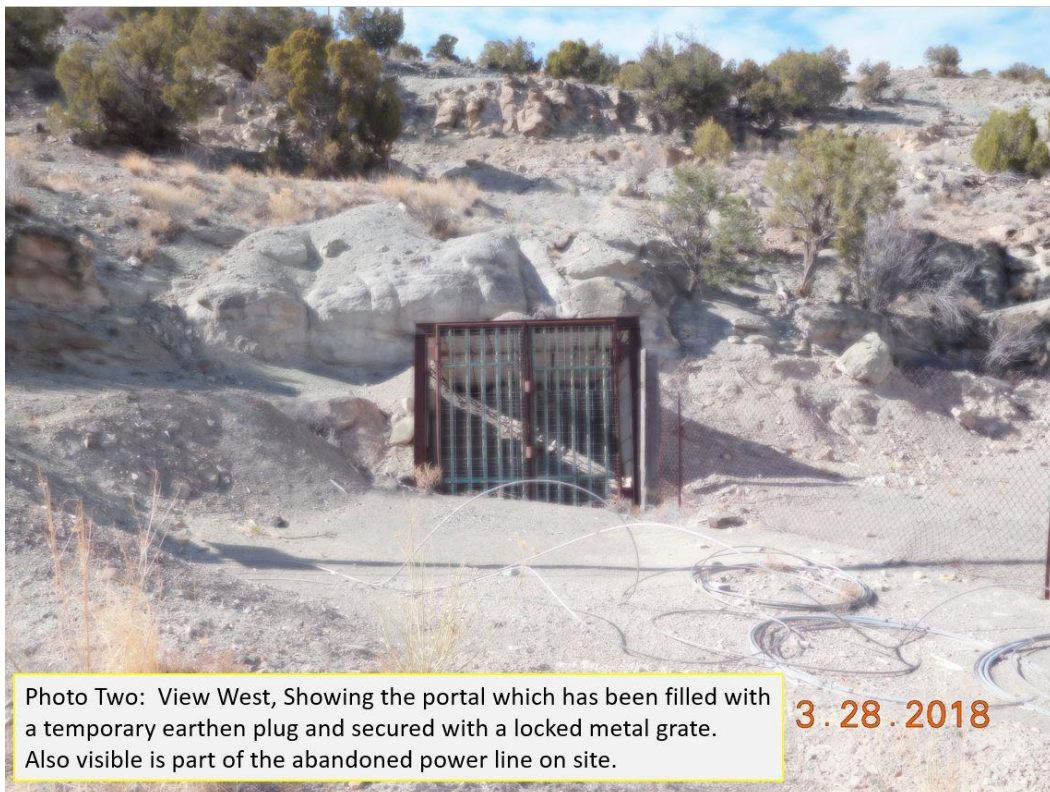
The portal located on site was also secured, it has been backfilled, closed off with steel grates as well as encompassed by a small berm as seen in Photo Two. No fuel storage containers were observed on site.

Photo Two: View West, Showing the portal which has been filled with a temporary earthen plug and secured with a locked metal grate. Also visible is part of the abandoned power line on site.

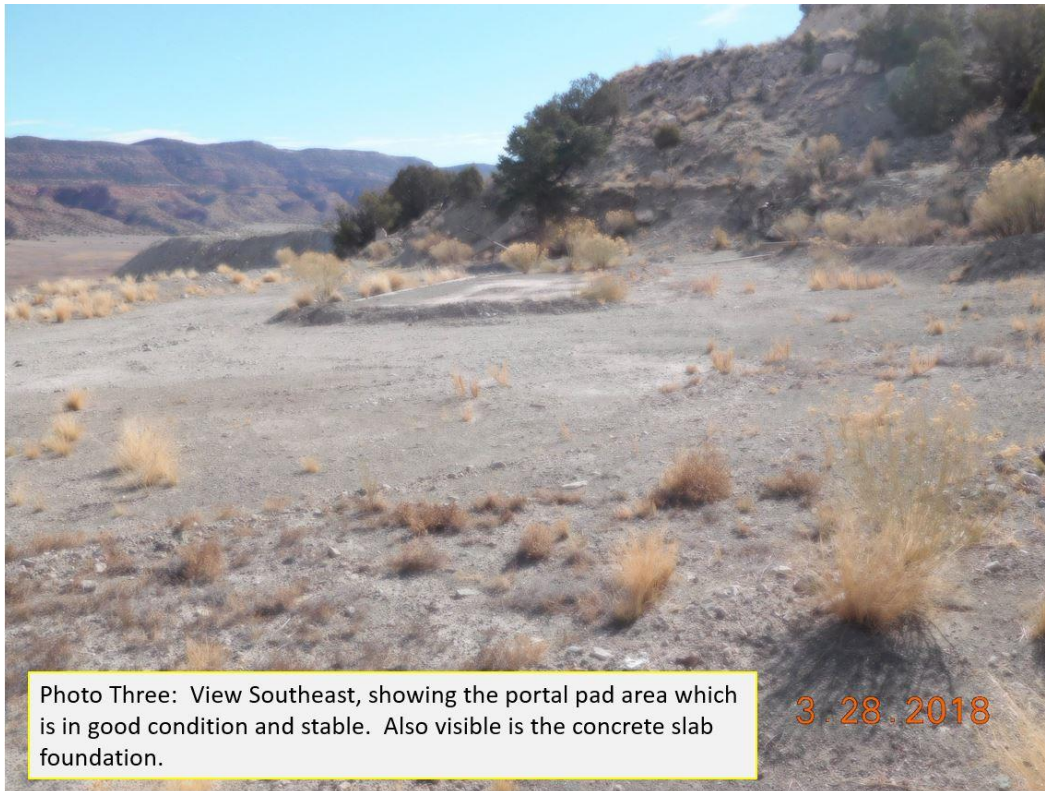
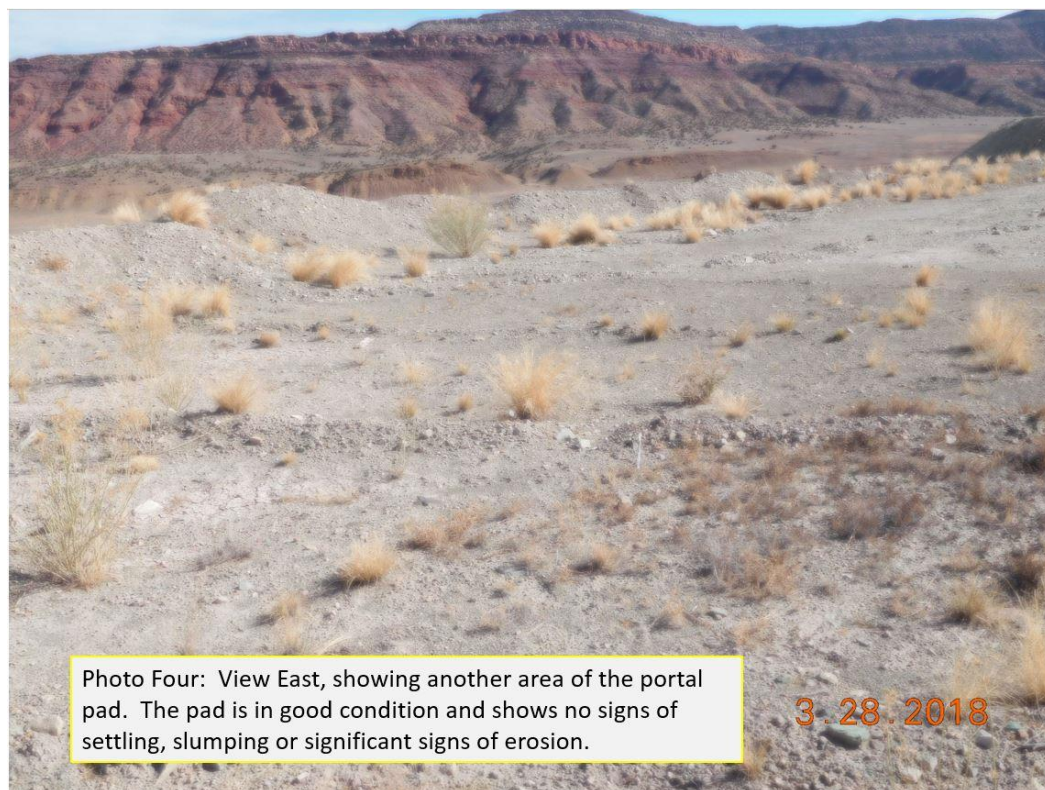
The main pad and work area was in good condition as seen in Photos Three and Four, evidence of weed management during the growing season was observed. The whole site exhibits positive drainage and no erosional issues were observed at this time. A concrete slab foundation is located on the portal pad measuring approximately 20 x 30 ft. with an adjacent utility pole and line. The foundation, utility pole and wire are slated to be removed during final reclamation. The portal pad area has begun to revegetate itself with volunteer species.
