MINERALS PROGRAM INSPECTION REPORT
PHONE: (303) 866-3567

MINE NAME: Lyons Pit	MINE/PROSPECTING ID#: M-1974-015	MINERAL: Sand and gravel	COUNTY: Boulder
INSPECTION TYPE: Monitoring	INSPECTOR(S): Peter S. Hays	INSP. DATE: March 8, 2018	INSP. TIME: 09:00
OPERATOR: Martin Marietta Materials, Inc.	OPERATOR REPRESENTATIVE: Julie Mikulas	TYPE OF OPERATION: 112c - Construction Regular Operation

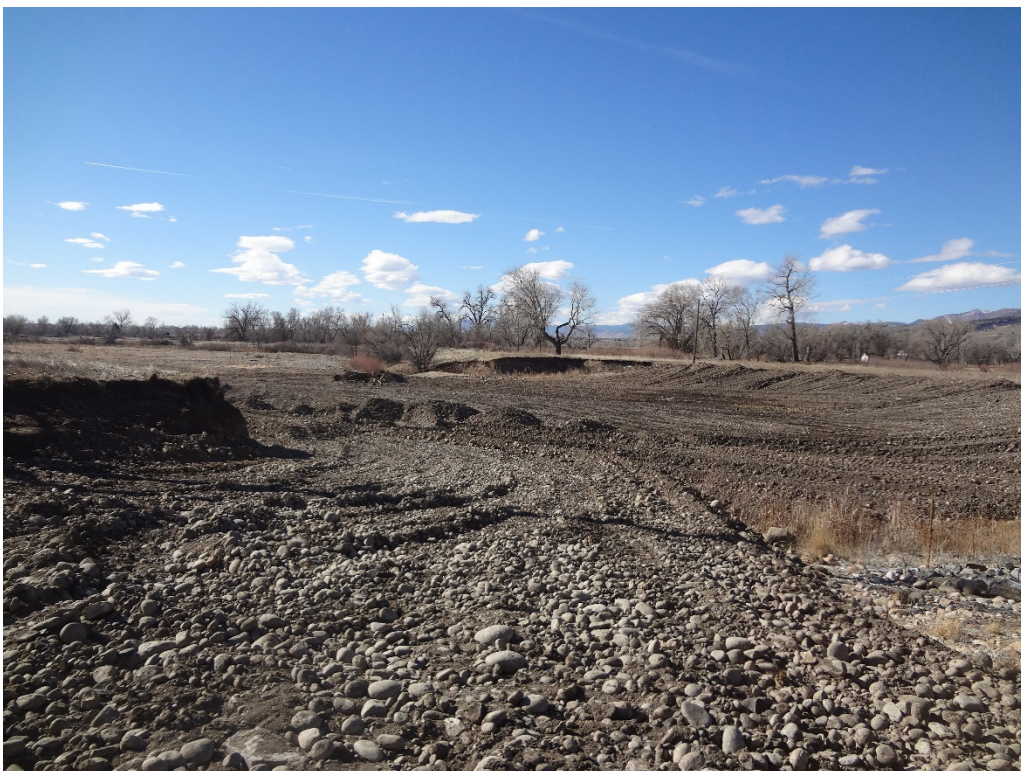
View of partially graded northwest corner of Lake 2 looking southeast from breach location

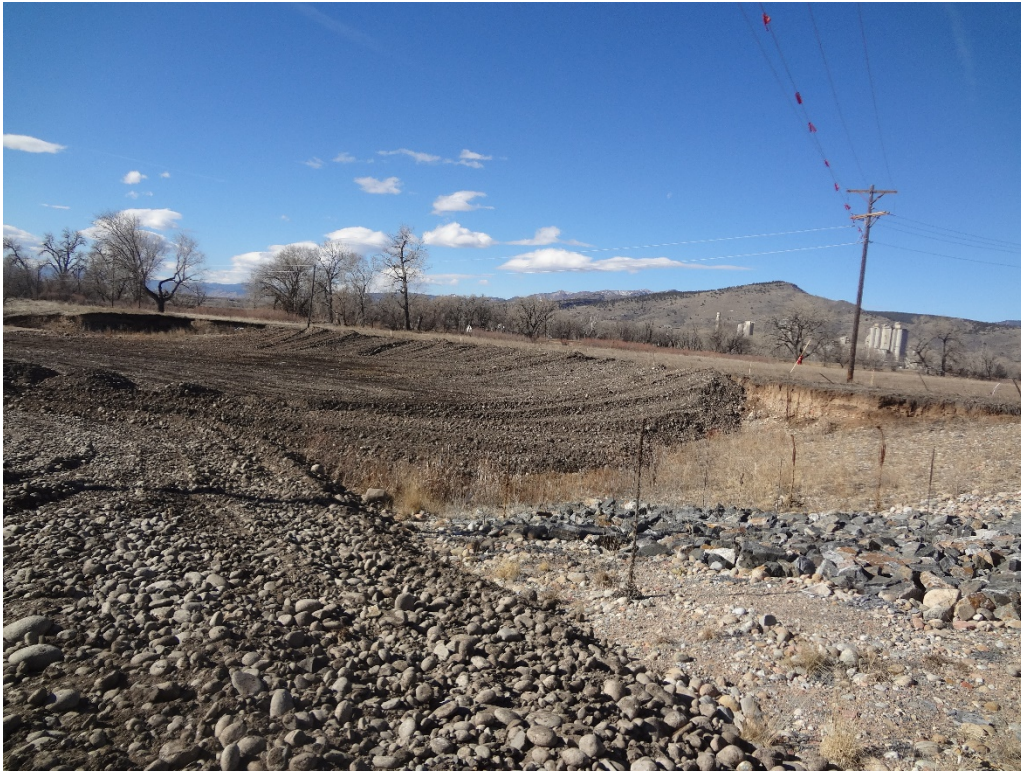
View of partially graded northwest corner of Lake 2 looking south from breach location

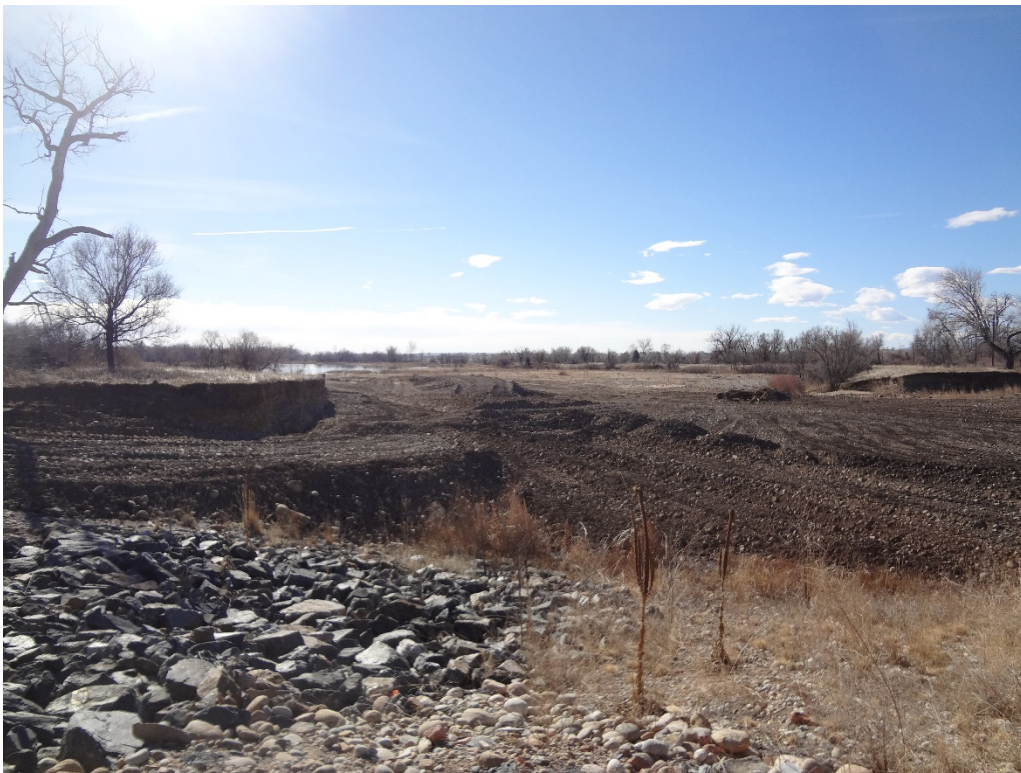
View of partially graded northwest corner of Lake 2 looking east from the breach location

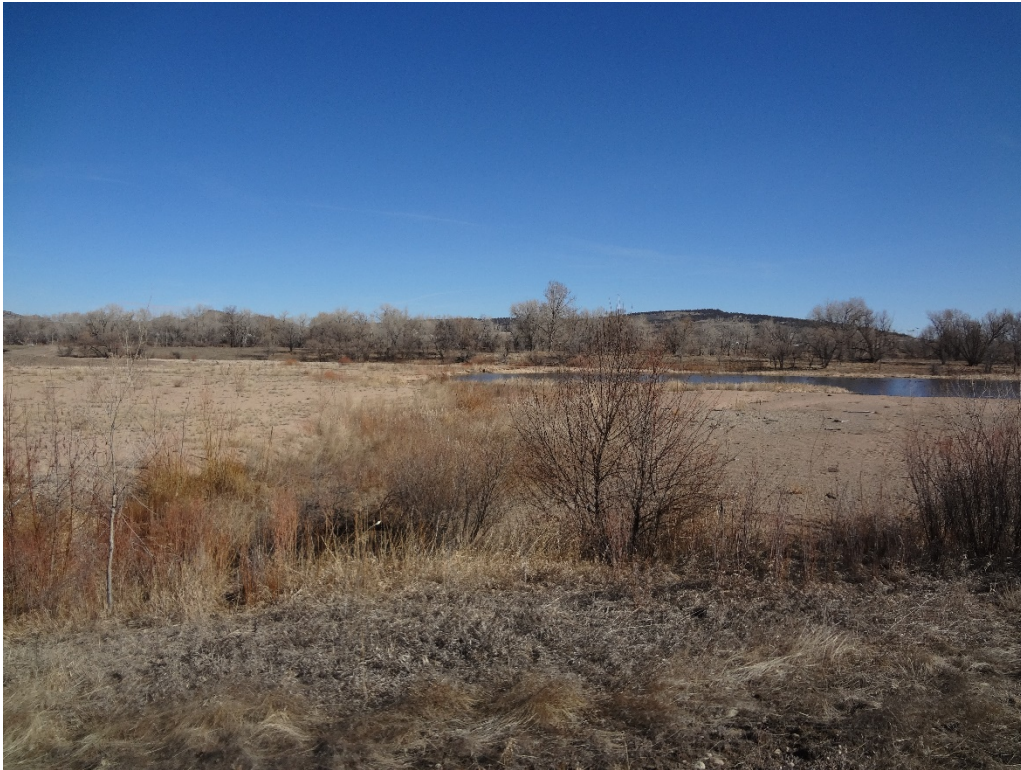
View of Lake 3 from the southwest corner of the lake looking at flood damage

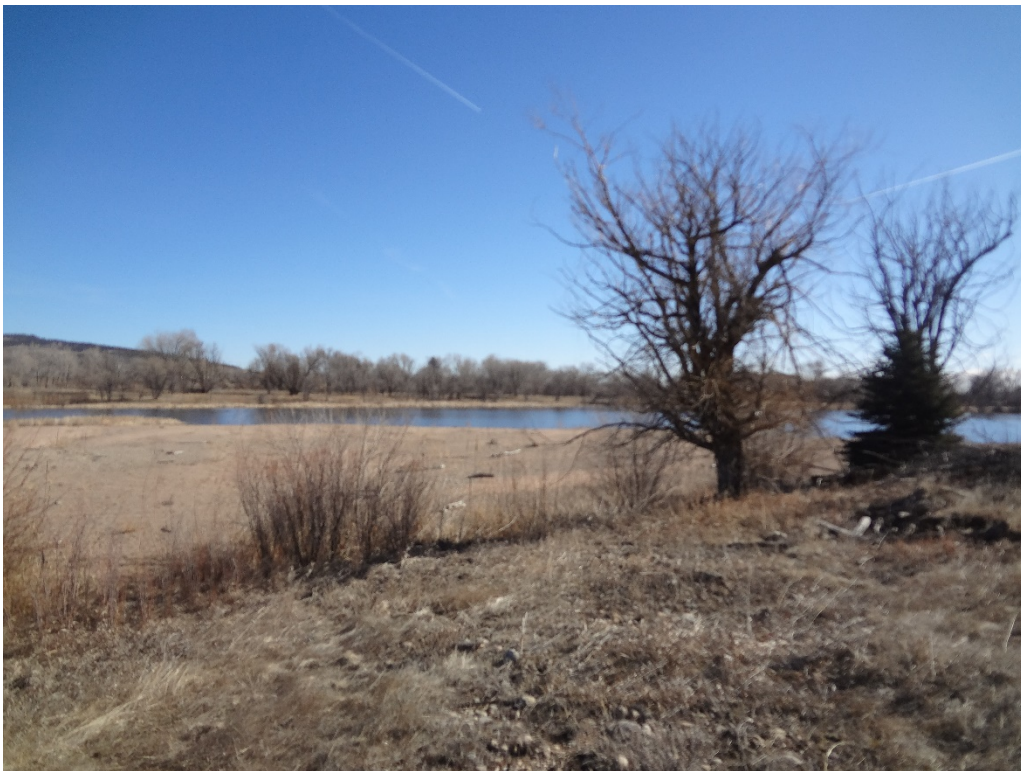
View of Lake 3 from the southwest corner of the lake looking at flood damage

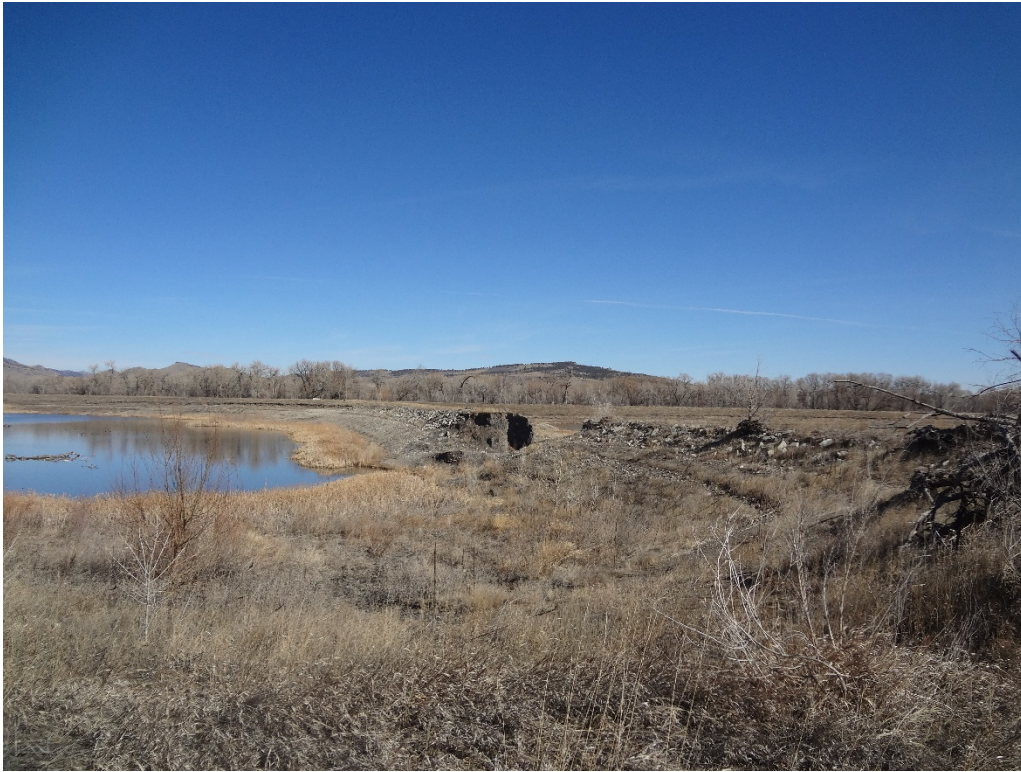
The slurry wall around Lake 4 was breached in two locations along the western bank and in the southeast corner. The Operator stated Boulder County is in the bid process to have the slurry wall repaired.

View of the south slurry wall breach in Lake 4 looking north

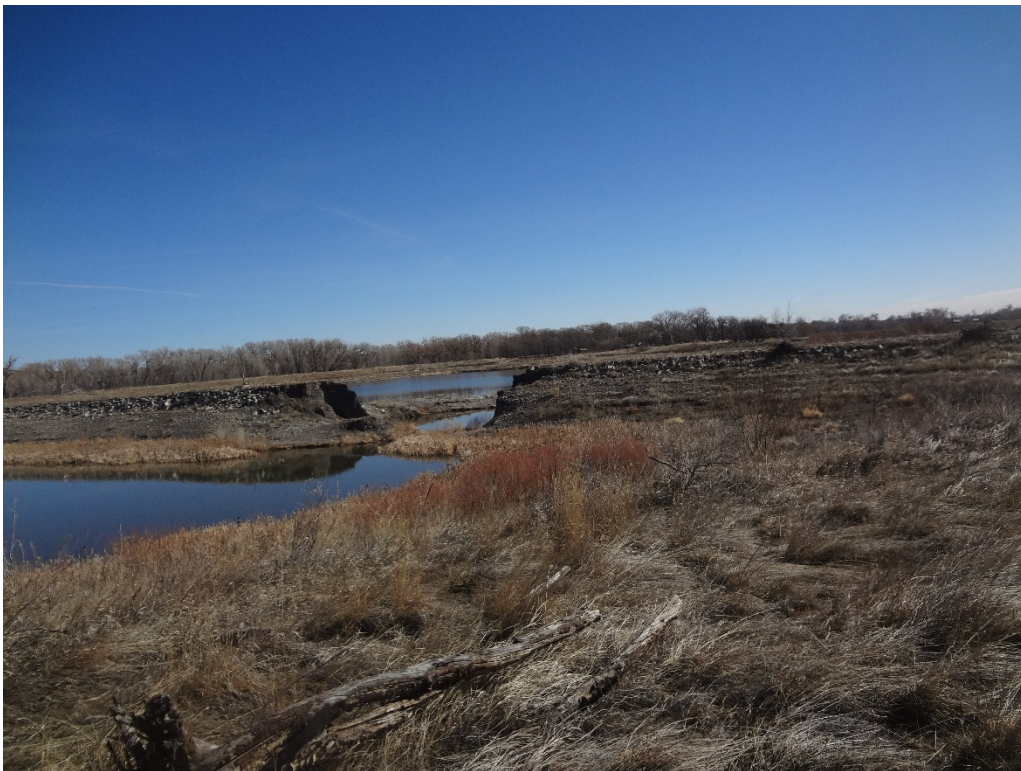
View of the south slurry wall breach in Lake 4 looking northeast

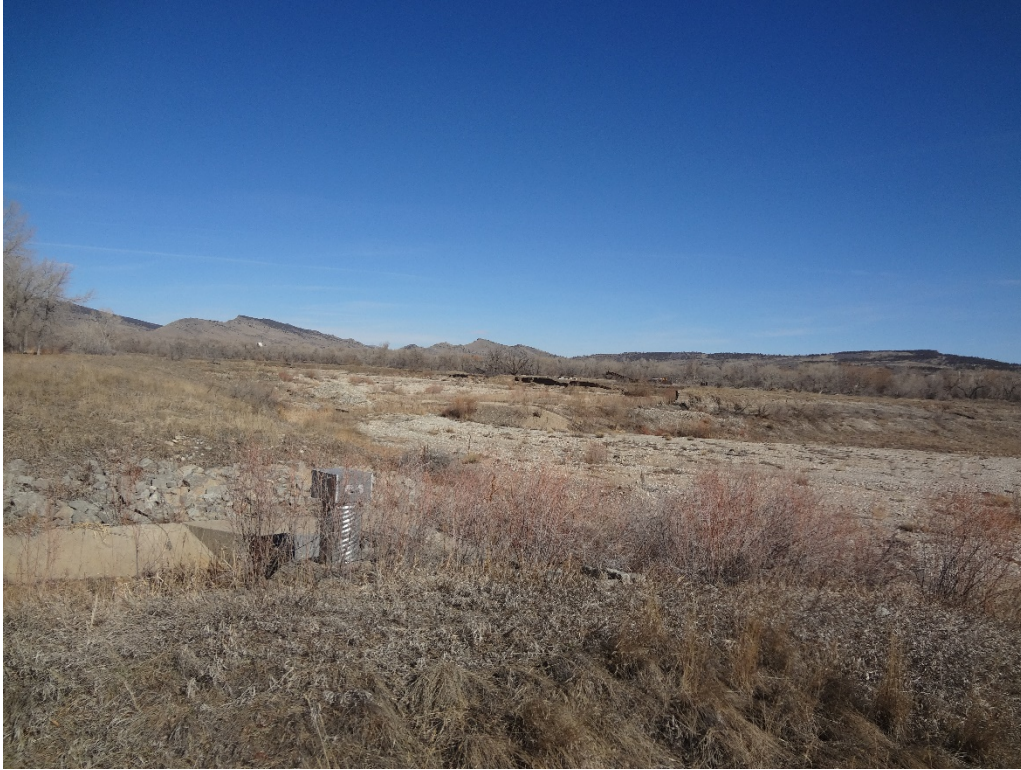
View of the north slurry wall breach in Lake 4 looking northwest

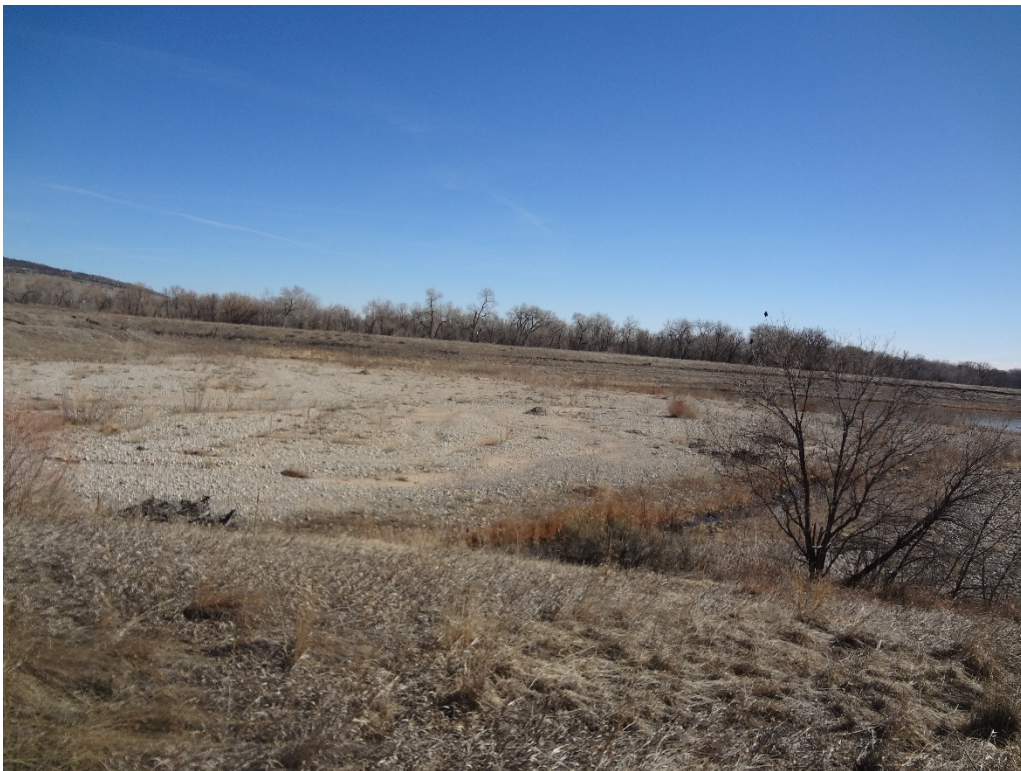
View of flood damage in Lake 4 from the southwest corner looking north
