MINERALS PROGRAM INSPECTION REPORT
PHONE: (303) 866-3567

MINE NAME: Sunday Mine	MINE/PROSPECTING ID#: M-1977-285	MINERAL: Uranium and vanadium	COUNTY: San Miguel
INSPECTION TYPE: Monitoring	INSPECTOR(S): Lucas J. West, Russ Means	INSP. DATE: March 28, 2018	INSP. TIME: 08:45
OPERATOR: Pinon Ridge Mining LLC	OPERATOR REPRESENTATIVE: George Glasier, Mike Rutter	TYPE OF OPERATION: 112d-2 - Designated Mining Operation

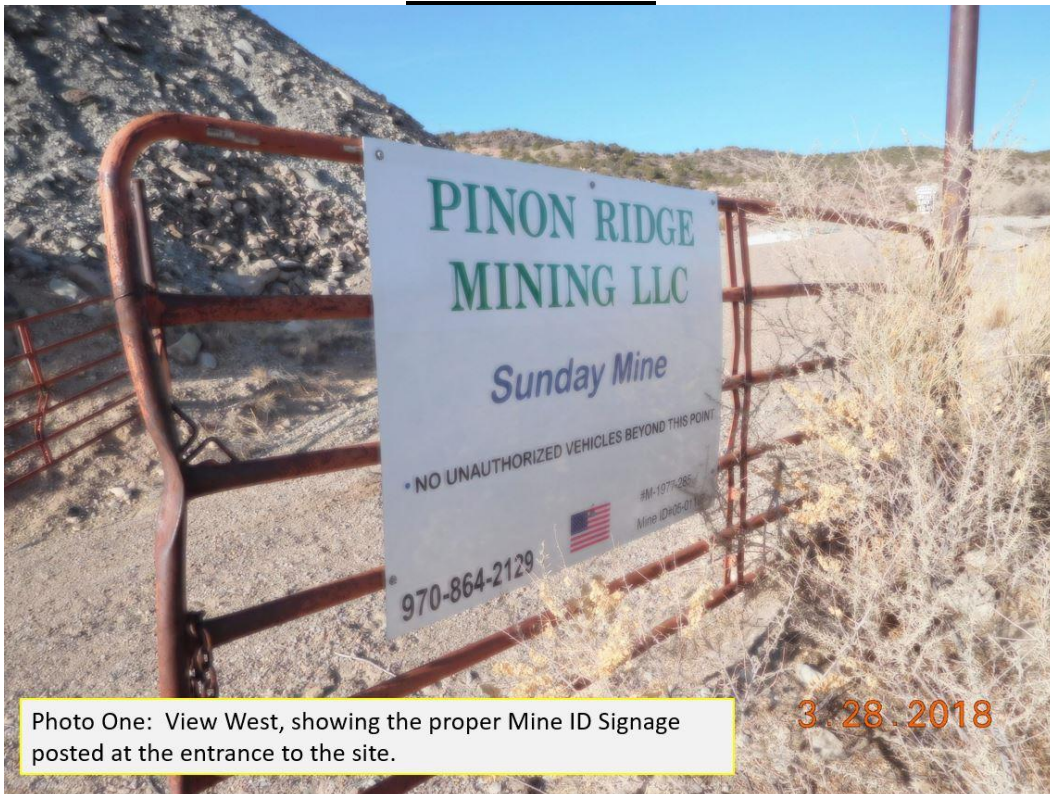
As seen in Photo One, the permit ID sign was observed at the entrance to the site. The permit boundary markers were also observed. Photo Two shows an example of the sediment catchment basins that are located on site as part of the storm water management plan. All storm water control devices are in good condition and appear to be functioning as designed. All diversion ditches appear to be functioning as designed and no significant erosion was observed throughout most of the site. An example of one of the diversion ditches located on site can be seen in Photo Three.

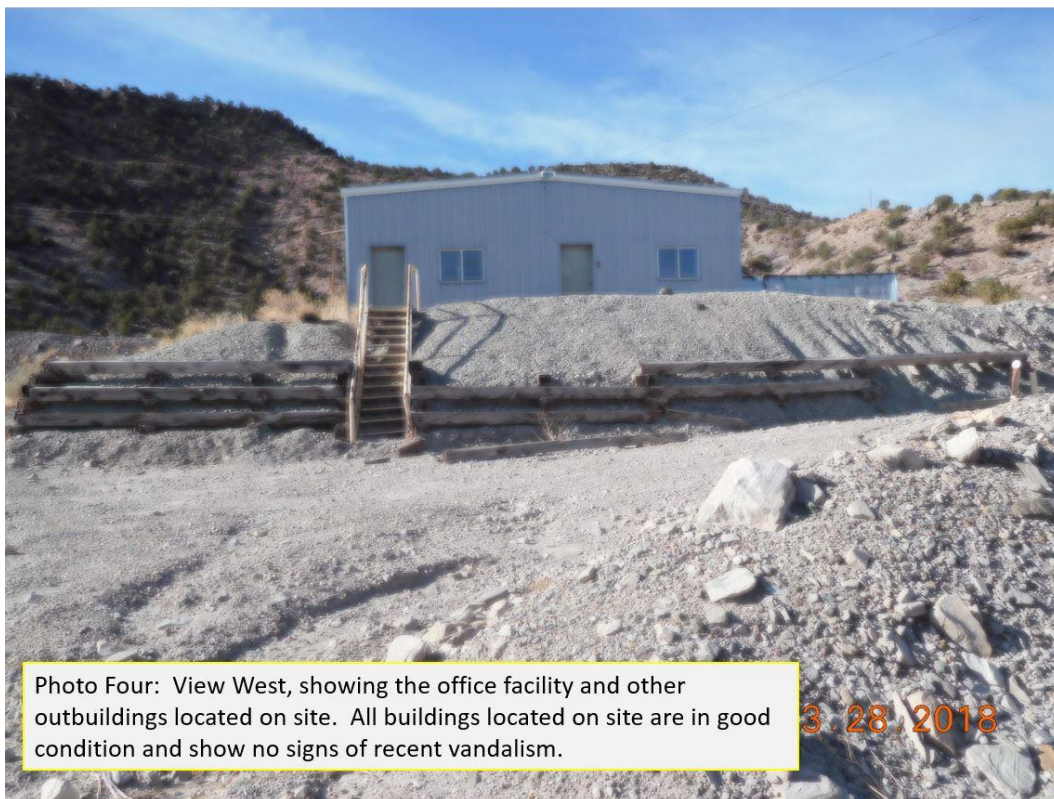
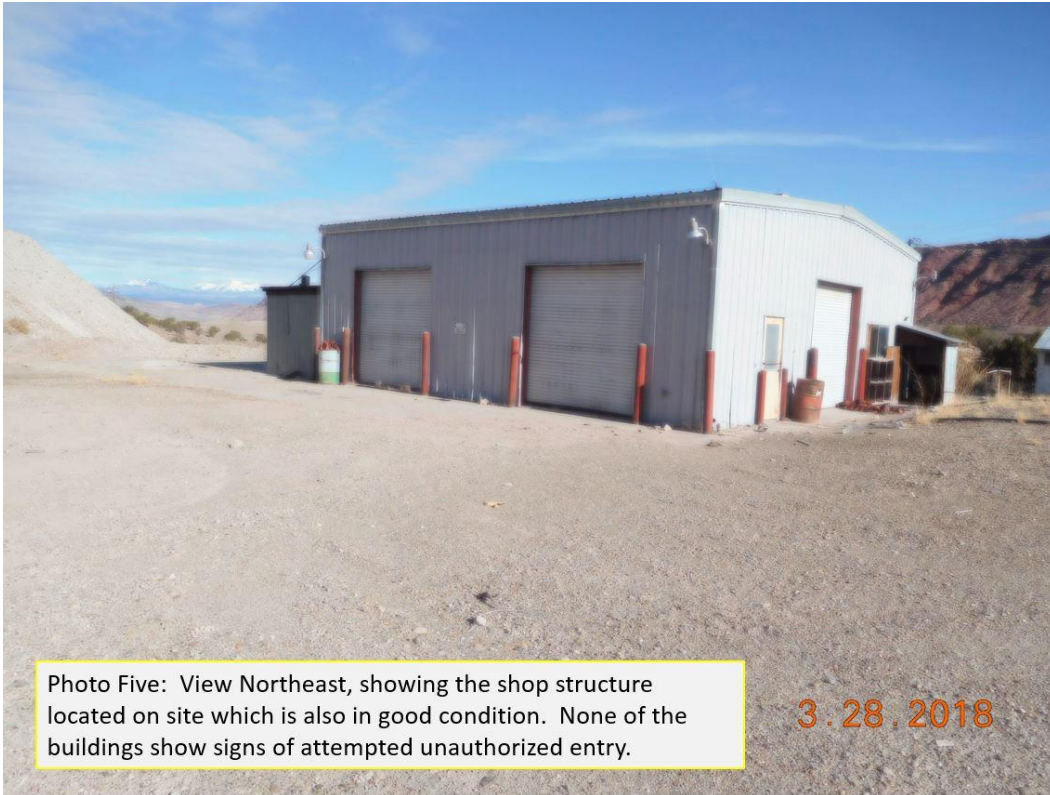
All work facilities were secure and seemed to be in good condition during the time of the inspection. No signs of vandalism or general site degradation were noted. Examples of the work facilities can be seen in Photos Four and Five. The portal located on site was also secured. The portal has been backfilled and closed off with steel grates that are in good condition as seen in Photo Six. Vent shaft S-2, located to the Northwest of the shop facilities is covered with a steel grate and has been secured. All loadouts, roads and pad areas that exist on site were observed and in good condition. Evidence of chemical weed treatment was observed and the operator expressed that weed management is ongoing throughout the whole Sunday Mine Complex.
