MINERALS PROGRAM INSPECTION REPORT PHONE: (303) 866-3567

MINE NAME:		MINE/PROSPECTING ID#:	MINERAL:	COUNTY:		
St Jude Mine		M-1978-039-HR	Uranium and vanadiu	San Miguel		
INSPECTION TYPE:		INSPECTOR(S):	INSP. DATE:	INSP. TIME:		
Monitoring		Lucas J. West	March 28, 2018	10:22		
OPERATOR:		OPERATOR REPRESENTATIVE:	TYPE OF OPERATION:			
Pinon Ridge Mining LLC		George Glasier, Mike Rutter	110d - Designated Limited Impact			
REASON FOR INSPECTION:		BOND CALCULATION TYPE:	BOND AMOUNT:			
Normal I&E Program		Complete Bond	\$47,700.00			
DATE OF COMPLAINT:		POST INSP. CONTACTS:	JOINT INSP. AGENCY:			
NA		None	None			
WEATHER:	INSPECTOR'S SIGNATURE:		SIGNATURE DATE:			
Clear	Agan		April 5, 2018

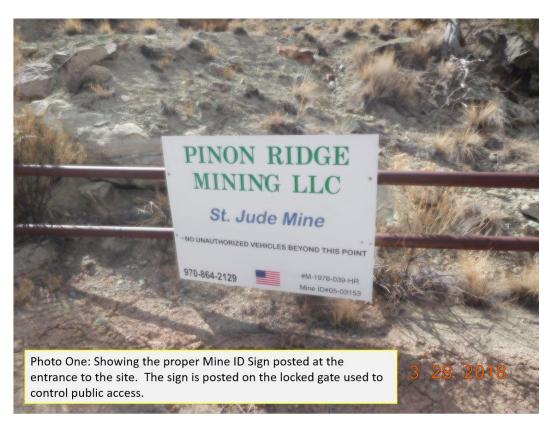
As seen in Photo One, the permit ID sign was observed at the entrance to the site. The permit boundary markers were also observed. All disturbances are contained within the permitted areas. The remote vent shaft sites were not inspected at this time. The diversion ditches and storm water control devices appear to be functioning as designed and no significant erosion was observed throughout the site. The main work area, adjacent to the portal and shops, appeared to be stable and in good condition. The portal located on this site has been backfilled and secured. Photo Two shows the earthen cover placed over the portal. No evidence of vandalism or attempted unauthorized entry to the portal was observed during the inspection.

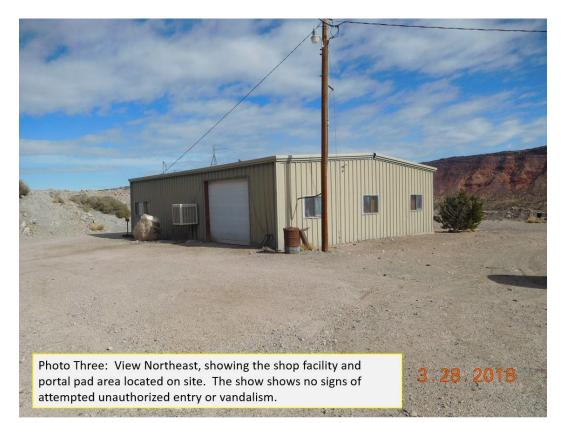
All work and shop facilities onsite were secured and appeared to be in good condition as seen in Photo Three. No fuel storage containers were observed on site. Various other debris was observed on site however it was stored in an orderly fashion and was not a concern at this time. The waste rock dump storage area was observed, and appears to be stable and in good condition. The waste rock stored in the area can be seen in Photos Four and Five.
