**COLORADO**Division of Reclamation,
Mining and Safety

MINERALS PROGRAM INSPECTION REPORT**PHONE: (303) 866-3567**

MINE NAME: Salt Canyon Project	MINE/PROSPECTING ID#: M-1997-064	MINERAL: Anhydrite, Gypsum	COUNTY: Fremont
INSPECTION TYPE: Monitoring	INSPECTOR(S): Timothy A. Cazier	INSP. DATE: March 28, 2018	INSP. TIME: 08:30
OPERATOR: GCC Rio Grande, Inc.	OPERATOR REPRESENTATIVE: Joseph Joshua	TYPE OF OPERATION: 112c - Construction Regular Operation	
REASON FOR INSPECTION: Normal I&E Program	BOND CALCULATION TYPE: Partial Bond	BOND AMOUNT: \$69,832.00	
DATE OF COMPLAINT: NA	POST INSP. CONTACTS: Colo. Land Board	JOINT INSP. AGENCY: None	
WEATHER: Clear	INSPECTOR'S SIGNATURE:

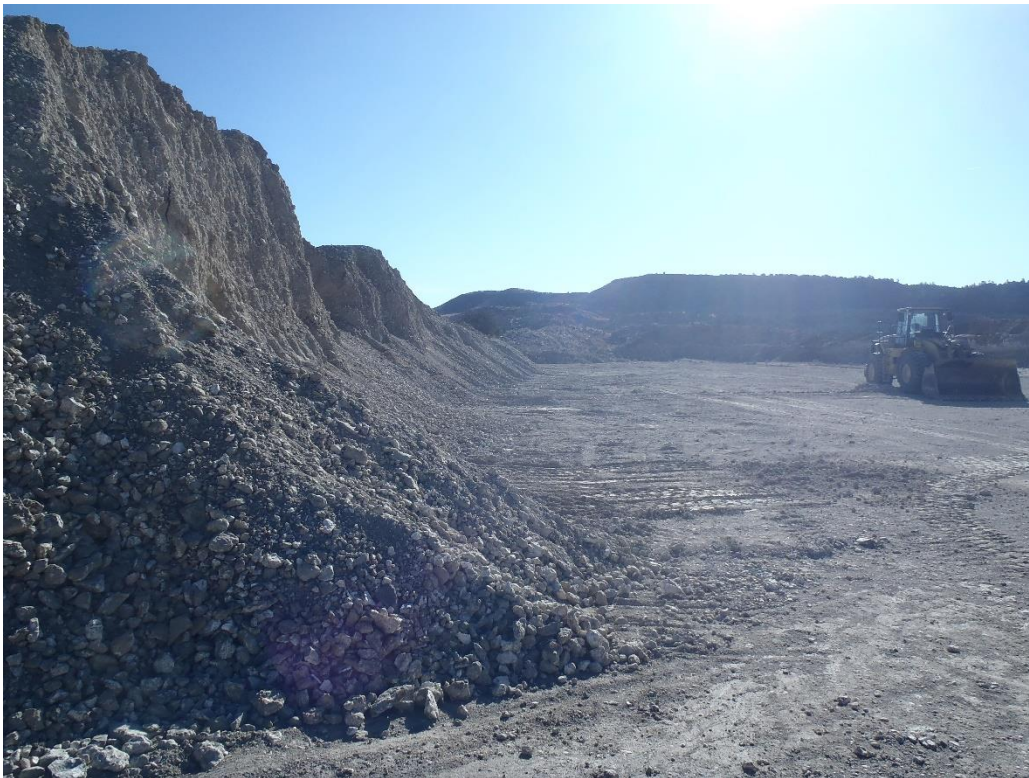
Photo 1. North side highwall (looking east).

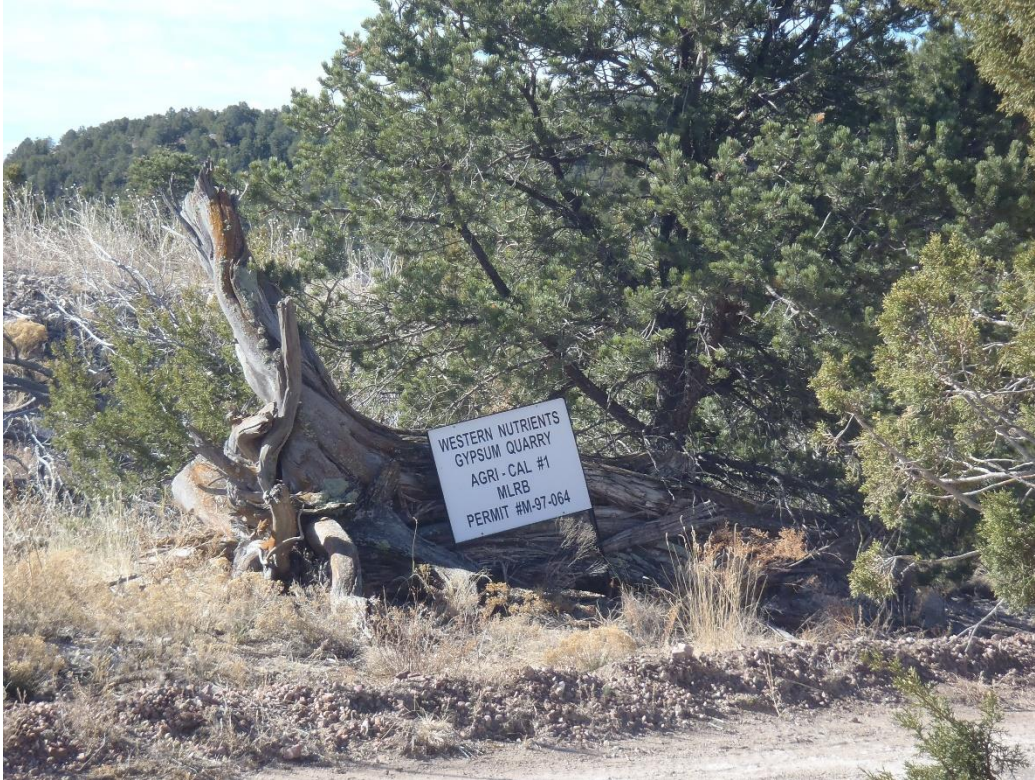
Gen. Compliance with Mine Plan: The operation appeared to be in compliance with the approved mine plan with the exception of missing boundary markers on the west side as discussed under "Signs and Markers" below. Google Earth was used to measure the disturbed area, which was estimated to be approximately 15 acres, based on June 2017 satellite imagery. Highwalls were estimated to vary between 8 and 12 feet in height and appeared stable (see **Photo 1**). Mine representatives indicated the mine progression is towards the southeast and a rough estimate for the remaining life of mine is 10 years. This Inspector reminded the site representatives that the previously disturbed area mined by Western Nutrients (see **Photo 2**) is considered part of the current disturbed area.

Photo 2. Old permit sign at entrance to area mined by Western Nutrients (included in affected area).

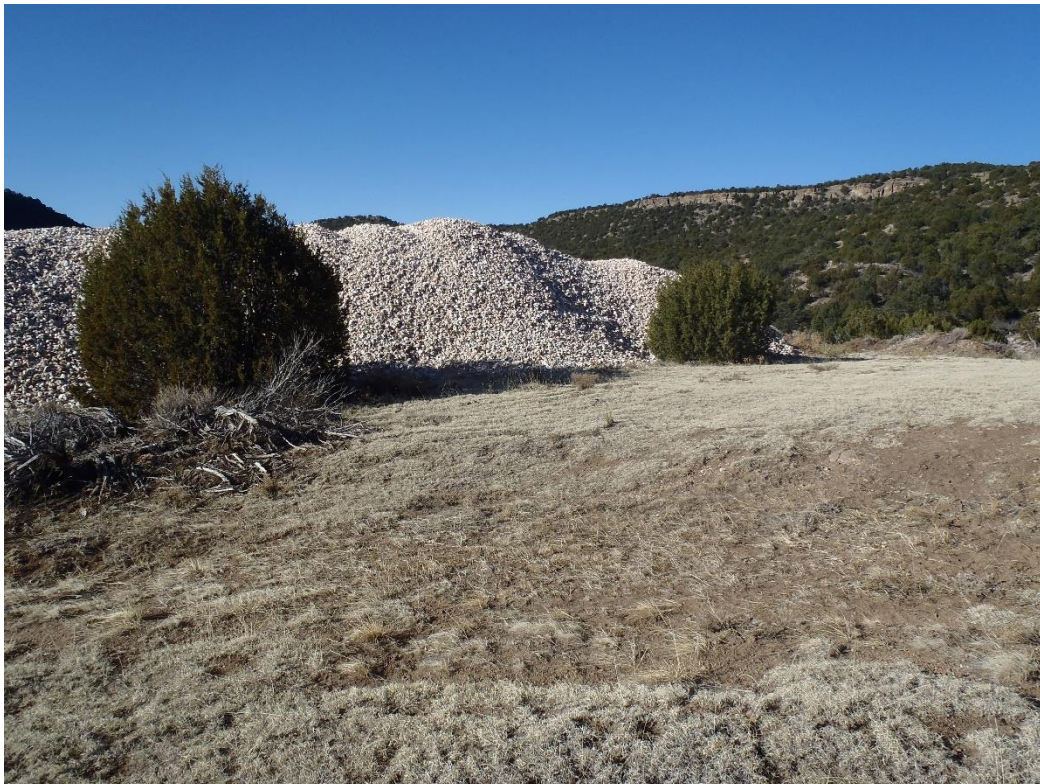
Off-site Damage: A Google Earth review suggested stockpiles on the northwest (see **Photo 3**) may be outside the permit affected area boundary as indicated by the red cloud on the **enclosed Pre-Inspection Map**. This inspector could not confirm this as the boundary was not marked on the ground as discussed under "Signs and Markers" below. The lack of boundary markers on the majority of the affected area permit boundary is cited as a problem under Signs and Markers. The missing markers will need to be placed as part of the Corrective Action for this problem. Once the boundary markers are placed, the Division will determine whether or not mining activity has occurred outside the affected area boundary. If this proves to be the case, additional problems may be cited.

Photo 3. Product stockpile near affected area boundary (NW side).

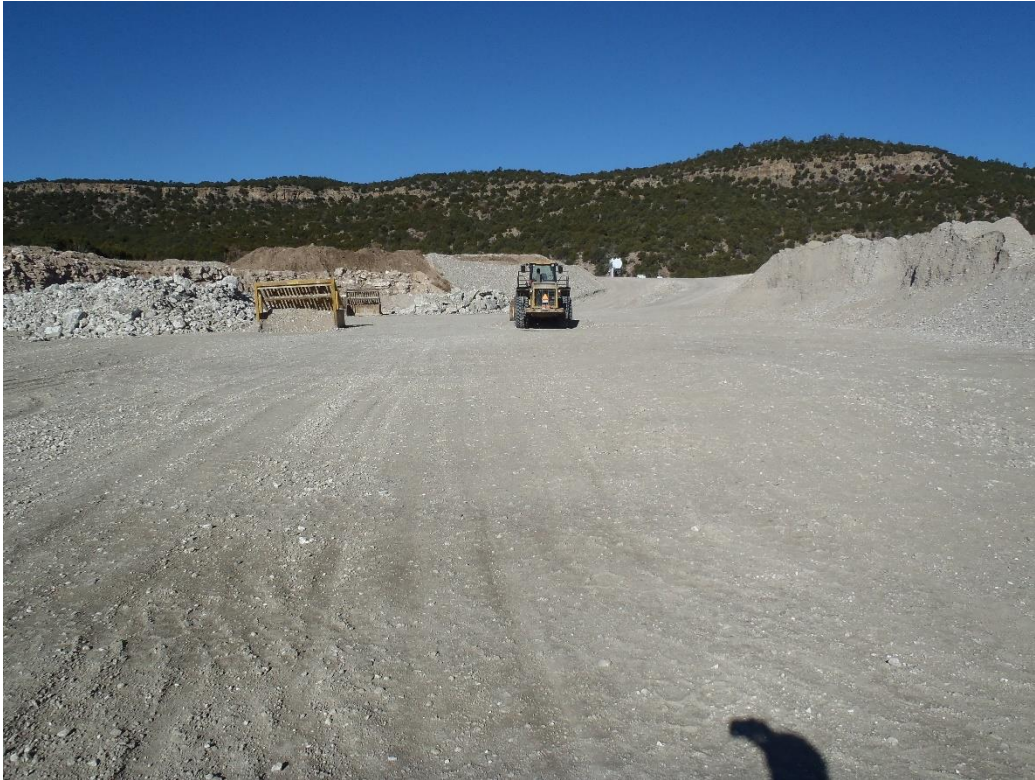
Support Facilities On-site: Two screens and a loader were observed on site (see **Photo 4**).

Photo 4. Screens and loader (looking west).

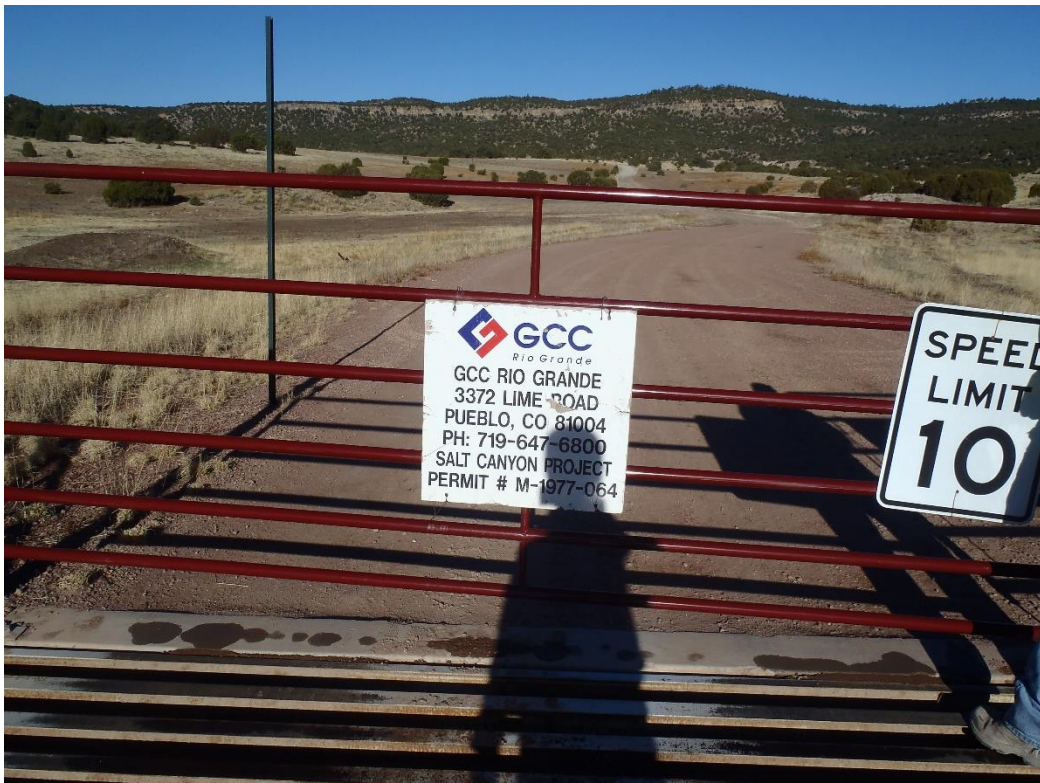
Signs and Markers: The permit sign was properly posted (see **Photo 5**). The affected area boundary apparently is only marked by a fence on the southeast. No other boundary markers could be located in the field. **The missing boundary markers are cited as a problem on page 1 of this report.**

Photo 5. Permit sign at entrance off Hwy 115.

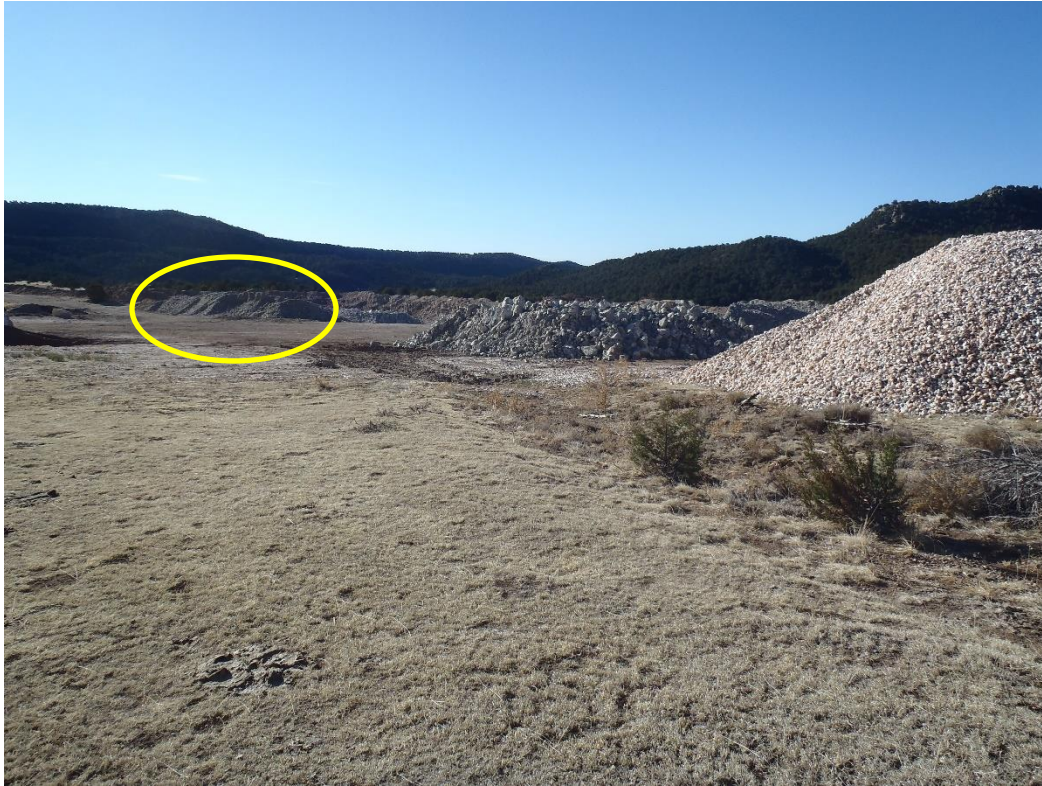
Topsoil: Topsoil stockpiles were observed as berms along the haul road (see **Photo 6**) and appeared stable.

Photo 6. Typical topsoil stockpile berm along haul road (NW side, looking SE).
