Re: King I Mine, C-1981-035
Stoner Engineering: Quarterly Inspection: Water Quality Improvements
1st Quarter 2018

Re: King Coal I – Quarterly Water Quality Improvements Inspection

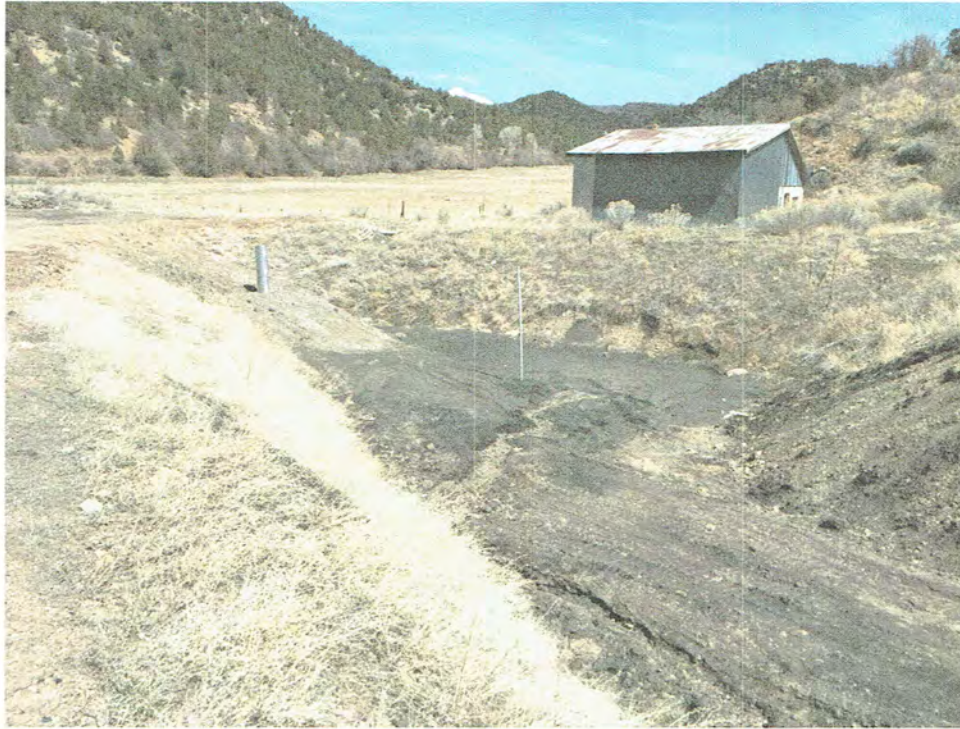
Both ponds were dry at the time of the inspection (see Pic's. 1 & 2). The ponds are both in generally good condition. The required storage volume appears to be adequate at this time based upon the sedimentation gages installed. The ponds should continue to be monitored after storm events to ensure that excess sediment does not reduce the required storage capacity available for storm water runoff.

Pic. 1 – East pond.

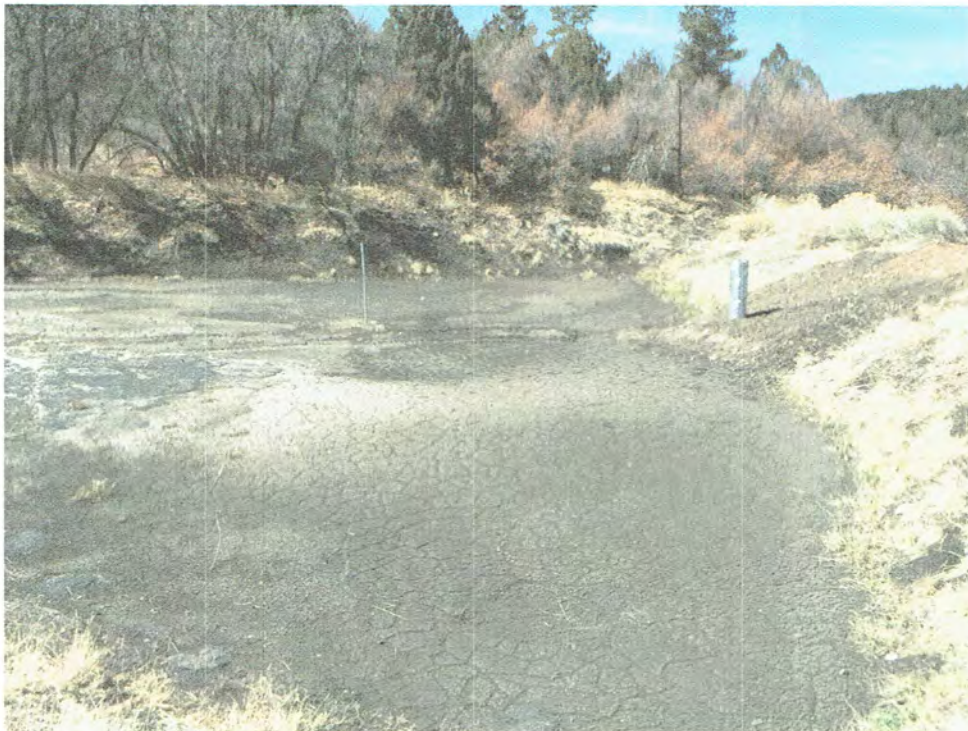
Pic. 2 – West pond.

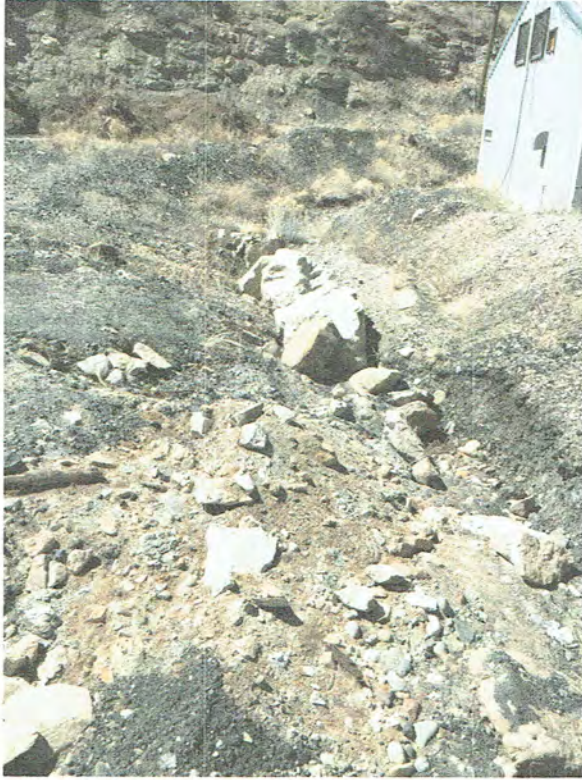
The drainage ditches and pipes were generally in good condition based upon a visual inspection from the inlet and outlet locations. There was some riprap added to the ditch leading to the west pond in an attempt to limit erosion during runoff events (see Pic. 3). All pipes, ditches and sediment traps should be inspected and repaired as necessary, especially after storm events.

Pic. 3 – New riprap in ditch to west pond.

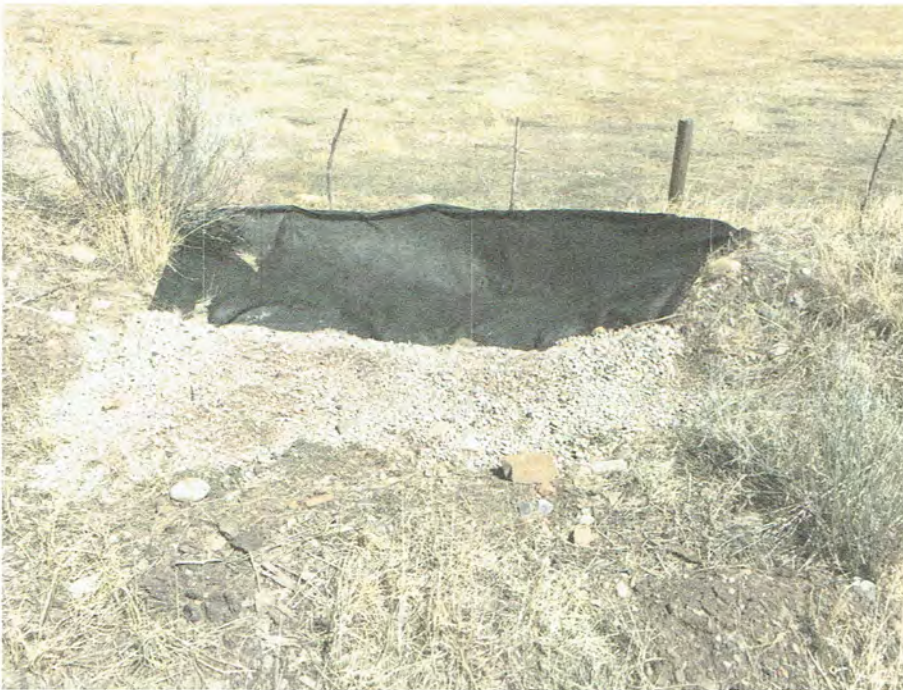
The sediment traps located along the west side of the driveway at the entrance are in good condition though the sediment trap on the east side of the driveway has been repaired (see Pic. 4).

Pic. 4 – Sediment trap along east side of driveway has been repaired.
