Re: King I Mine, C-1981-035
Stoner Engineering: Quarterly Inspection: Refuse Pile
1st Quarter 2018

Re: King Coal I – Quarterly Waste Pile/Embankment Inspection

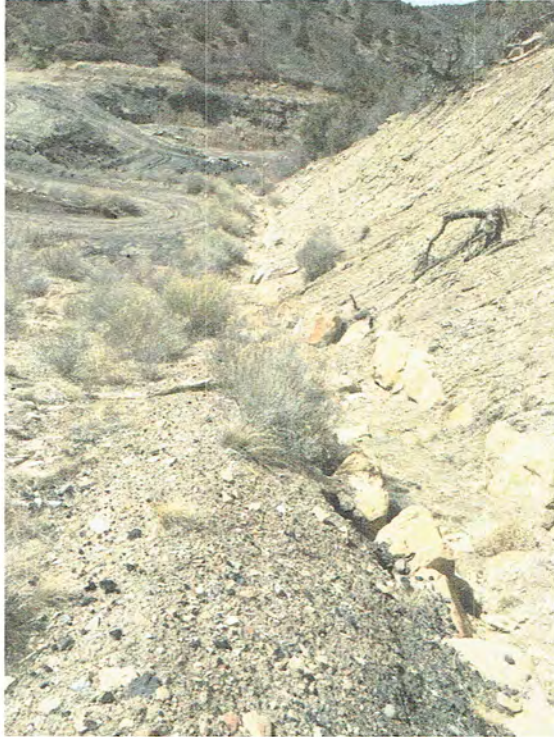
The condition of the perimeter ditches located along the north and south sides of the property were generally in good condition. The drainage channels were generally clear of debris (see Pic. 1) and there was no damage observed to any of the channel sections. The pipe sections were found to be clear of debris and functioning as designed (see Pic. 2).

Pic. 1 – North channel in good condition.

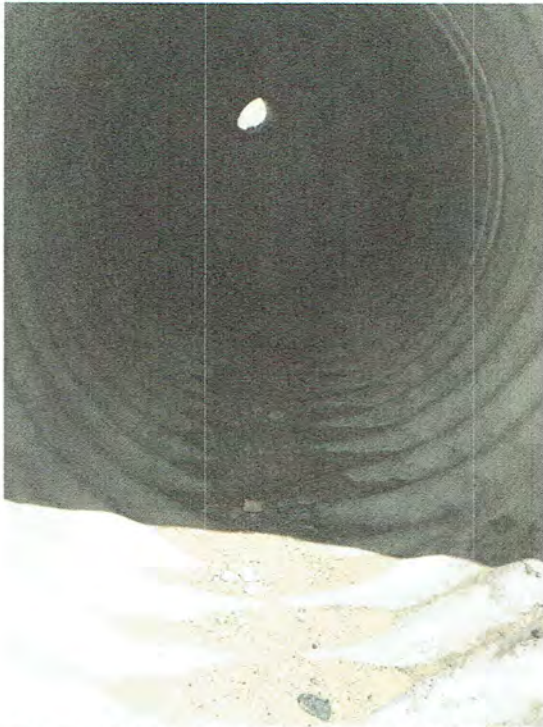
Pic. 2 – Culvert under road near top of embankment.

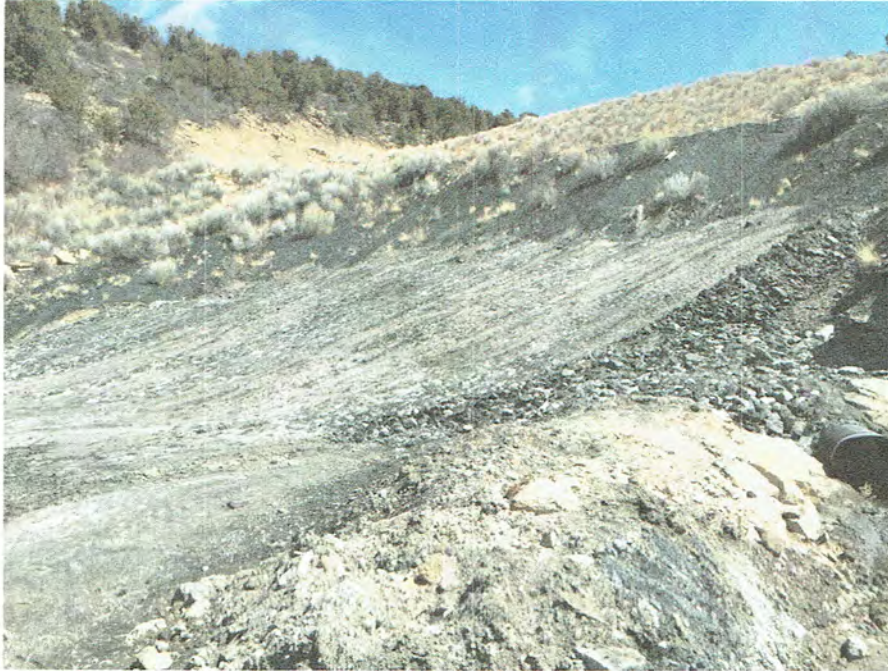
Additional embankment fill continues to be stockpiled and placed at the base of the waste pile/embankment (see Pic. 3). The existing grade to the west of the under drain outlet has been improved to direct flows away from the pipe outlet (see Pic. 4). At the time of the inspection there was a small amount of water located at the pipe outlet. Standing water can accumulate near the pipe outlet to a depth of approximately two inches before it flows away in the newly improved channel. This area should be monitored and maintained regularly given the proximity of the tie-in location of Reach 10 and the potential for sedimentation to inhibit flows from the under drain. The pipe that drains into Reach 10 is clear of debris/sediment and appears to be functioning as designed (see Pic. 5). There was no visible staining at the outlet at the time of the inspection.

Pic. 3 – New material installed at base of embankment/waste pile.

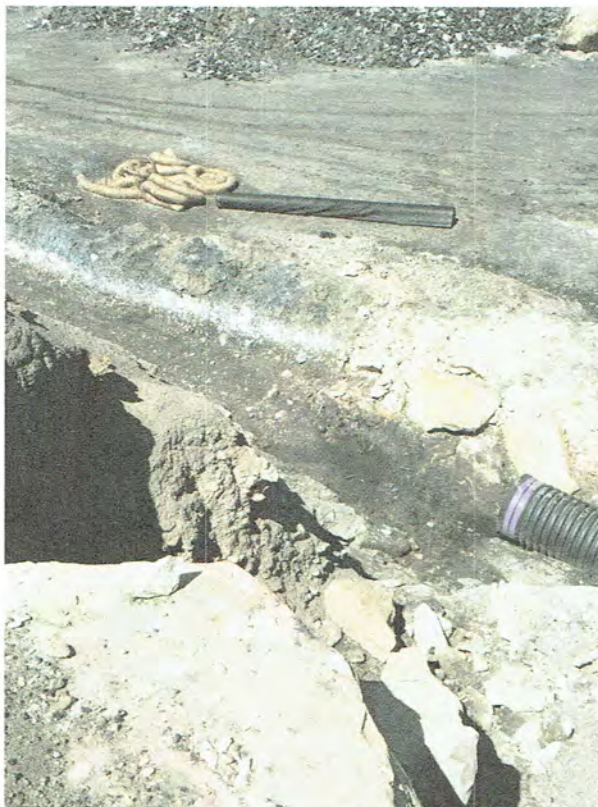
Pic. 4 – Grading improved at outlet of under drain from Reach 10 ditch.

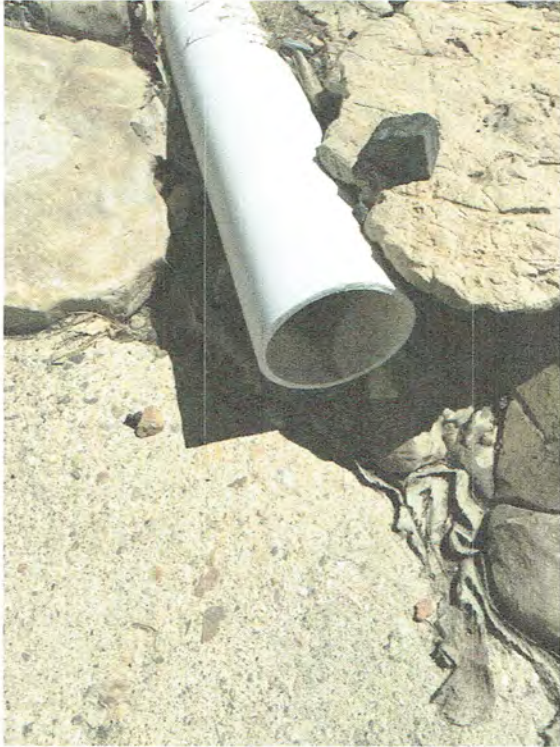
Pic. 5 – Pipe drain into Reach 10.

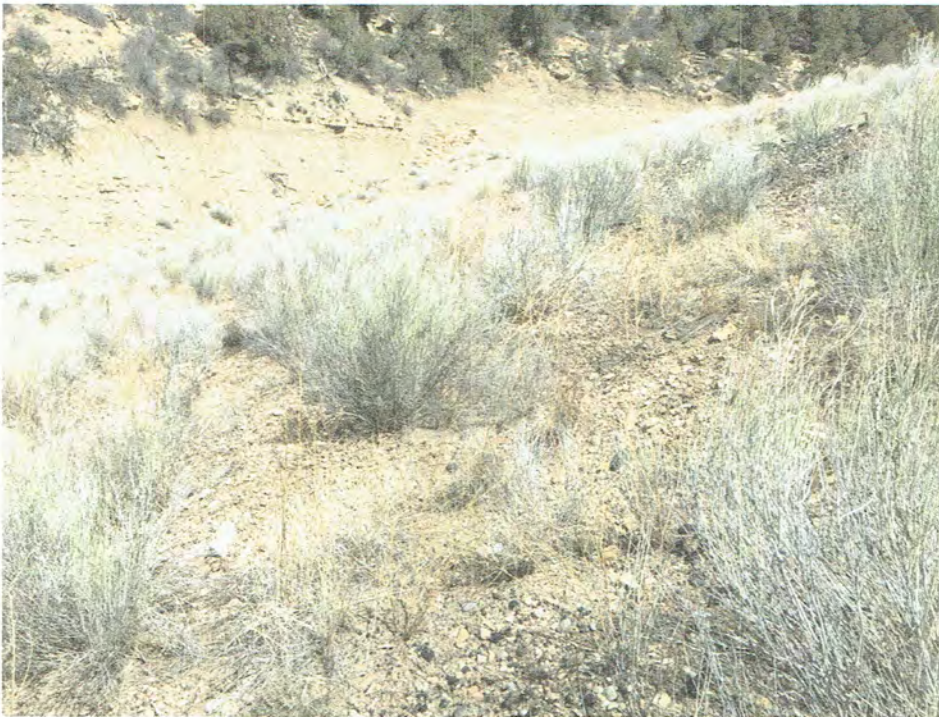
There is no material stockpiled at the top of the embankment as it is currently being installed at the base of the waste pile/embankment. The face of the embankment was in good condition and does not show any signs of excessive erosion, instability or weakness (see Pic. 6).

Pic. 6 – Waste pile/embankment face in good condition.
