PITCH RECLAMATION PROJECT COLORADO MINED LAND RECLAMATION BOARD 2017 ANNUAL RECLAMATION REPORT

RECLAMATION PERMIT NUMBER M-1977-004

Homestake Mining Company of California P.O. Box 40 Sargents, Colorado 81248

April 19, 2018

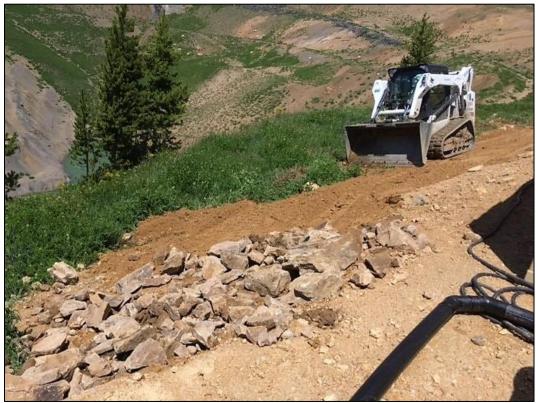
Photograph 1: Riprap being placed adjacent to the underground mine workings injection system platform

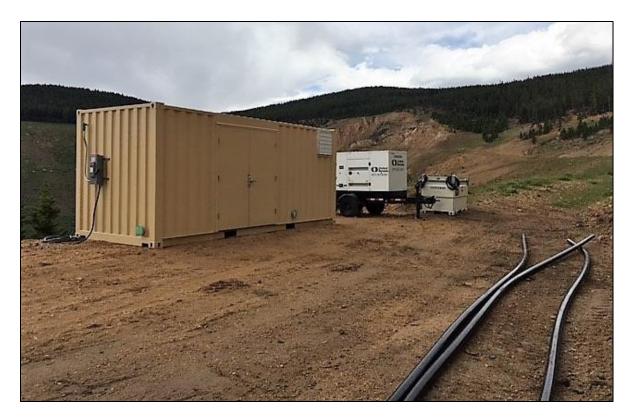
Photograph 2: Underground mine workings injection system platform

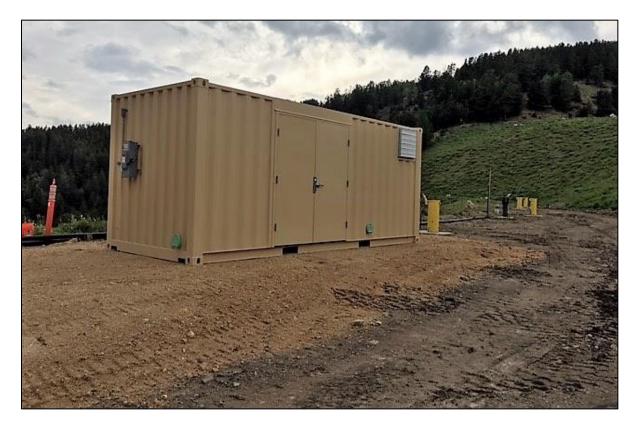
Photograph 3: Indian Rock Dump injection system platform

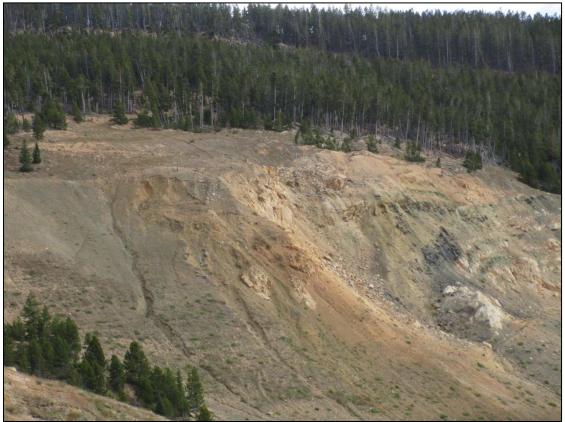
Snowmelt, summer precipitation, and springs in the east wall of the North Pit have caused recurring erosion since the pit was developed almost four decades ago. A topographic low exists on the east wall of the North Pit between the 10,800 and 10,600 benches that concentrates surface drainage from a relatively large area above the crest of the east wall. In 2010, displacement in the 10,600 bench, coupled with snow pack and precipitation, caused a pond to form. The pond was graded and filled to re-establish appropriate drainage along the bench. The repairs were effective in keeping water from ponding on the 10,800 and 10,600 benches. In 2012, a diversion ditch was constructed to channel water from the 10,800 bench to the 10,600 bench and on to the "Spring" channel. This channel was effective until May 2015 when a sluff occurred on the east wall of the North Pit below the 10,800 bench. The area continues to be monitored following snowmelt to confirm that water does not pond on the 10,800 or 10,600 benches. Photograph 7, taken in 2017, shows that no additional sluffing has occurred on the east wall of the North Pit since 2015. Photograph 8 shows the diversion ditch in 2017. Photograph 9 was taken in October 2017 following fertilizer addition on the 10,800 bench above the diversion ditch. Straw bales were also placed for additional erosion control.

Photograph 7: East Wall of North Pit below the 10,800 bench in 2017 showing no additional sluffing

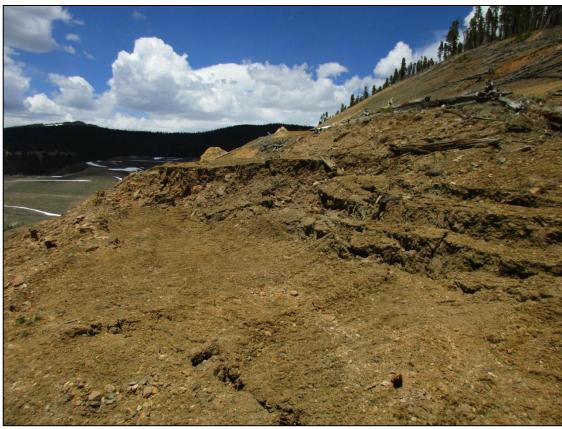
Monitoring in 2015 identified additional slope displacement on the east wall of the South Mine area, including redevelopment of tension cracks that showed both vertical and horizontal offsets. The total displacement of the tension cracks was on the order 1 to 2 feet. The heavy precipitation in late spring is likely the cause of the accelerated slope displacement and related tension crack development. In 2016, these cracks were graded closed, positive drainage of the bench was re-established, and a lower bench was added to the slope. However, the tension cracks reappeared in 2017 (Photograph 10). Additional control measures will be considered in 2018. Reclamation activities in the South Mine area was limited to monitoring of current roadways and slopes. Additional activities were conducted in the South Mine area in support of the installation of new piezometers and other injection/recirculation infrastructure as described in Section 4.

Photograph 10: Tension cracks redeveloped in 2017 in the East Wall of the South Mine area

- South Mine area: Some slope failure in the upper portion of the South Pit area that affects approximately 0.75 acre was noted. This is an area of recurring failure, and HMC is working to better understand the failure so that a more permanent fix can be developed. The failure poses no risk to public safety.

- Conduct annual surveys of the slope monitoring monuments and inclinometers.
- Conduct grading and/or surface control in the South Mine area to avoid continued degradation associated with the tension cracks in the east wall.
- Monitor the drainage channels on the east and south walls of the North Pit, the east wall of the South Mine area, and other areas throughout the property, and make improvements as necessary.
- Inspect and maintain the diversion ditch between the 10,800 and 10,600 benches on the east wall of the North Pit.

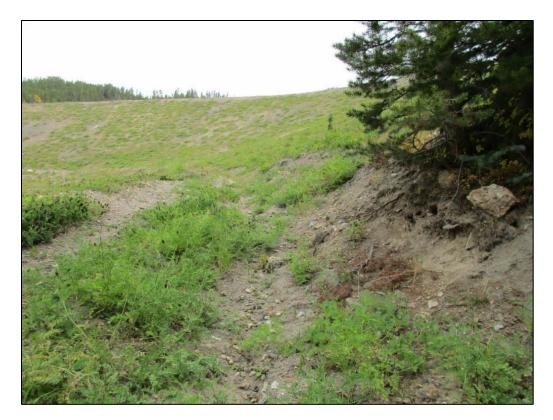
In 2012, repair work was completed on the top three benches and dump slope faces between benches to remove sediment build up that was directing snowmelt and stormwater down the dump face and creating rill erosion. Monitoring in 2017 showed that the repairs completed in 2012 have resolved issues on the top three benches and that the repairs continue to function. Photographs 11, 12, and 13, taken in 2017, show snowmelt and precipitation continue to move off the bench into the adjacent forested area with no sediment buildup and rill erosion on the face of the rock dump.

Photograph 11: Tie Camp Rock Dump upper bench

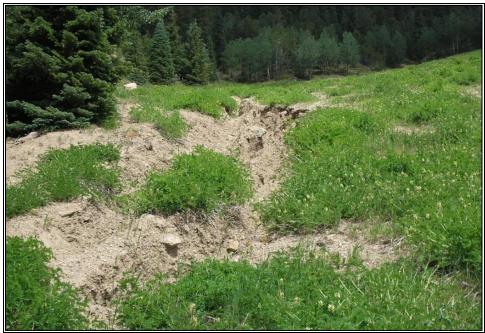
Erosion on the Indian Rock Dump was identified in 2010 (Photograph 14). Repairs were completed in 2012 and included grading and placement of boulders and riprap in the groin areas west of the Indian Rock Dump. The repairs continue to be effective in 2017 (Photograph 15).

Photograph 14: Indian Rock Dump groin area erosion in 2010

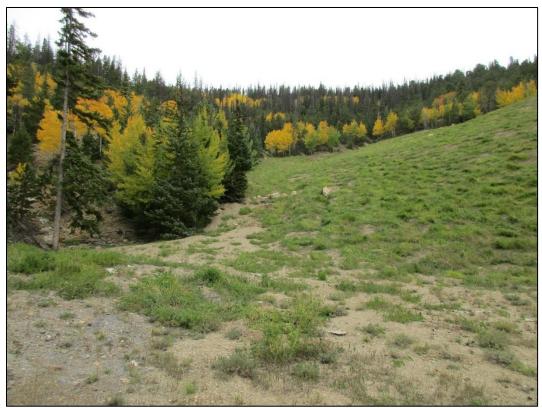
Photograph 15: Indian Rock Dump groin area in 2017 showing no additional erosion

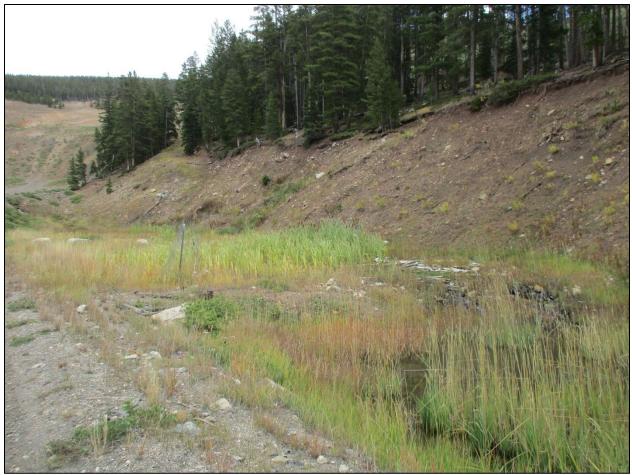
Reclamation-related activities in 2017 consisted of continued monitoring of the improvements to the constructed marsh area near the location of the former Radium Treatment Plant (RTP) and the drainages above the sediment control pond. Photograph 16 reflects the growth of cattails and sedges in 2017.

Photograph 16: Cattail and sedge growth near the former RTP site in 2017

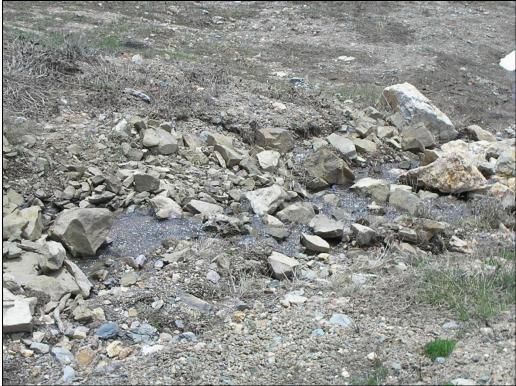
In 2011, the surface water drainage channel on the Tie Camp Disposal Cell was repaired to correct erosion issues noted during an inspection by the Colorado Department of Public Health and Environment (CDPHE). The erosion was repaired in accordance with an approved plan and conditions in the RML and the Pitch Reclamation Project Procedures Manual. In 2014, waddles were placed in erosion areas to slow the movement of runoff and impede erosion from the face of the Tie Camp Disposal Cell. The repair work appears to have corrected drainage and erosion issues. Photograph 17 shows water flowing across the riprap repair area.

Photograph 17: Tie Camp Disposal Cell showing repaired area with water flowing across the riprap

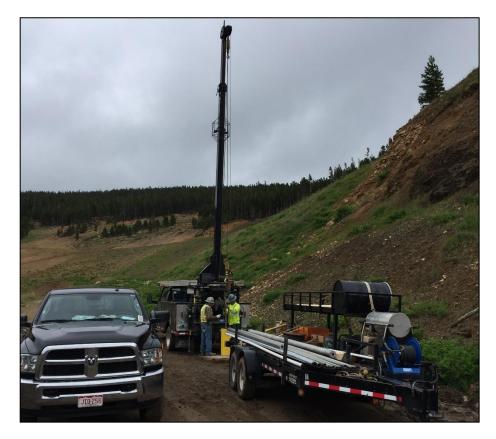
Photograph 19: Development pump being installed in piezometer P-14

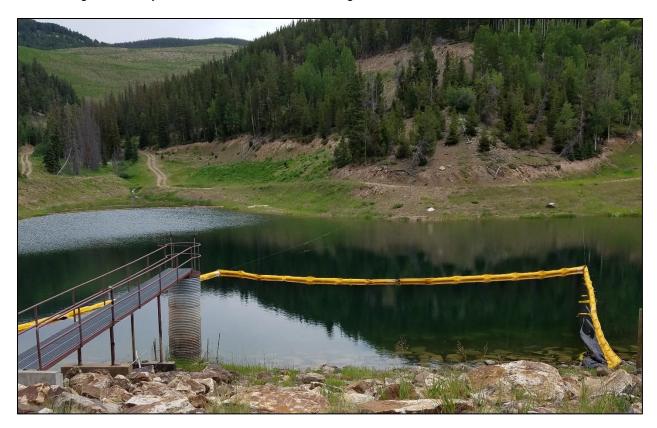
Photograph 21 shows the new silt/turbidity curtain as seen from the sediment control pond embankment. The existing silt/turbidity curtain can be seen in the background.

Photograph 21: Sediment control pond silt/turbidity curtain as observed from the embankment

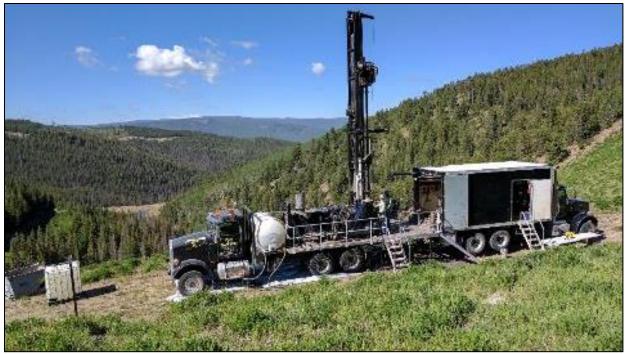
Photograph 22: Drilling RD-06 at the Indian Rock Dump using a standard truck-mount Terra Sonic International 150S drill rig

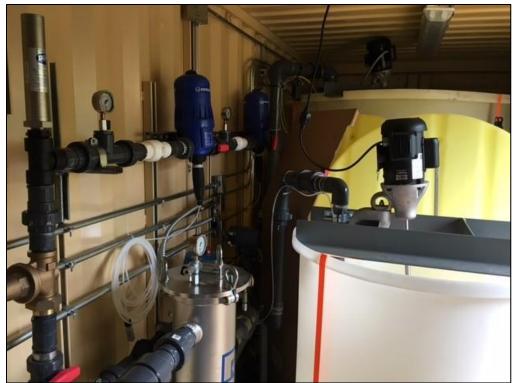
Photograph 27: Injection system interior

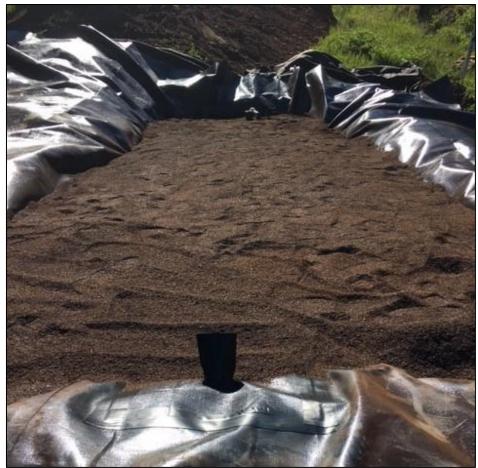
The in-ground zero valent iron (ZVI) ETC, installed adjacent to Tie Camp drainage, is 3 feet deep, 5 feet wide, and 15 feet long, with approximately 33,000 pounds of blended ZVI media (65% iron and 35% sand by volume). The ETC operated from August 2017 through early October 2017, with near complete uranium removal initially, followed by up to 56% removal after system stabilization. Drum-scale BCRs containing organic-based media (woodchips, manure, hay) and ZVI operated from late July 2017 to early October 2017 demonstrated near complete uranium removal for the duration of operation. 2017 results suggest optimal treatment media is primarily composed of organic material (i.e., woodchips, manure, and hay) with a lesser fraction of ZVI to facilitate reducing conditions and provide additional uranium removal capacity. The ZVI media following placement in the ETC is shown in Photograph 28.

Photograph 28: Zero valent iron media

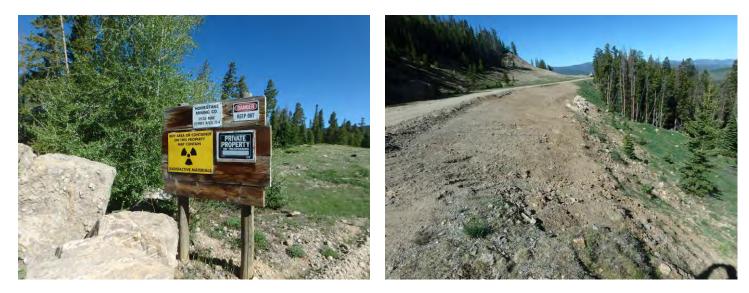
<u>Roads</u>: No problems were noted with any of the internal roads. The roads are well maintained. The repair work completed in 2015 on the failed portion of the access road appears stable. The repair area has been seeded, but vegetation is not yet well established.

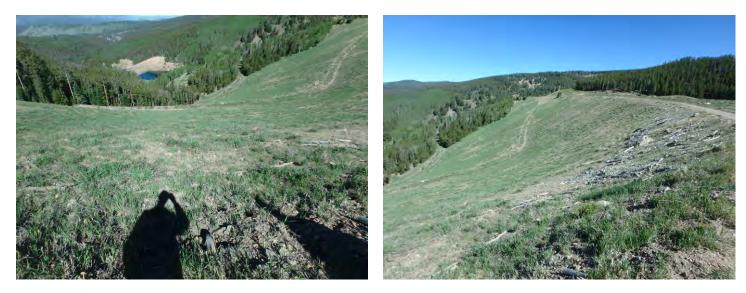
<u>Tie Camp Rock Dump</u>: The slope below the access road still appears stable. Vegetation is well established on the slope.

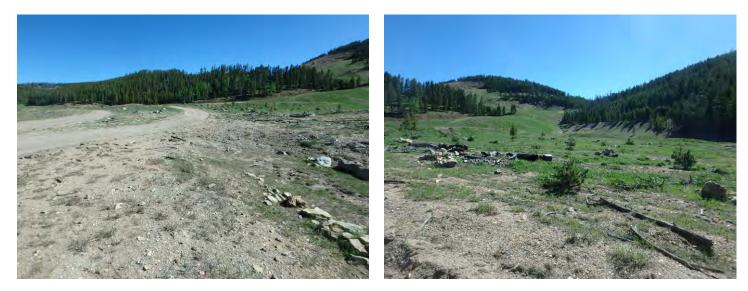
<u>Tie Camp Disposal Cell</u>: Slopes are stable in this area and vegetation is well established. Several mule deer were feeding in this area during the inspection.

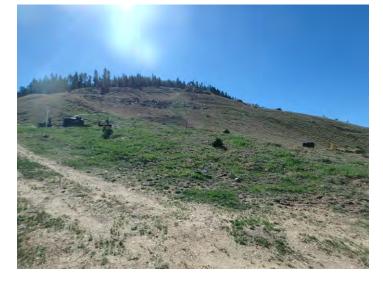
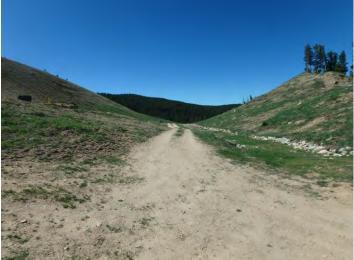
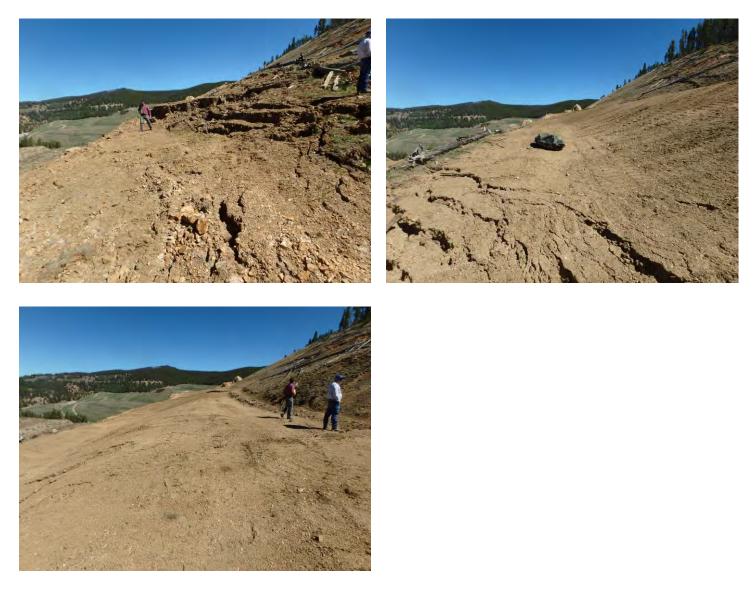
<u>South Pit</u>: The phosphate injection program continues in this area. Several more boreholes, as approved through TR-8, are to be drilled this season in this area. There has been some slope failure in the upper part of the south pit area. The failure affects approximately 0.75 acres. This is an area of recurring failure, so the operator plans to drill a borehole in the slope this season in order to better understand the failure so that a more permanent fix can be developed. The failure poses no risk to public safety.

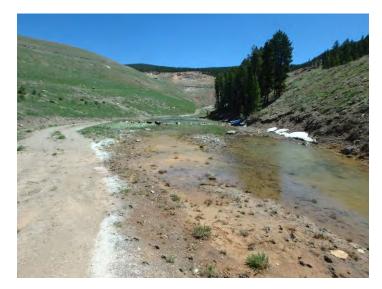
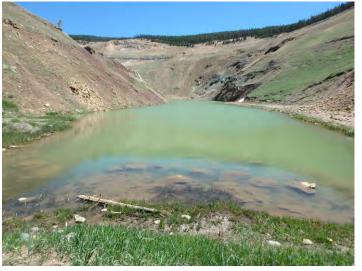
<u>North Pit</u>: Slope movement above the North Pit continues to be monitored. A final reclamation/stabilization plan is not yet developed for this area. Efforts are ongoing to control erosion and drainage on the east wall of the north pit.

Discharge from the North Pit Lake flows through the valve and culvert as designed. The Pinnacle Portal continues to discharge and flow is measured through a v-notch weir. The discharge reports to a marsh area above the facilities shop building.

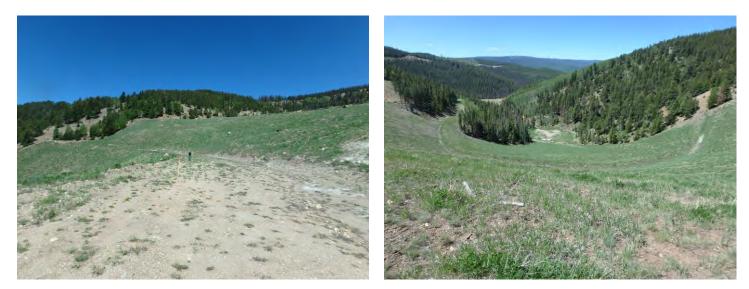
<u>Indian Rock Dump</u>: Slopes appear stable and vegetation is becoming well established. No significant erosional features were noted. Additional drilling will take place on the slope this season as part of the phosphate injection program. Inclinometers are to be installed on the slope as well, as proposed in TR-8.

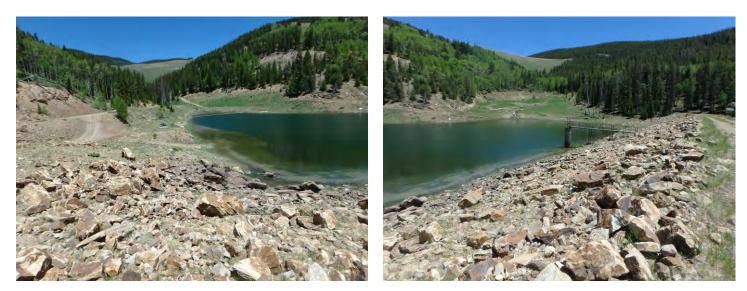
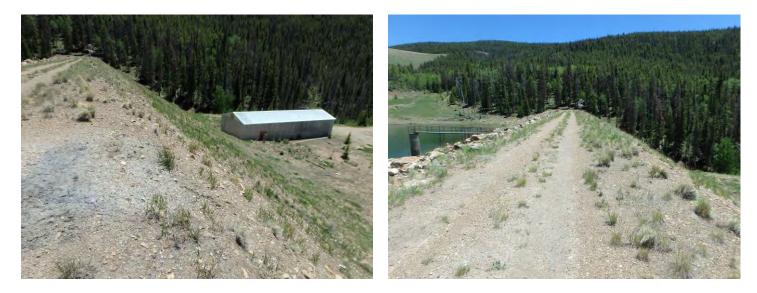
<u>Sediment Pond</u>: The sediment pond appears functional and the pond slopes appear stable. A surface filter boom placed at the upper end of the pond is maintained and still in place. No seepage or stability concerns were noted around the dam.
