MINERALS PROGRAM INSPECTION REPORT
PHONE: (303) 866-3567

MINE NAME: West Sunday	MINE/PROSPECTING ID#: M-1981-021	MINERAL: Uranium and vanadium	COUNTY: San Miguel
INSPECTION TYPE: Monitoring	INSPECTOR(S): Lucas J. West	INSP. DATE: March 28, 2018	INSP. TIME: 10:45
OPERATOR: Pinon Ridge Mining LLC	OPERATOR REPRESENTATIVE: George Glasier, Mike Rutter	TYPE OF OPERATION: 112d-3 - Designated Mining Operation	
REASON FOR INSPECTION: Normal I&E Program	BOND CALCULATION TYPE: Complete Bond	BOND AMOUNT: \$85,036.00	
DATE OF COMPLAINT: NA	POST INSP. CONTACTS: None	JOINT INSP. AGENCY: None	
WEATHER: Clear	INSPECTOR'S SIGNATURE:

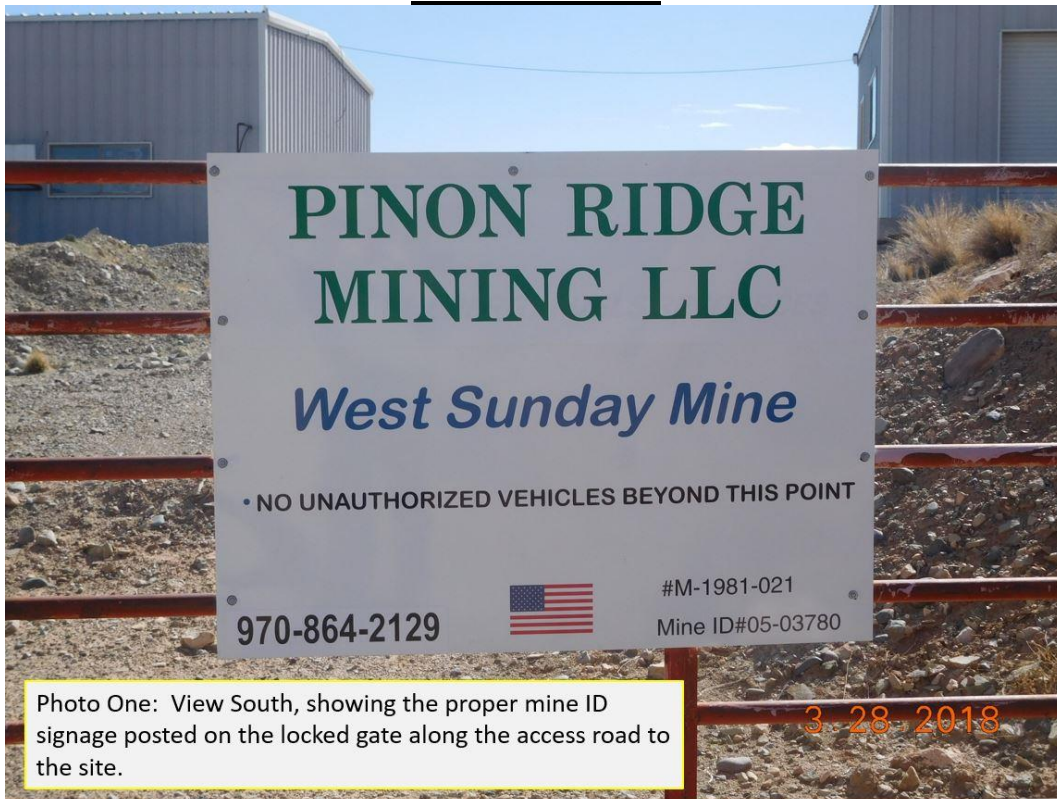
As seen in Photo One, the permit ID sign was observed at the entrance to the site. The permit boundary markers were also observed. The remote vent shaft sites were not inspected at this time. Evidence that the diversion ditches and storm water control devices are functioning as designed was observed and no significant erosion was observed throughout the site.

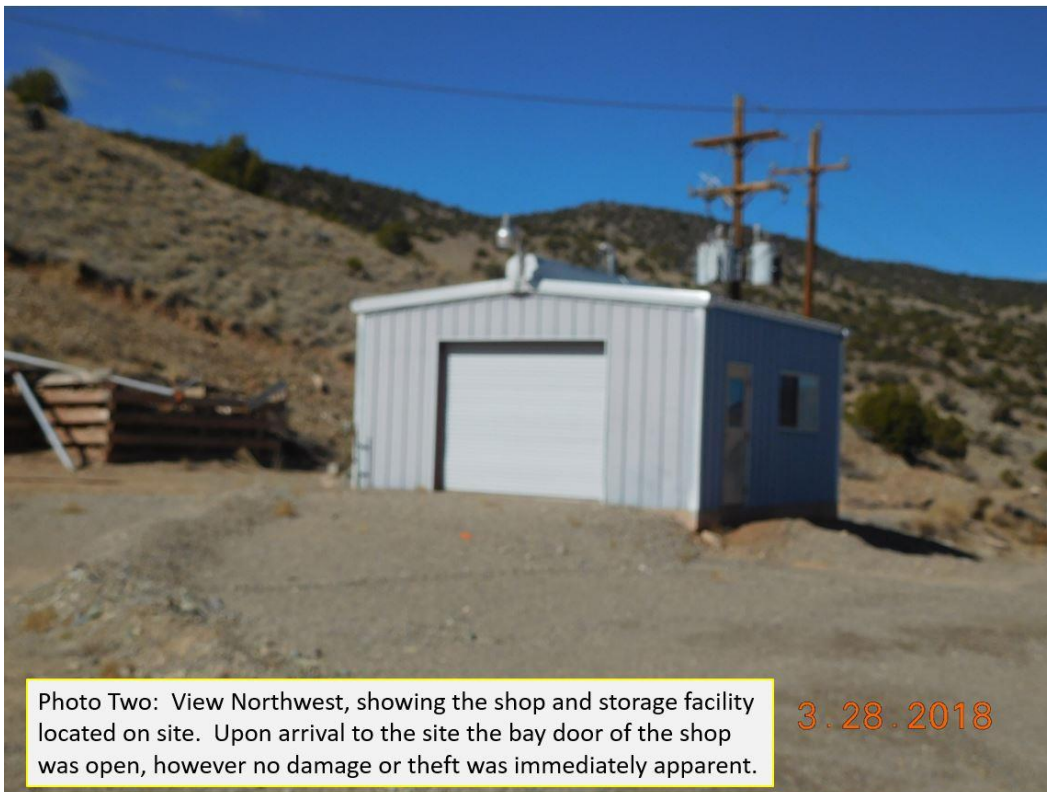
All work and shop appeared to be in good condition as seen in Photos Two and Three. The shop and storage facility in Photo Two was discovered to be unsecure, with the bay door opened. According to the operator there appeared to be no signs of theft or damage to the structure. The office facility was secured, and no signs of attempted unauthorized entry were noted on that facility. The portal located on site was also secured, it has been backfilled, closed off with steel grates as well as encompassed by a small berm as seen in Photo Four. Two fuel storage containers were observed on site but were empty and appear to have not been utilized in some time. Various other debris was observed on site however it was stored in an orderly fashion and was not a concern at this time.
