MINERALS PROGRAM INSPECTION REPORT
PHONE: (303) 866-3567

MINE NAME: Dollerschell Pit	MINE/PROSPECTING ID#: M-1986-074	MINERAL: Sand and gravel	COUNTY: Logan
INSPECTION TYPE: Surety Release Inspection	INSPECTOR(S): Jared L. Ebert	INSP. DATE: April 4, 2018	INSP. TIME: 11:50
OPERATOR: Kym A. Schure	OPERATOR REPRESENTATIVE: None	TYPE OF OPERATION: 112c - Construction Regular Operation	
REASON FOR INSPECTION: Surety Release Requested	BOND CALCULATION TYPE: Complete Bond	BOND AMOUNT: \$26,140.00	
DATE OF COMPLAINT: NA	POST INSP. CONTACTS: None	JOINT INSP. AGENCY: None	
WEATHER: Clear	INSPECTOR'S SIGNATURE:

Dollerschell Pit, DRMS Permit No. M-1986-074

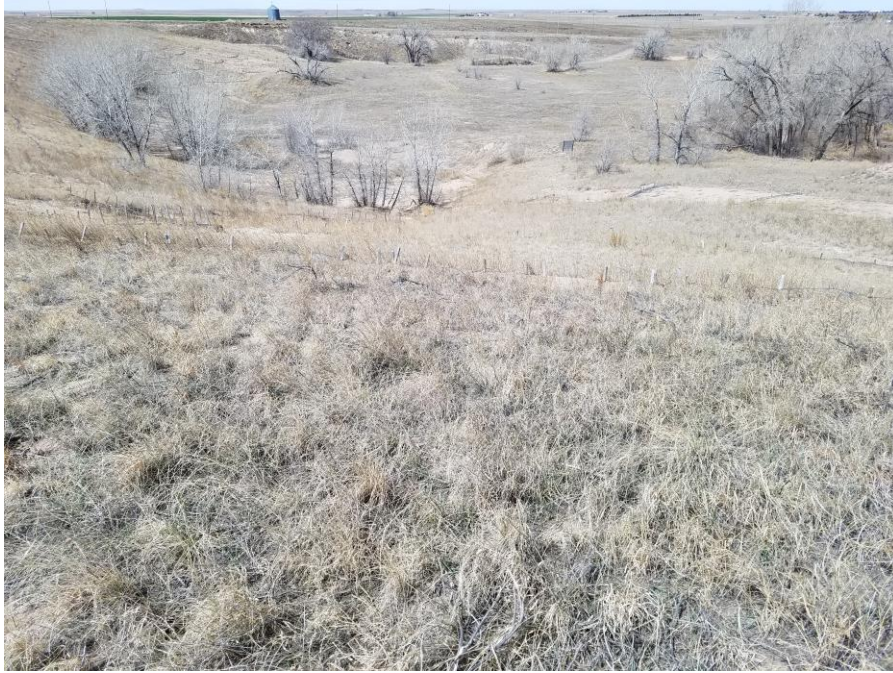
Figure 1. From the southeast corner of the AR01 area looking northwest.

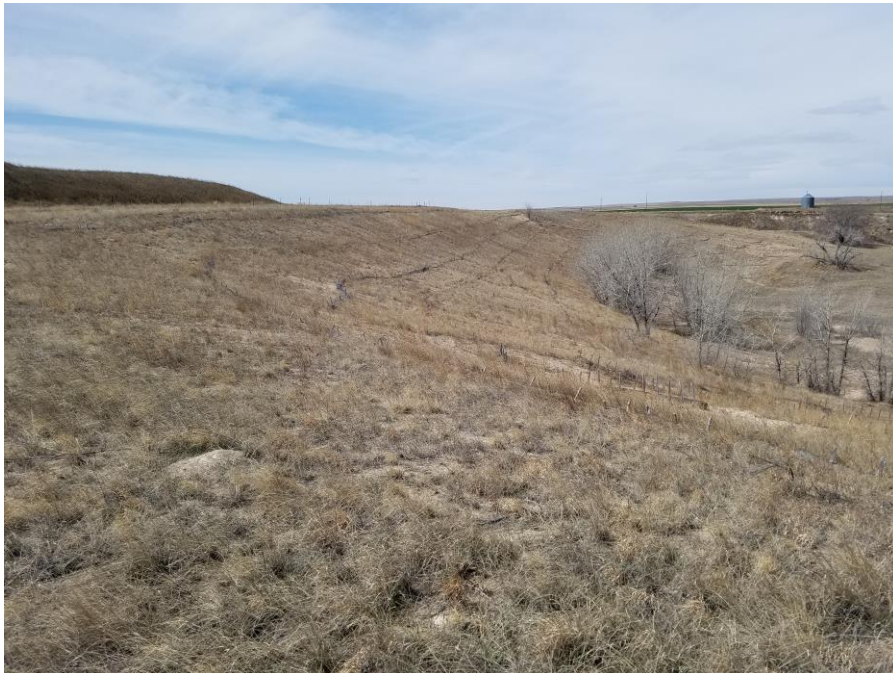
Figure 2. From the southeast corner of the AR01 area looking west.

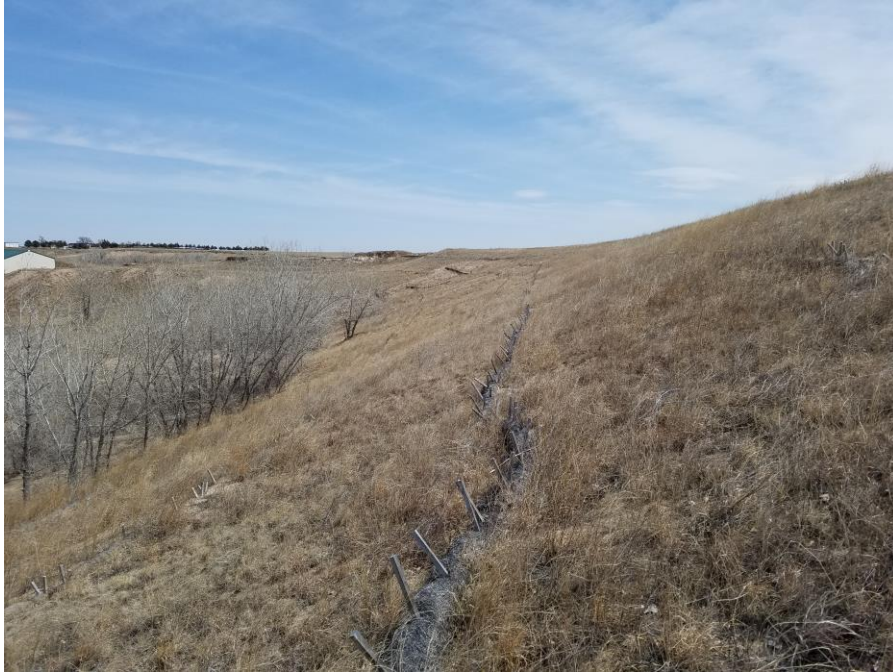
Figure 3. From the southwest corner of the bond release area looking east.

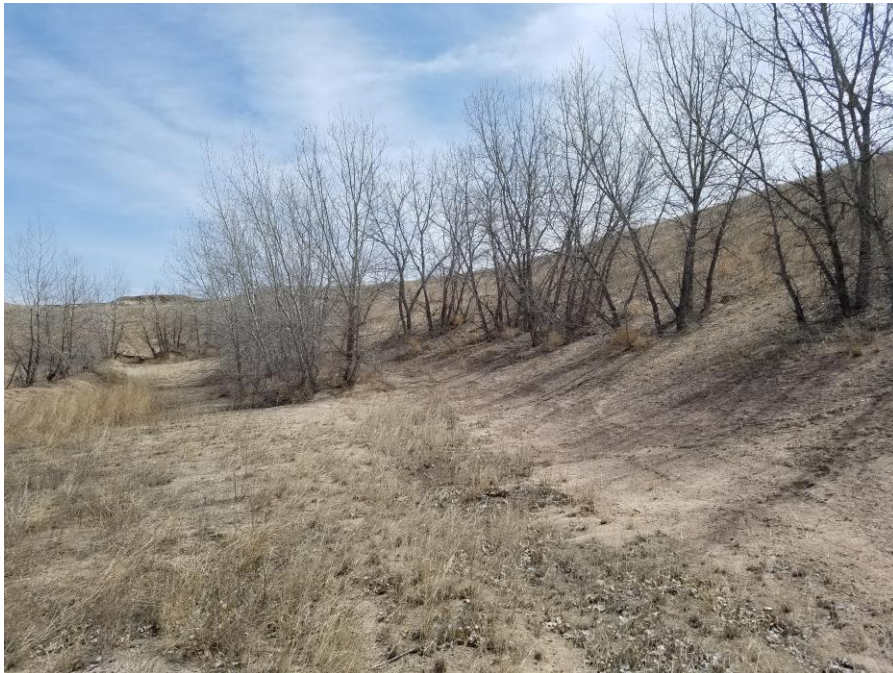
Figure 4. From the northwest end of the AR01 area looking southeast.
