MINERALS PROGRAM INSPECTION REPORT

MINE NAME: Topaz Mine	MINE/PROSPECTING ID#: M-1980-055-HR	MINERAL: Uranium and vanadium	COUNTY: San Miguel
INSPECTION TYPE: Monitoring	INSPECTOR(S): Lucas J. West	INSP. DATE: March 28, 2018	INSP. TIME: 11:05
OPERATOR: Pinon Ridge Mining LLC	OPERATOR REPRESENTATIVE: George Glasier, Mike Rutter	TYPE OF OPERATION: 112d-3 - Designated Mining Operation	
REASON FOR INSPECTION: Normal I&E Program	BOND CALCULATION TYPE: Complete Bond	BOND AMOUNT: \$94,791.00	
DATE OF COMPLAINT: NA	POST INSP. CONTACTS: None	JOINT INSP. AGENCY: None	
WEATHER: Clear	INSPECTOR'S SIGNATURE:

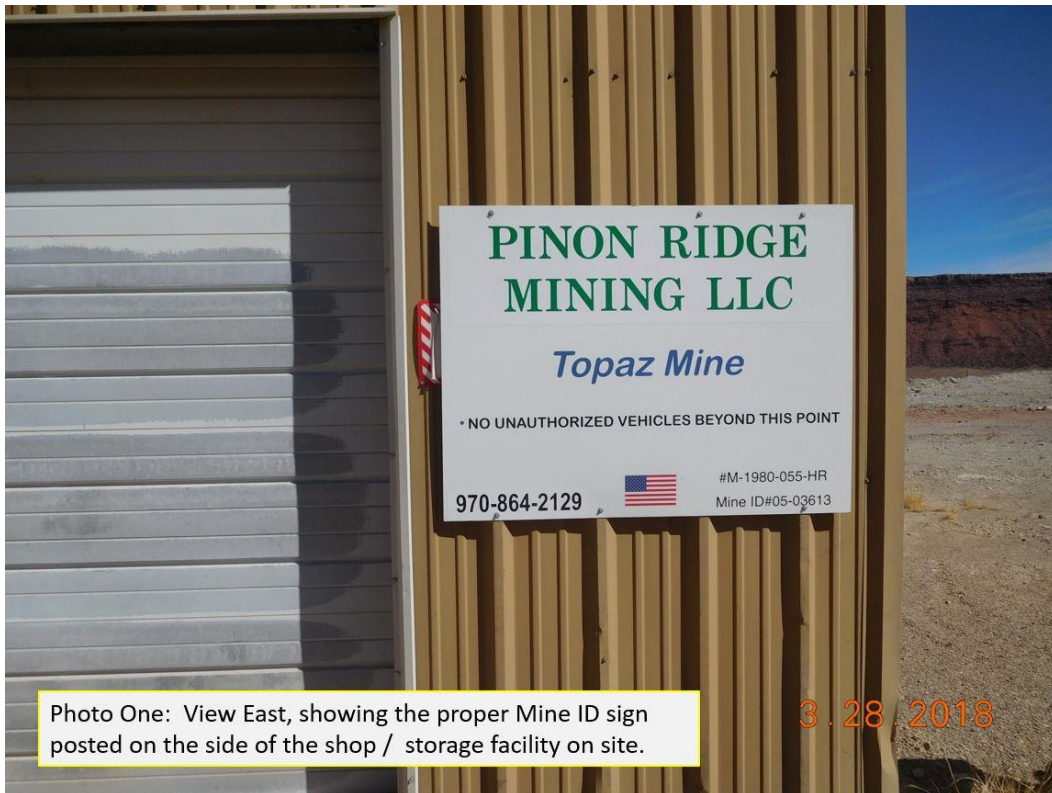
As seen in Photo One, the permit ID sign was observed near the entrance to the site. The permit boundary markers were also observed. Evidence that the diversion ditches and storm water control devices are functioning as designed and no significant erosion was observed throughout the site.

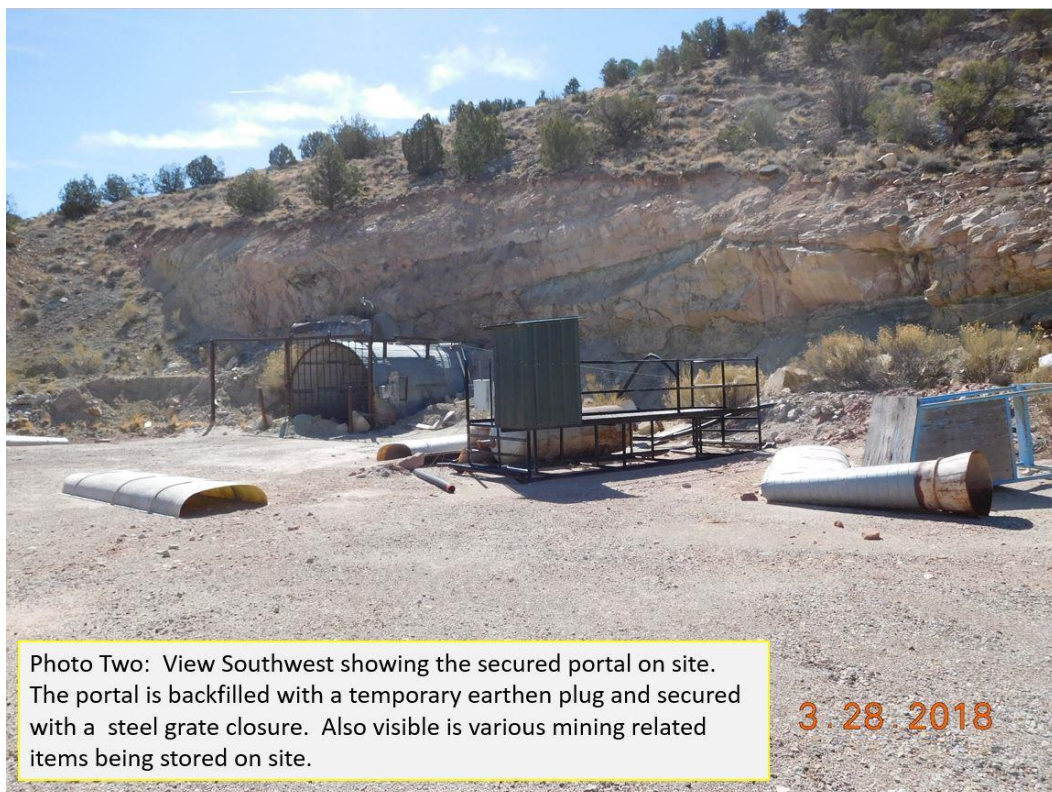
All work and shop facilities onsite were secured and appeared to be in good condition. The portal located on site was also secured, it has been backfilled, closed off with steel grates as well as encompassed by a small berm as seen in Photo Two. Some mining related equipment including vent tubing and steel scaffolding is being stored on site. The items that are stored are in a neat and orderly fashion and not considered a problem at this time. No fuel storage containers were observed on site. Various other debris was observed on site however it was stored in an orderly fashion and was not a concern at this time.

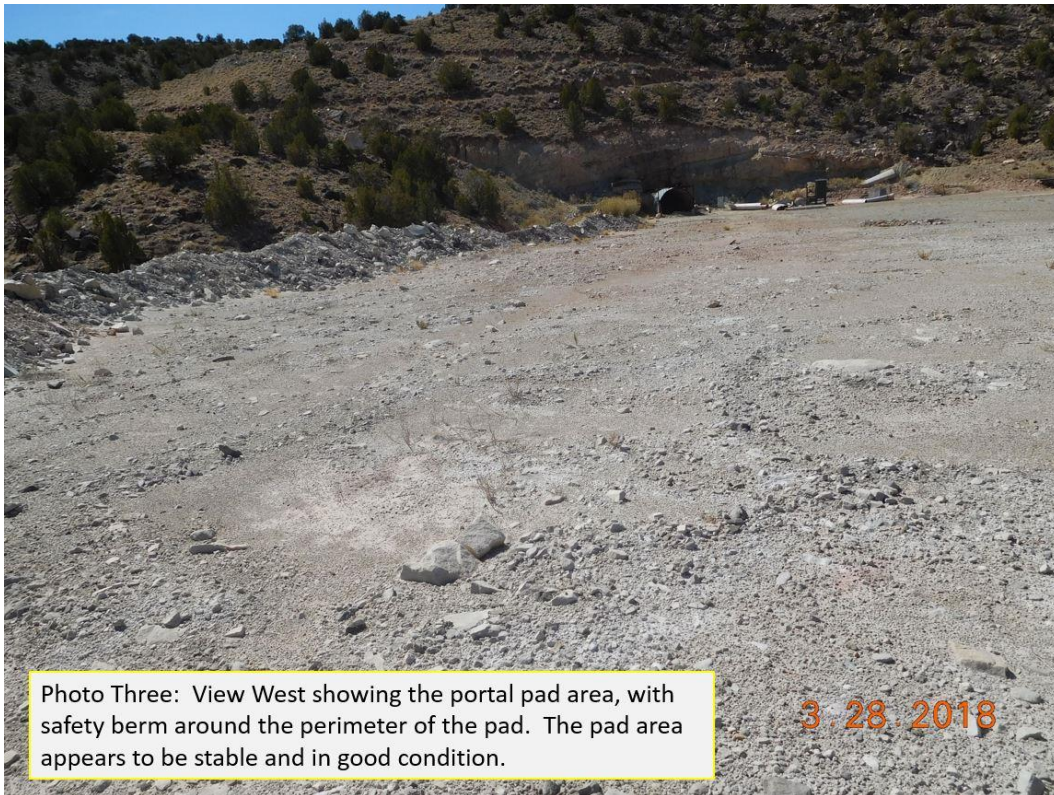
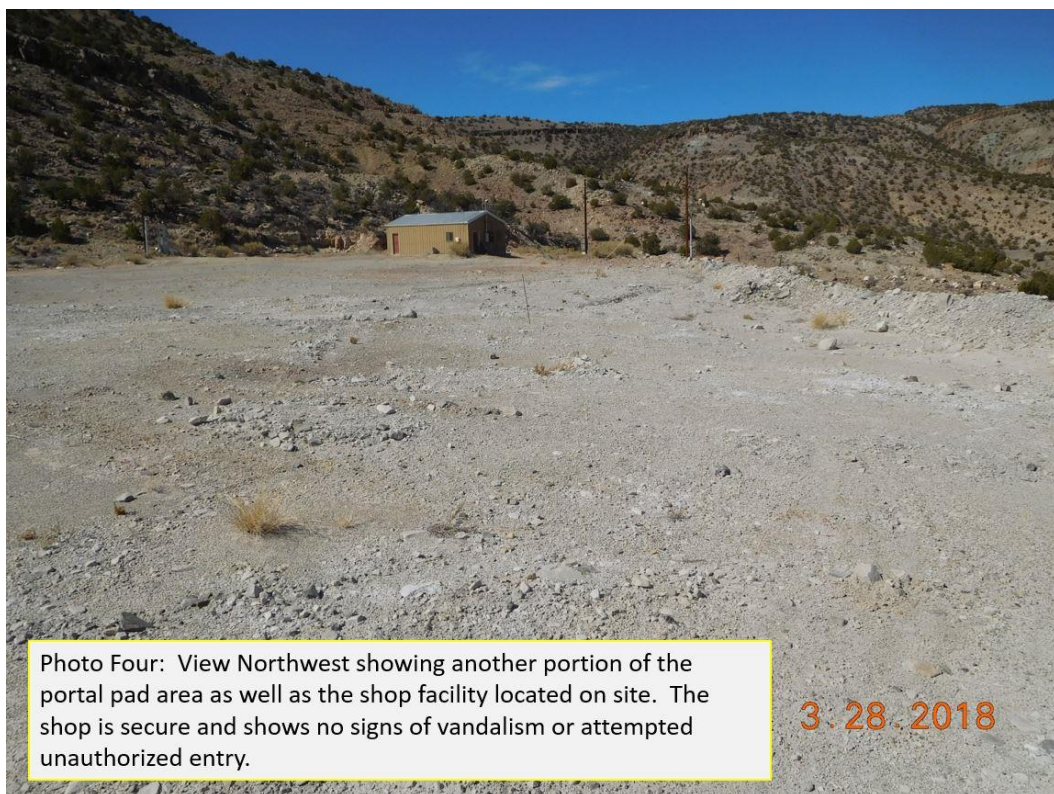
The main pad and work area was in good condition as seen in Photos Three and Four, evidence of weed management during the growing season was observed. Some areas around the perimeter of the pad area have begun to revegetate themselves with volunteer species. The whole site exhibits positive drainage and no erosional issues were observed at this time.
