**MINERALS PROGRAM INSPECTION REPORT**  
**PHONE: (303) 866-3567**

<b>MINE NAME:</b> Stagecoach Pit	<b>MINE/PROSPECTING ID#:</b> M-1983-067	<b>MINERAL:</b> Sand and gravel	<b>COUNTY:</b> Adams
<b>INSPECTION TYPE:</b> Surety Release Inspection	<b>INSPECTOR(S):</b> Jared L. Ebert	<b>INSP. DATE:</b> April 9, 2018	<b>INSP. TIME:</b> 09:00
<b>OPERATOR:</b> Albert Frei & Sons Inc.	<b>OPERATOR REPRESENTATIVE:</b> Ben Frei	<b>TYPE OF OPERATION:</b> 112c - Construction Regular Operation	
<b>REASON FOR INSPECTION:</b> Normal I&E Program	<b>BOND CALCULATION TYPE:</b> None	<b>BOND AMOUNT:</b> \$231,191.00	
<b>DATE OF COMPLAINT:</b> NA	<b>POST INSP. CONTACTS:</b> None	<b>JOINT INSP. AGENCY:</b> None	
<b>WEATHER:</b> Cloudy	<b>INSPECTOR'S SIGNATURE:</b>

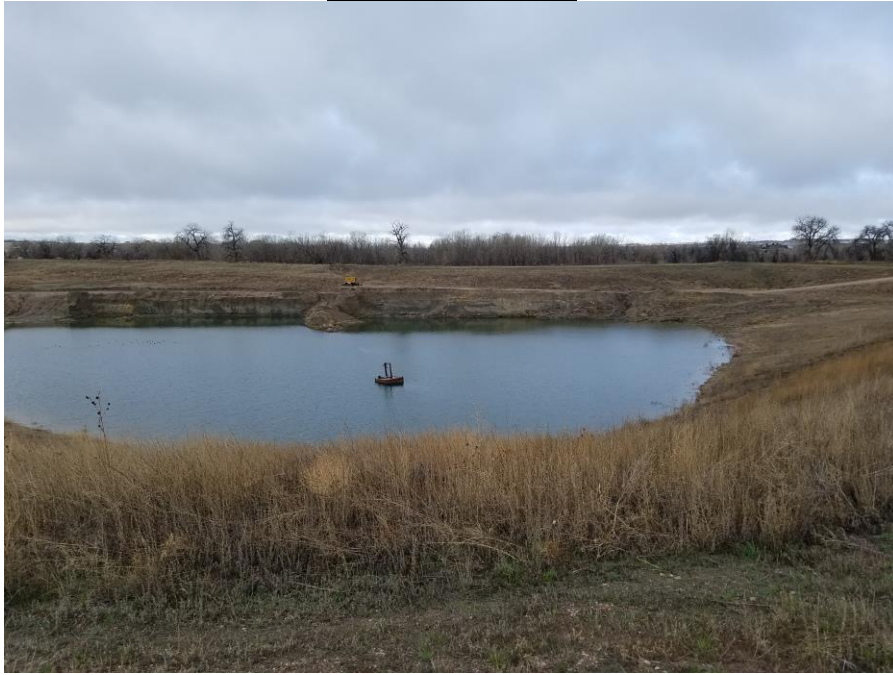
Figure 1. From the northeast corner of the reservoir looking west.

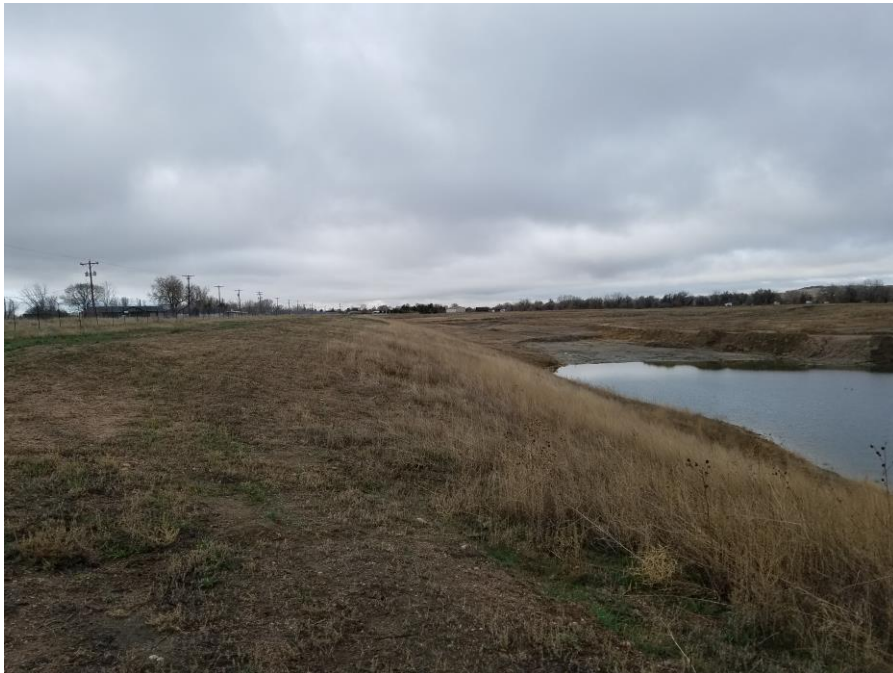
Figure 2. From the northeast corner of the reservoir looking south.

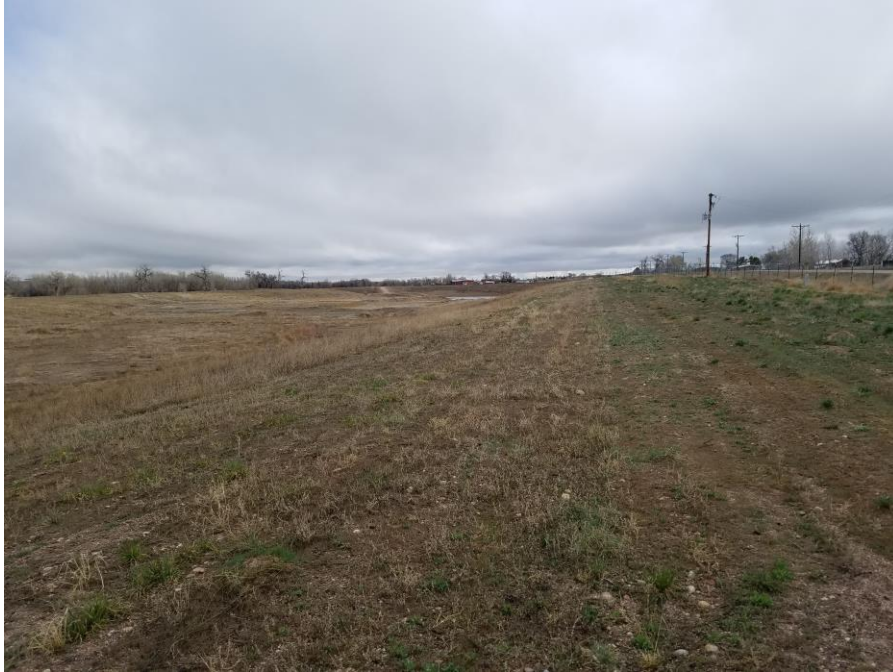
Figure 3. From the southeast corner of the reservoir looking north.

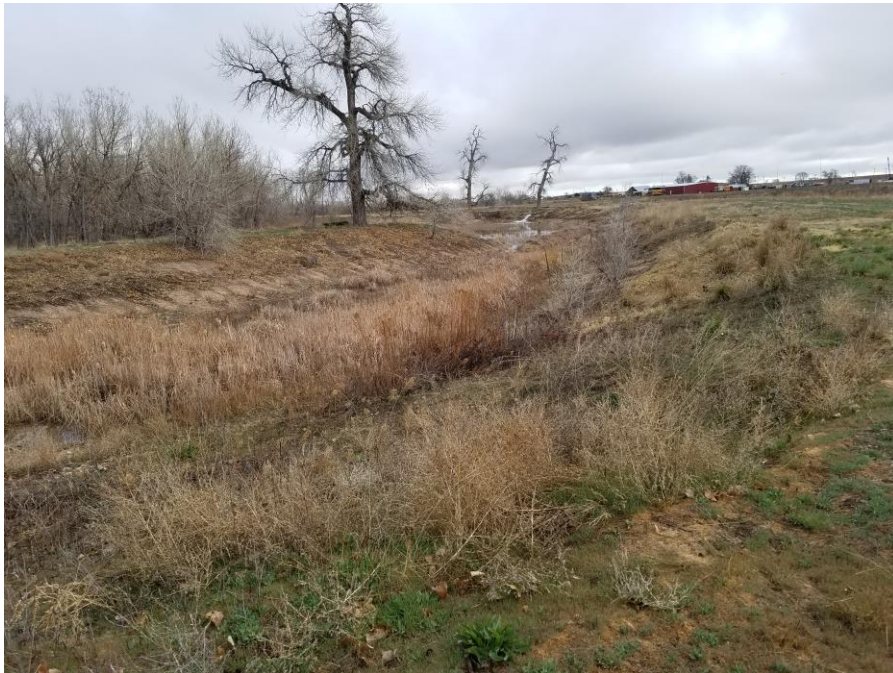
The slurry wall was installed between October of 2005 and December of 2005. On March 12, 2018, the Division received a letter from the Colorado Division of Water Resources indicating the final liner for the reservoir was approved by the State Engineer's Office on August 4, 2015 and that they did not have any objections to the request for full reclamation responsibility release. Water was observed at the north end of the reservoir and the Operator was pumping the water from the pit to the catchment basin on the west side of the site.

Figure 4. Western catchment basin.

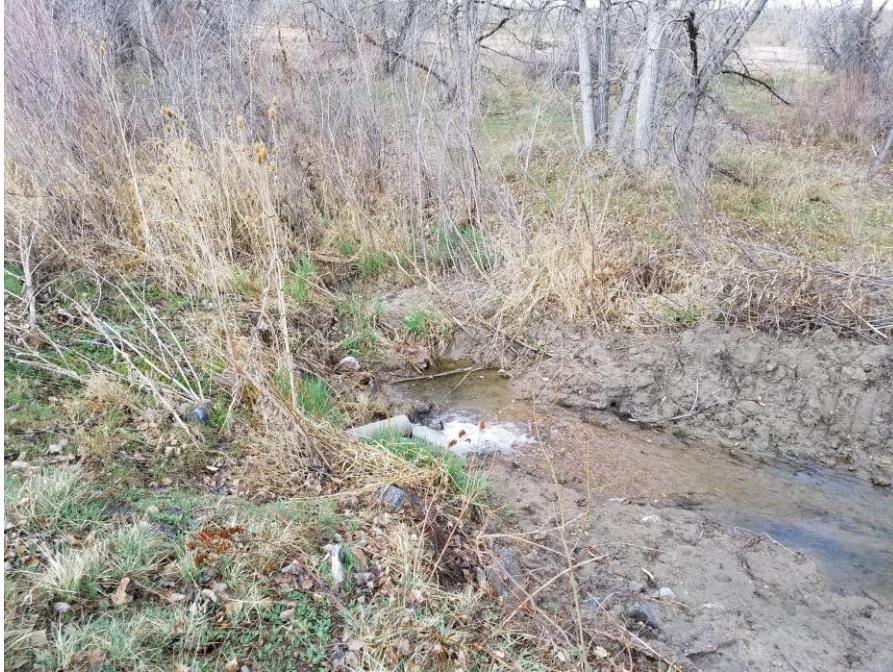
was observed and water was discharging to the South Platte River.

**Figure 5. Discharge from the Zigan Lake pipe to the South Platte River.**

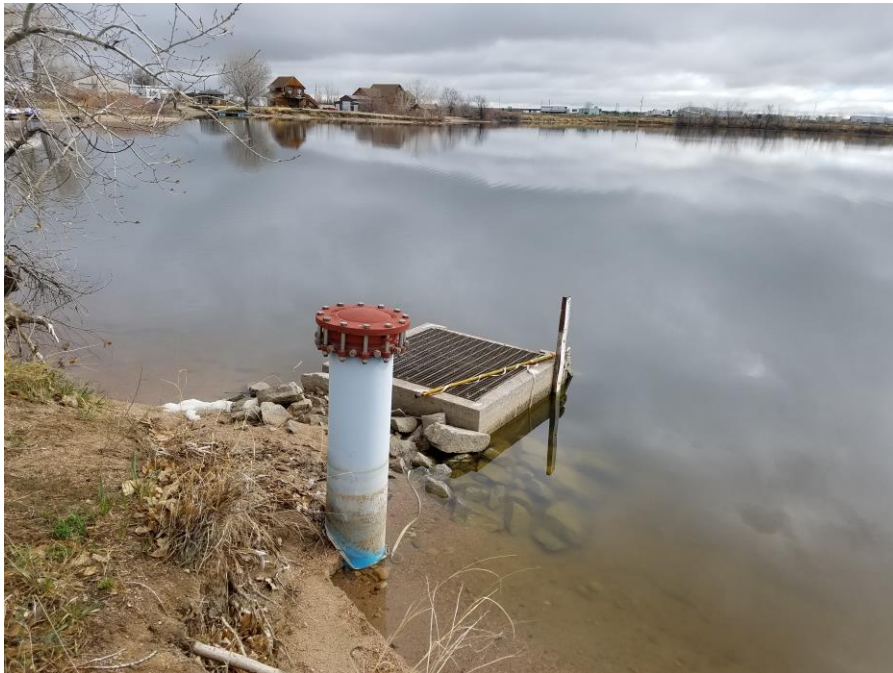
For the Stagecoach Stop Pit, the mitigation plan was approved with Technical Revision No. 4 (TR04) which was approved on March 23, 2010. According to TR04, there is a direct correlation between the adjacent Zigan Lake water elevation and the level of the water behind the slurry wall. The plan was for AFS to install a permanent drainage structure between Zigan Lake and the South Platte River to allow the Zigan Lake HOA to regulate the water elevation of the lake. The drainage structure was installed and based on the Division's records several maintenance items and updates to the system were completed in 2014 and 2015 to insure the system functions properly. At the time of this inspection the inlet structure was observed. Based on past records, the top of the inlet vault is 5,015.65 feet. The water level was about 1 foot below the top of the vault. The outlet

**Figure 6. Inlet structure at Zigan Lake.**
