**MINERALS PROGRAM INSPECTION REPORT**  
**PHONE: (303) 866-3567**

<b>MINE NAME:</b> Tezak No 2 Pit	<b>MINE/PROSPECTING ID#:</b> M-1981-080	<b>MINERAL:</b> Sand and gravel	<b>COUNTY:</b> Fremont
<b>INSPECTION TYPE:</b> Preoperation Inspection	<b>INSPECTOR(S):</b> Timothy A. Cazier	<b>INSP. DATE:</b> March 28, 2018	<b>INSP. TIME:</b> 16:00
<b>OPERATOR:</b> Tezak Stone & Aggregate Supply, Inc.	<b>OPERATOR REPRESENTATIVE:</b> Mike Tezak & Ken Klco	<b>TYPE OF OPERATION:</b> 110c - Construction Limited Impact	
<b>REASON FOR INSPECTION:</b> Preoperation Inspection	<b>BOND CALCULATION TYPE:</b> Complete Bond	<b>BOND AMOUNT:</b> Current: \$17,500.00 Req'd: \$55,535.00	
<b>DATE OF COMPLAINT:</b> NA	<b>POST INSP. CONTACTS:</b> None	<b>JOINT INSP. AGENCY:</b> None	
<b>WEATHER:</b> Raining	<b>INSPECTOR'S SIGNATURE:</b>

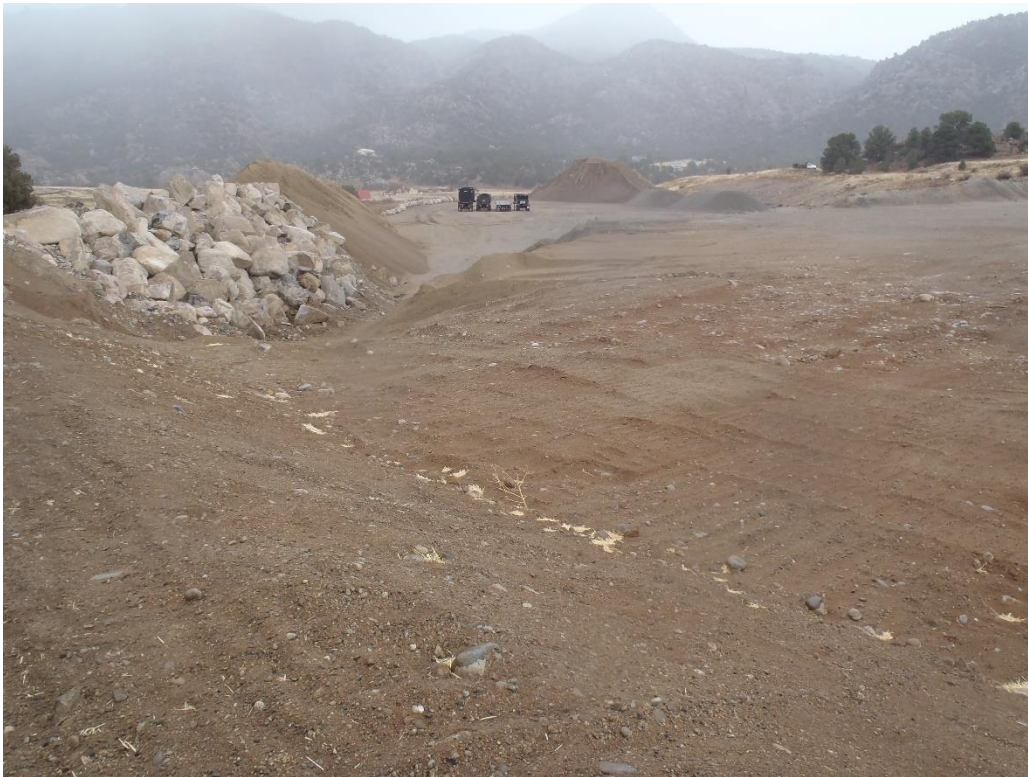
Gen. Compliance with Mine Plan: The operation appeared to be in compliance with the approved mine plan. High walls were estimated to vary between 15 and 20 feet in height and appeared stable (see **Photo 1**). We discussed the eventual extraction of the material between the highway borrow ditch (US 50) and the current visual berm. The Division acknowledges this is allowed by an agreement between CDOT and Tezak Stone & Aggregate Supply. However, the Division requests Tezak Stone & Aggregate Supply notify the Division of the intent to begin mining this material 30 days prior to initiating extraction of said material.

Photo 1. 110c pit (looking SE, highwalls on right).

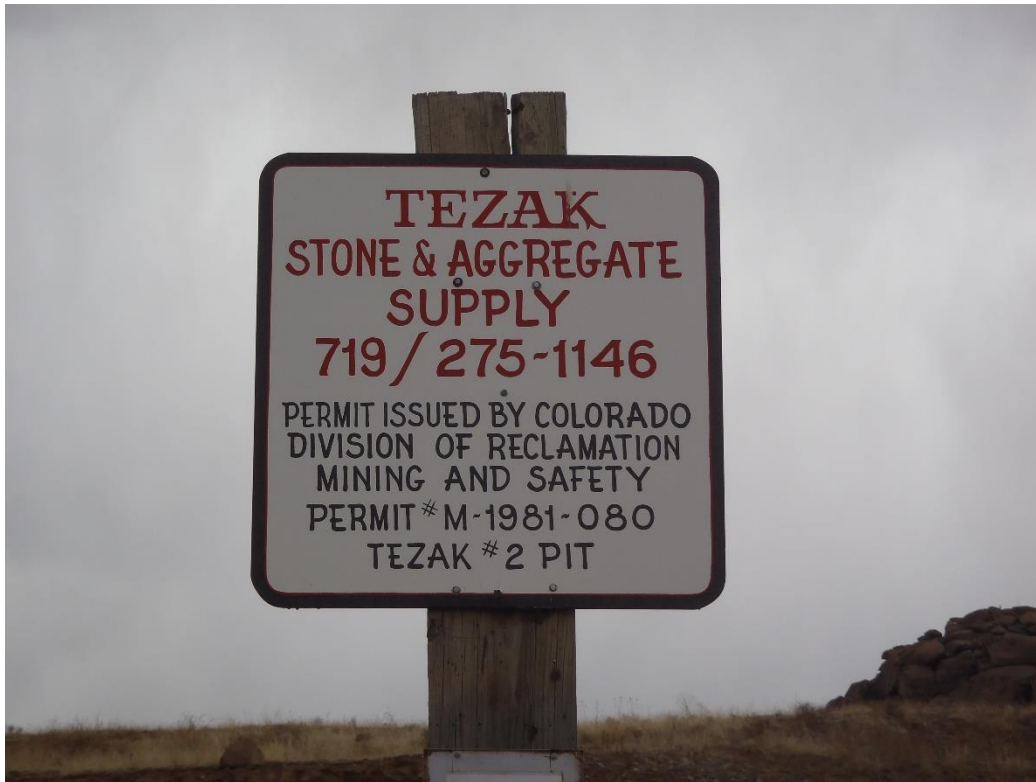
Signs and Markers: A new permit sign had been posted (see **Photo 2**) since the previous inspection. The new permit boundary was marked with orange tipped T-posts (see **Photo 3**). Mr. Tezak explained the actual permit boundary along the US Hwy 50 side is the borrow ditch flowline. According to Mr. Klco, the boundary markers on the visual berm crest are offset 30 to 80 feet from the flowline to preserve the berm until mining the berm commences near the end of the mine life. The Division's request to notify us at least 30 days prior to initiating this final mining phase is discussed under "Gen. Compliance with Mine Plan" above.

Photo 2. Permit sign.

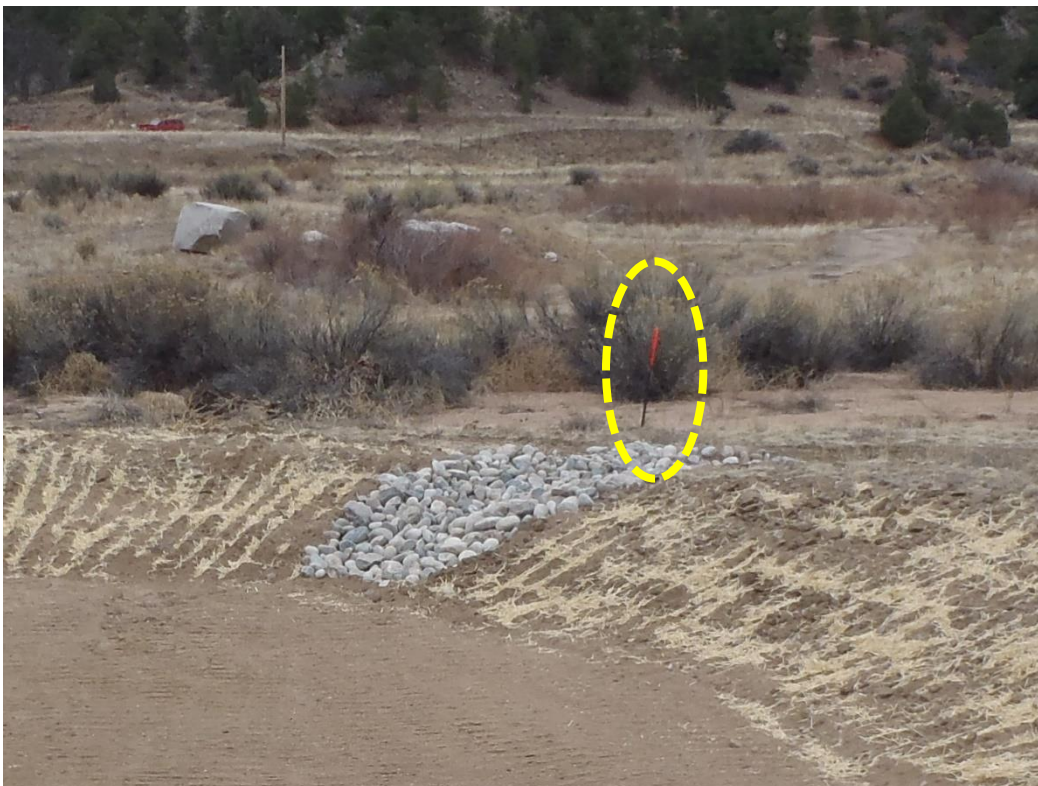
Photo 3. Typical permit boundary marker (near McCoy Gulch sediment pond).

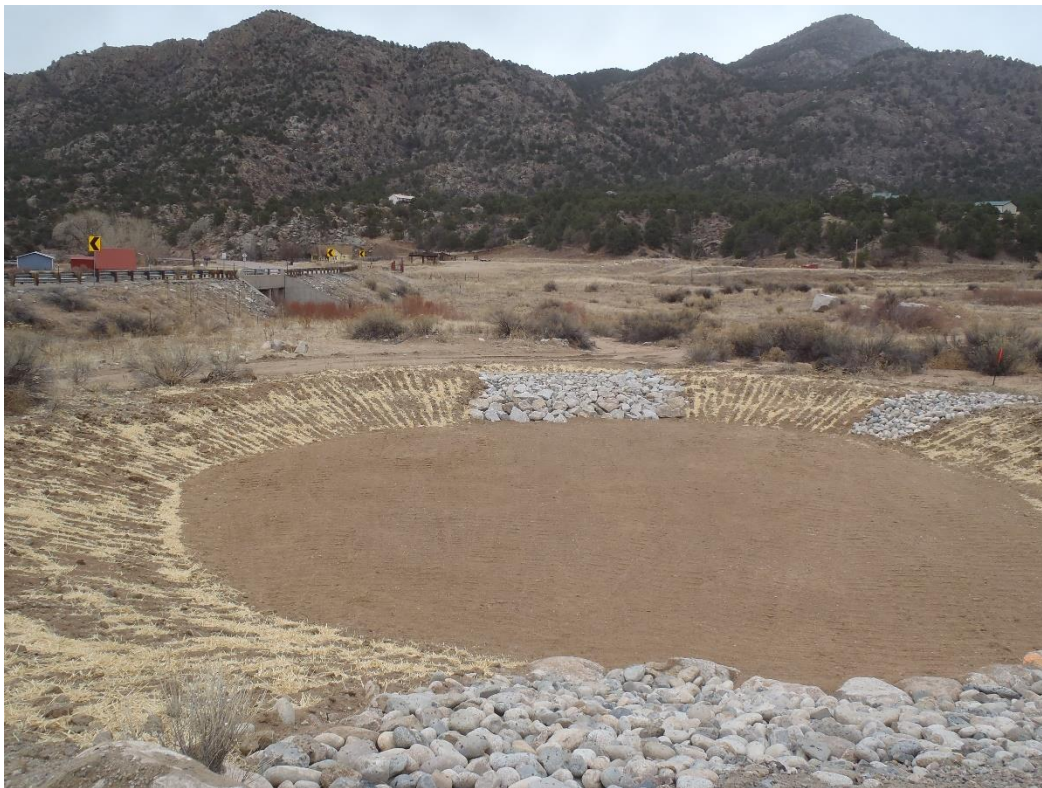
Storm Water MGT Plan: No oil or fuel spills observed. Representatives stated the stormwater drains to either the newly improved sediment pond (see **Photo 4**), or the new sediment pond on the east end near McCoy Gulch (see **Photo 5**).

Photo 5. New sediment pond near McCoy Gulch (looking east).

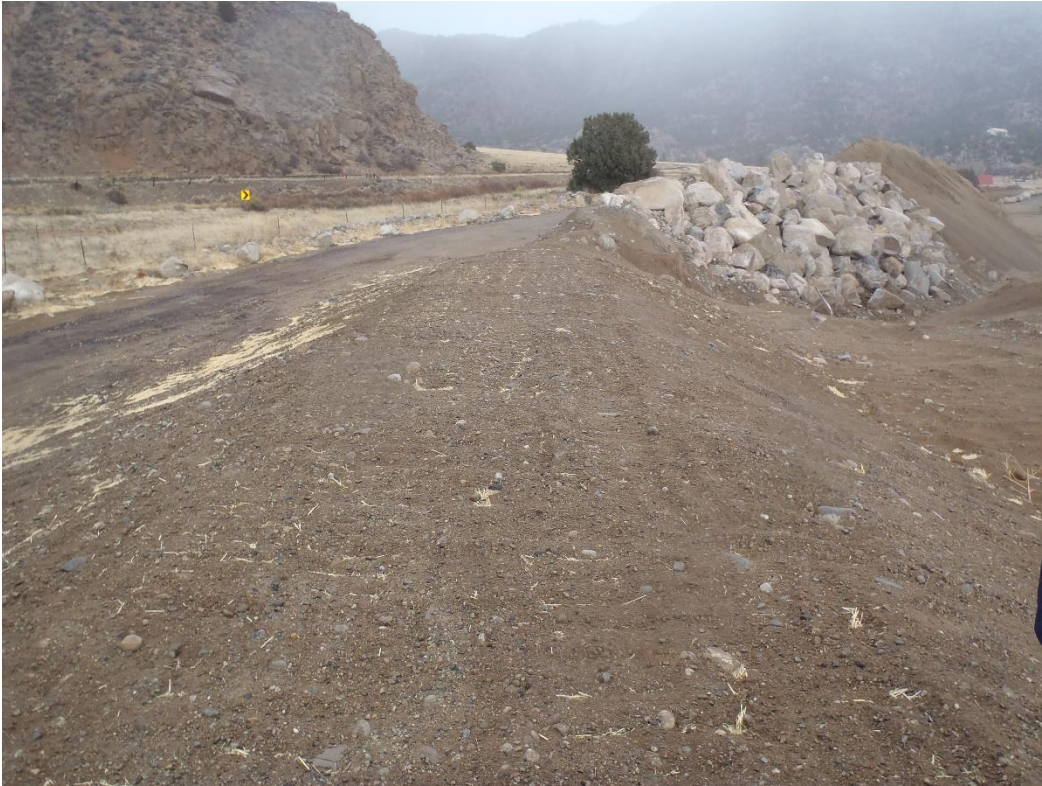
Topsoil: The crest of the visual berm along US Hwy 50 consists of stockpiled topsoil (see **Photo 6**).

Photo 6. Visual berm/topsoil stockpile along US 50 (looking SE).
