COLORADO
Division of Reclamation,
Mining and Safety
Department of Natural Resources

Permit Number: C-1981-012 Mine Name: New Elk Mine Operator: New Elk Coal Company, LLC Operator Address: Mr. Louis Head 12250 Highway 12 Weston, CO 81091	County: Las Animas Operation Type: Underground Permit Status: Active Ownership: Private
	Operator Representative Present: Nick Mason
Operator Representative Signature: (Field Issuance Only)

Inspection Start Date: April 9, 2018 Inspection Start Time: 13:00 Inspection End Date: April 10, 2018 Inspection End Time: 09:00		Inspection Type: Coal Partial Inspection Inspection Reason: Normal I&E Program Weather: Clear	
Joint Inspection Agency: None		Joint Inspection Contacts: 	
Post Inspection Agency: None		Post Inspection Contacts: 	
Inspector(s): Robert D. Zuber, P.E.	Inspector's Signature:

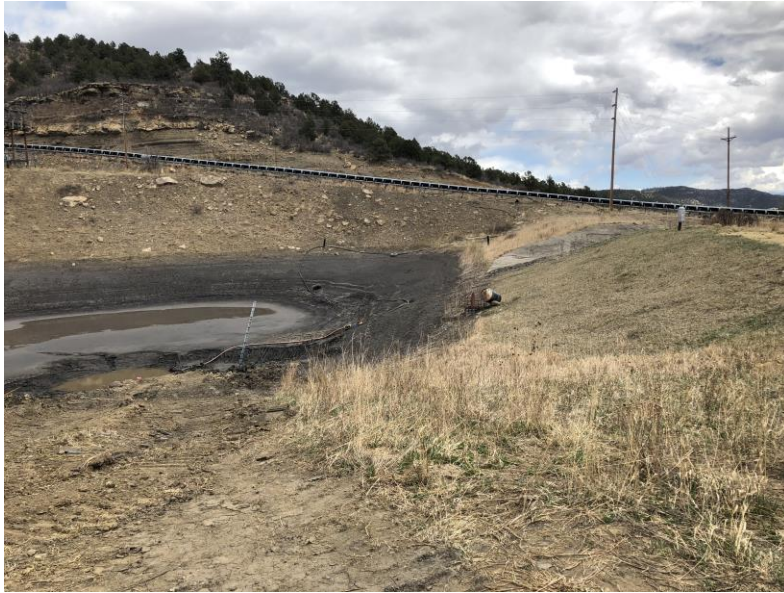
Ponds 006A, 007A, and 08 were inspected. None of them were discharging, but all held water. No problems were identified with embankments or spillways. Other observations:

- No flow into Pond 006A was seen.
- The impounded water in Pond 007A was below seven rows of holes in the primary spillway.
- There is emergent vegetation on the top of the Pond 08 embankment.

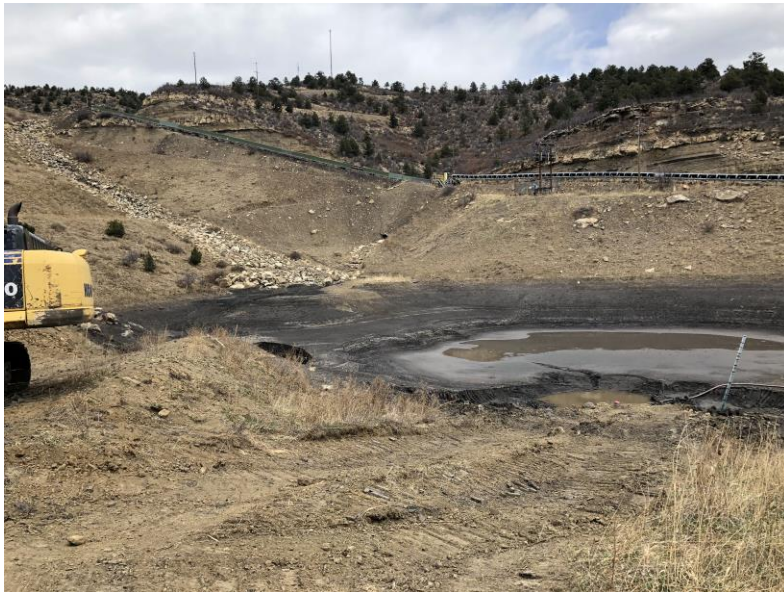
Significant sediment has been removed from Pond 08. Use of a laser Range Finder indicated that the majority of the bottom of the pond is approximately 16 feet below the discharge point of the primary spillway. Some portions of the pond have sediment levels even lower. Based on a conversation with Vince Massarotti and the sight of a Komatsu excavator still at the pond, NECC plans to remove significantly more sediment.

Pond 08 – evidence of cleaning operation

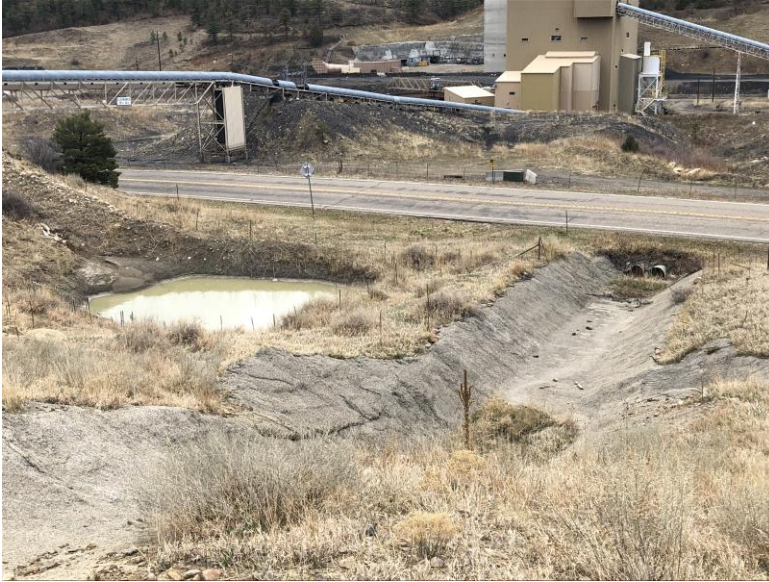
Containment Area 5 and channel below Pond 08

Containment Area 5 was holding water that was several feet below the top of the structure. There was no sign of discharge from this structure.

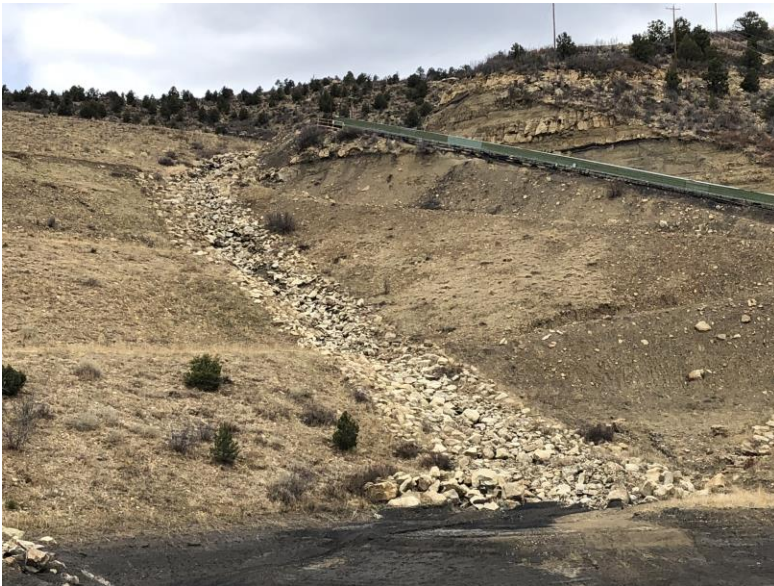
East side of lower portion of RDA

There is good vegetation cover on the majority of the reclaimed portion of the RDA. No problems were seen with the RDA, including the ditch and sumps between the un-reclaimed (upper) and reclaimed (lower) portions, but recently placed piles should be spread in the near future.

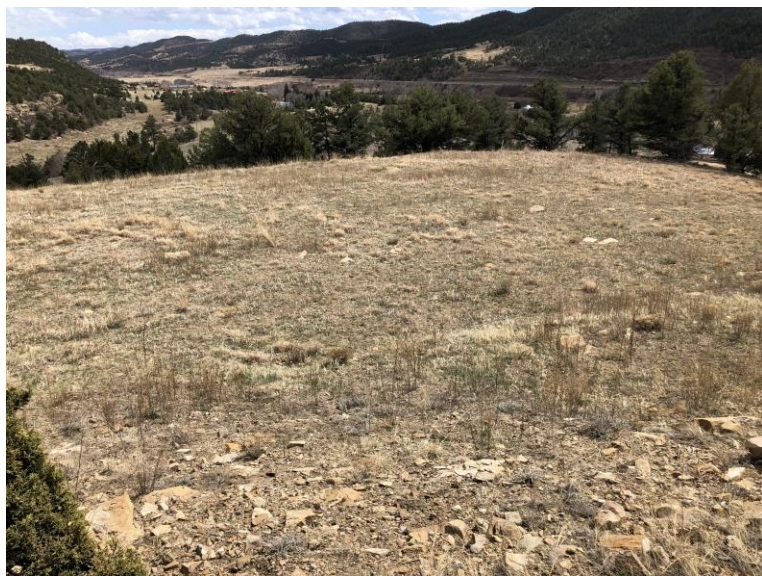
Fan site (formerly Golden Eagle permit)

No problems were seen with reclamation at the former Golden Eagle fan site.

At the former Golden Eagle fan site, the sign at the entrance contained the correct information.

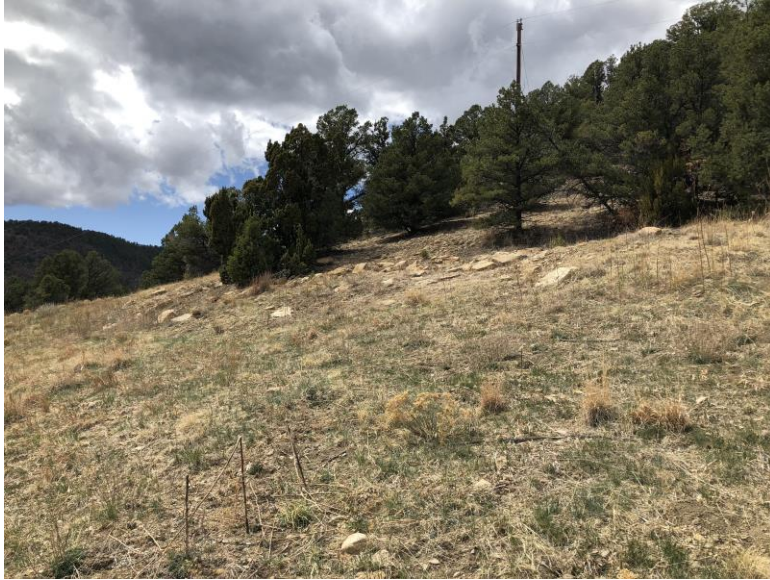
Hill between fan pad and clear water ditch (formerly Golden Eagle permit)

The following ditches were inspected and no problems were identified: the east end of the clear water ditch above the RDA (D55), D10, and the ditch above the fan pad (former Golden Eagle site).

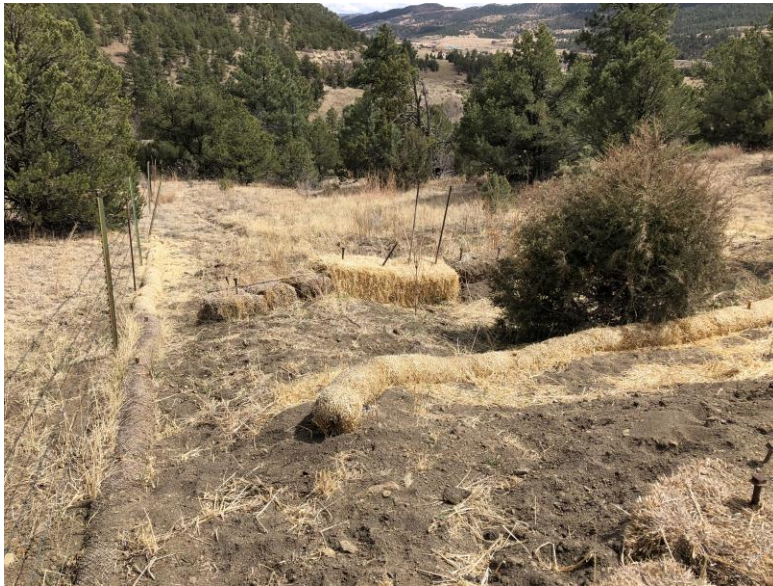
The erosion and sediment BMPs at the former Golden Eagle fan site appear to be functioning well.

Sediment BMPs (formerly Golden Eagle permit)

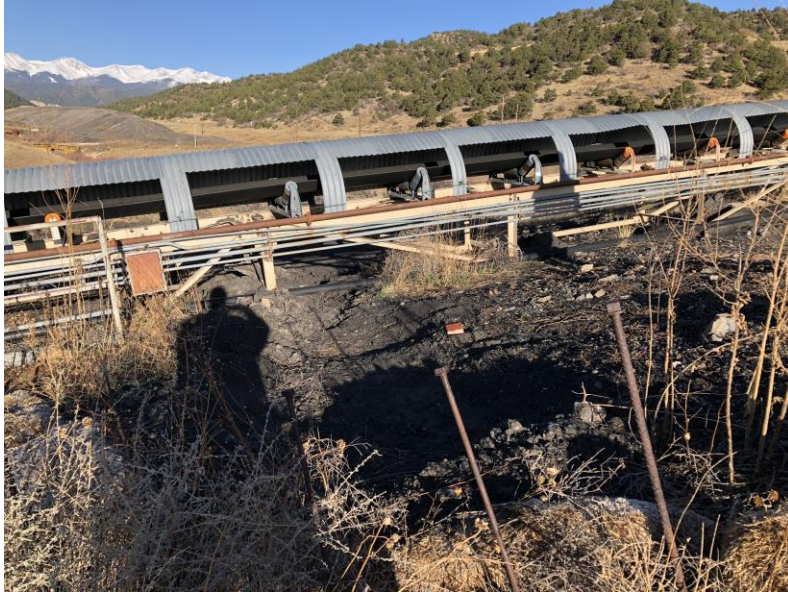
Containment Areas 3 and 4 were dry. NECC has performed sufficient work (created small ditch) to direct runoff from the conveyor to these areas. The refuse material under the conveyor still needs to be removed. If the conveyor is used in the future, a device should be added to reduce the amount of material that collects under it. This would be feasible per Bill Massarotti.

Recently dug ditch under conveyor, near Containment Areas 3 and 4

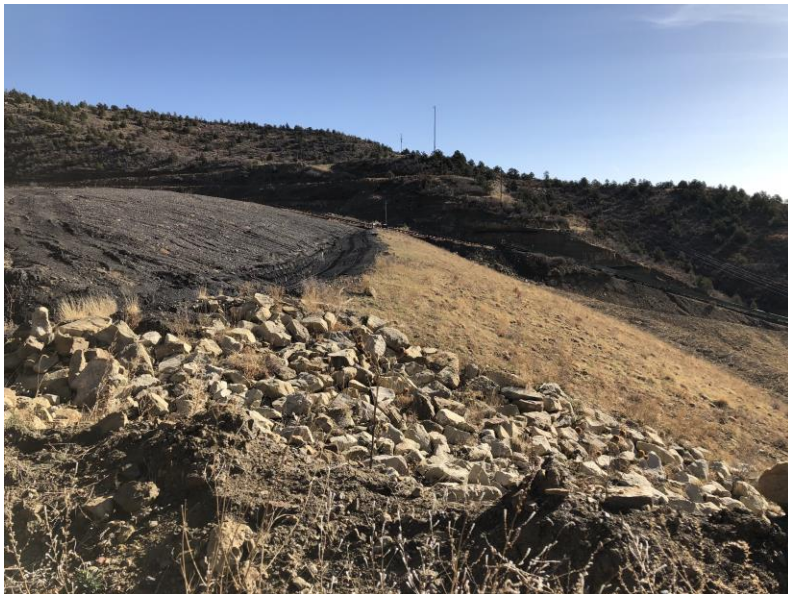
RDA – interface between upper and lower portions
