Permit Number: C-1996-084

Mine Name: Lorencito Canyon Mine

A partial inspection was conducted by Rob Zuber of DRMS on April 10, 2018. The weather was clear, and the ground was dry. Nick Mason of NECC was present for the inspection.

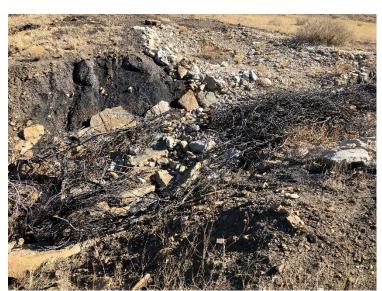
The small unnumbered ditch in the Pond 5 watershed (south of ditch D16) was inspected. The banks are not armored well but tree branches appear to be limiting the erosion of this feature.

Ditch in Pond 5 watershed

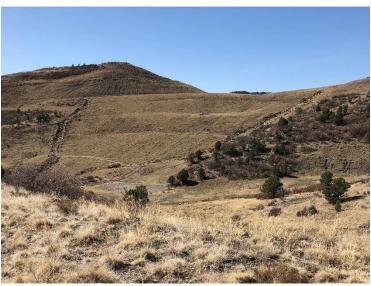
Fill 8

Fills 7, 8, and 9 were inspected. All were generally in good condition with good vegetation cover.

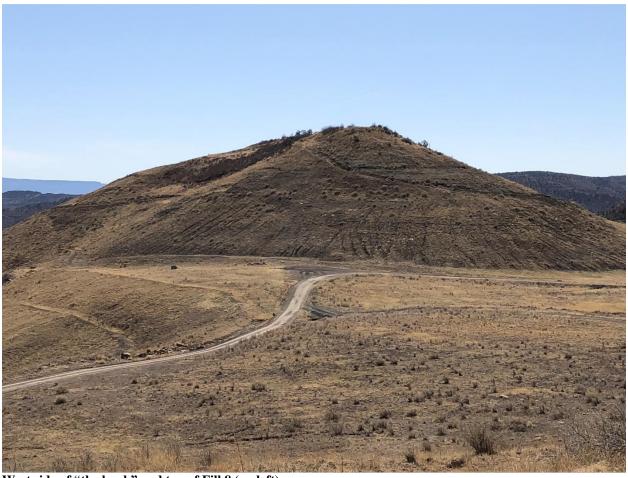
West side of "the knob" and top of Fill 8 (on left)

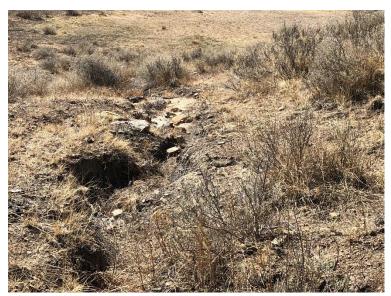
Ditch D15 was found to be in good shape with a much larger cross section at the bottom (approximately five feet deep and 10-foot top width) than at the top of the ditch, where the depth is approximately two feet and the top width is approximately four feet. Ditch D16 should be maintained as it is somewhat eroded. No problems were identified with Ditch D9.
