MINERALS PROGRAM INSPECTION REPORT

MINE NAME: Hitch Rack Ranch Quarry	MINE/PROSPECTING ID#: M-2017-049	MINERAL: Granite Aggregate	COUNTY: El Paso
INSPECTION TYPE: Preoperation Inspection	INSPECTOR(S): Amy Eschberger, Tim Cazier	INSP. DATE: January 30, 2018	INSP. TIME: 12:50
OPERATOR: Transit Mix Concrete Co.	OPERATOR REPRESENTATIVE: Brandon Hesser, Paul Kos, and Bob Stabo	TYPE OF OPERATION: 112c - Construction Regular Operation	
REASON FOR INSPECTION: Preoperation Inspection	BOND CALCULATION TYPE: Complete Bond	BOND AMOUNT: No Bond Held	
DATE OF COMPLAINT: NA	POST INSP. CONTACTS: None	JOINT INSP. AGENCY: None	
WEATHER: Clear	INSPECTOR'S SIGNATURE:

This was a preoperation inspection of the proposed Hitch Rack Ranch Quarry (File No. M-2017-049) conducted by Amy Eschberger and Tim Cazier of the Division of Reclamation, Mining and Safety (Division). The 112c permit application for the proposed Hitch Rack Ranch Quarry (Application) was filed for review on November 9, 2018 by Transit Mix Concrete Co. (Applicant). The Applicant was represented during the inspection by Brandon Heser, Paul Kos, and Bob Stabo.

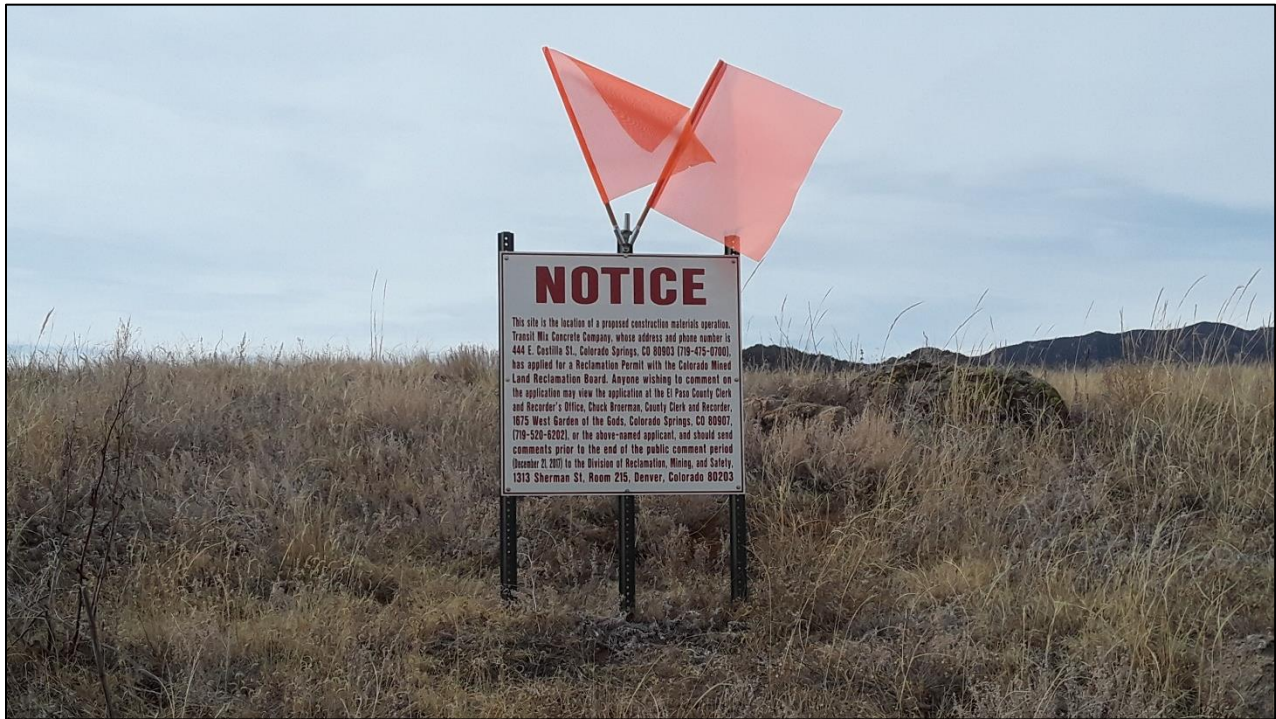
At the time of the inspection, it was partly cloudy and cool. The public notice signs, required by Rule 1.6.2(1)(b), were posted at the Little Turkey Creek Road entrance off Hwy 115 (**Photo 1**), and at the location of the proposed access road off Hwy 115. Given that Hwy 115 is the only road located near the proposed mine site

where the notices may be viewed by the public, the locations chosen are sufficient.

Photo 1. View of public notice sign posted at Little Turkey Creek Road entrance off Hwy 115.

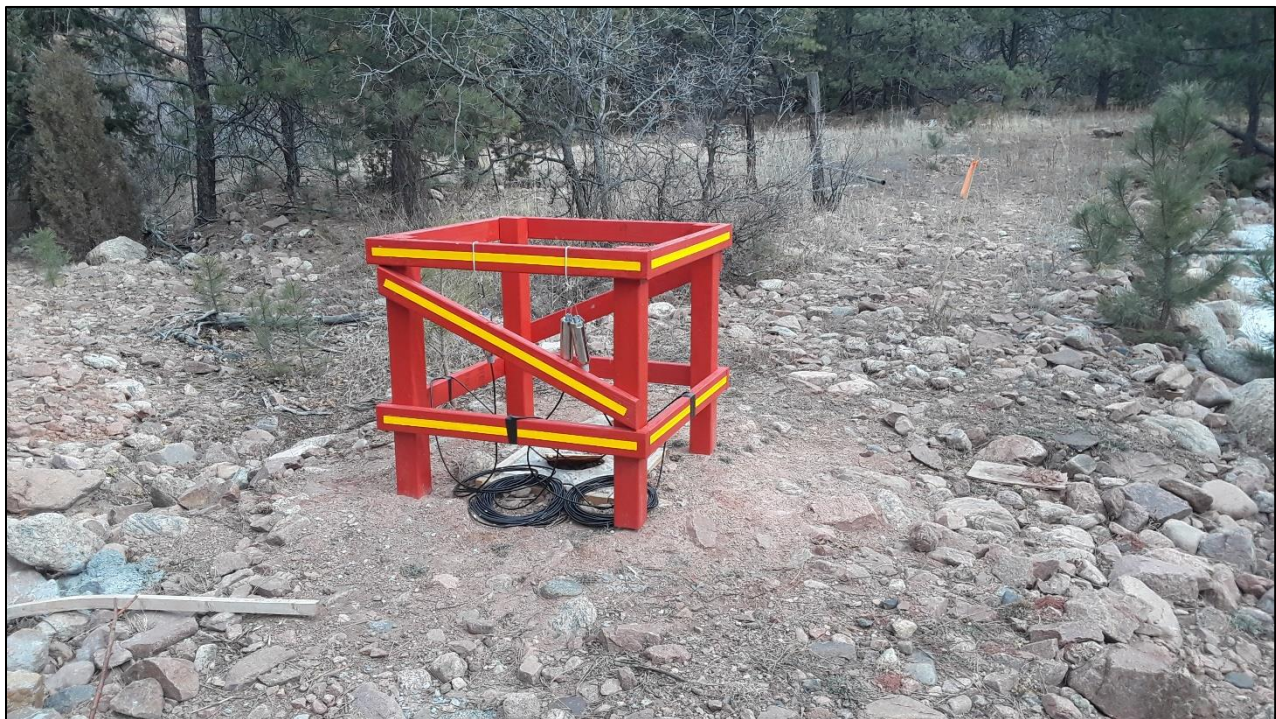
The Division observed the locations of groundwater monitoring wells LTC-GW-7, LTC-GW-6, LTC-GW-2, and LTC-GW-1, discussed in Exhibit G of the Application. Monitoring wells LTC-GW-1, LTC-GW-2, and LTC-GW-7 were completed with continuous monitoring well tubing (**Photos 2-5**). Monitoring well LTC-GW-6 was completed without the continuous monitoring well tubing (**Photos 6 and 7**). Three additional monitoring wells were installed on site, including LTC-GW-3, LTC-GW-4, and LTC-GW-5. These wells were installed outside (and south) of the Little Turkey Creek valley, in the proposed mining area. The seven monitoring wells were installed in 2017 under a Notice of Intent to Conduct Exploration Operations (NOI) to begin collecting baseline groundwater quality and quantity data for the site. Once the required baseline data has been collected, the Applicant will submit a final report to the Division in the form of a Technical Revision. This revision will also propose a groundwater compliance monitoring plan based on the results of the baseline study. The Application proposes two compliance monitoring wells, LTC-GW-1, located upstream of the proposed quarry area, and LTC-GW-2, located downstream of the proposed quarry area. The proposed compliance wells are located within the permit area.

Photo 2. View of groundwater monitoring well LTC-GW-7, installed downgradient from proposed quarry area in Section 16, near eastern property boundary.

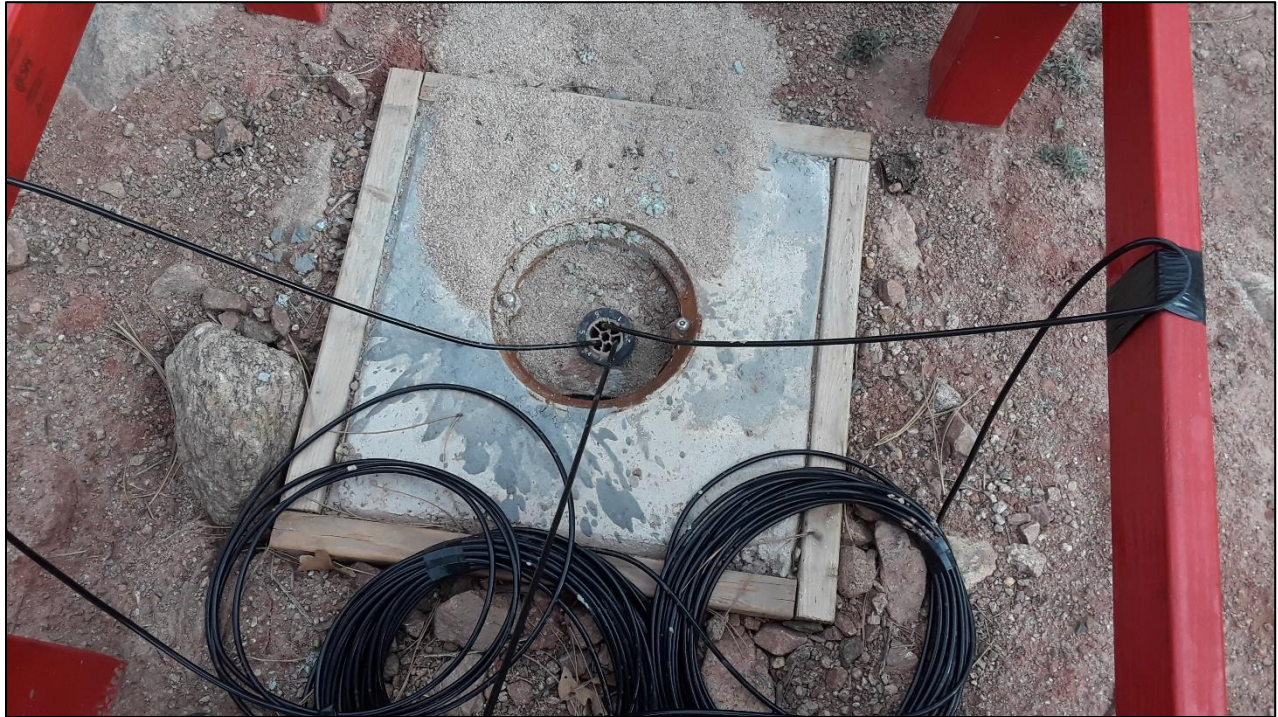
Photo 3. Close-up view of groundwater monitoring well LTC-GW-7, completed with continuous monitoring well tubing.

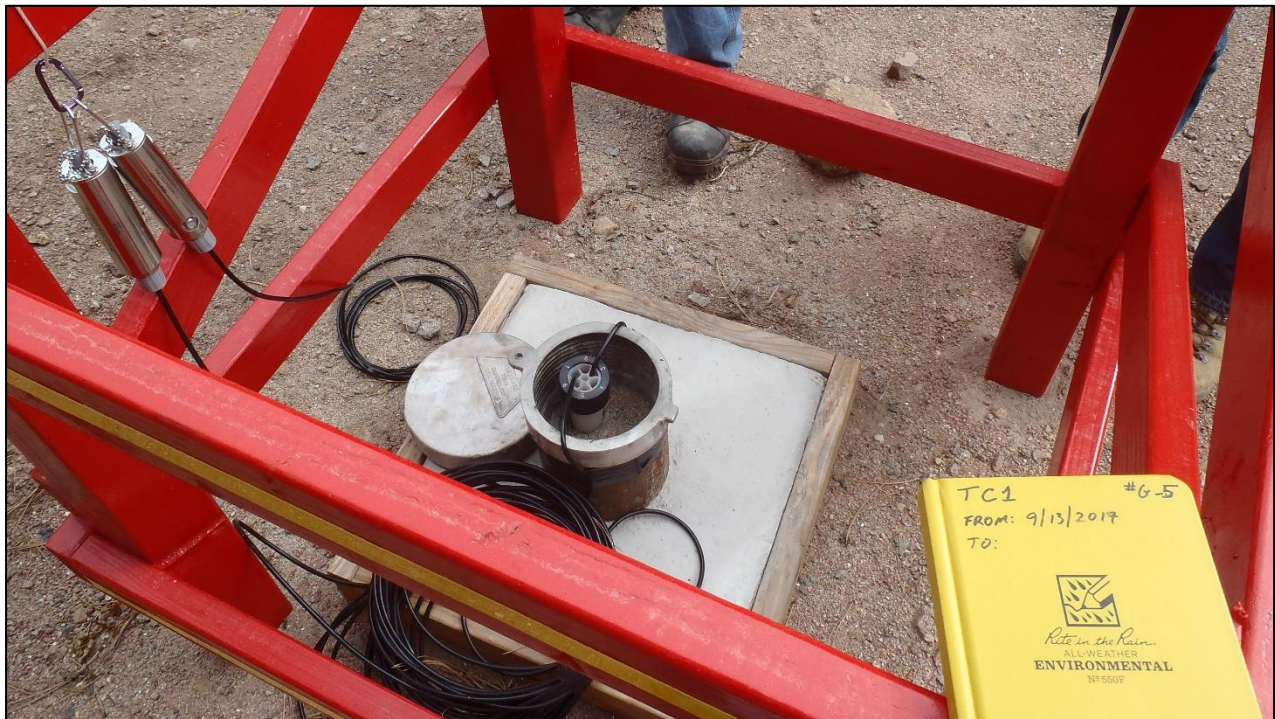
Photo 4. View of groundwater monitoring well LTC-GW-2, installed downgradient from proposed quarry area in Section 16, completed with continuous monitoring well tubing.

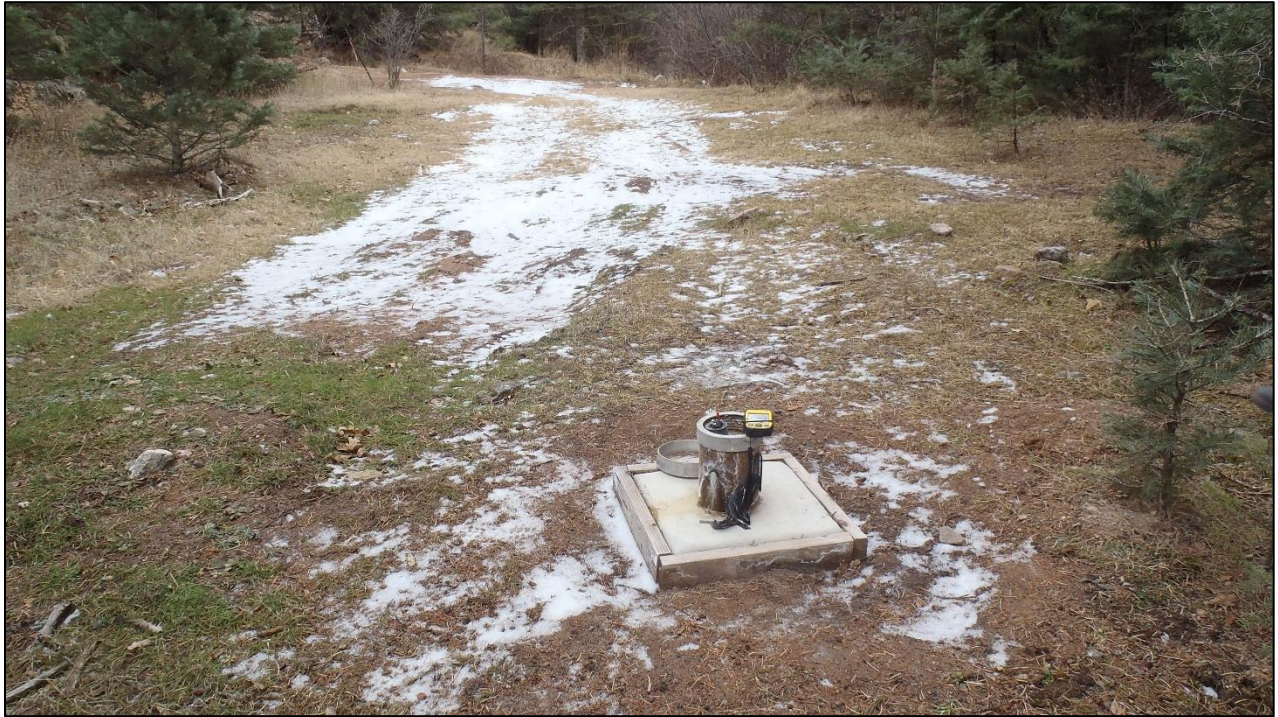
Photo 5. View of groundwater monitoring well LTC-GW-1, installed upgradient from proposed quarry area in Section 16, near western property boundary.

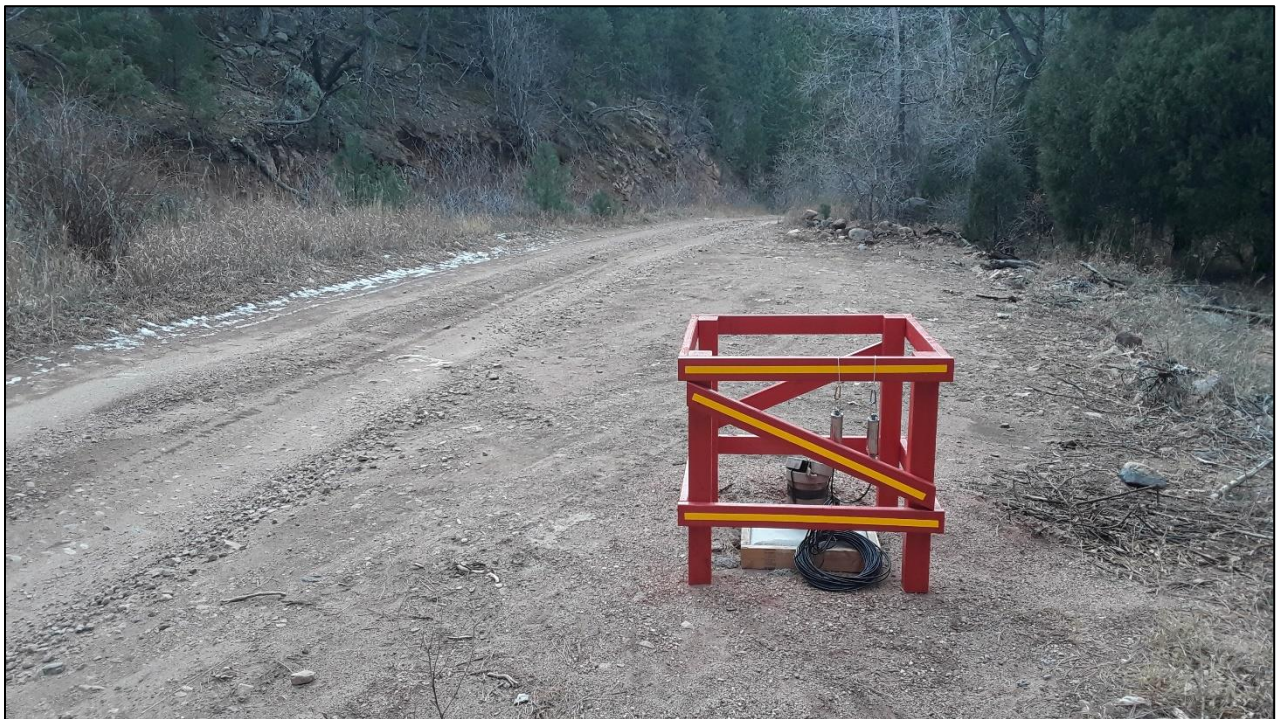
Photo 6. View of groundwater monitoring well LTC-GW-6, installed downgradient from proposed quarry area in Section 16, between monitoring wells LTC-GW-2 and LTC-GW-7.

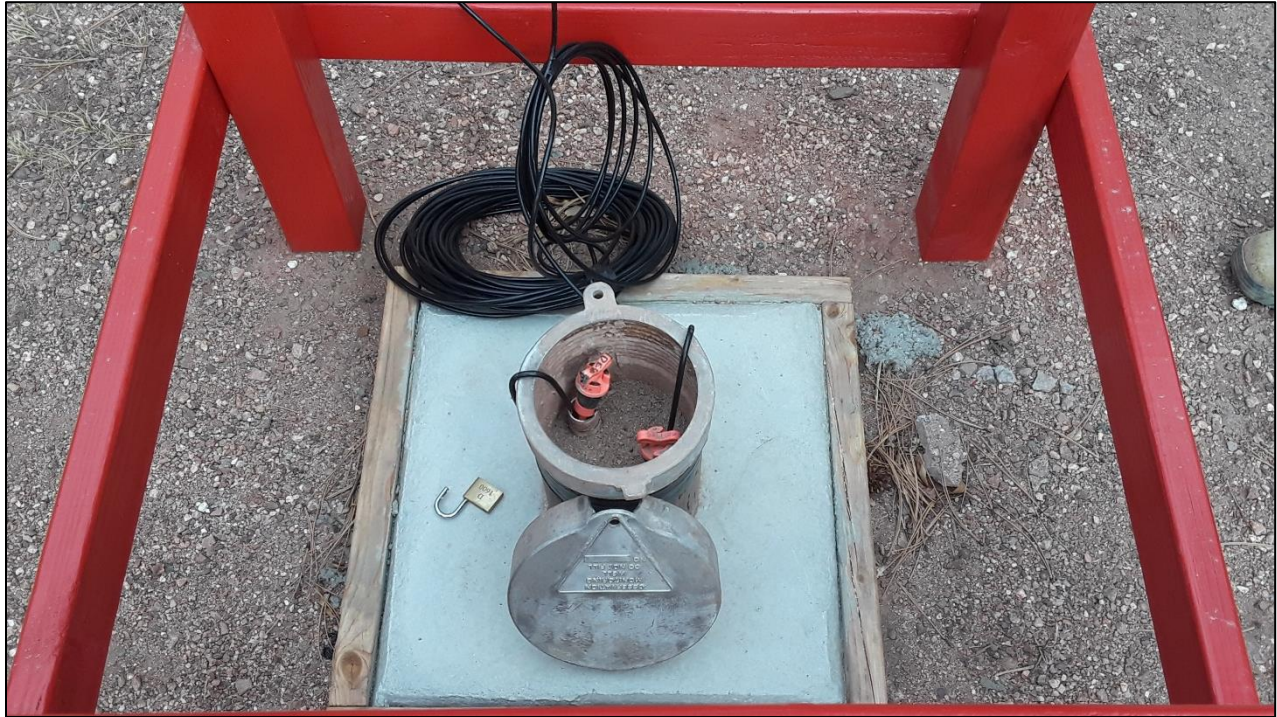
Photo 7. Closer view of groundwater monitoring well LTC-GW-6, installed downgradient from proposed quarry area in Section 16, completed without continuous monitoring well tubing

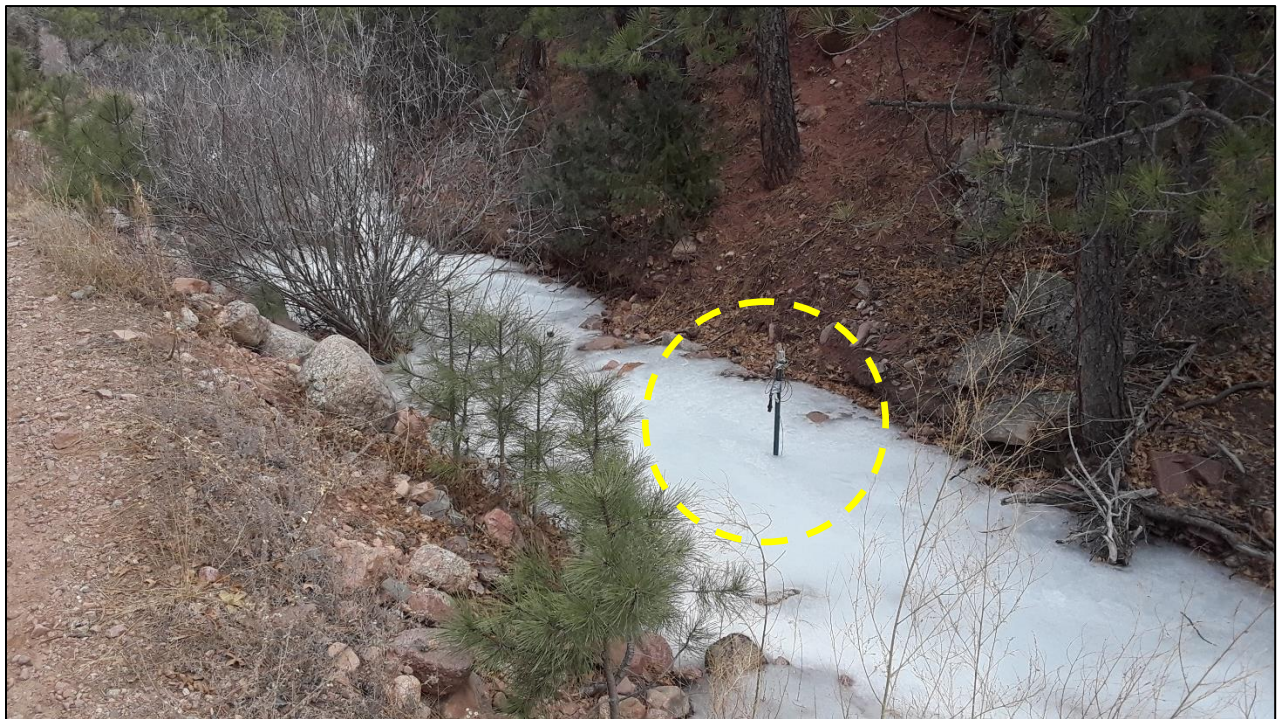
The Division also observed the two surface water monitoring stations on Little Turkey Creek, including LTC-1 (**Photo 8**), located downstream of the proposed quarry area, and LTC-2 (**Photo 9**), located upstream from the proposed quarry area. The Applicant has begun collecting baseline surface water quality and quantity data for Little Turkey Creek at these two monitoring locations. The results of the surface water baseline study will be submitted with the results of the groundwater baseline study in the form of a Technical Revision. The revision will also propose a surface water compliance monitoring plan based on the results of the baseline study.

Photo 8. View of surface water monitoring station LTC-1 (circled) on Little Turkey Creek, located downstream from proposed quarry area. Note creek partially frozen during inspection.

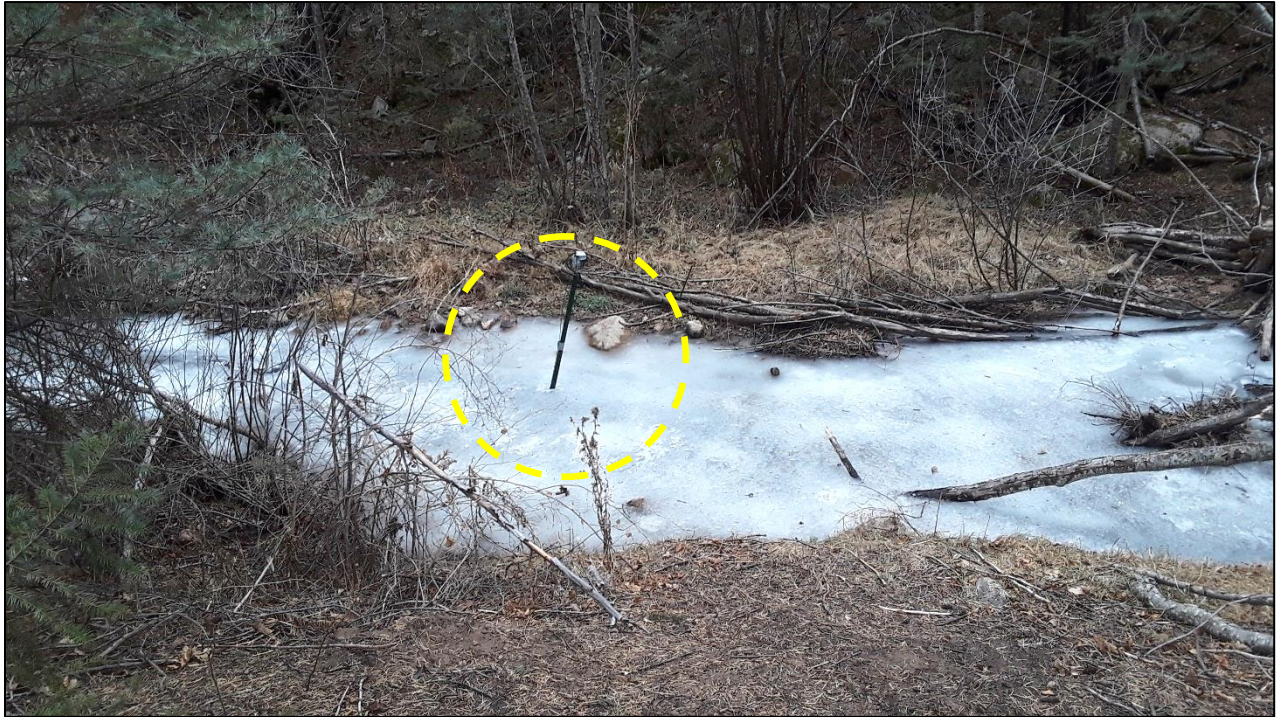
Photo 9. View of surface water monitoring station LTC-2 (circled) on Little Turkey Creek, located upstream from proposed quarry area. Note creek partially frozen during inspection.

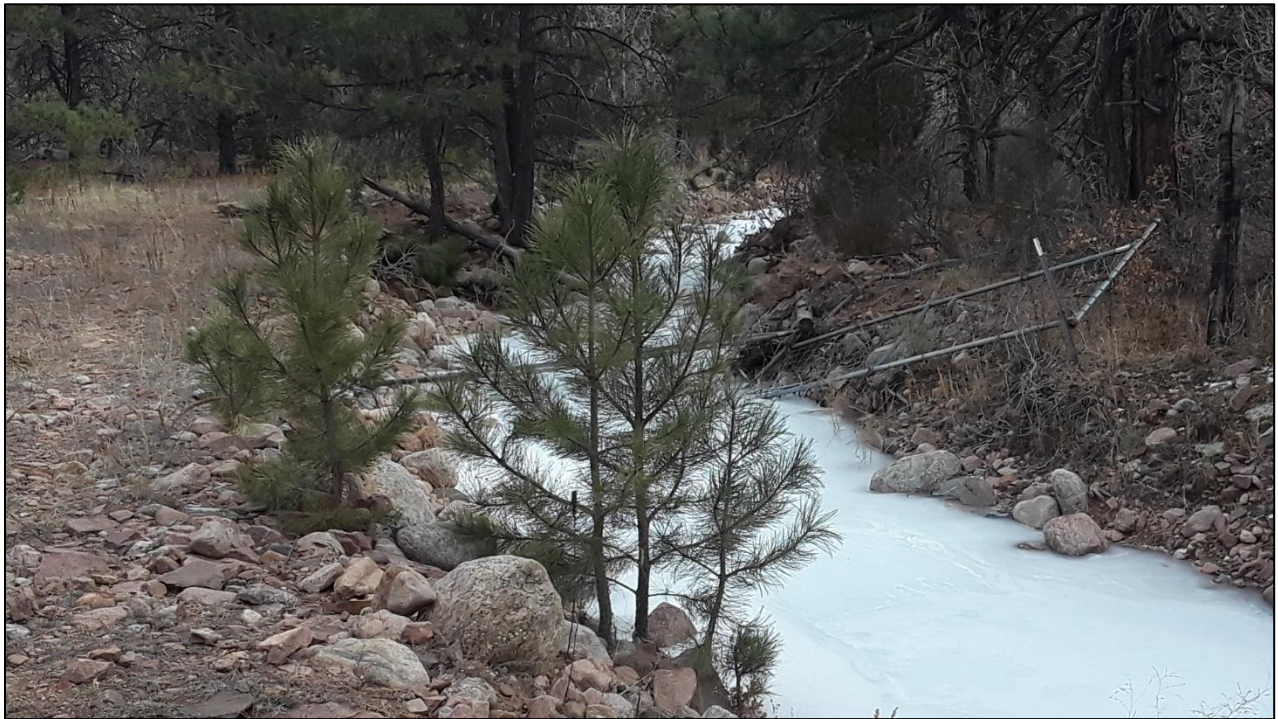
Photo 10. View of gate observed lying on ground near monitoring well LTC-GW-7. The Division does not consider this a significant, valuable, and permanent structure as described in Rule 6.4.19, which would require a structure agreement.

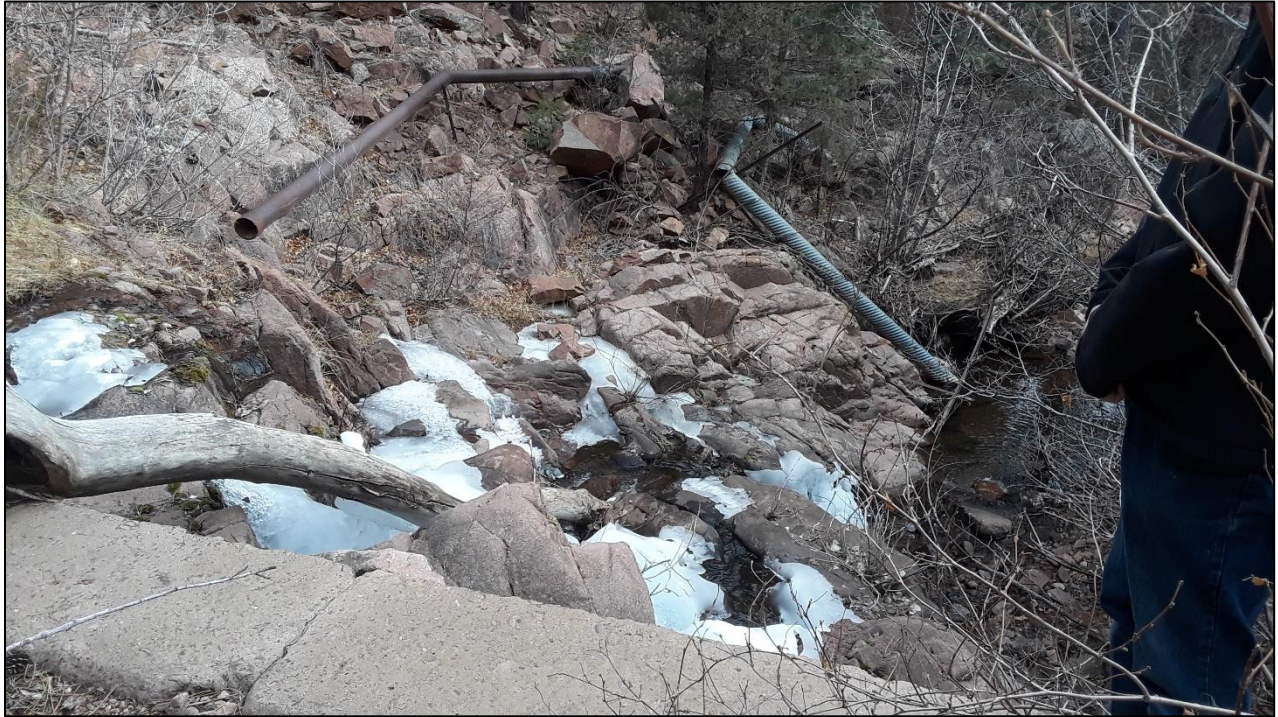
The Application identified several significant, valuable and permanent man-made structures located within 200 feet of the proposed affected land, in accordance with Rule 6.4.19. These structures were identified on Figure C-2 of the Application. The originally submitted Figure C-2 showed structures located within 200 feet of the proposed permit boundary. However, the revised Figure C-2 (submitted March 9, 2018), showed all structures located within 200 feet of the proposed affected land boundary, as required by Rule 6.4.3(b). With this revision, some of the structures shown on the originally submitted Figure C-2 were removed on the revised Figure C-2, as they are not located within 200 feet of the proposed affected land boundary. For example, the gates that exist at the entrances to the property along Little Turkey Creek Road are not shown on the revised Figure C-2. The Division observed a gate lying on the ground (**Photo 10**) near monitoring well LTC-GW-7. The Division does not consider this gate to be a significant, valuable, and permanent structure as described in Rule 6.4.19, which would require a structure agreement. The Division observed the location of the Schluckebier headwall, headgate, and pipeline (**Photos 11 and 12**) located within 200 feet of the proposed affected land boundary, north of Little Turkey Creek. The pipeline was disconnected and the structure appeared to be in disrepair. The Division did not observe any significant, valuable, and permanent man-made structures located within 200 feet of the proposed affected land that were unaccounted for in the Application.

Photo 11. View looking downstream on Little Turkey Creek, showing Schluckebier Headwall, Headgate, and Pipeline structures identified in application as located within 200 feet of proposed affected land boundary. Note pipeline is disconnected.

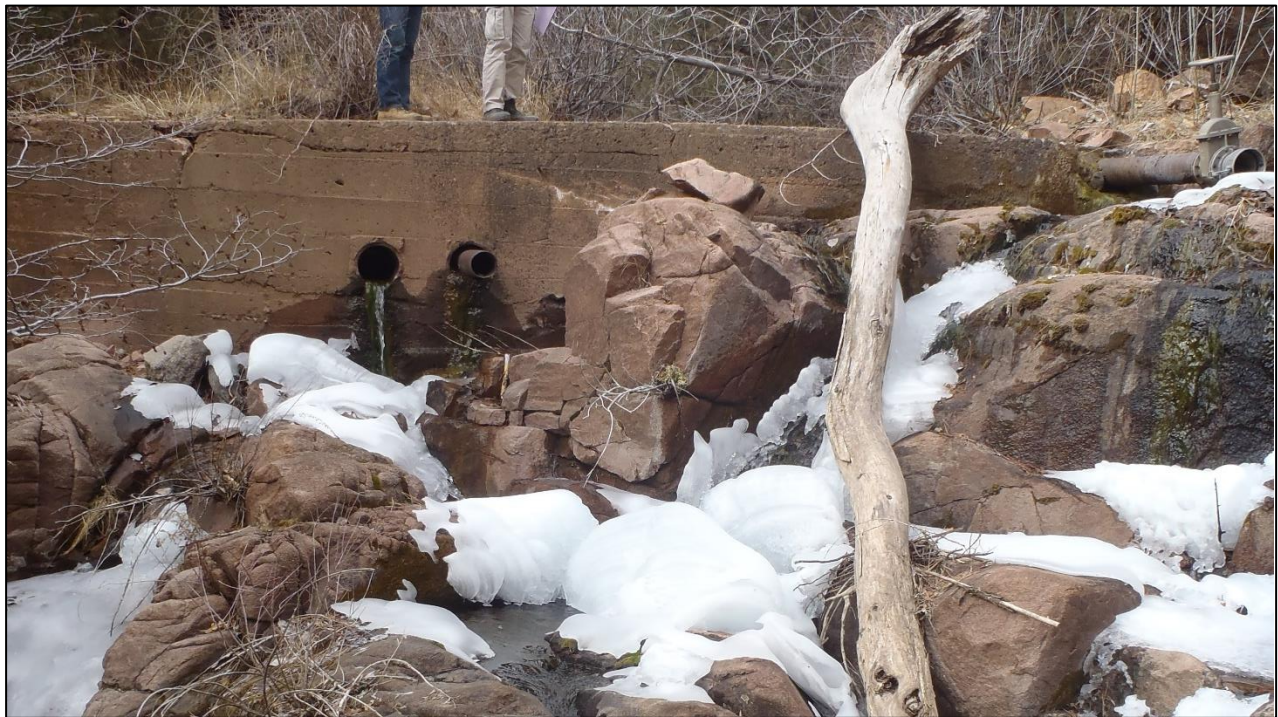
Photo 12. View looking upstream on Little Turkey Creek, showing Schluckebier Headwall, Headgate, and Pipeline structures identified in application as located within 200 feet of proposed affected land boundary.

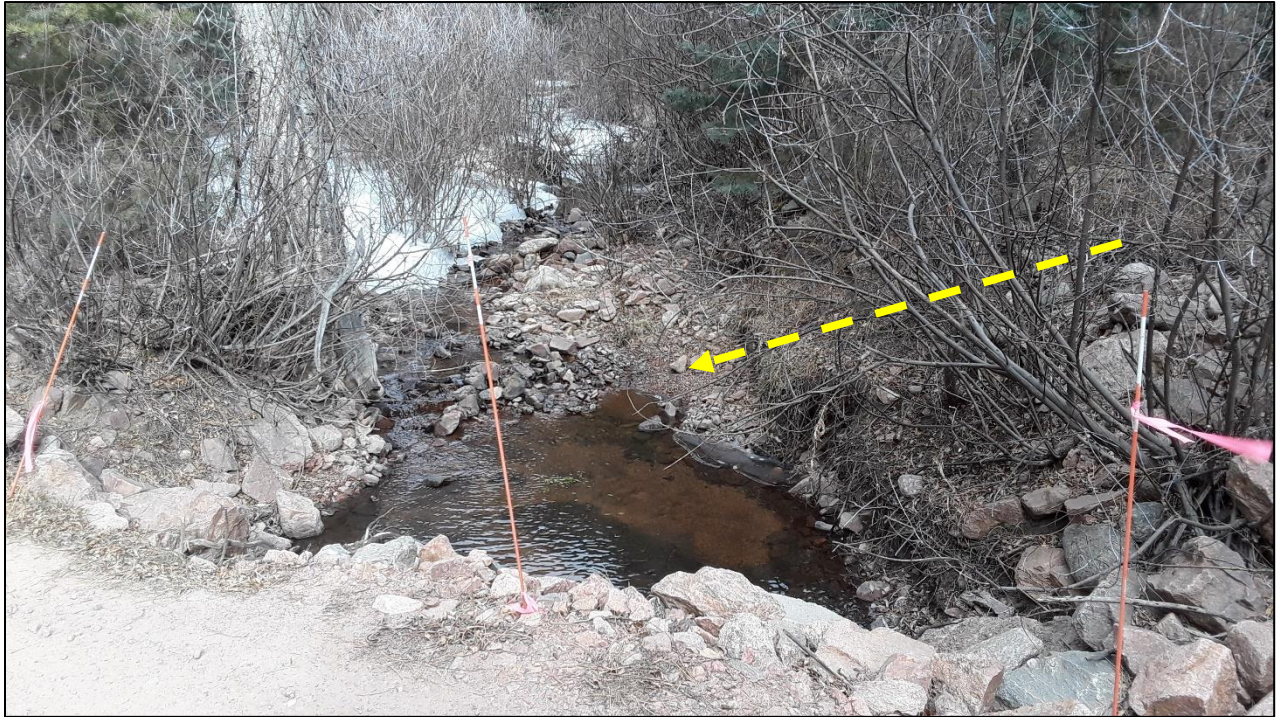
The Division observed the location for the proposed discharge point from the pit area into Little Turkey Creek (**Photo 13**). This point is located east of the proposed quarry area. During operations, water from the pit area will be temporarily detained in a sediment basin, before being released via a culvert to the discharge point. For reclamation, a channel will be constructed along the F2 Fines stockpile (inside the pit), across the pit floor, and through the ridge between the pit area and the creek to convey water to the same discharge point. The reclamation channel will follow the alignment of the plant sediment detention basin outlet culvert to minimize disturbances at the confluence with Little Turkey Creek. During the inspection, the Division observed water present in this portion of the creek. It should be noted, that all waters discharged from the site will be regulated by a National Pollutant Discharge Elimination System (NPDES) permit obtained from the Colorado Department of Public Health and Environment, Water Quality Control Division. The discharge permit will have specific

effluent limitations and monitoring requirements.

Photo 13. View looking downstream on Little Turkey Creek from Little Turkey Creek Road, showing proposed discharge point for which Applicant will obtain a NPDES permit from CDPHE, WQCD. Discharge pipe/drainage would be from right side of photo as indicated with arrow (location approximated).

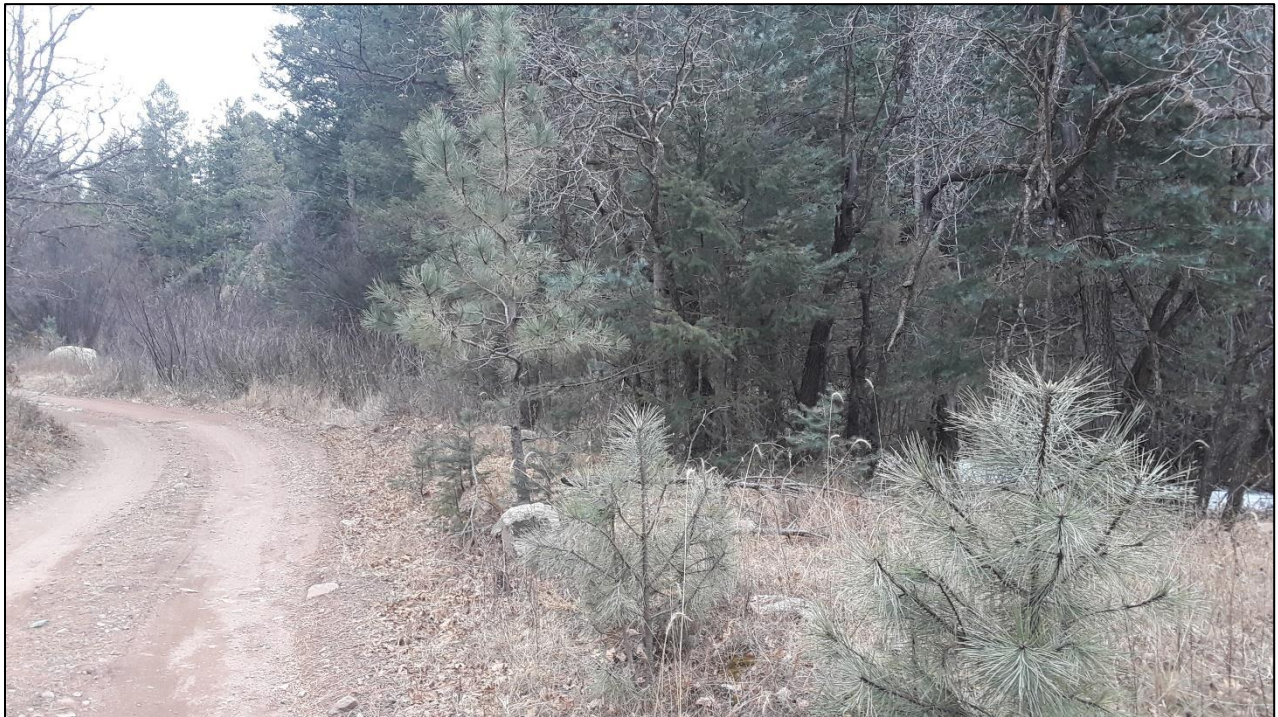
The Application proposes maintaining a 100 foot mining buffer from Little Turkey Creek. This buffer zone is also south of Little Turkey Creek Road in much of Section 16, except in the area where the creek crosses and is located north of the road, for a stretch of approximately 600-700 feet. The Division observed the buffer area to consist primarily of forested land, which separates the proposed quarry area from Little Turkey Creek and Little Turkey Creek Road (**Photos 14 and 15**).

Photo 14. View looking east from Little Turkey Creek Road, showing existing vegetation between the road and Little Turkey Creek (located south of road at this location, at right).

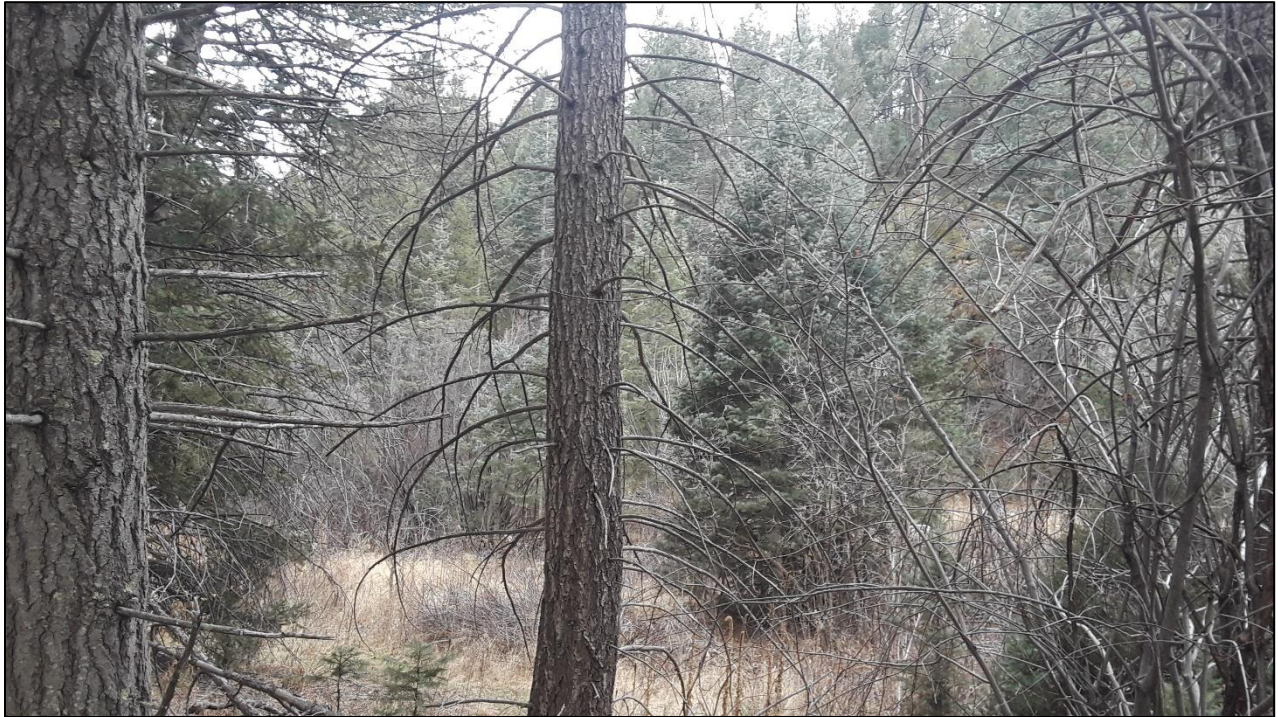
Photo 15. View looking south from Little Turkey Creek Road, showing existing vegetation between the road and the proposed quarry area (hill in background).
