**COLORADO**Division of Reclamation,
Mining and Safety

MINERALS PROGRAM INSPECTION REPORT**PHONE: (303) 866-3567**

MINE NAME: Schwartzwalder Mine	MINE/PROSPECTING ID#: M-1977-300	MINERAL: Uranium	COUNTY: Jefferson
INSPECTION TYPE: Monitoring	INSPECTOR(S): Michael A. Cunningham	INSP. DATE: March 22, 2018	INSP. TIME: 09:30
OPERATOR: Colorado Legacy Land, LLC	OPERATOR REPRESENTATIVE: Jim Harrington	TYPE OF OPERATION: 112d-2 - Designated Mining Operation	
REASON FOR INSPECTION: Normal I&E Program	BOND CALCULATION TYPE: None	BOND AMOUNT: \$8,900,000.00	
DATE OF COMPLAINT: NA	POST INSP. CONTACTS: None	JOINT INSP. AGENCY: None	
WEATHER: Clear	INSPECTOR'S SIGNATURE:

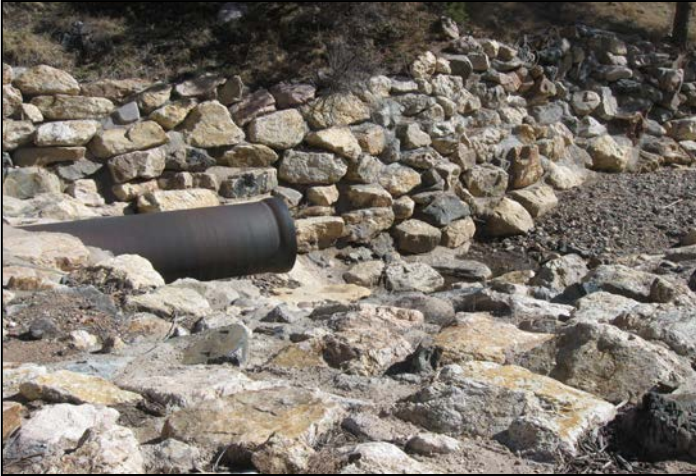
1. Ralston Creek below the cut-off wall.

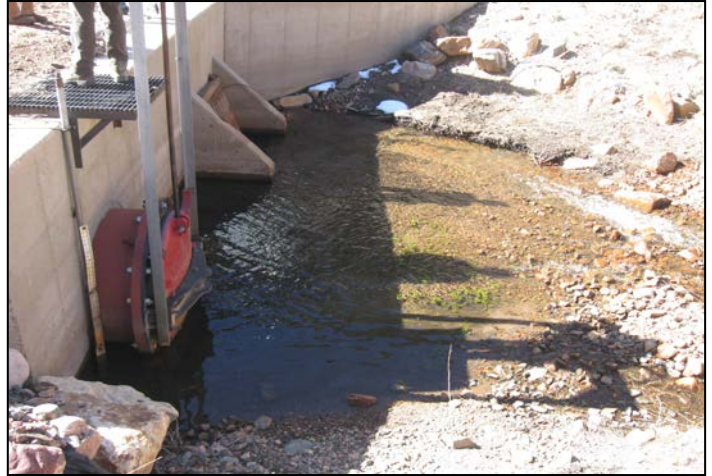
2. Ralston Creek above the cut-off wall.

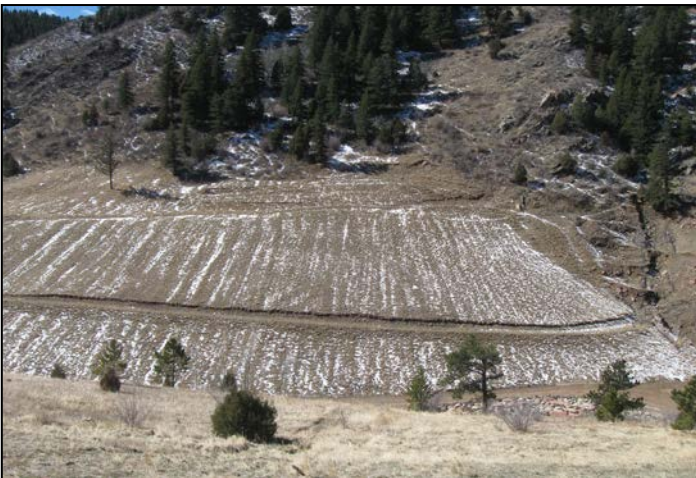
The northern and southern waste rock piles were inspected and were found to be stable. All areas of erosion which were identified and repaired in 2017 continue to be stable and no new erosion was noted. The Division inspected the seep on top of the northern waste rock pile, which had been identified during the inspection conducted on June 28, 2016. The seep was contained to the top of the waste rock pile, no water was observed flowing off the top of the slope. The Division approved a diversion channel to direct the flows off and away from the north waste rock pile. The details of the diversion channel can be found under Technical Revision No. 23.

3. Overview of south waste rock pile.

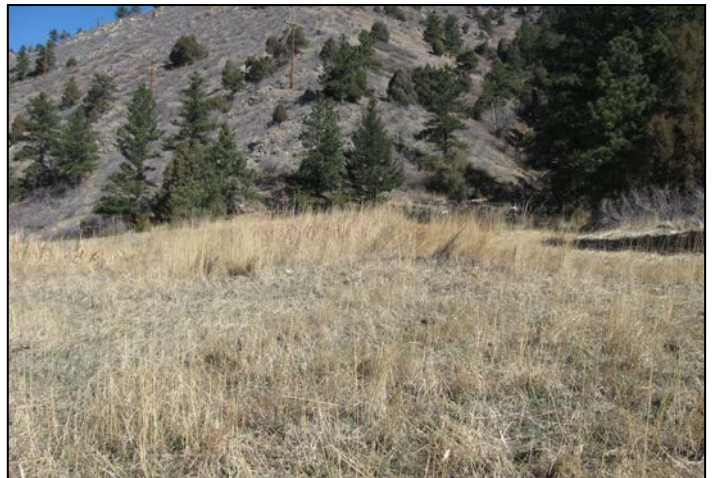
4. Seep area on top of north waste rock pile.

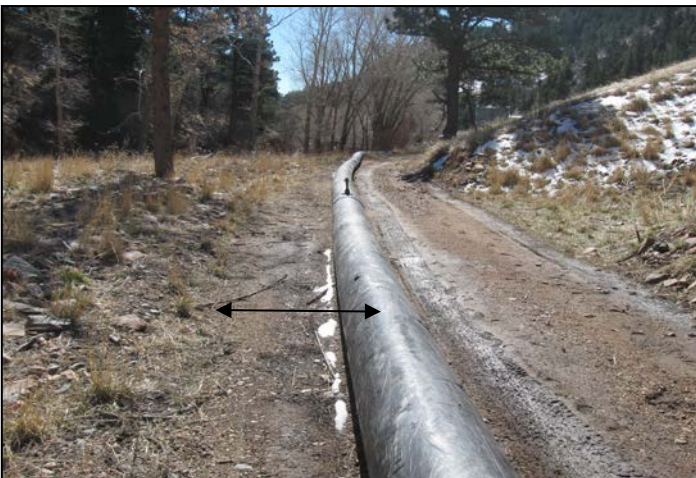
The Division inspected the cut-off wall during the inspection and observed that Ralston Creek was being diverted through the bypass pipeline. The Division observed a section of the bypass pipeline, approximately 100 feet in length had moved approximately 3 feet to the south of its former location. The section of the pipeline which moved was located along the south waste rock pile. The movement of the bypass pipeline was attributed to the effects of thermal expansion. The bypass pipeline is designed to flex and withstand movement. The Operator will move the bypass pipeline back to its former position and will attempt to anchor the section which moved.

5. Section of bypass pipeline which moved from its former location.
