**COLORADO**Division of Reclamation,
Mining and Safety

MINERALS PROGRAM INSPECTION REPORT**PHONE: (303) 866-3567**

MINE NAME: Climax Mine	MINE/PROSPECTING ID#: M-1977-493	MINERAL: Molybdenum	COUNTY: Summit
INSPECTION TYPE: Monitoring	INSPECTOR(S): Lucas J. West	INSP. DATE: April 12, 2018	INSP. TIME: 09:52
OPERATOR: Climax Molybdenum Company	OPERATOR REPRESENTATIVE: Diana Kelts, Emile McCormick	TYPE OF OPERATION: 112d-3 - Designated Mining Operation	
REASON FOR INSPECTION: Normal I&E Program	BOND CALCULATION TYPE: None	BOND AMOUNT: \$78,246,088.00	
DATE OF COMPLAINT: NA	POST INSP. CONTACTS: None	JOINT INSP. AGENCY: None	
WEATHER: Clear	INSPECTOR'S SIGNATURE:

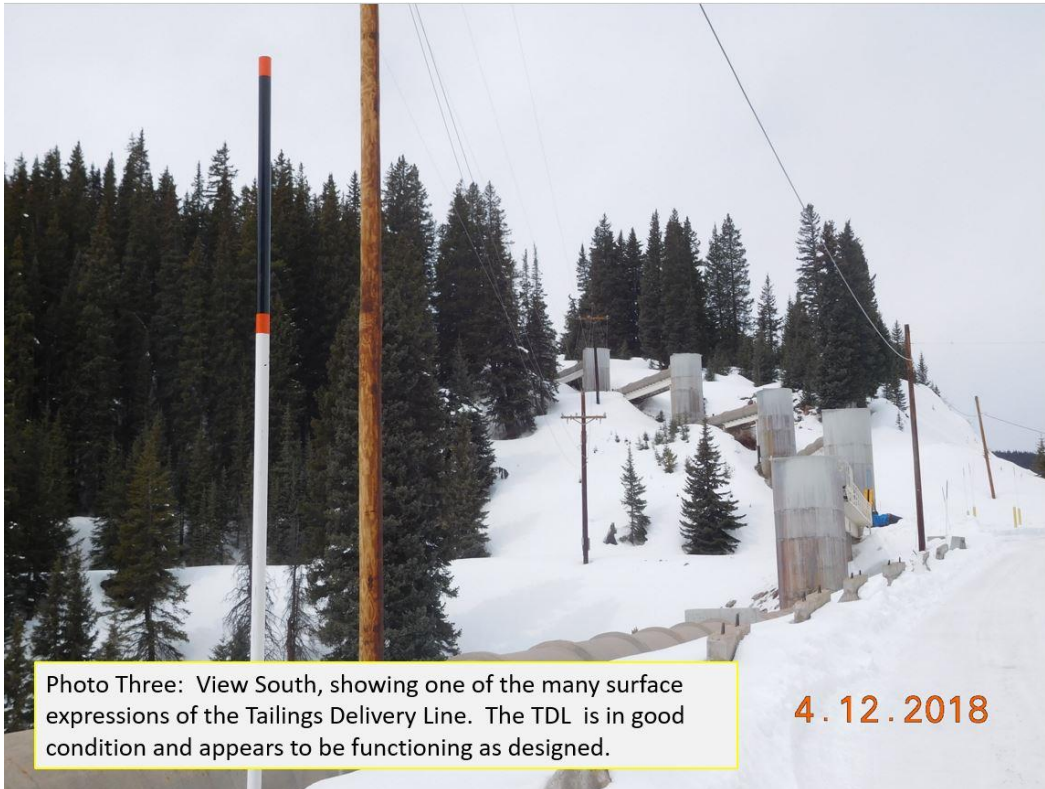
Tailings dams 1, 2 and 3 were observed despite the snowpack. The dams appeared to be in good condition and showed no signs of settling or slumping. The water management systems associated with these dams including both the Robinson Lake and Warren's ponds as well as the various pump stations and monitoring devices were observed. Discussions with the Operator Representatives indicate that all devices and systems are functioning properly. There are some preliminary discussions on upgrading the monitoring equipment communications systems but that will be a project to happen in the years to come. The Tenmile and Mayflower Tailings Storage Facilities were observed and appeared to be in good condition. The Mayflower TSF can be seen in Photos **One** and **Two**. The Tailings Deliver Line (TDL) was observed where it can be seen on the surface. The line appears to be functioning as designed and is in good condition and can be seen in Photo **Three**.

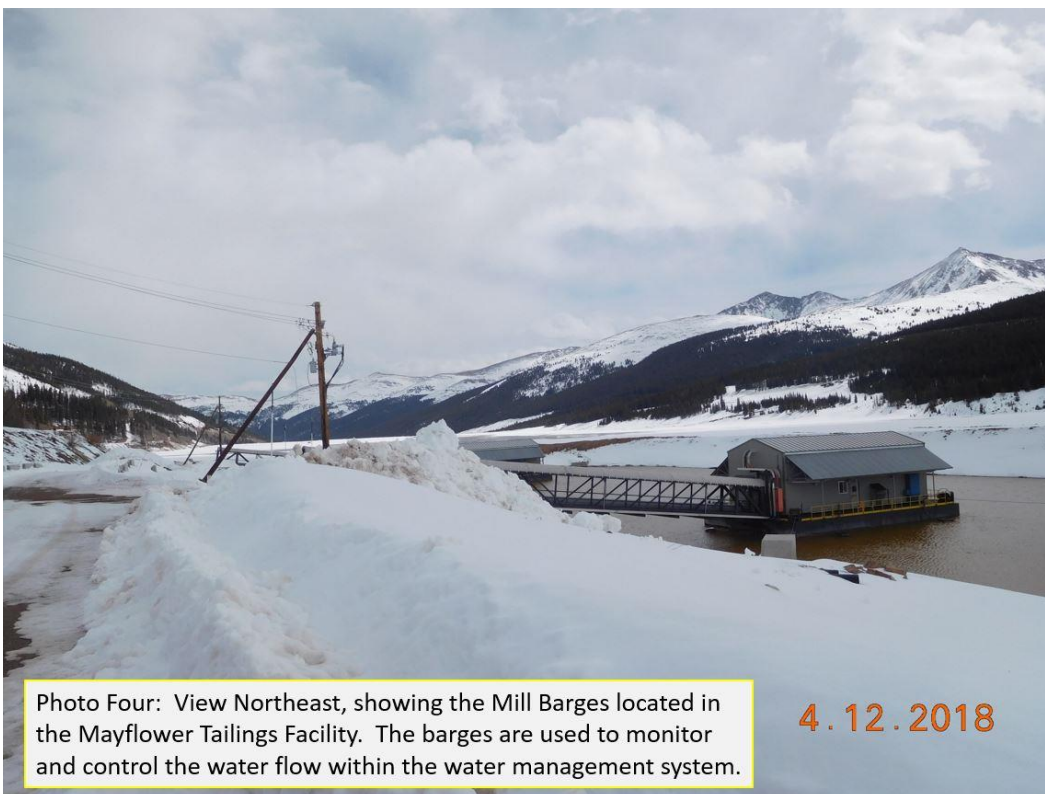
The Water management systems associated with the dams and Tailings Storage Facilities was inspected. The Toe drains of the dams however were not due to snowpack. The 3 dam pump station, Mayflower pump station and Mill barges were all inspected and no issues with those facilities were noted. Photo Four shows the Mill barges used to monitor and control the water levels in the Tailings Storage Facility.
