## MINERALS PROGRAM INSPECTION REPORT

<b>MINE NAME:</b> MMM Partnership Gravel Pit	<b>MINE/PROSPECTING ID#:</b> M-2006-042	<b>MINERAL:</b> Sand, gravel and borrow material	<b>COUNTY:</b> Logan
<b>INSPECTION TYPE:</b> Monitoring	<b>INSPECTOR(S):</b> Jared L. Ebert	<b>INSP. DATE:</b> April 18, 2018	<b>INSP. TIME:</b> 13:30
<b>OPERATOR:</b> MMM Partnership, LLP.	<b>OPERATOR REPRESENTATIVE:</b> Mark Kokes	<b>TYPE OF OPERATION:</b> 112c - Construction Regular Operation	
<b>REASON FOR INSPECTION:</b> Normal I&E Program	<b>BOND CALCULATION TYPE:</b> Complete Bond	<b>BOND AMOUNT:</b> \$67,200.00	
<b>DATE OF COMPLAINT:</b> NA	<b>POST INSP. CONTACTS:</b> None	<b>JOINT INSP. AGENCY:</b> None	
<b>WEATHER:</b> Clear	<b>INSPECTOR'S SIGNATURE:</b>

This was an inspection of the MMM Partnership Gravel site, DRMS Permit No. M-2006-042 operated by MMM Partnership, LLP (MMM). I, Jared Ebert with the Colorado Division of Reclamation, Mining and Safety (DRMS or Division) conducted the inspection. Mr. Mark Kokes with MMM accompanied me during the inspection.

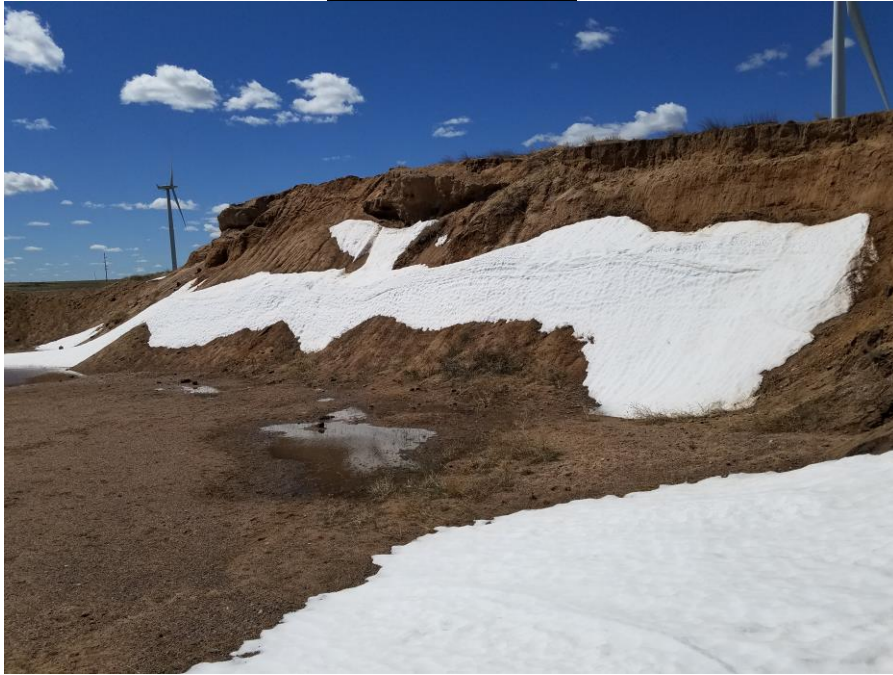
Figure 1. Base of the eastern highwall looking northwest.

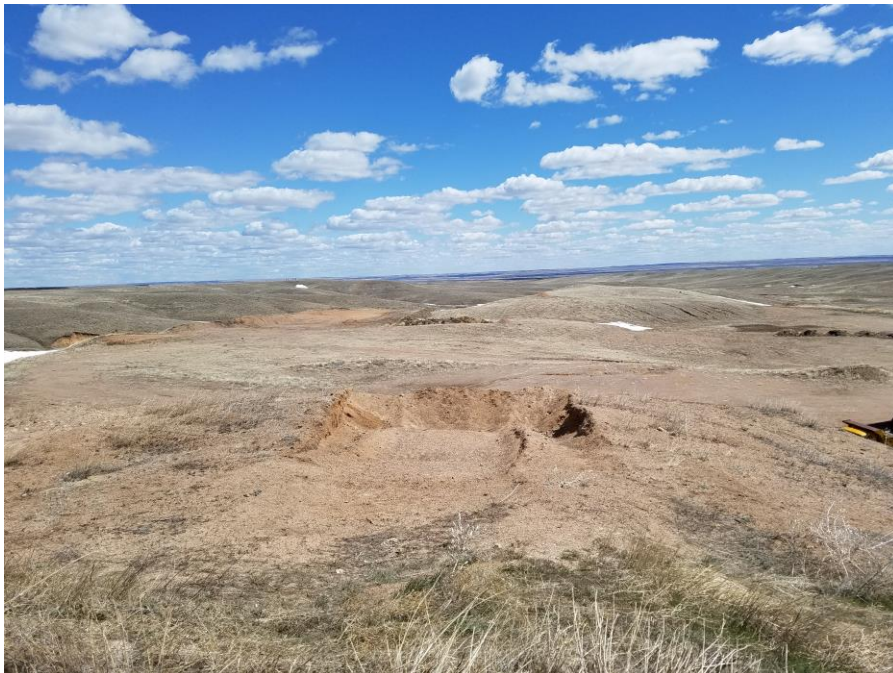
Figure 2. From on top of the eastern highwall looking southeast.

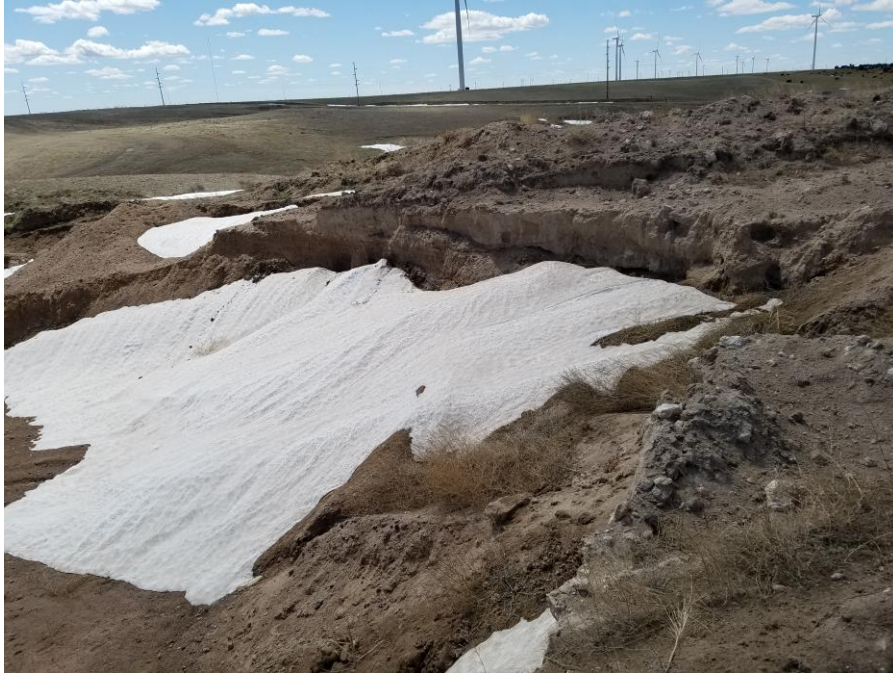
The primary excavation is occurring in the north/north central portion of the permit area consisting of two primary highwalls. The Division measured the location of these highwalls using the ArcCollector Application. These features are shown on the attached map. The western highwall is about 243 feet in length and the eastern highwall is about 227 feet in length. Both highwalls range in height from 15 to 25 feet and are nearly vertical at the top. These highwalls daylight facing south and the base of the pit is a relatively gentle slope undulating with the natural topography.

Figure 3. Western highwall

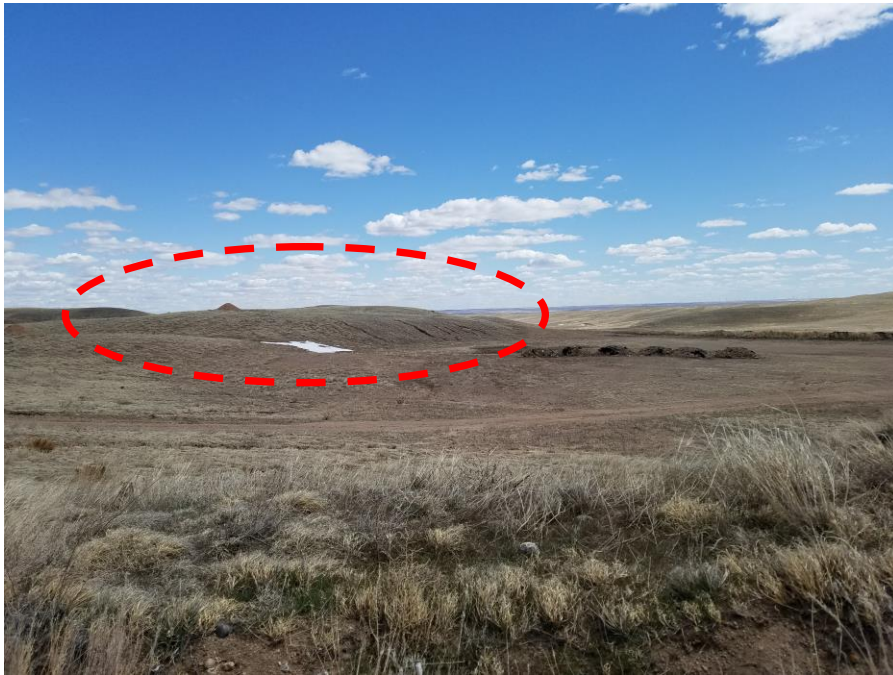
The 2016-2017 annual report map depicts a "Preliminary Slope Area", this area is a graded area with native vegetation established. It appears this area was the top of a ridge that has been lowered with 3H:1V to 4H:1V side slopes. Some rills were observed in this area. These rills end at the base of the pit and a berm of topsoil and manure compost keep the sediment contained onsite. According to Mr. Kokes, MMM plans on mining into the area with the rills in the future, so this area will be re-affected.

Figure 4. From the base of the highwalls looking southeast. "Preliminary Slope Area" outlined in red-dashed oval.
