PERMIT INFORMATION

Permit Number: C-1981-028 Mine Name: Keenesburg Strip Mine Operator: Coors Energy Company Operator Address: Mr. Danny Kipp P.O Box 467 Golden , CO 80402	County: Weld Operation Type: Surface Permit Status: Active Ownership: Private
	Operator Representative Present: Danny Kipp
Operator Representative Signature: (Field Issuance Only)

INSPECTION INFORMATION

Inspection Start Date: April 25, 2018 Inspection Start Time: 09:45 Inspection End Date: Inspection End Time:		Inspection Type: Coal Partial Inspection Inspection Reason: Normal I&E Program Weather: Clear	
Joint Inspection Agency: None		Joint Inspection Contacts:	
Post Inspection Agency: None		Post Inspection Contacts:	
Inspector(s): Robert D. Zuber, P.E.	Inspector's Signature:

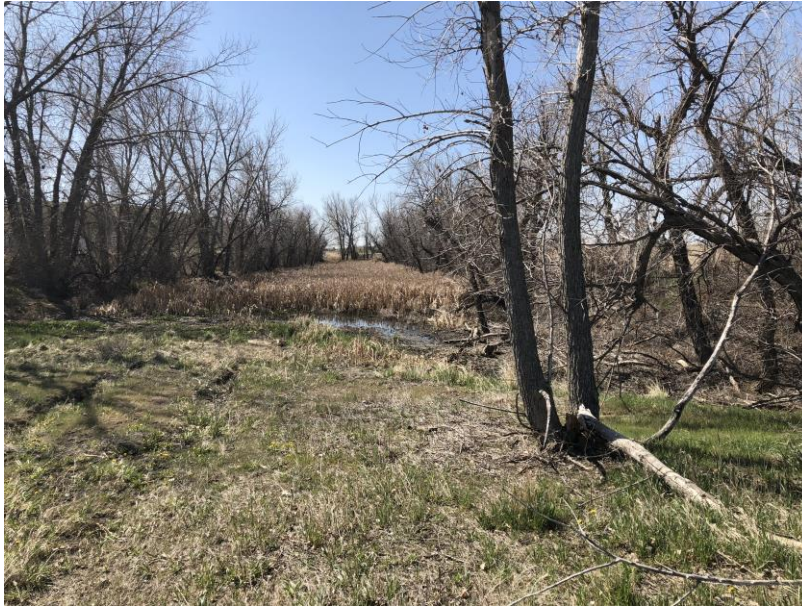
Dugout Pond

Standing water was observed in Sediment Pond 2 and the Dugout Pond. Neither pond was discharging. No problems were observed with the two ponds.

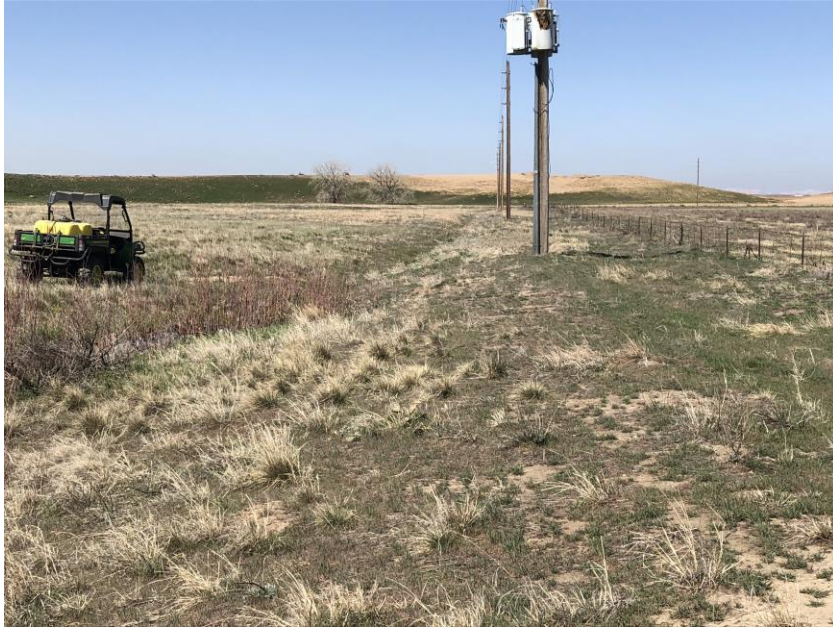
Topsand Pile A-3, Topsand Pile A-1, and Topsand Pile B-1 were observed from roads and from the tops of the piles. No erosion or other problems were observed with any of the piles.

Fence line and ditch west of Sediment Pond 2 with Topsand Pile A-3 in background

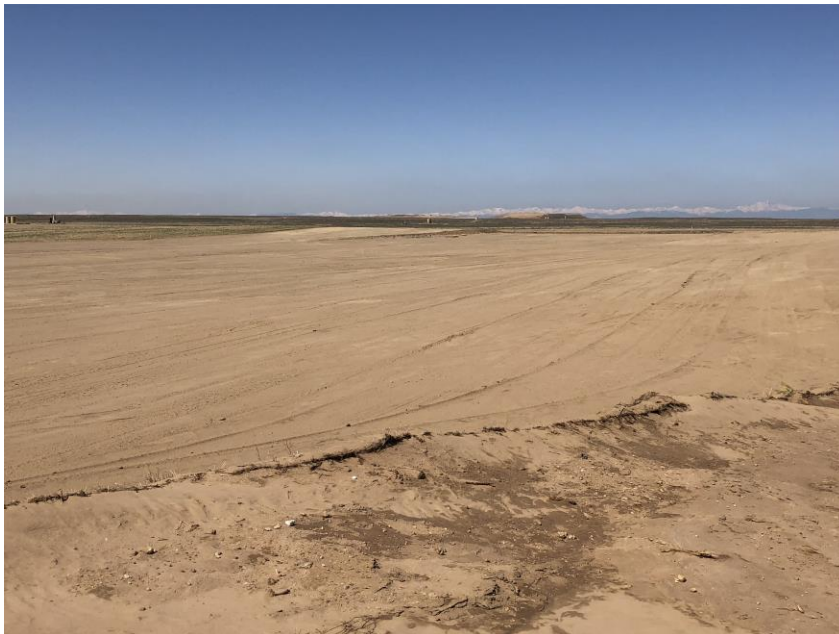
During the inspection, no backfill or grading operations were taking place. Significant spoil material remains to be moved onto the B Pit and Long Term Spoil areas. Danny Kipp indicated that these operations will likely be completed around December 2018.

Use of a GPS device (iPhone with Collector) and discussion with Danny Kipp indicated that the line on permit maps that delineates the B Pit from the Long Term Spoil area is incorrect. The line should be moved to the west, showing a smaller area for B Pit on the map. Mr. Kipp indicated that he plans to submit a Minor Revision to correct this error. Also, Reach B-1 (and possibly other drainage channels) should be relocated on permit maps to match the on-the-ground locations.

Long Term Spoil Area with B Pit area in background

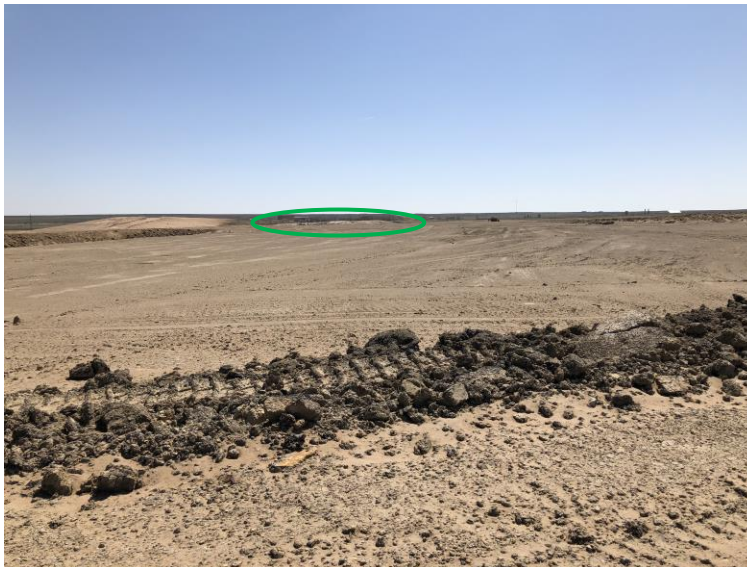
B Pit area with remaining spoil pile (circled)
