**MINERALS PROGRAM INSPECTION REPORT**  
**PHONE: (303) 866-3567**

<b>MINE NAME:</b> Mask Ranch Pit #2	<b>MINE/PROSPECTING ID#:</b> M-2018-015	<b>MINERAL:</b> Aggregate and grave	<b>COUNTY:</b> Archuleta
<b>INSPECTION TYPE:</b> Multi Person Inspection	<b>INSPECTOR(S):</b> Lucas J. West	<b>INSP. DATE:</b> April 26, 2018	<b>INSP. TIME:</b> 13:00
<b>OPERATOR:</b> Fremont Paving & Redi-Mix, Inc.	<b>OPERATOR REPRESENTATIVE:</b> Jody Schreiber, James Higgs	<b>TYPE OF OPERATION:</b> 111 - Construction by Government Agency	
<b>REASON FOR INSPECTION:</b> Pre-operation Inspection	<b>BOND CALCULATION TYPE:</b> Complete Bond	<b>BOND AMOUNT:</b> No Bond Held	
<b>DATE OF COMPLAINT:</b> NA	<b>POST INSP. CONTACTS:</b> None	<b>JOINT INSP. AGENCY:</b> None	
<b>WEATHER:</b> Clear	<b>INSPECTOR'S SIGNATURE:</b>

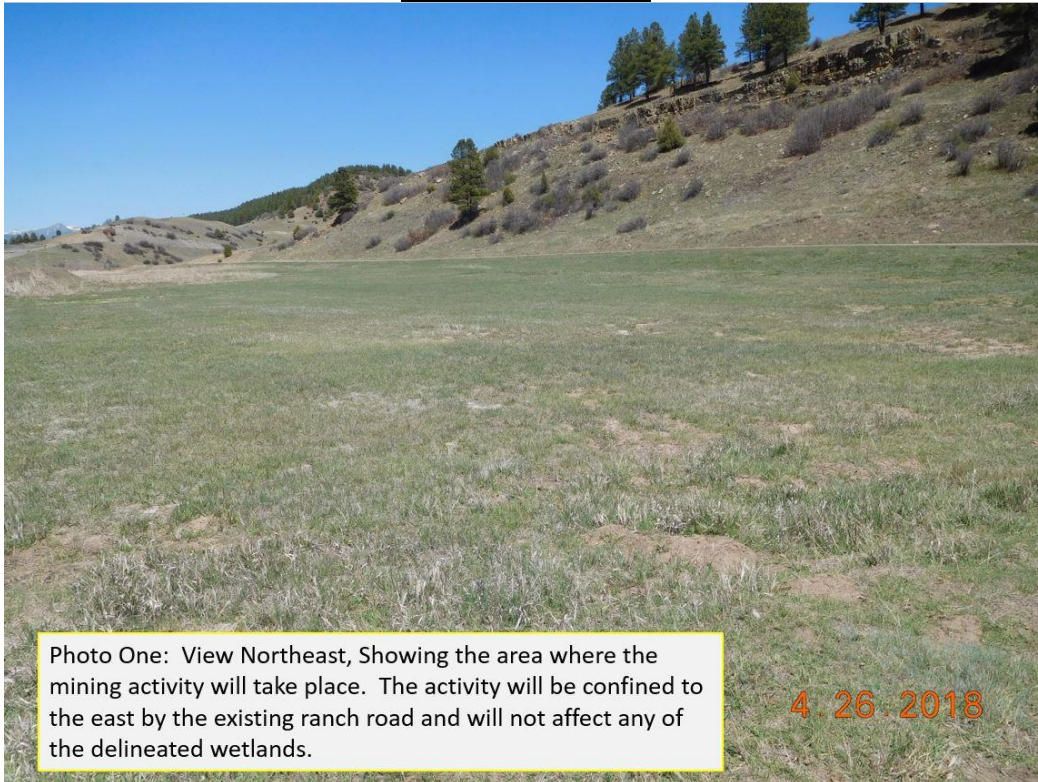
Photo One: View Northeast, Showing the area where the mining activity will take place. The activity will be confined to the east by the existing ranch road and will not affect any of the delineated wetlands.

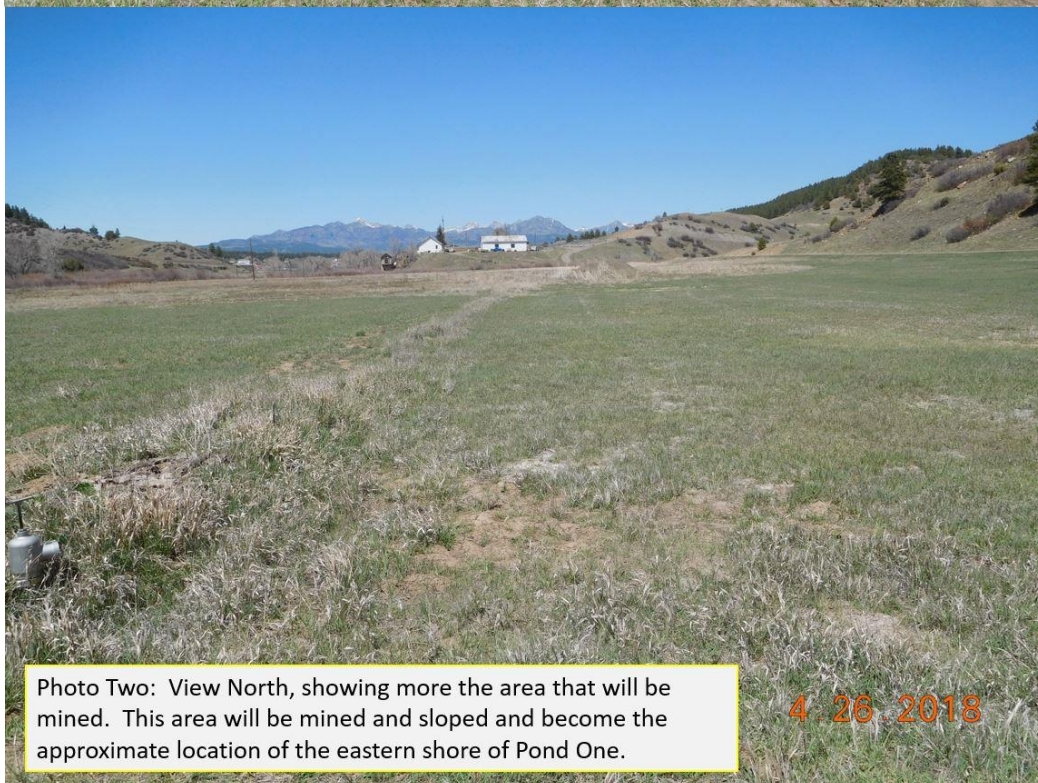
Photo Two: View North, showing more the area that will be mined. This area will be mined and sloped and become the approximate location of the eastern shore of Pond One.
