MINERALS PROGRAM INSPECTION REPORT**PHONE: (303) 866-3567**

MINE NAME: T.H.E. Aggregate Source	MINE/PROSPECTING ID#: M-1977-193	MINERAL: Granite, granite Gneiss and gravel	COUNTY: Fremont
INSPECTION TYPE: Monitoring	INSPECTOR(S): Timothy A. Cazier	INSP. DATE: March 28, 2018	INSP. TIME: 11:30
OPERATOR: Tezak Heavy Equipment Co. Inc.	OPERATOR REPRESENTATIVE: Randy DiLuzio & Lu Toxvard	TYPE OF OPERATION: 112c - Construction Regular Operation	
REASON FOR INSPECTION: Normal I&E Program	BOND CALCULATION TYPE: Partial Bond	BOND AMOUNT: \$732,350.00	
DATE OF COMPLAINT: NA	POST INSP. CONTACTS: None	JOINT INSP. AGENCY: None	
WEATHER: Cloudy	INSPECTOR'S SIGNATURE:

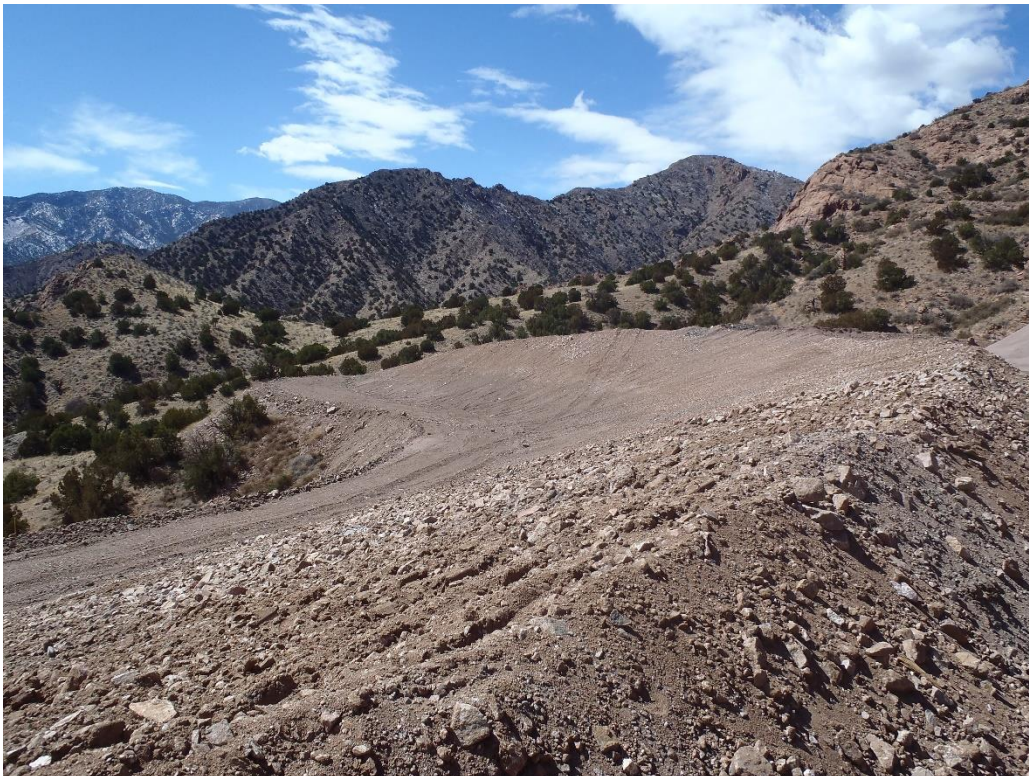
Backfilling and Grading: Some areas on the south end of phase 1 had been graded for final reclamation (see **Photo 1**).

Reclamation Success: As mentioned under backfilling and grading above, some final grading has been accomplished at the south end of Phase 1.

Photo 1. Reclaimed portion of Phase 1 (looking SW).

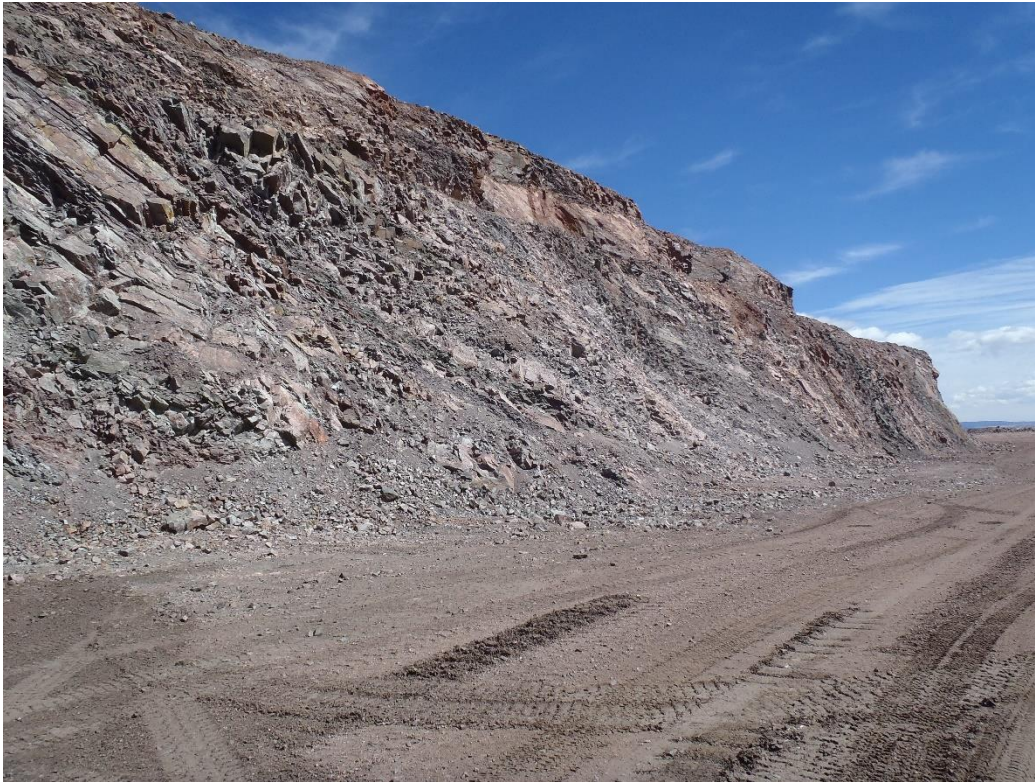
Gen. Compliance with Mine Plan: The operation appeared to be in compliance with the approved mine plan. Google Earth was used to measure the disturbed area, which was estimated to be approximately 95 acres (based on June 2016 satellite imagery). Highwalls were benched at an estimated 40 feet in height and appeared stable (see **Photo 2**). Mr. DiLuzio indicated the phase 1 pit floor was at elevation 5,660, but the permit allows it to be lowered to 5,550 as reiterated in Amendment 5. Subsequent to the inspection, this inspector was contacted by Mr. Ken Klco who indicated he had visited the site and was working on the annual highwall stability evaluation as agreed to during the Division's inspection on June 20, 2013.

Photo 2. Active highwall (looking NE).

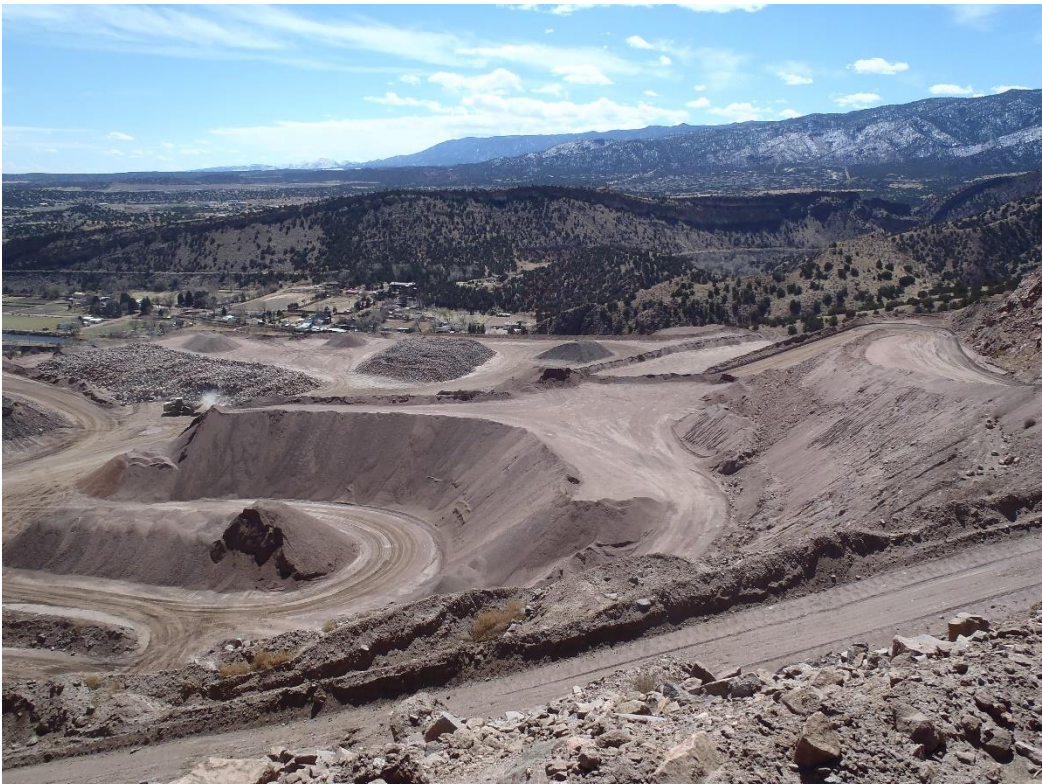
Processing Waste: The fines are currently being stockpiled near the southwest corner of phase 1 (see **Photo 3**) for the purpose of the highwall backfill approved as part of TR-9. Mr. DiLuzio indicated there may be a market for some of the fines material. If so the backfill may take longer than originally anticipated.

Photo 3. Fines stockpile, for TR-09 backfill (looking south).

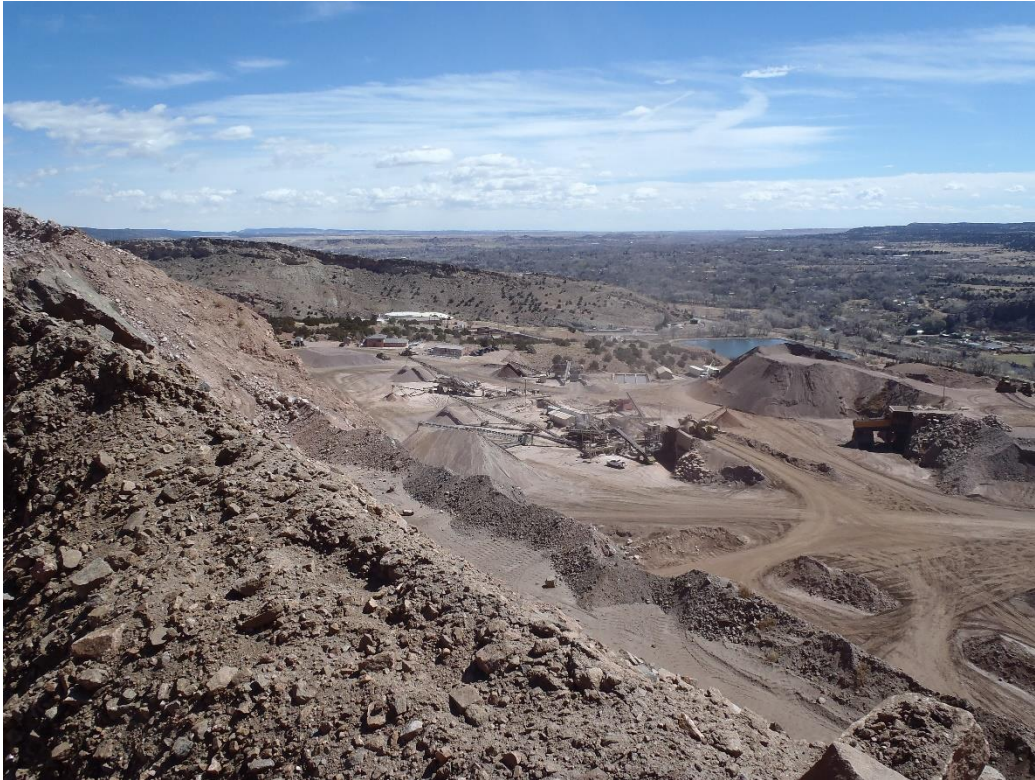
Support Facilities On-site: A screen plant, crusher, excavators, and haul trucks were observed on site (see **Photo 4**).

Photo 4. Processing equipment on pit floor (looking NNE).

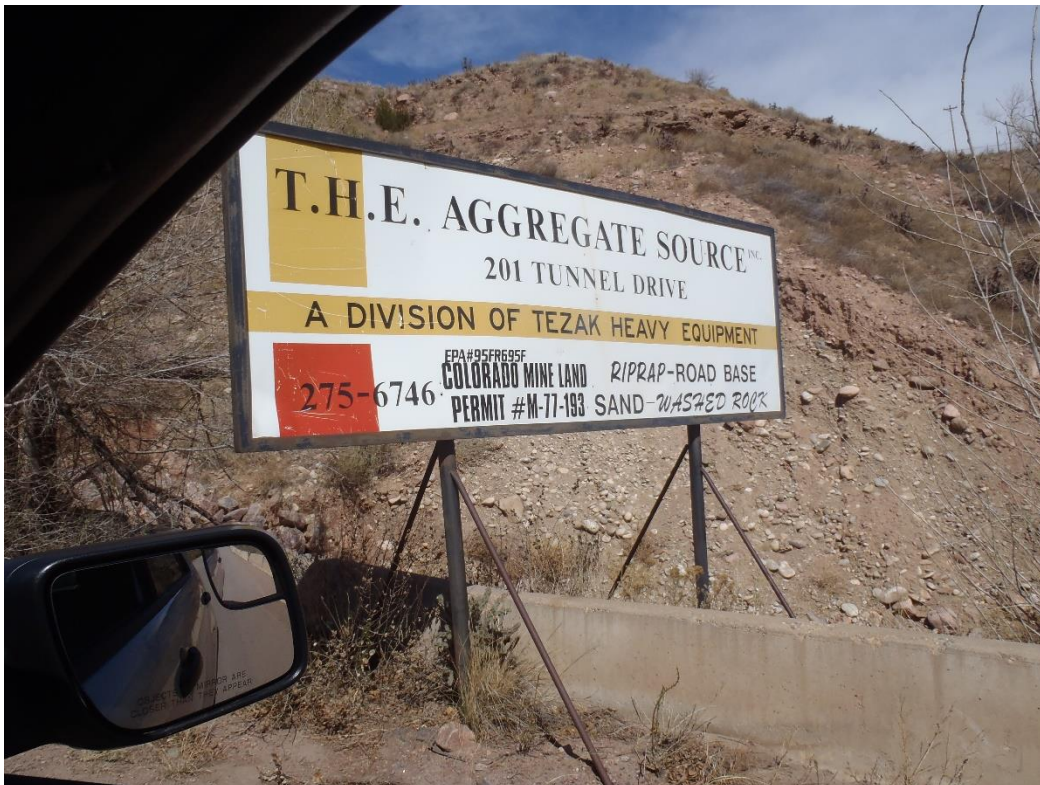
Signs and Markers: The permit sign was properly posted (see **Photo 5**) and boundary markers were observed to delineate the permit boundary (see **Photo 6**).

Photo 5. Permit boundary sign (near entrance).

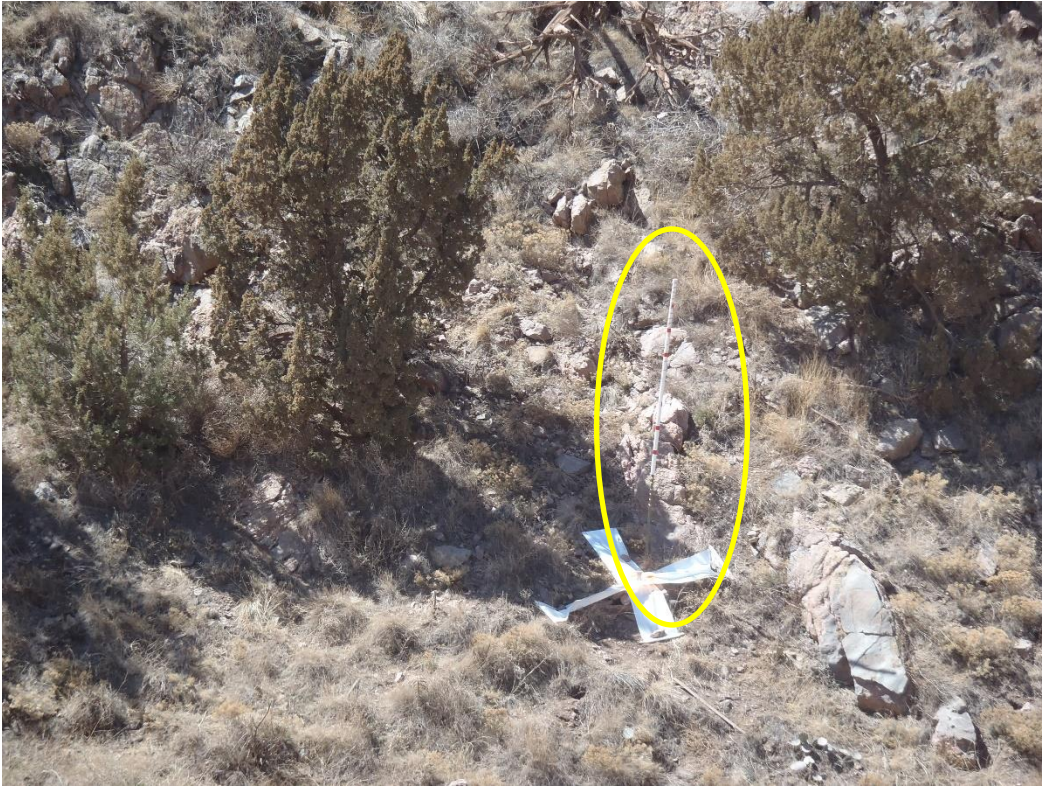
Photo 6. Typical permit boundary marker (phase 2 corner).
