COLORADO

Division of Reclamation,
Mining and Safety

MINERALS PROGRAM INSPECTION REPORT

MINE NAME: Kunau Site	MINE/PROSPECTING ID#: M-2008-025	MINERAL: Gravel	COUNTY: El Paso
INSPECTION TYPE: Monitoring	INSPECTOR(S): Timothy A. Cazier	INSP. DATE: April 10, 2018	INSP. TIME: 12:00
OPERATOR: Tim Kunau	OPERATOR REPRESENTATIVE: John Juarez	TYPE OF OPERATION: 110c - Construction Limited Impact	
REASON FOR INSPECTION: Normal I&E Program	BOND CALCULATION TYPE: Partial Bond	BOND AMOUNT: \$11,218.00	
DATE OF COMPLAINT: NA	POST INSP. CONTACTS: None	JOINT INSP. AGENCY: None	
WEATHER: Clear	INSPECTOR'S SIGNATURE:

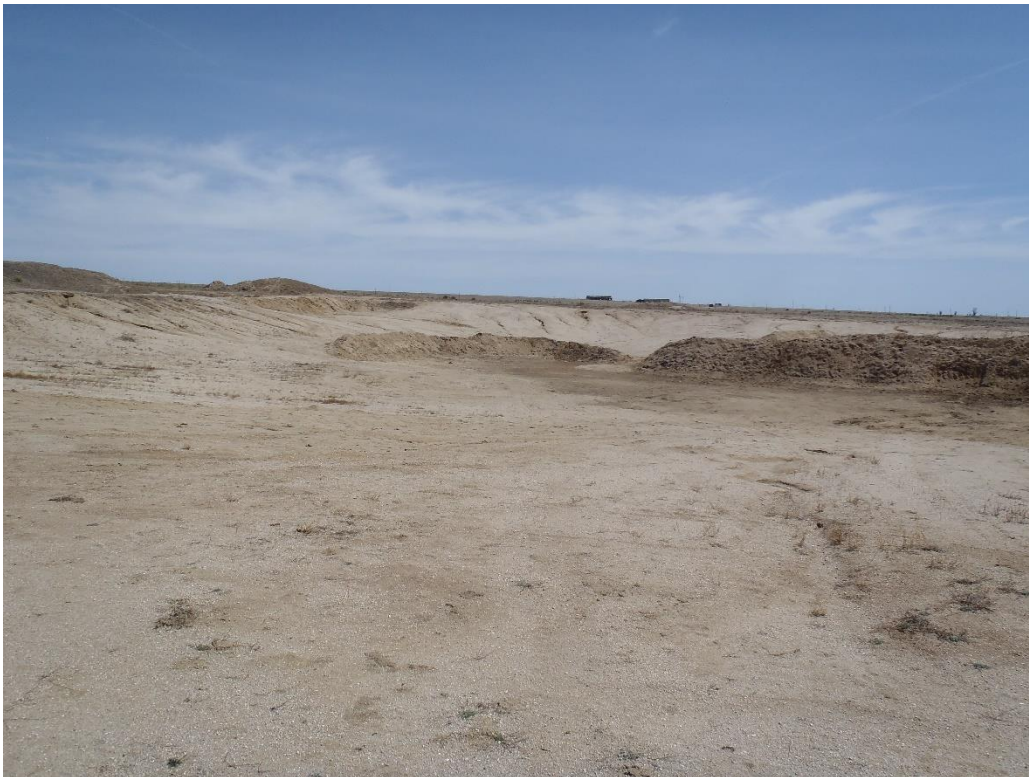
Backfilling and Grading: East and west highwalls appeared to be sloped at 5H:1V or flatter (see **Photo 1**), whereas the north and south highwalls were sloped closer to 3H:1V (see **Photo 2**). As such, no backfill was required at the time of this inspection.

Photo 1. East (center background) and west (foreground) highwalls sloped at 5H:1V or flatter (looking NE).

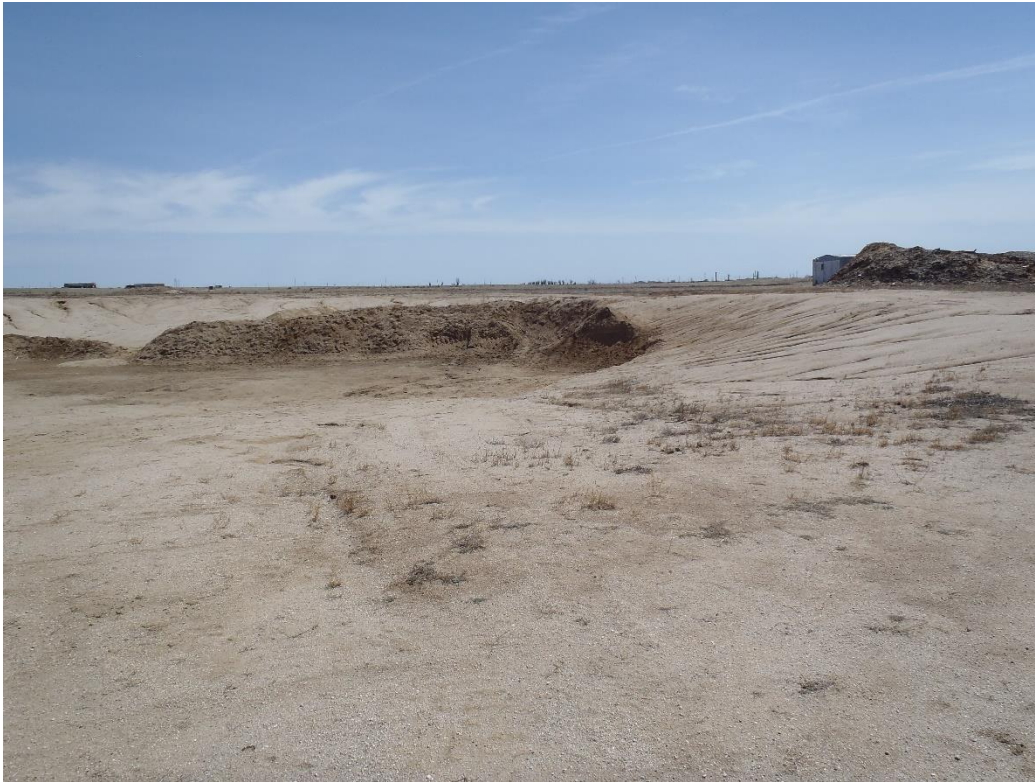
Photo 2. North (left) and west (right) highwalls sloped at 3H:1V or flatter.

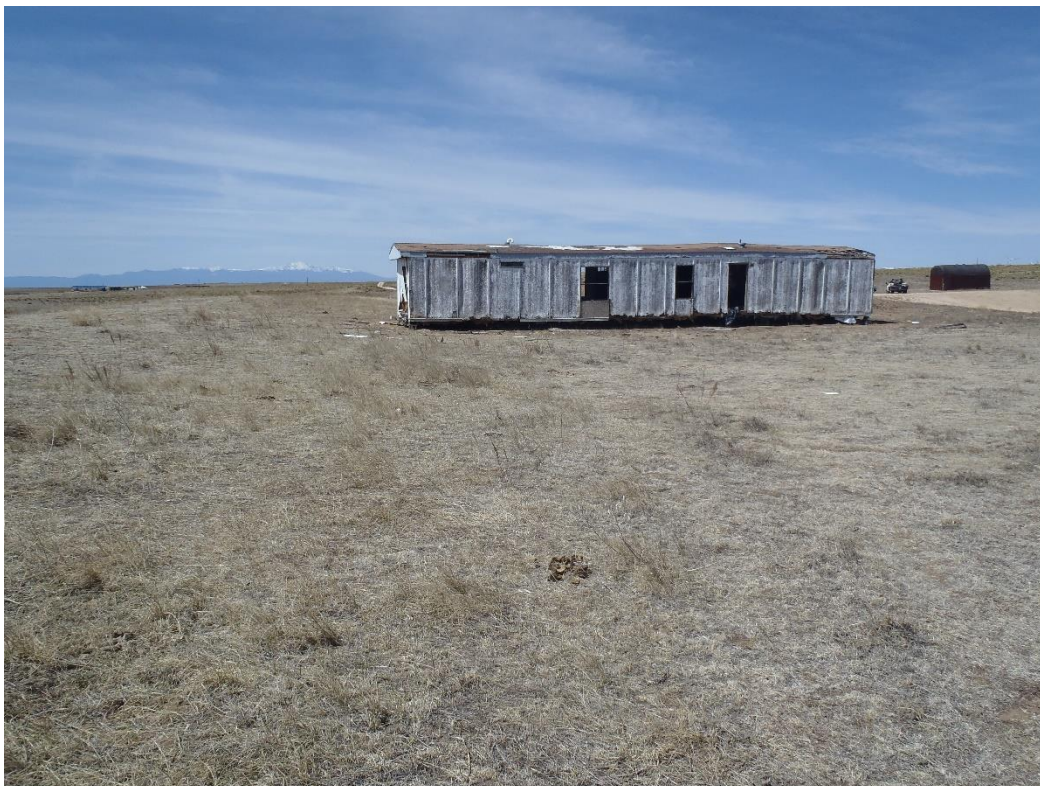
Support Facilities On-site: No support facilities were observed. However, a house trailer in poor condition was observed within the permit boundary (see **Photo 3**).

Photo 3. House trailer in poor condition within permit boundary (south side, looking west).

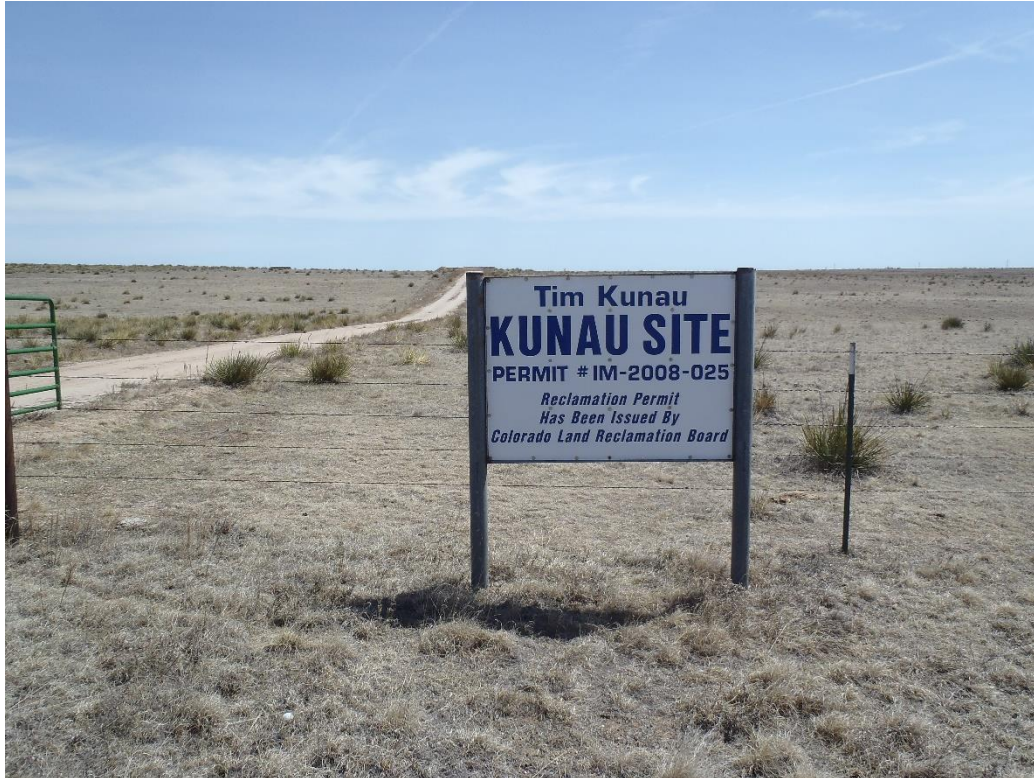
Signs and Markers: The permit sign was properly posted (see **Photo 4**) and boundary markers were observed

Photo 4. Permit sign (at gated entrance, looking east).

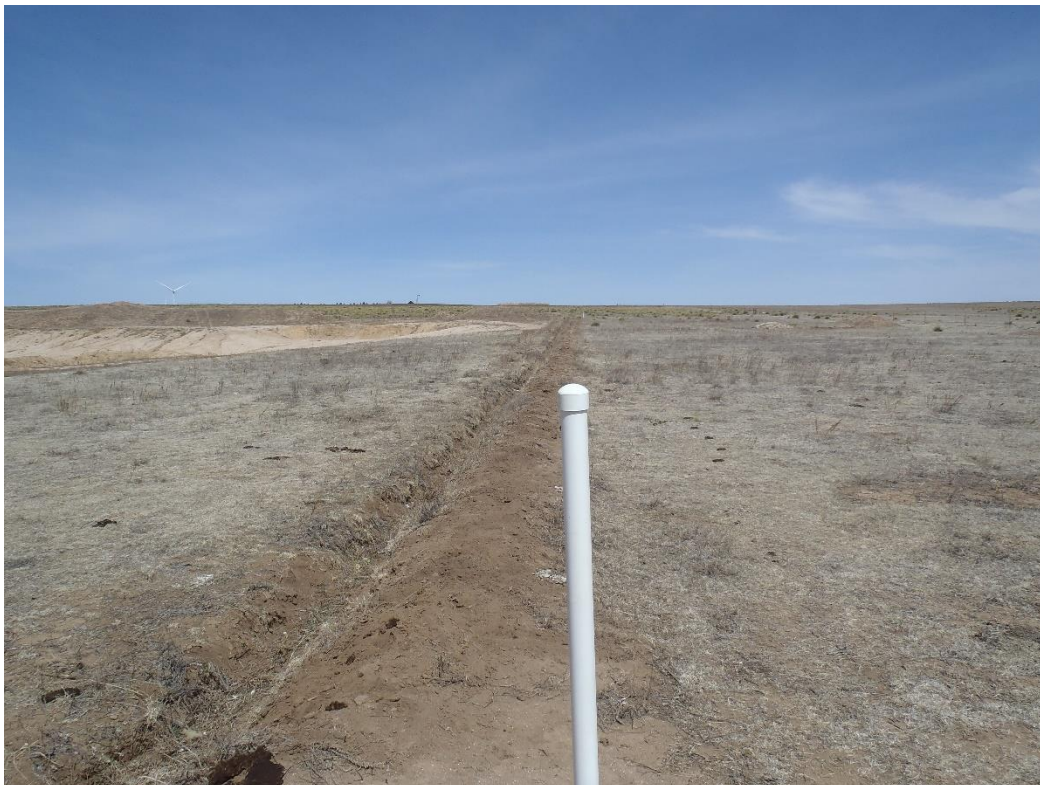
to delineate the permit boundary (see **Photo 5**).

Photo 5. Typical permit boundary marker (SE corner, looking north).

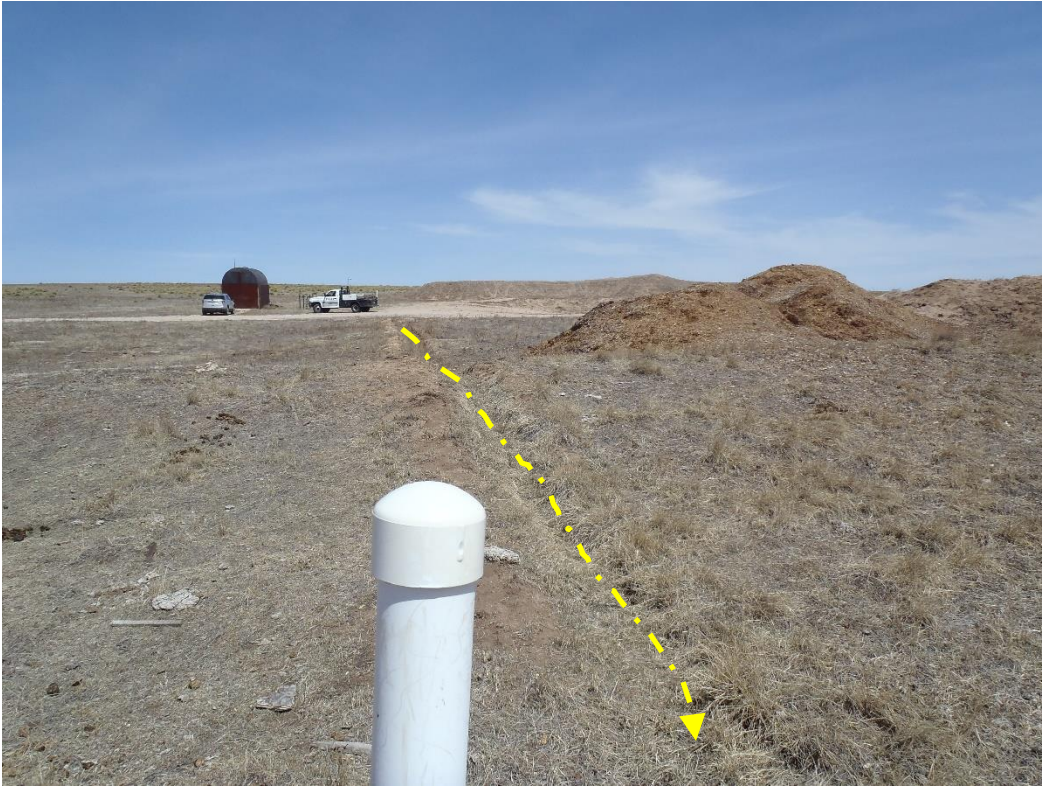
Storm Water MGT Plan: No oil or fuel spills observed. Ditches (see **Photo 6**) were observed intended to divert runoff away from the pit and towards a stormwater pond on the southwest corner of the existing pit. Stormwater captured within the pit, infiltrates.

Photo 6. West side diversion ditch (looking north).

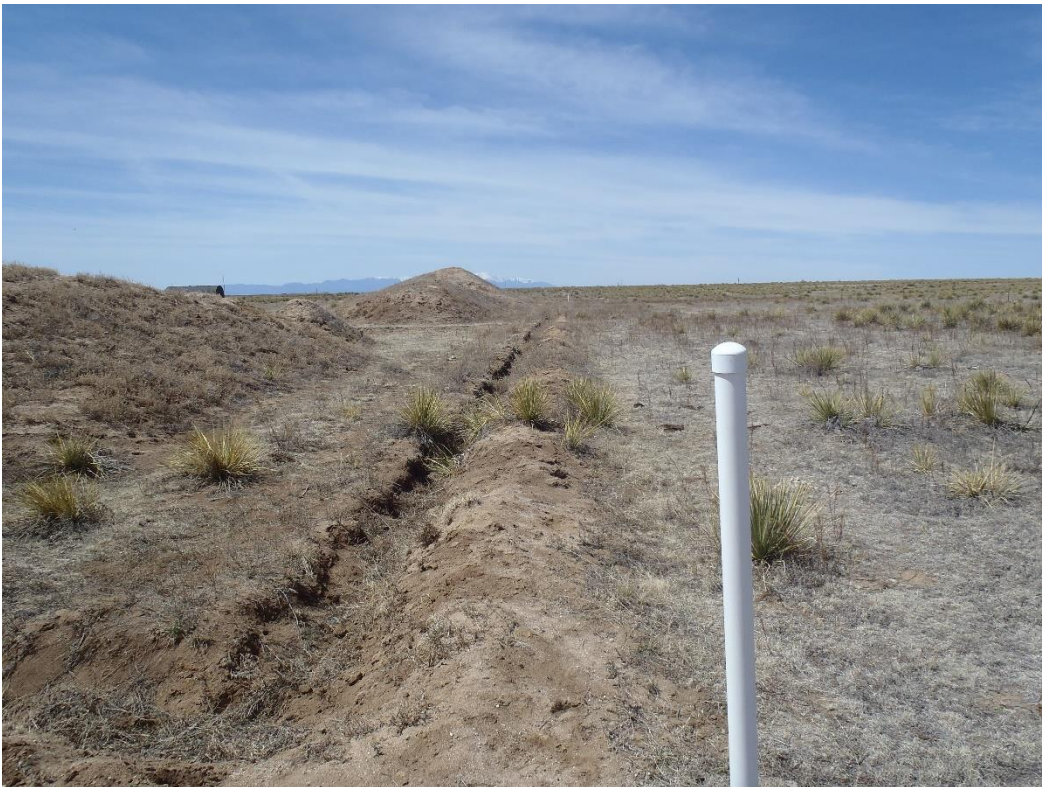
Topsoil: A topsoil stockpile was observed on the north side of the existing pit (see **Photo 7**).

Photo 7. North pit topsoil stockpiles (north side, looking west).

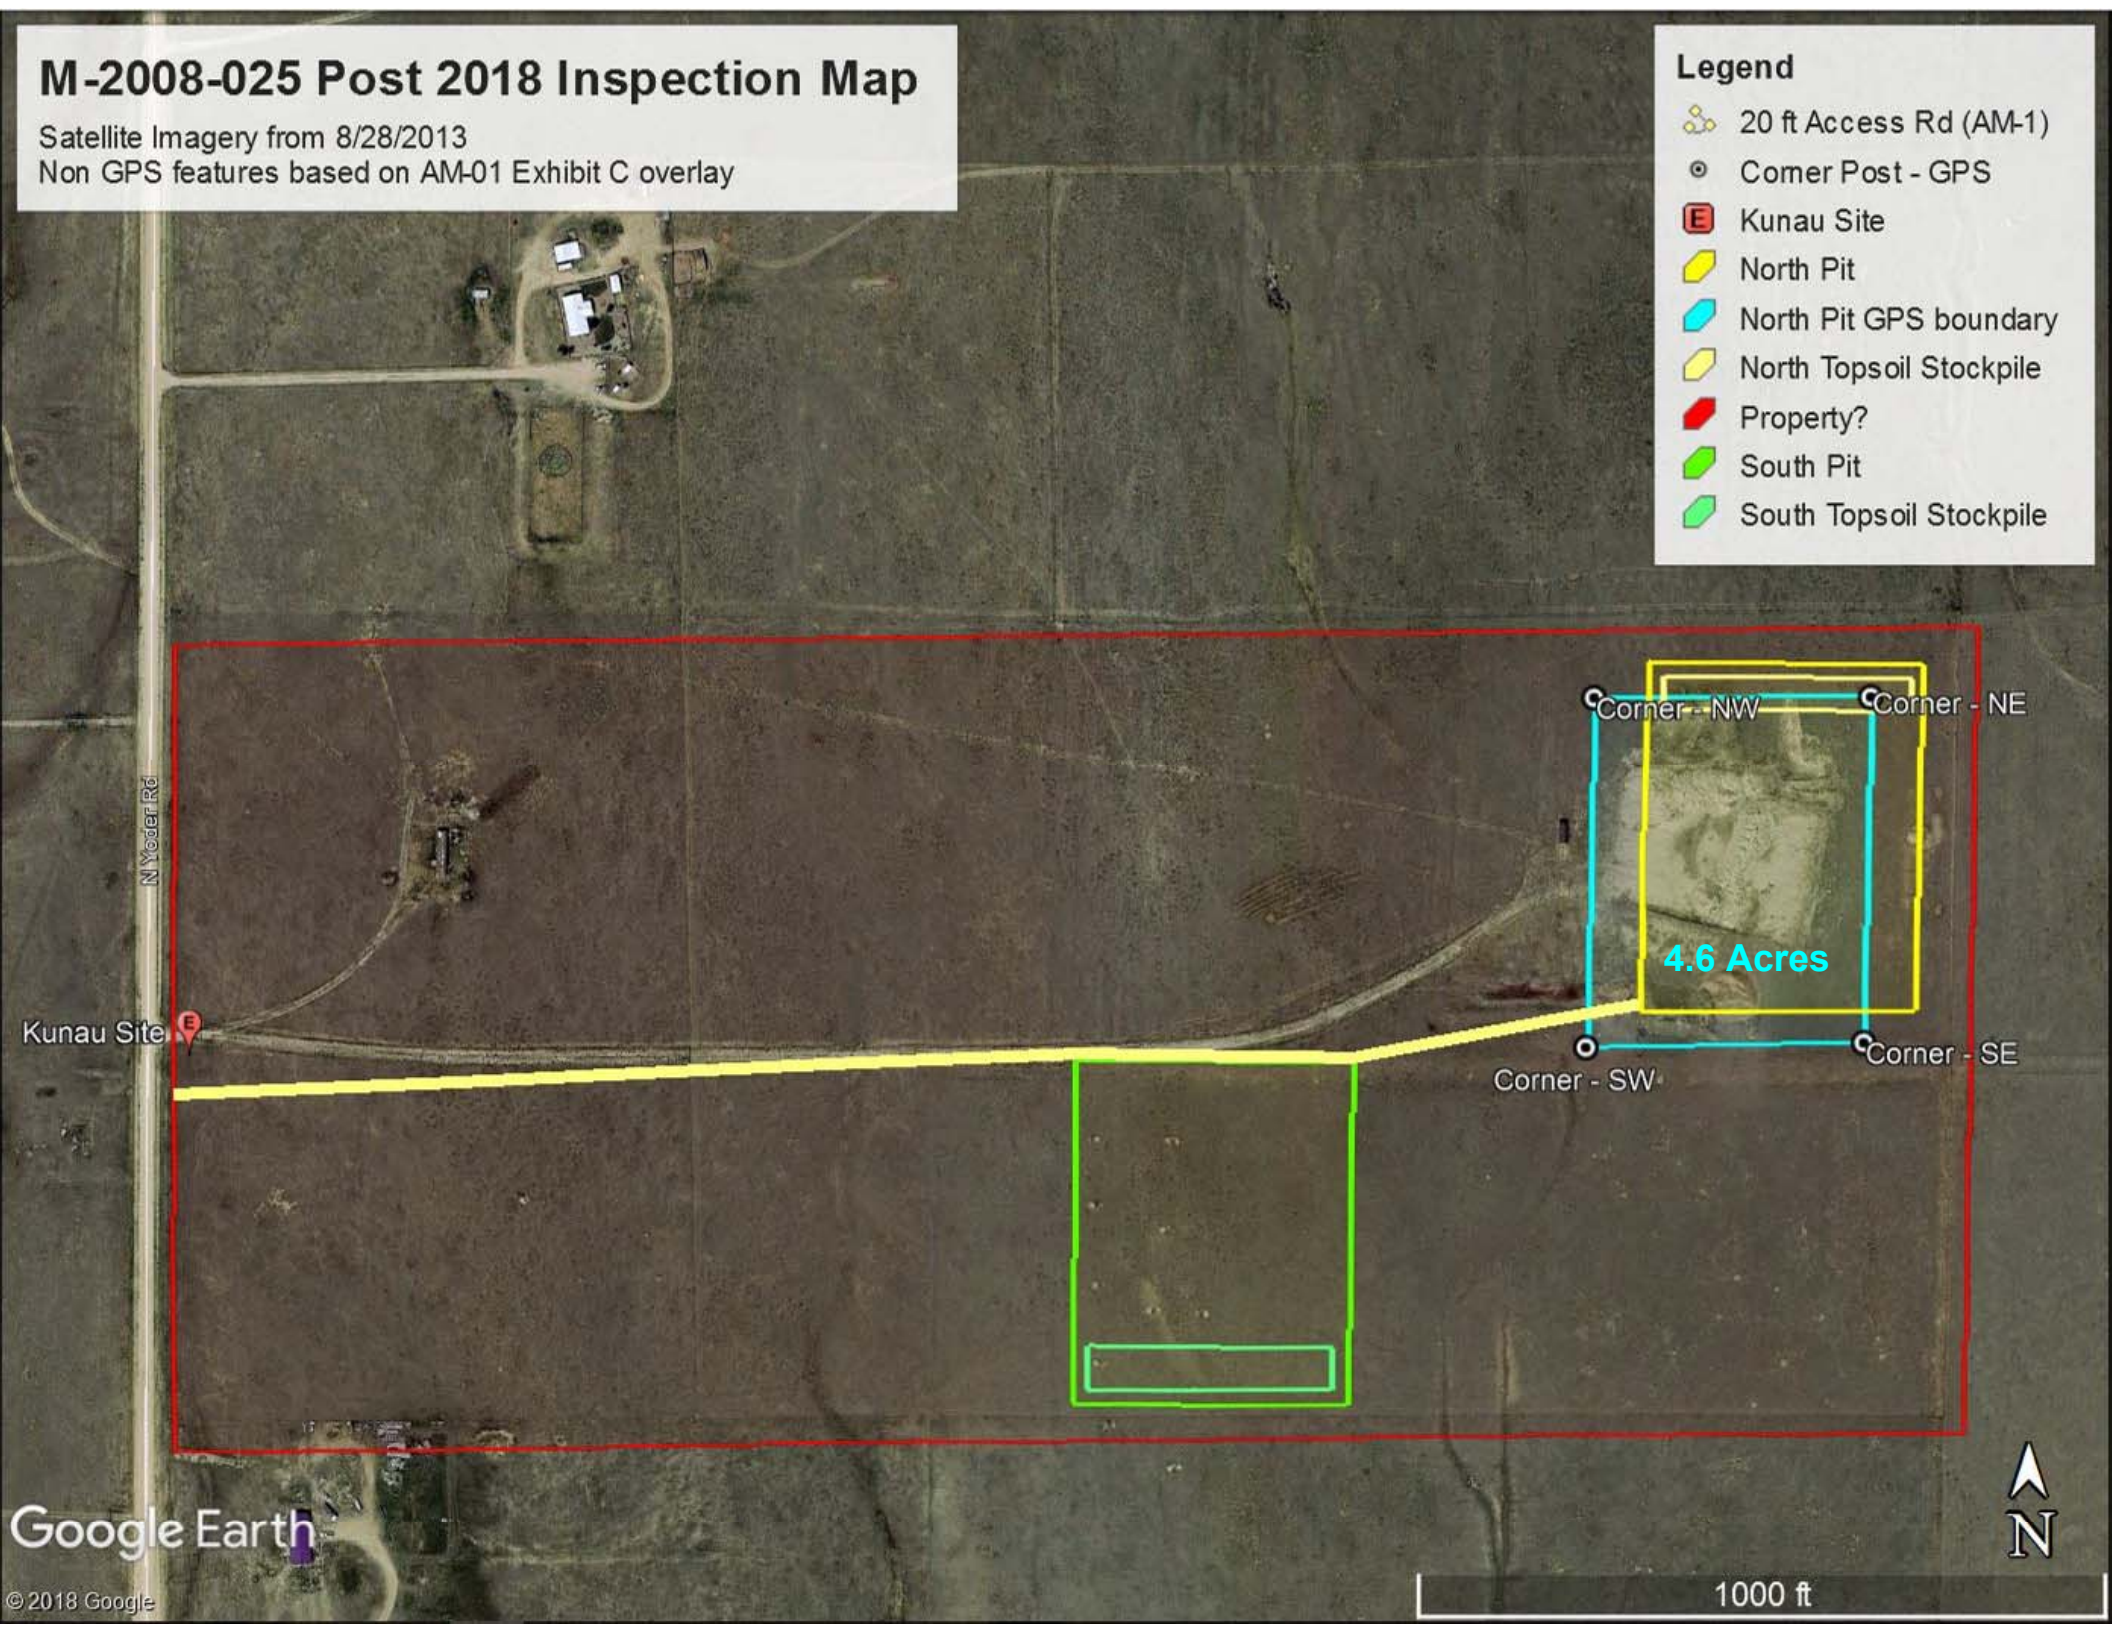
M-2008-025 Post 2018 Inspection Map

Off-site Damage: The operation appeared to be confined to the permit boundary, based on site observations. It should be noted the current access road runs through the area designated as the future south pit (see **enclosed post inspection map**).
