**COLORADO**Division of Reclamation,  
Mining and Safety

**MINERALS PROGRAM INSPECTION REPORT****PHONE: (303) 866-3567**

<b>MINE NAME:</b> Schmidt Site	<b>MINE/PROSPECTING ID#:</b> M-2011-014	<b>MINERAL:</b> Borrow material for	<b>COUNTY:</b> Archuleta
<b>INSPECTION TYPE:</b> Multi Person Inspection	<b>INSPECTOR(S):</b> Lucas J. West	<b>INSP. DATE:</b> May 2, 2018	<b>INSP. TIME:</b> 14:45
<b>OPERATOR:</b> Dale and Ellen Schmidt	<b>OPERATOR REPRESENTATIVE:</b> Dale Schmidt	<b>TYPE OF OPERATION:</b> 110c - Construction Limited Impact

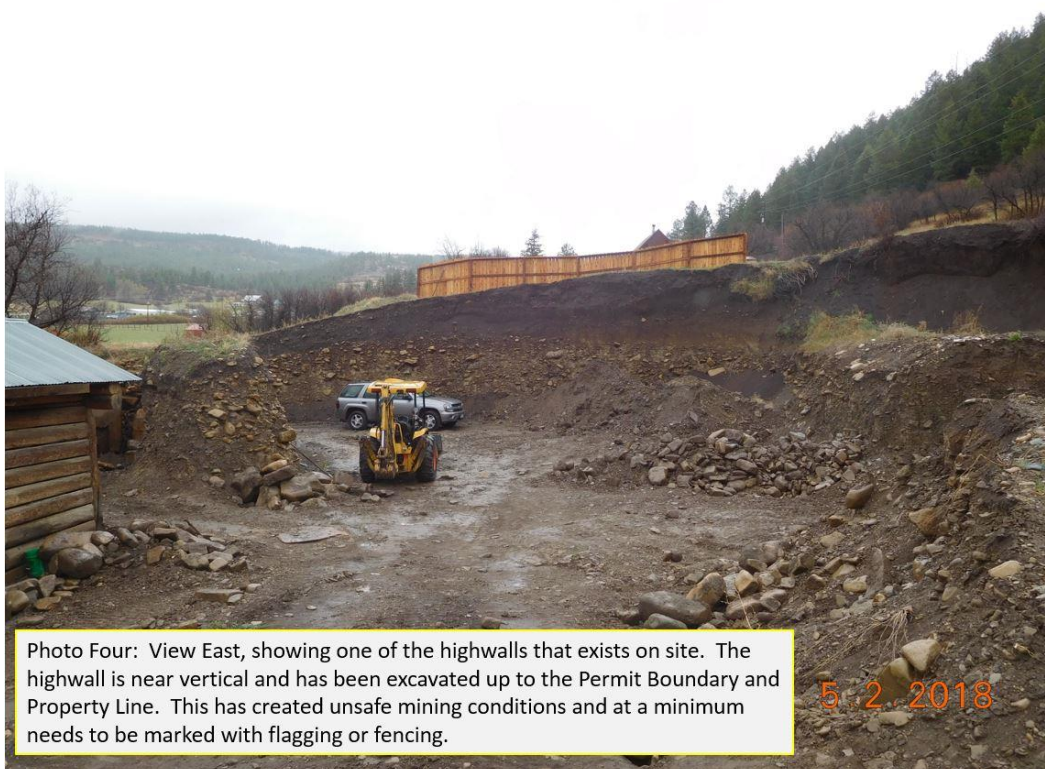
The mining activities that are being conducted on site have also created unsafe conditions in the way of having unmarked highwalls near the property line. Examples of the unsafe conditions can be seen in Photos Four and Five. In addition to marking the Permit Boundaries along the Eastern and Western edges the Operator should install safety flagging, marking or signage along all highwalls, mining faces and areas where dangerous conditions exist along the property lines. Several areas throughout the site are being used to store scrap and excess materials. Examples of these items can be seen in Photos Six and Seven. While this is allowed on sites the materials that are being stored need to be kept in a neat and orderly fashion. The Operator should conduct a general site cleanup and consolidate all excess materials being stored on site to one location and kept as neat as possible.

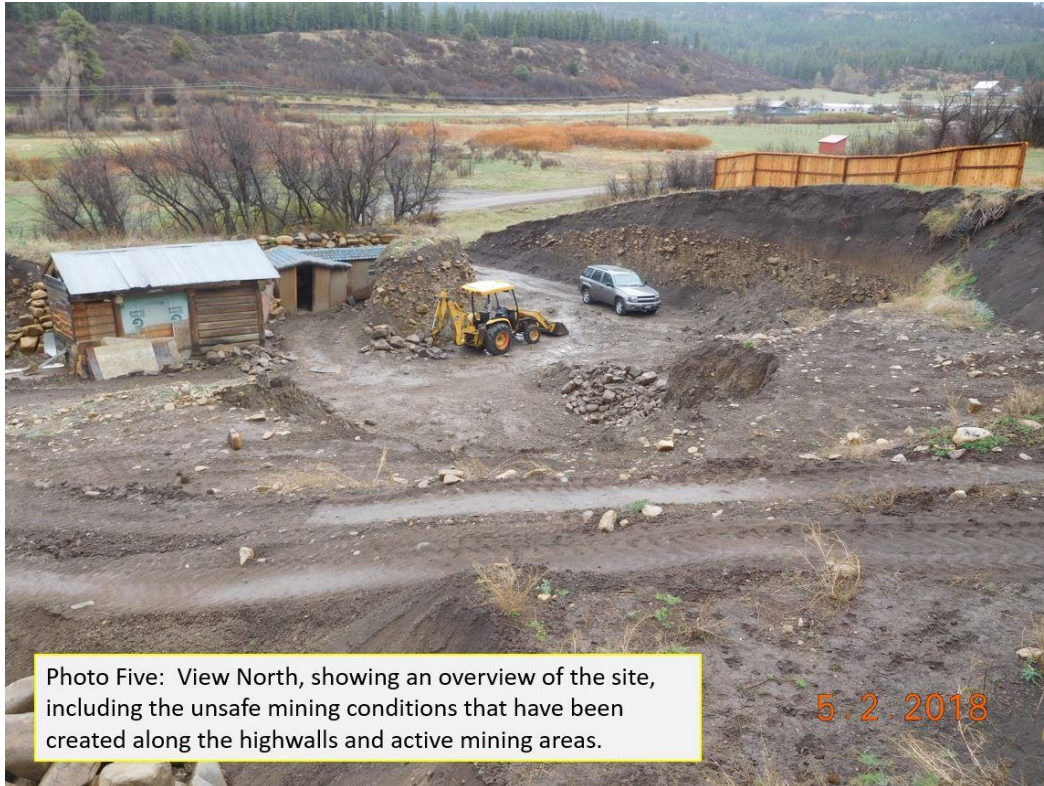
Photo Five: View North, showing an overview of the site, including the unsafe mining conditions that have been created along the highwalls and active mining areas.

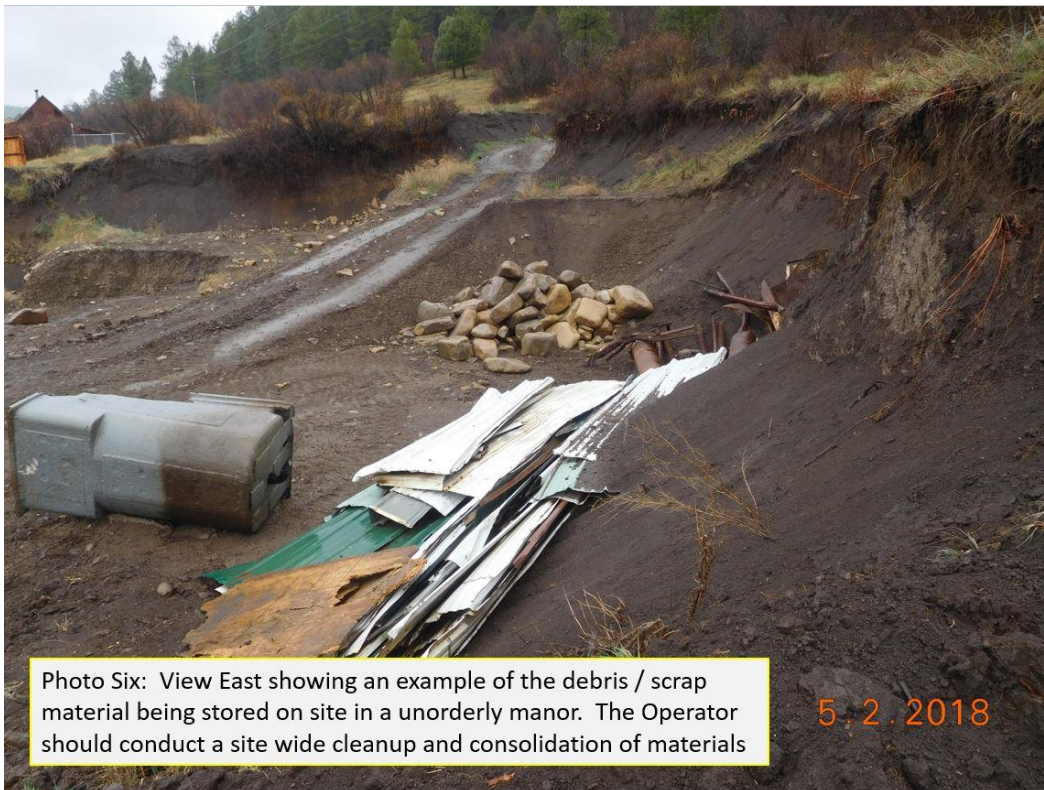
Photo Six: View East showing an example of the debris / scrap material being stored on site in an unorderedly manor. The Operator should conduct a site wide cleanup and consolidation of materials

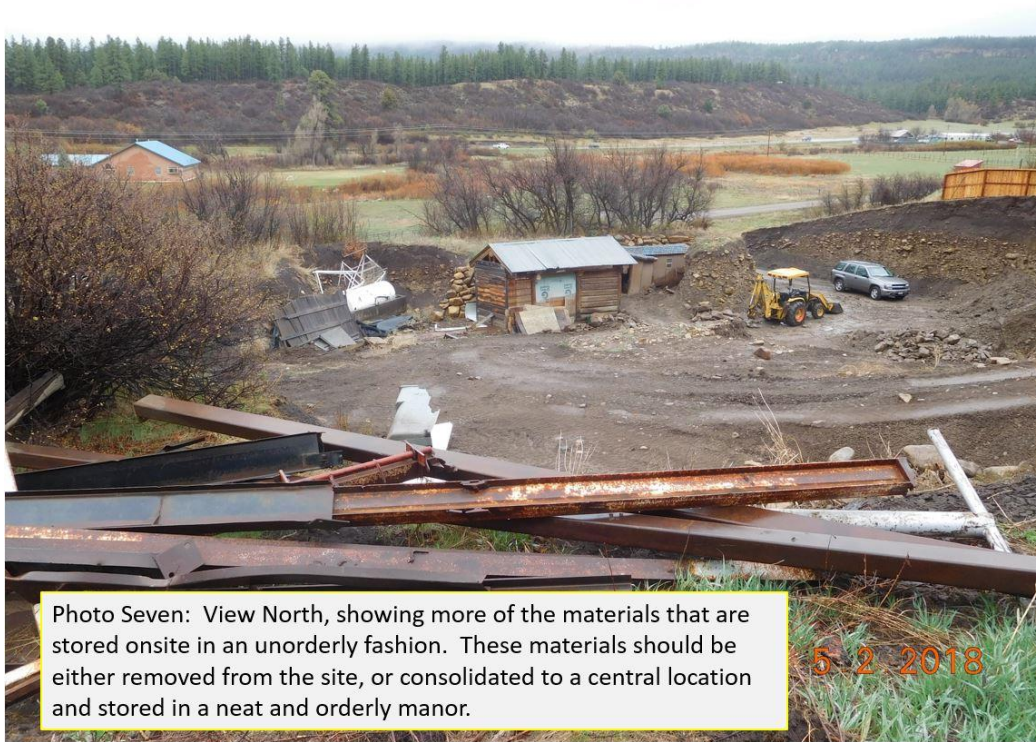
Photo Seven: View North, showing more of the materials that are stored onsite in an unordered fashion. These materials should be either removed from the site, or consolidated to a central location and stored in a neat and orderly manor.
