MINERALS PROGRAM INSPECTION REPORT**PHONE: (303) 866-3567**

MINE NAME: Riverside Pit	MINE/PROSPECTING ID#: M-1976-056	MINERAL: Sand and gravel	COUNTY: Logan
INSPECTION TYPE: Monitoring	INSPECTOR(S): Jared L. Ebert	INSP. DATE: April 19, 2018	INSP. TIME: 08:00
OPERATOR: McAtee Construction Company	OPERATOR REPRESENTATIVE: Jeff Harms	TYPE OF OPERATION: 112c - Construction Regular Operation

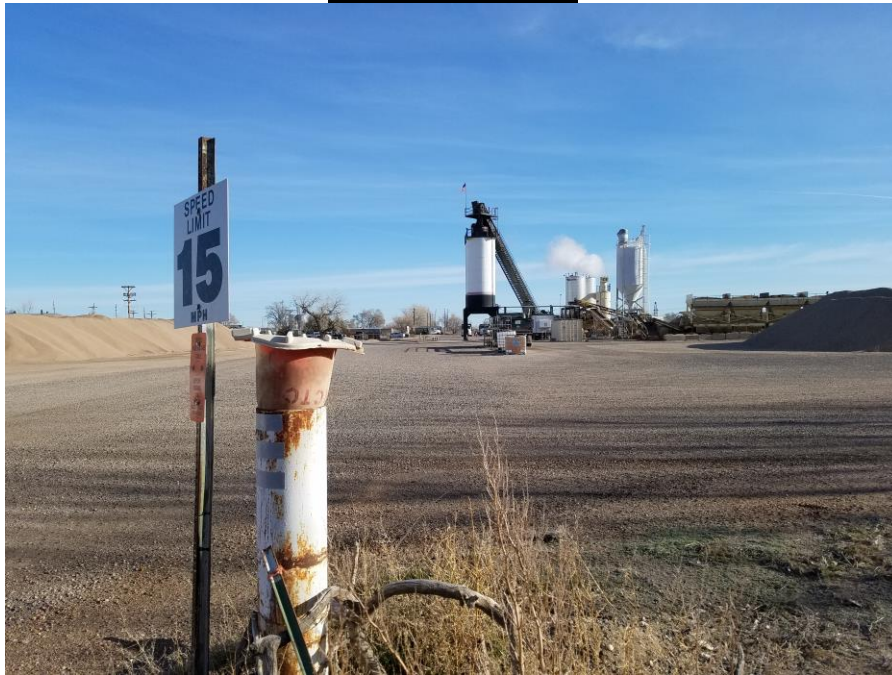
Figure 1. From the Southwest corner of the original permit area looking north.

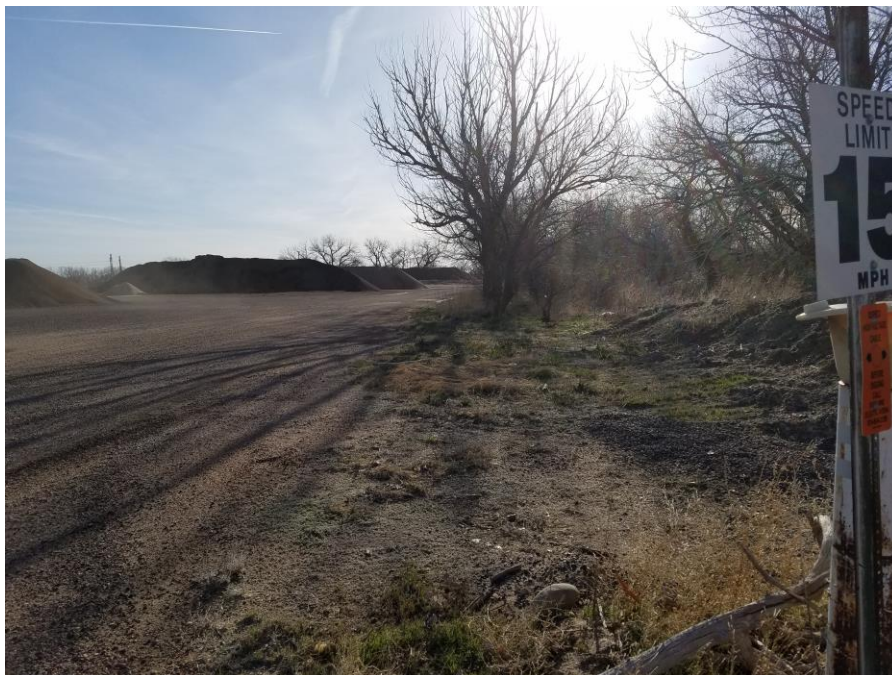
Figure 2. From the southwest corner of the original permit area looking east.

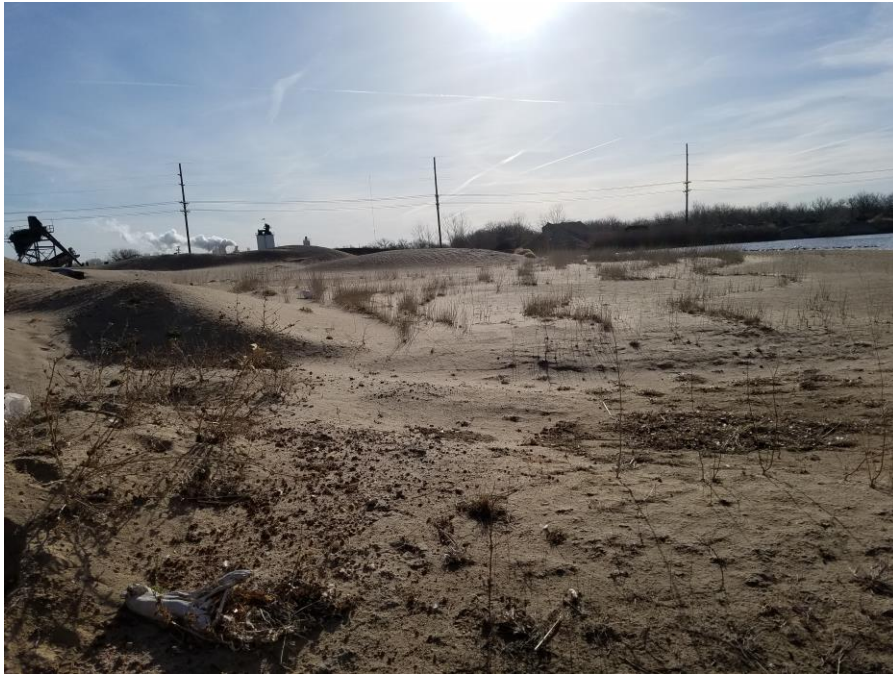
The AM01 mine area consists of a 10 acre pit where it appears the most recent mining activity has occurred. The north end consists of a fairly large beach area where fines from the operation have been placed. The slopes in this area appear fairly gentle. The western, eastern and southern pit slopes appear to be excavated to a 1.5 to 1.7 H:1V or steeper slope in areas above the waterline. It is difficult to tell below the waterline what the angle of the slope is.

Figure 3. Beach area on the north end of the pit within the AM01 area.

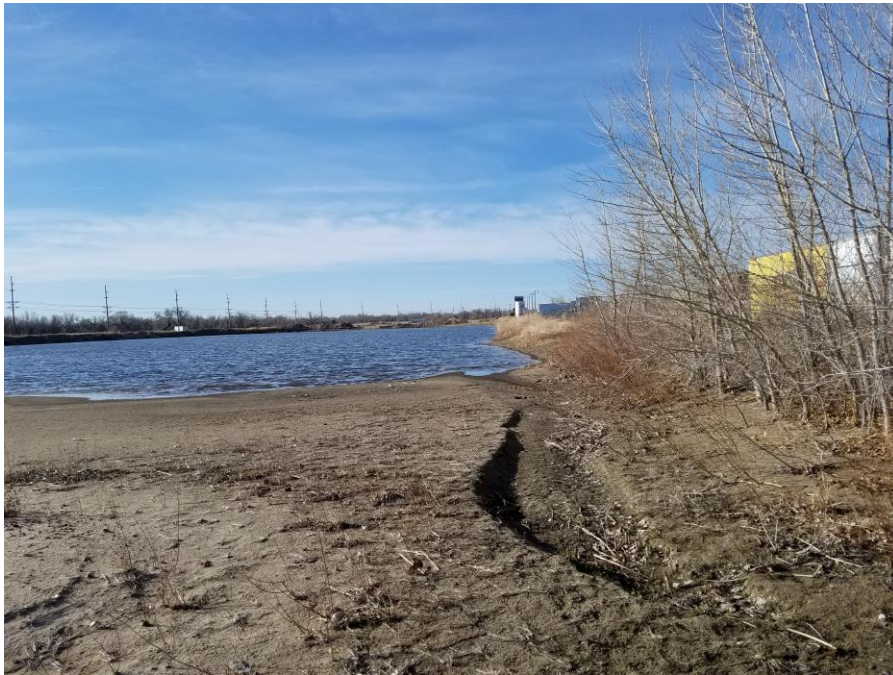
Figure 4. From the northwest corner of the pit within the AM01 area looking south.

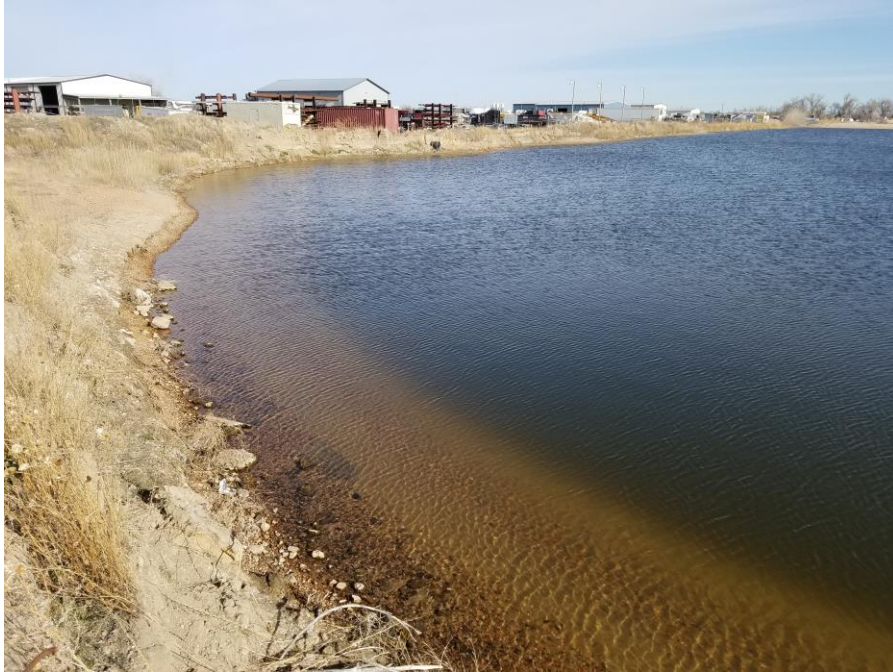
Figure 5. From the south end of the pit within the AM01 area looking northwest.

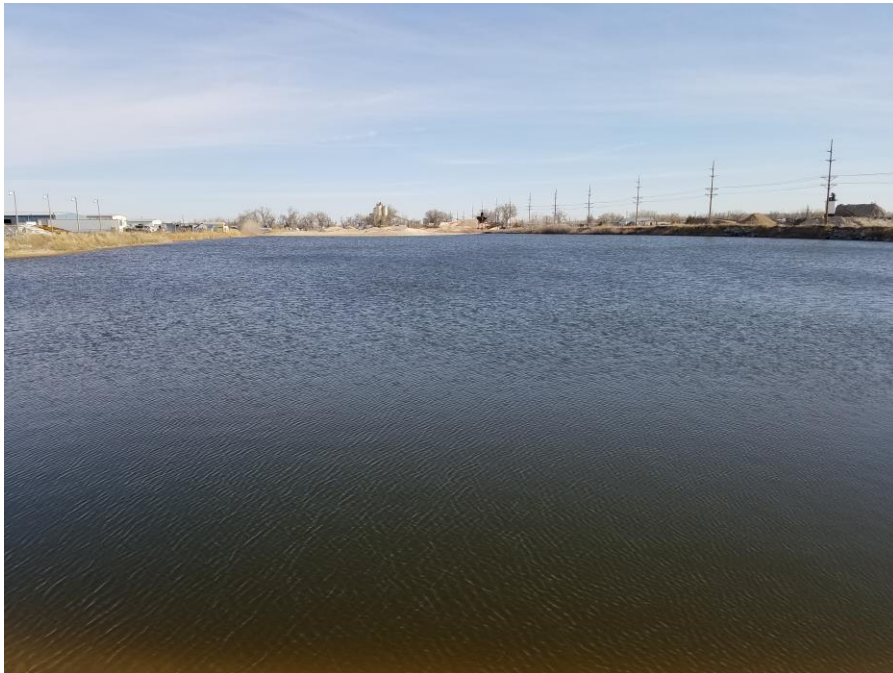
Figure 6. From the south end of the pit within the AM01 area looking north.

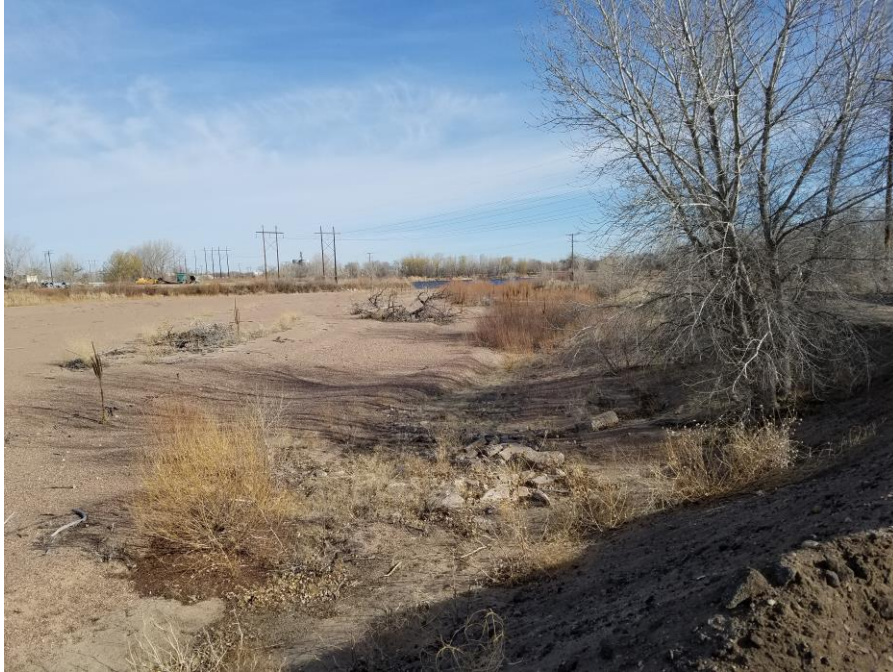
Figure 7. From the southeast corner of the Lake Robert area looking north.

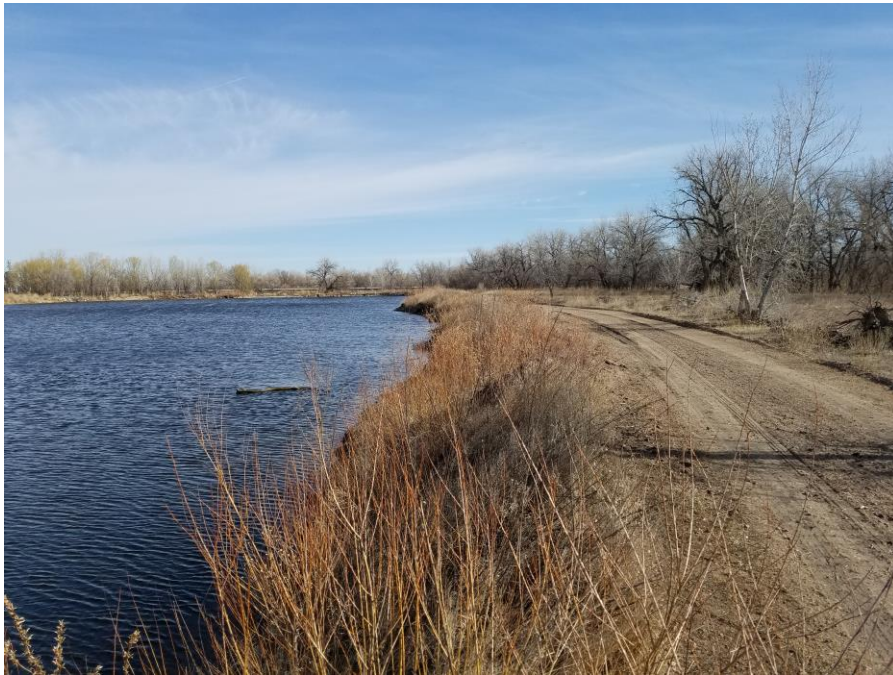
Figure 8. Midway along the Lake Robert eastern slope looking north.

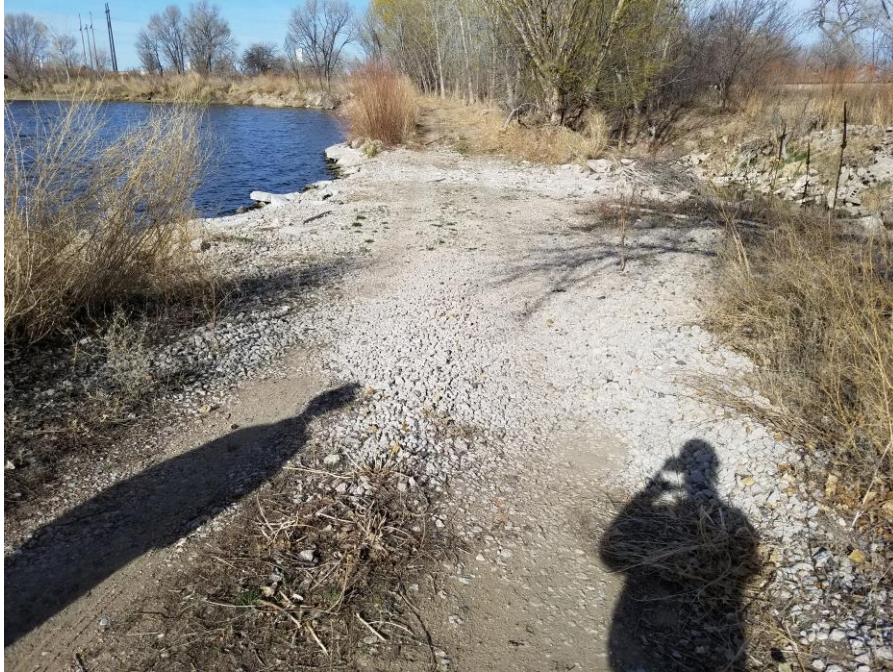
The Lake Robert area was reclaimed until the flood of 2013. With the approval of TR04, the Operator agreed to monitor the area for five years (ending December 31, 2020) to determine what additional reclamation activity should occur in this area. The remainder of the Lake Robert area appears stable and vegetated with the outlet spillway at the north end of the lake in place.

Figure 9. Spillway at the north end of Lake Robert.

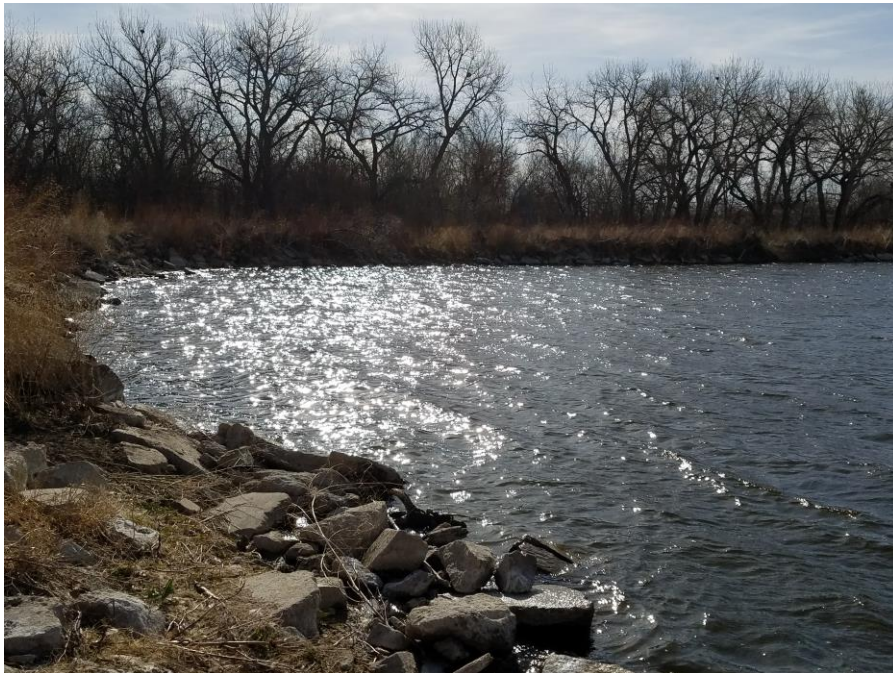
Figure 10. From the north end of Lake Robert looking east.

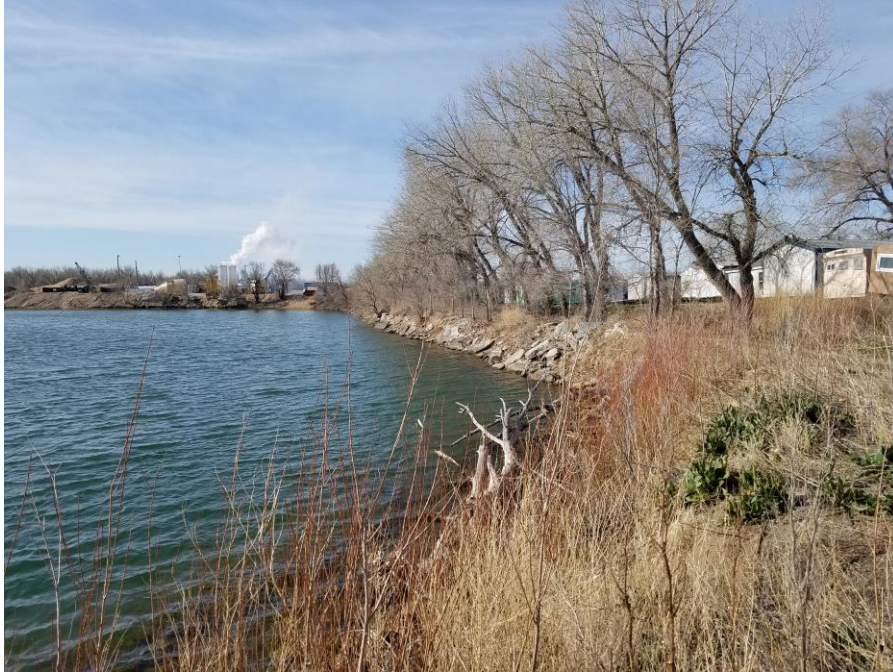
Figure 11. From the northwest corner of Lake Marjorie looking south.

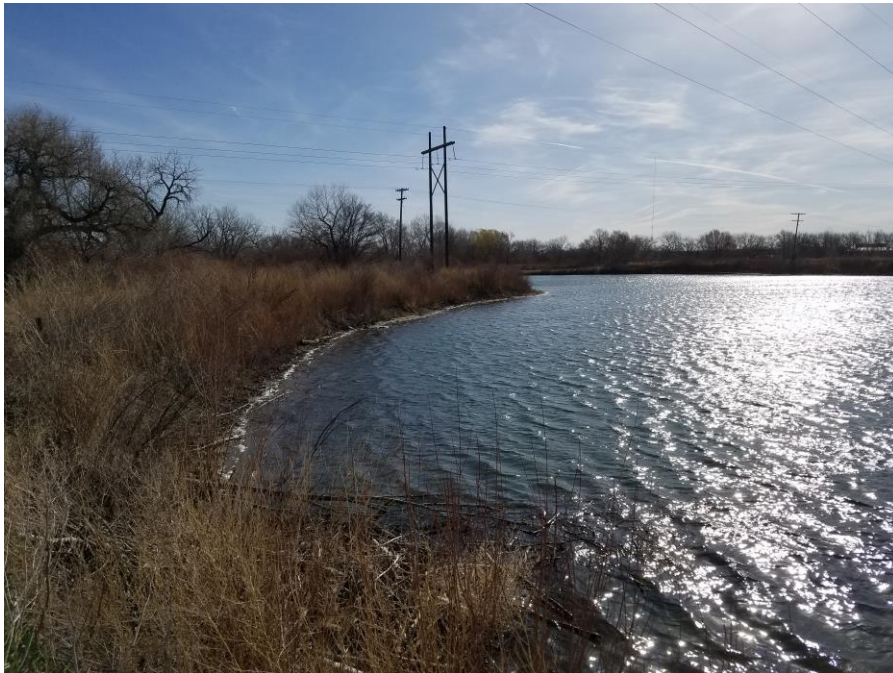
Figure 12. From the northwest corner of Lake Marjorie looking east.

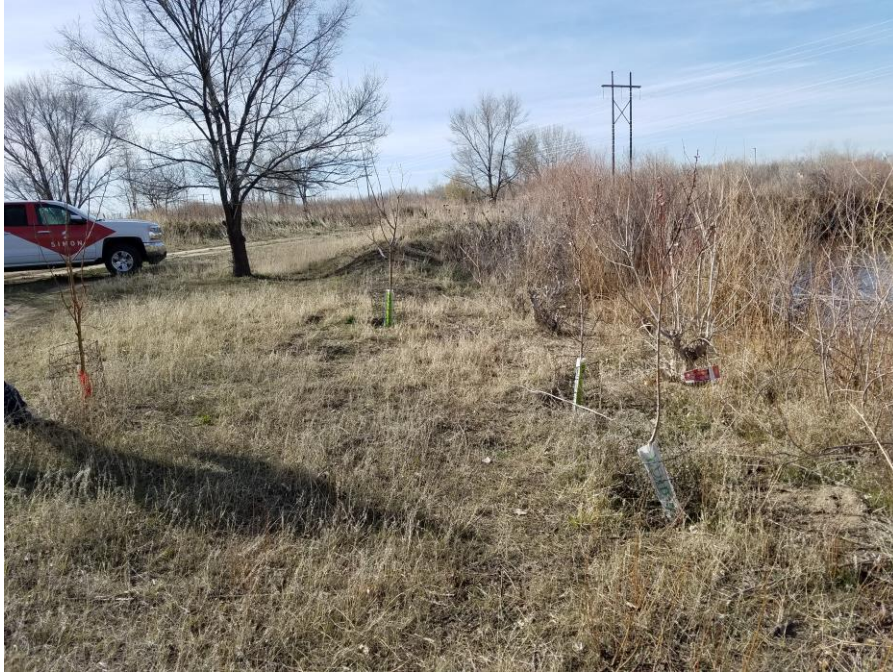
Vegetation has established around the reclaimed portions of Lake Robert and Lake Marjorie. Apple and peach trees were planted on the northeast corner of Lake Marjorie.

Figure 13. Peach and apple trees planted in the northeast corner of Lake Marjorie.

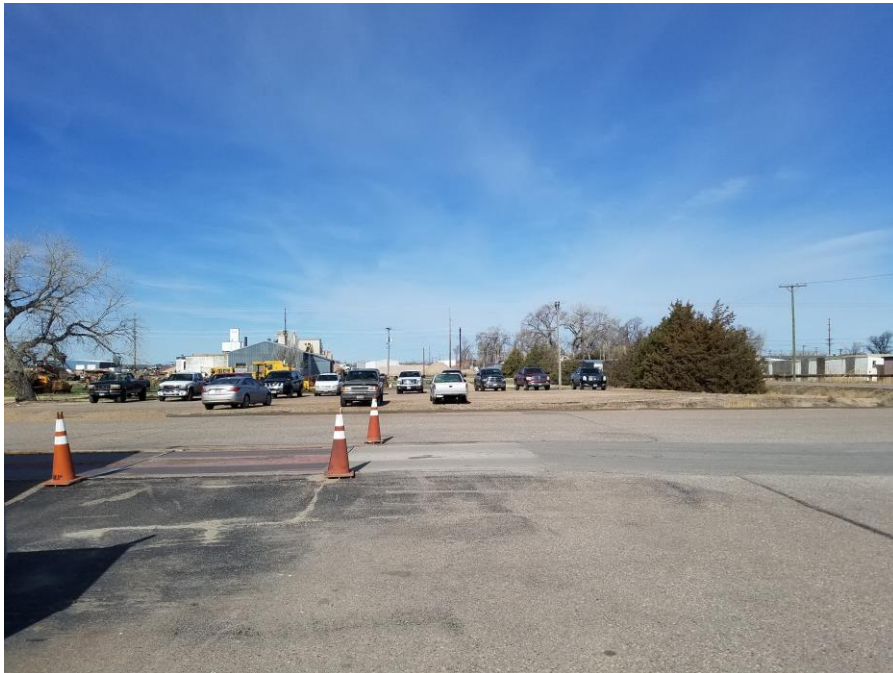
About 14 acres appear to be affected outside of the permit boundary north of the AM01 permit area and west of the original permit area. A processing plant consisting of a building and conveyors is located in this area as well as stockpiles of mined material and recycle material. Also located in this area is the scale, scale house, fuel storage area and parking area. Also a small portion of the pit excavation appears to extend into this area.

The disturbance observed outside of the approved permit boundary meets the definition of Affected Land in accordance with Rule 1.1(3) and is part of the Mining Operation as defined by Rule 1.1(27). This is a possible violation at this time pursuant to C.R.S. 34-32.5-109(1) for failure to first obtain from the Board or Office a reclamation permit prior to engaging in a new operation. This issue is cited as a possible violation at the beginning of this report.

Figure 14. From the scale house looking west. Area affected outside of the permit boundary.

CORRECTIVE ACTIONS: This possible violation will require a hearing before the Mined Land Reclamation Board. The schedule and other details for the MLRB hearing will be provided under a separate document to be sent via certified mail to the operator.

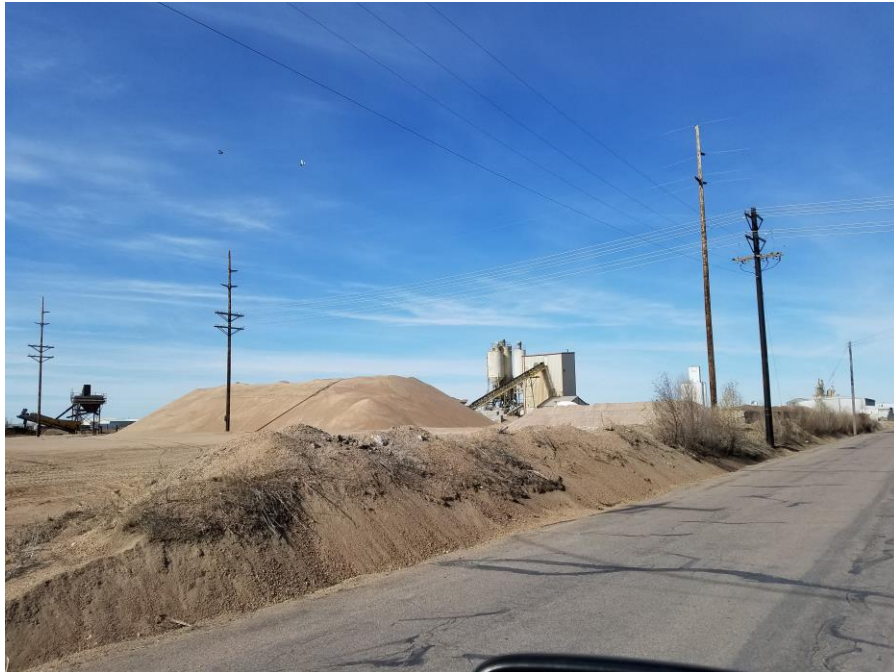
Figure 15. From Riverside Drive northwest of the permit area looking southwest. Area affected outside of permit boundary.

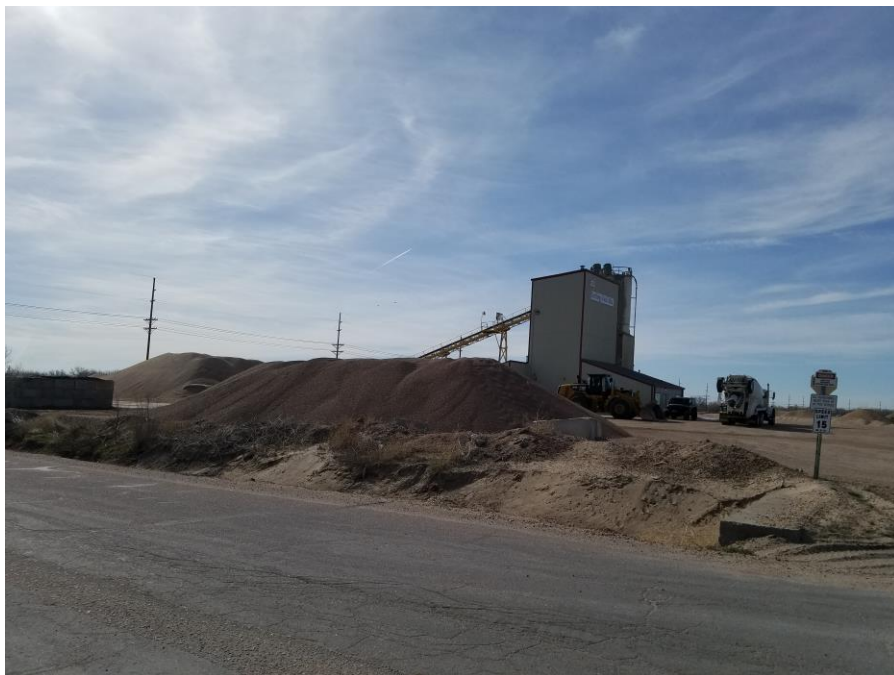
Figure 16. From Riverside Drive northwest of the permit area looking southeast. Area affected outside of permit boundary.

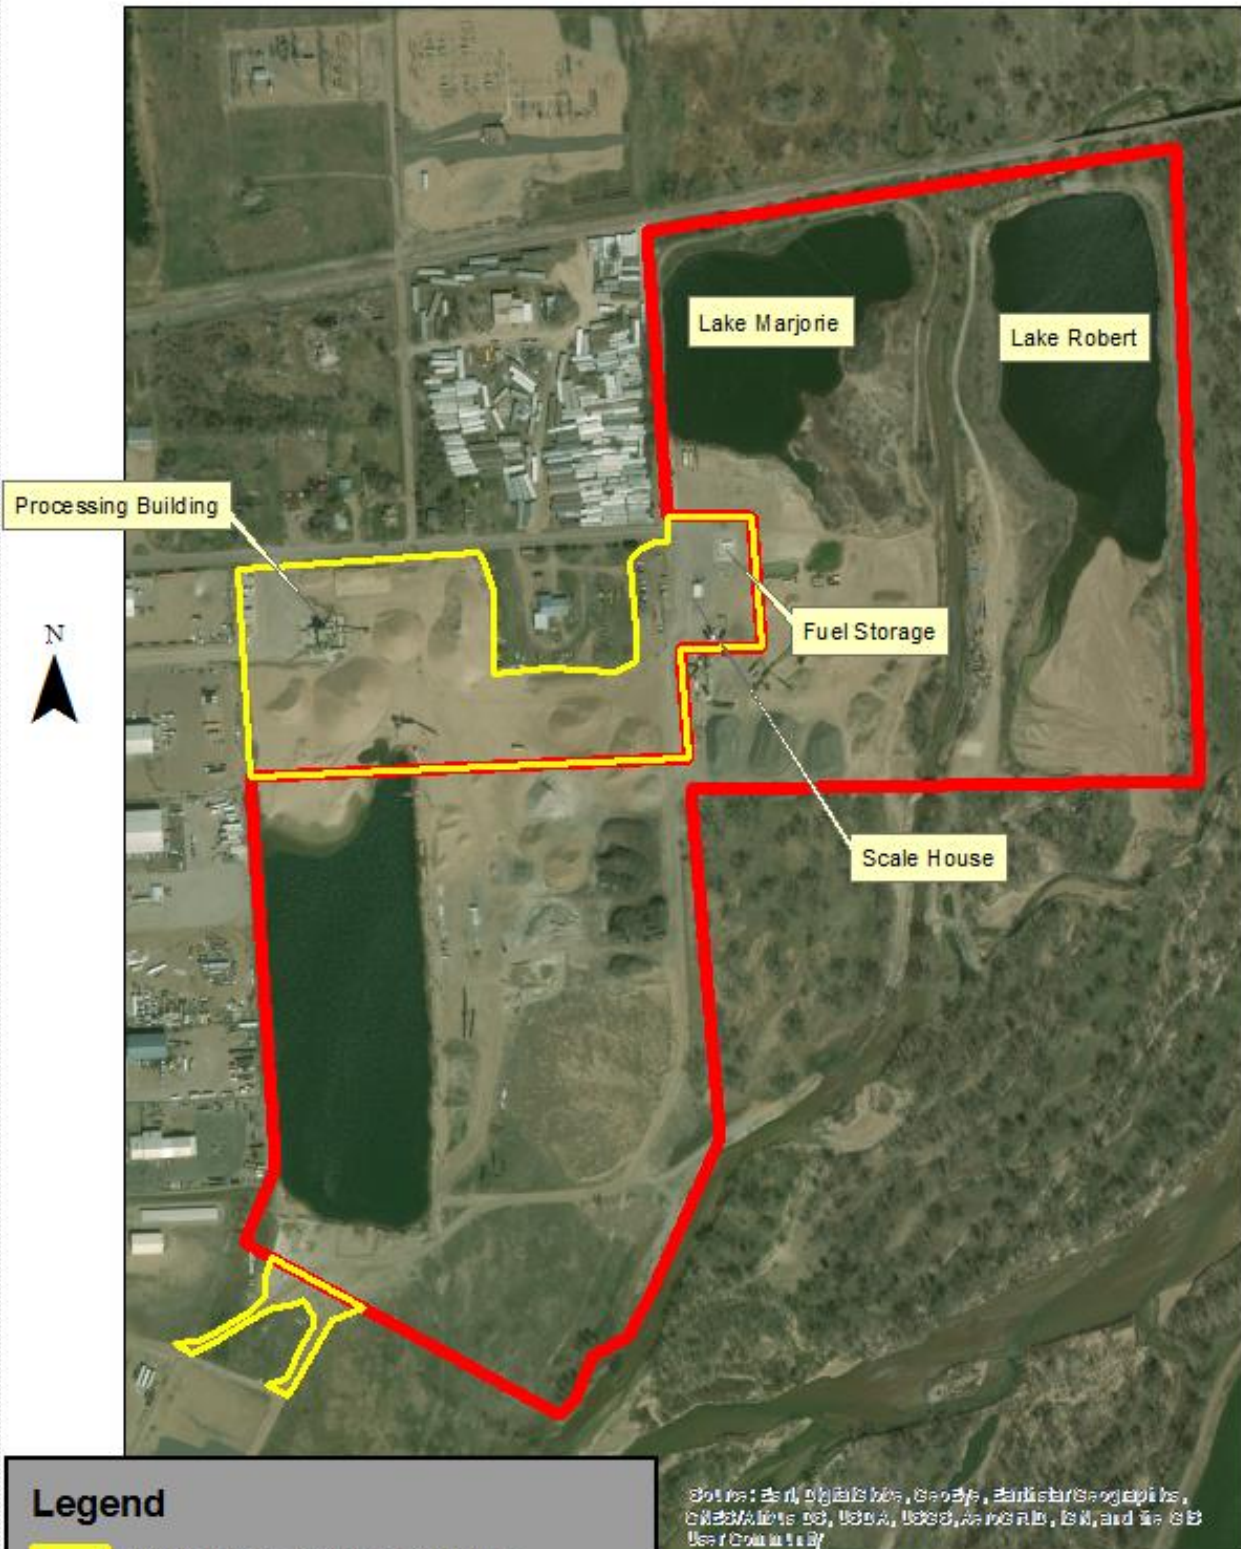
Riverside Pit, M-1976-056

The Division estimates about 15 acres has been affected outside of the permit boundary. Please see the map at the end of this report that depicts the areas the Division believes are outside of the approved permit boundary.
