**COLORADO**Division of Reclamation,  
Mining and Safety

**MINERALS PROGRAM INSPECTION REPORT****PHONE: (303) 866-3567**

| <b>MINE NAME:</b><br>Henderson Mine | <b>MINE/PROSPECTING ID#:</b><br>M-1977-342 | <b>MINERAL:</b><br>Molybdenum | <b>COUNTY:</b><br>Clear Creek, Grand |
| <b>INSPECTION TYPE:</b><br>Monitoring | <b>INSPECTOR(S):</b><br>Michael A. Cunningham | <b>INSP. DATE:</b><br>April 19, 2018 | <b>INSP. TIME:</b><br>09:30 |

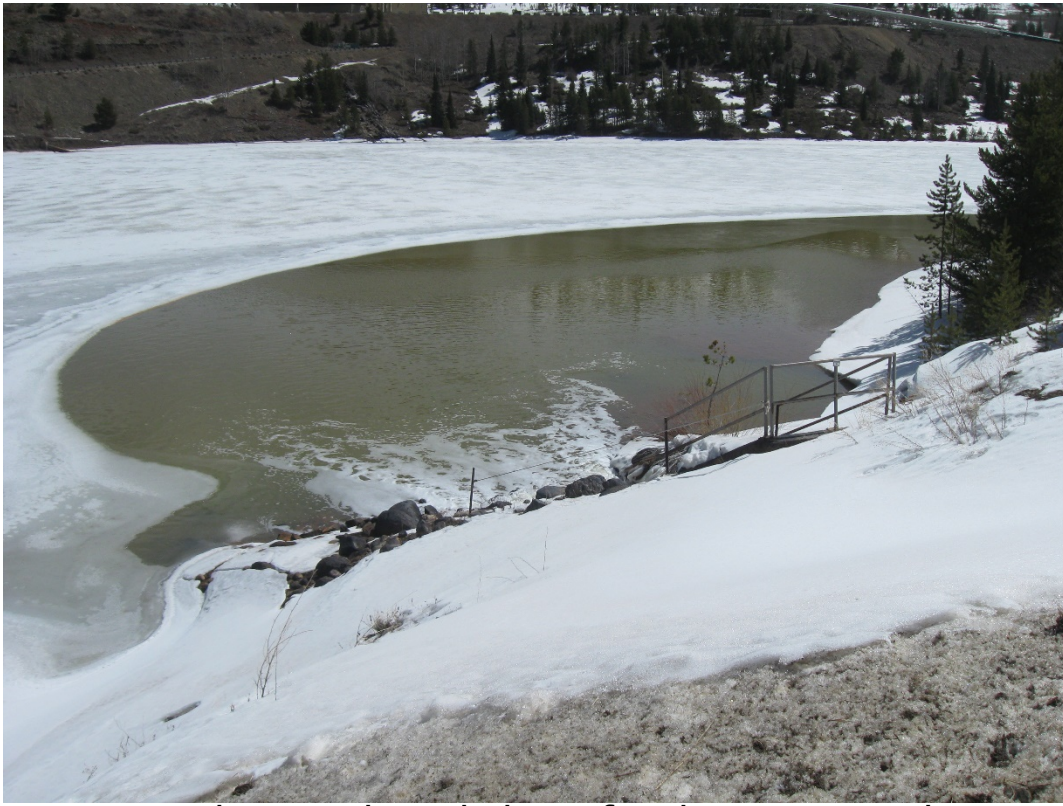
The East Branch Reservoir System includes the reservoir, dam, pump station, and process water line. The water stored in the reservoir consists of recycled process water, which is pumped to the process water tanks and is then pumped to the Mill. Stormwater up gradient of the East Branch Reservoir is diverted to an underground diversion pipeline which discharges through outfall (OF-M2) to the Williams Fork River. Stormwater was being routed around the East Branch Reservoir at the time of the inspection and the diversion intake and outfall were free of obstructions and were functioning properly. The Division also inspected the barge pump station which is a component of the tailings storage facility. The 3 pumps in the barge pump station were operational and decant water from the tailings storage facility was being delivered back to the East Branch Reservoir.

**1. East Branch Reservoir - Discharge from barge pump station.**

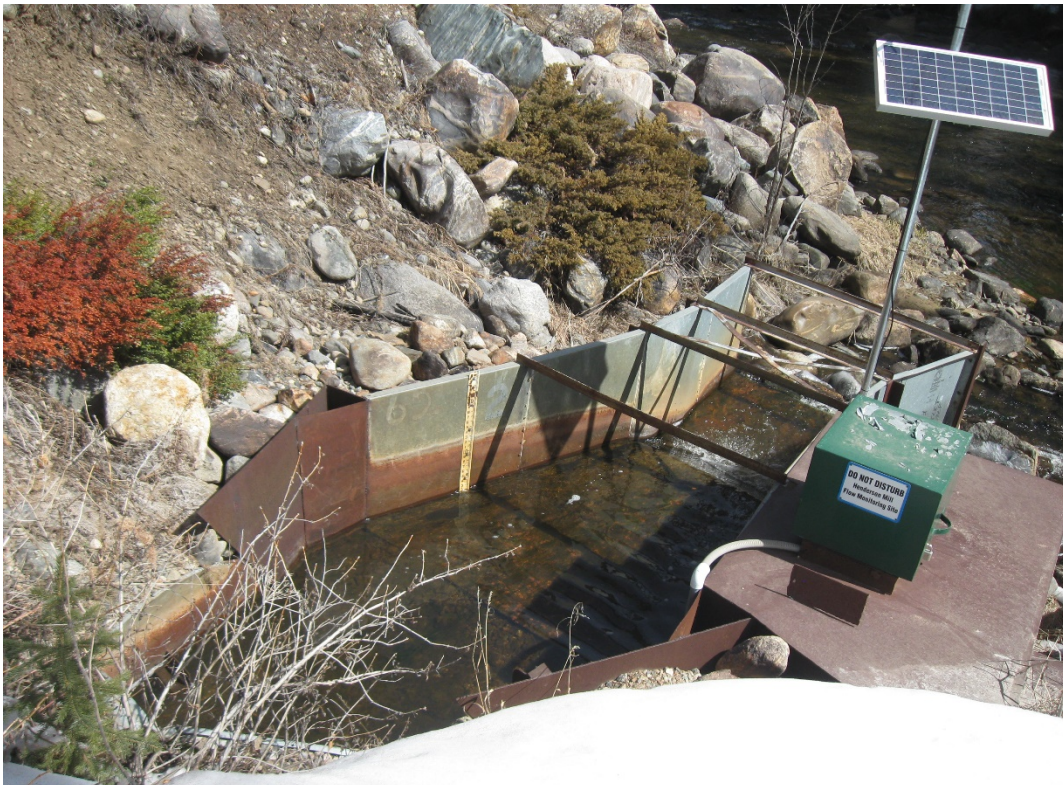
**2. East Branch Reservoir - Stormwater diversion discharge point.**

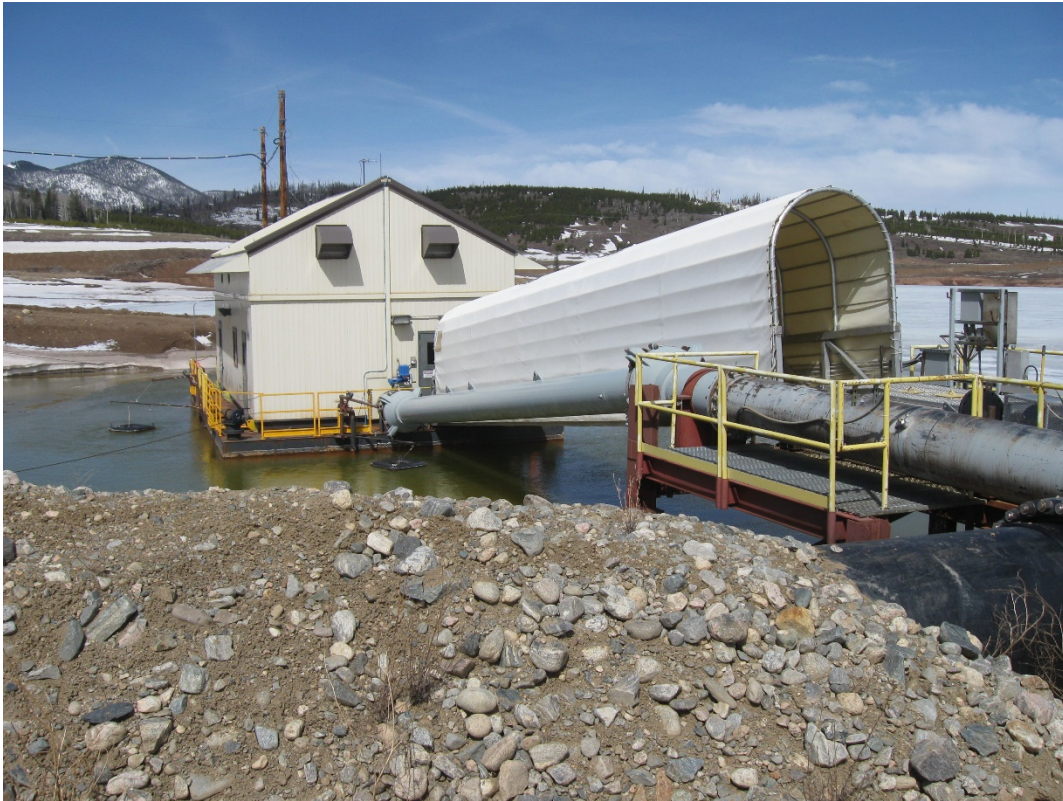
**3. Tailings Storage Facility - Barge pump station.**

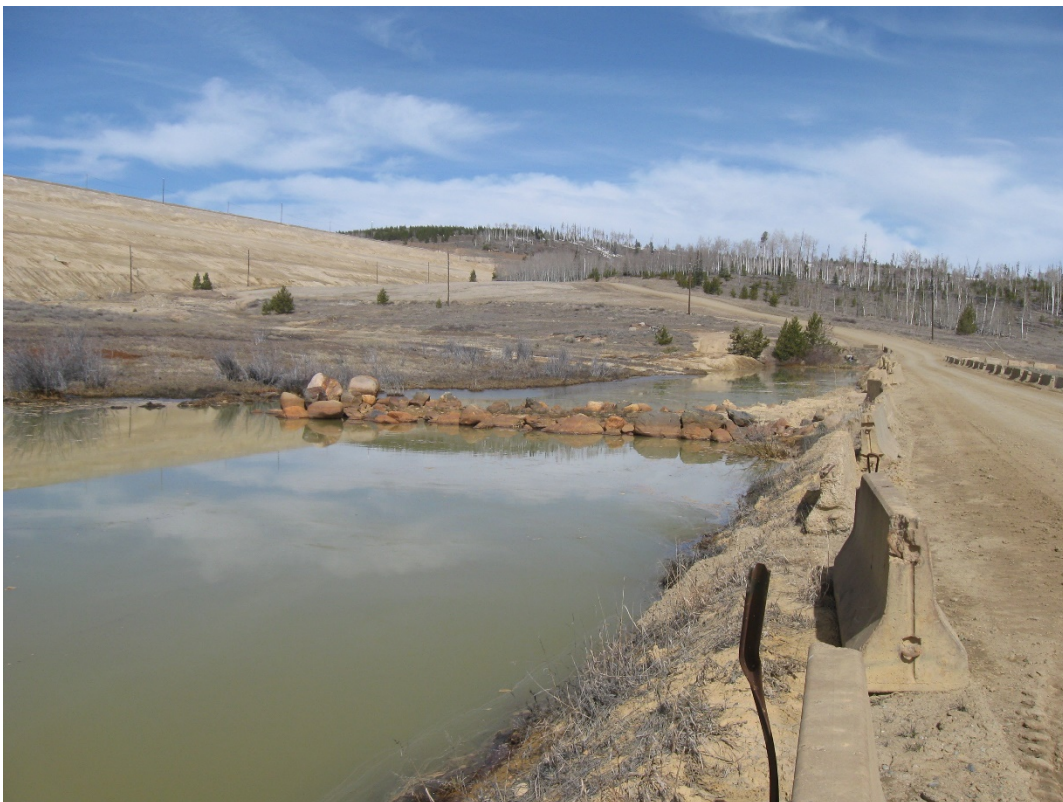
The Seep Water Collection and Return System was inspected and was found to be functioning properly. The seep water is collected in a main canal and then is routed into two diversion ditches which convey the seep water to the Ute Park Pump Station. No blockages were observed in system and seep water was being conveyed through both diversion ditches.

**4. Seep Water Collection - main collection canal.**

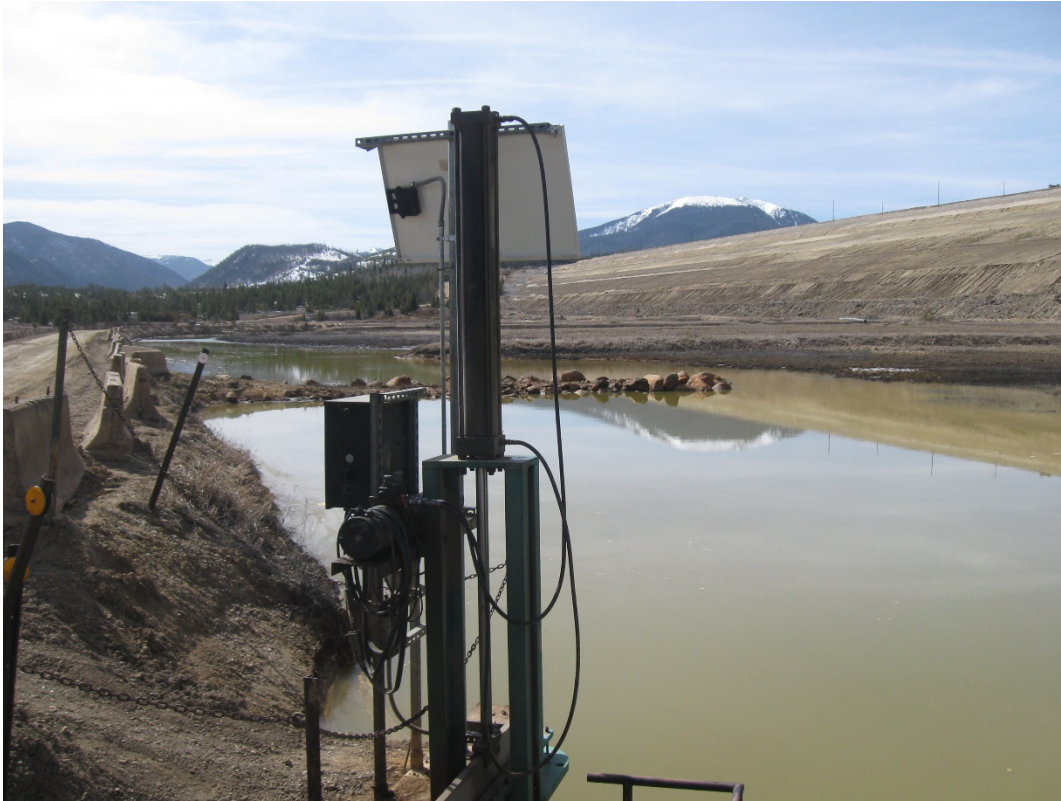
**5. Seep Water Collection - seep water gate connecting main canal to diversion ditch.**

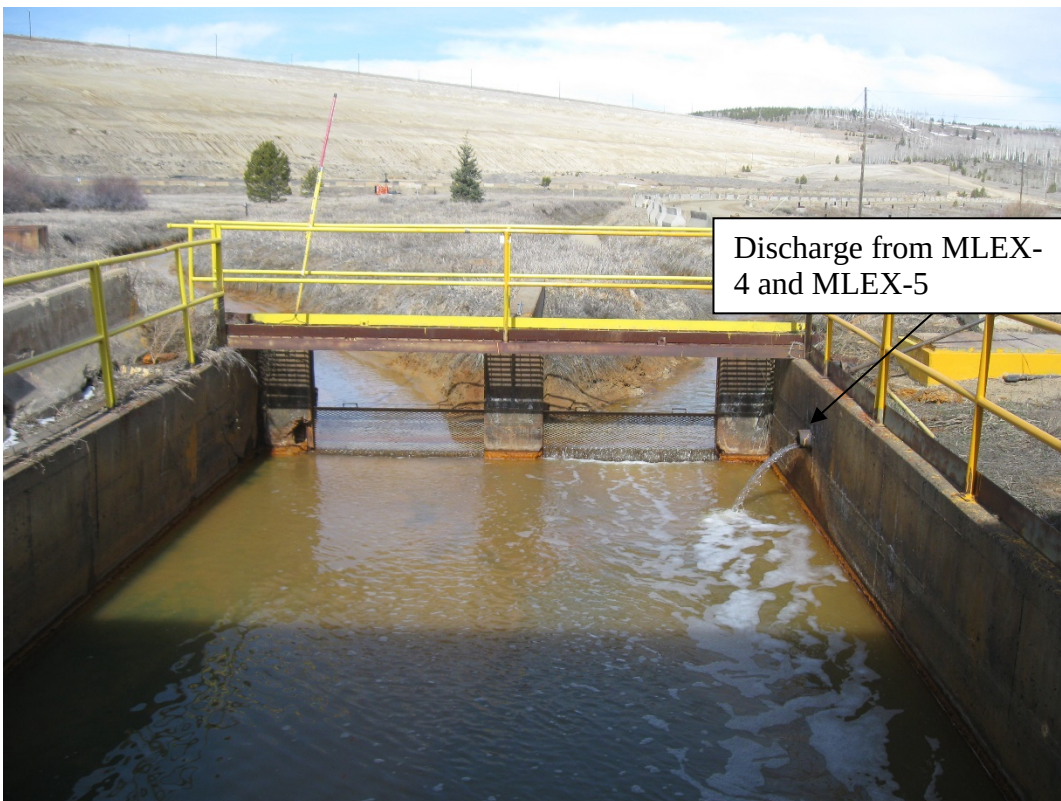
The Ute Park Pump Station was inspected and was found to be functioning properly. The pump station contains three pumps which are used to deliver the seep water back to the pool on the tailings storage facility.

**6. Seep Water Collection - Diversion ditches discharging to Ute Park Pump Station.**

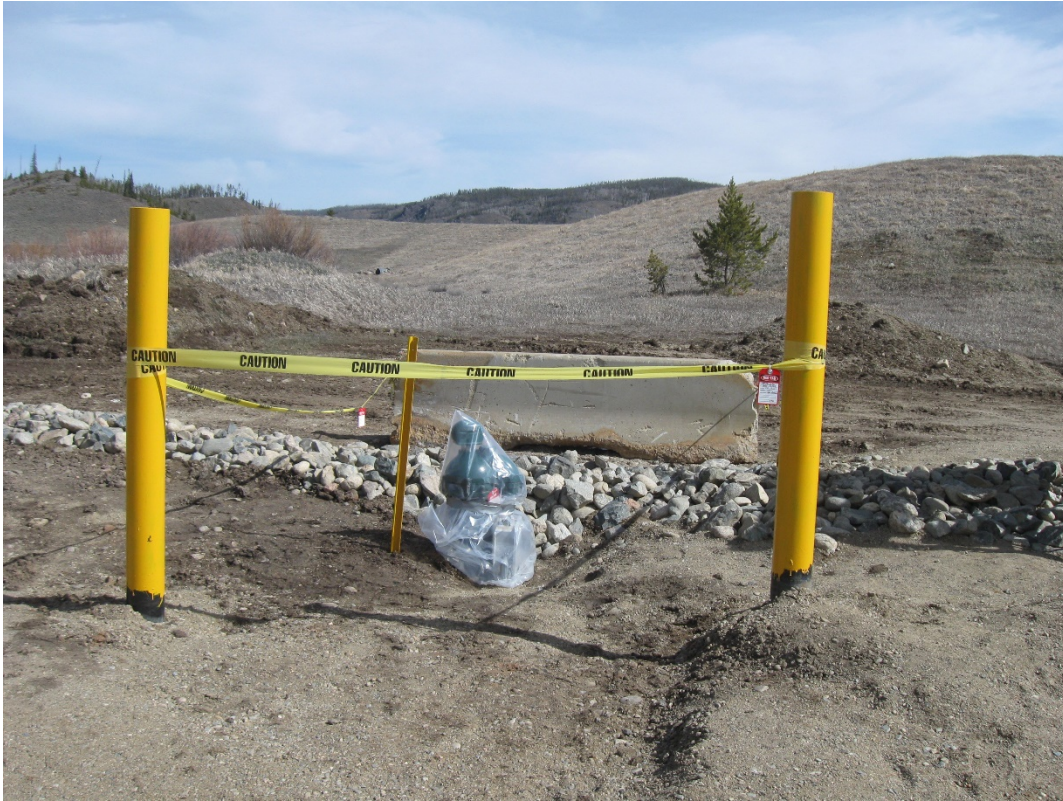
The Groundwater Intercept System is comprised of five wells which collect seepage affected groundwater below 1-Dam. The collected groundwater is pumped into the seep water collection canals, where it is then pumped into the tailings storage facility and recirculated back into the Mill process water system. All of the wells were operational at the time of the inspection. The Operator informed the Division that wells MLEX-4 and MLEX-5 both had a corroded steel pipe located between the well head and electrical panel which have been scheduled for replacement.

**7. Groundwater Intercept System - Pending repair on MLEX-4.**

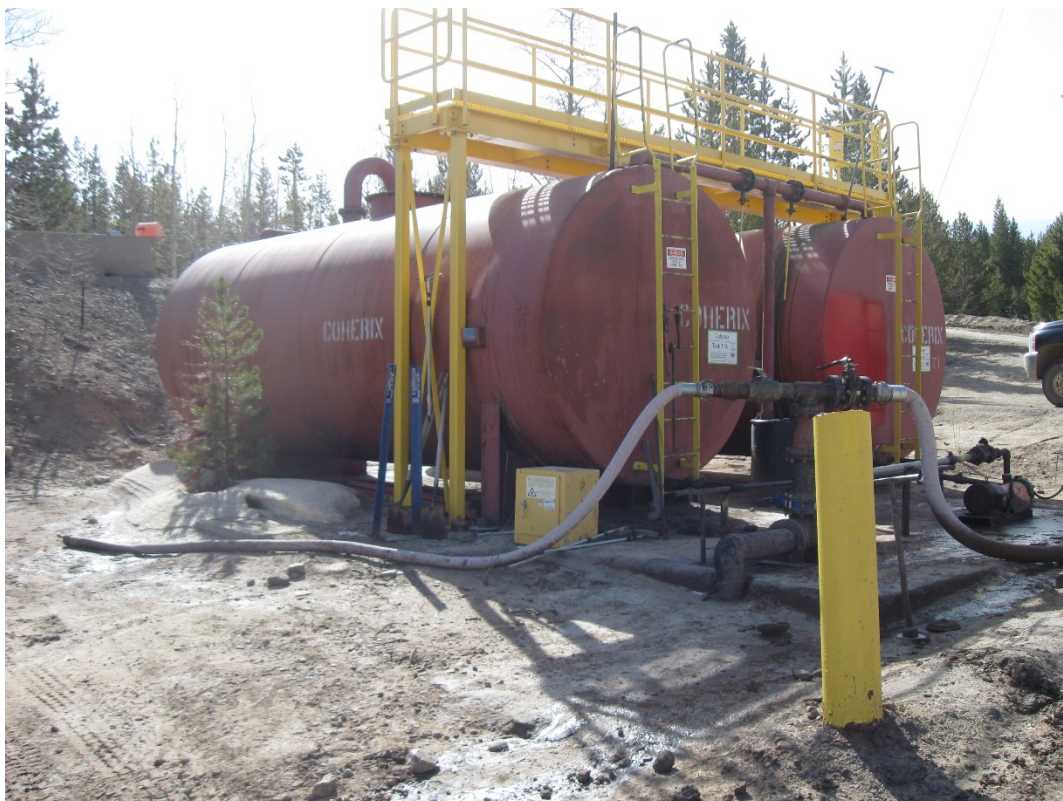
The Operator utilizes Coherex for dust suppression at the Mill. Coherex is stored in two 10,000 gallon double-walled tanks near the tailings storage facility maintenance building. The signage on the tanks correctly identified the capacity of the tanks. Coherex was being applied to the tailings storage facility during the inspection.

**8. Coherex Storage Tanks.**
