**COLORADO DIVISION OF RECLAMATION, MINING AND SAFETY**  
**MINERALS PROGRAM INSPECTION REPORT**  
**PHONE: (303) 866-3567**

| <b>MINE NAME:</b><br>Riverside Pit | <b>MINE/PROSPECTING ID#:</b><br>M-1976-056 | <b>MINERAL:</b><br>Sand and gravel | <b>COUNTY:</b><br>Logan |
| <b>INSPECTION TYPE:</b><br>Monitoring | <b>INSPECTOR(S):</b><br>Elliott R. Russell | <b>INSP. DATE:</b><br>October 1, 2015 | <b>INSP. TIME:</b><br>10:30 |

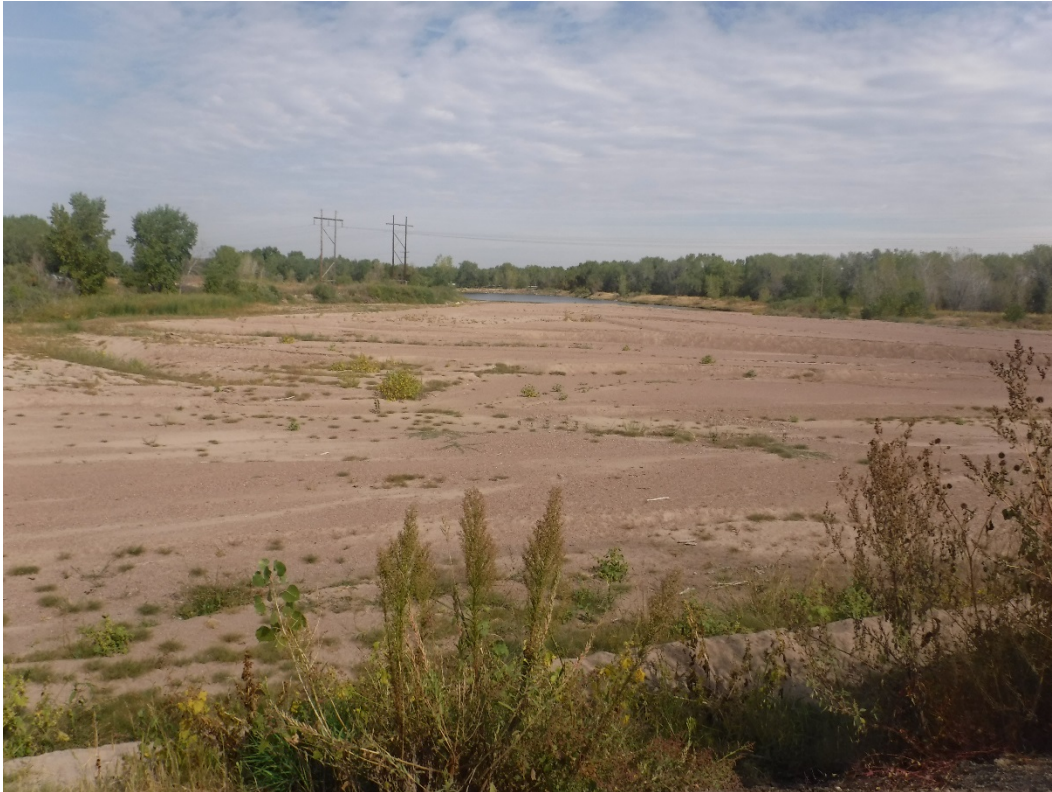
This inspection focused on the Lake Robert, located in the eastern portion of the permit on the east side of the Lowline Ditch. This area had been damaged by floods that occurred in the fall of 2013 and the spring of 2015. As previously observed during the last DRMS inspection, it appears this damage was caused the Lowline Ditch, which had overflowed its banks during the flooding events and caused water to enter Lake Robert from a return channel located south of the permit. Flood waters cut a channel into Lake Robert on the southeast corner and out in the center of the northern shoreline. During this inspection, the Division observed that approximately the southern 5 acres of Lake Robert has been filled in with sediment, reducing the amount of open water in the lake to approximately 7 acres (all located in the northern portion of the lake now). A small channel had developed from the southeast corner of the lake to the central-western shoreline. No water was entering the Lake at the time of the inspection.

Lake Robert filled partly by sediment; looking north from the original southern bank.

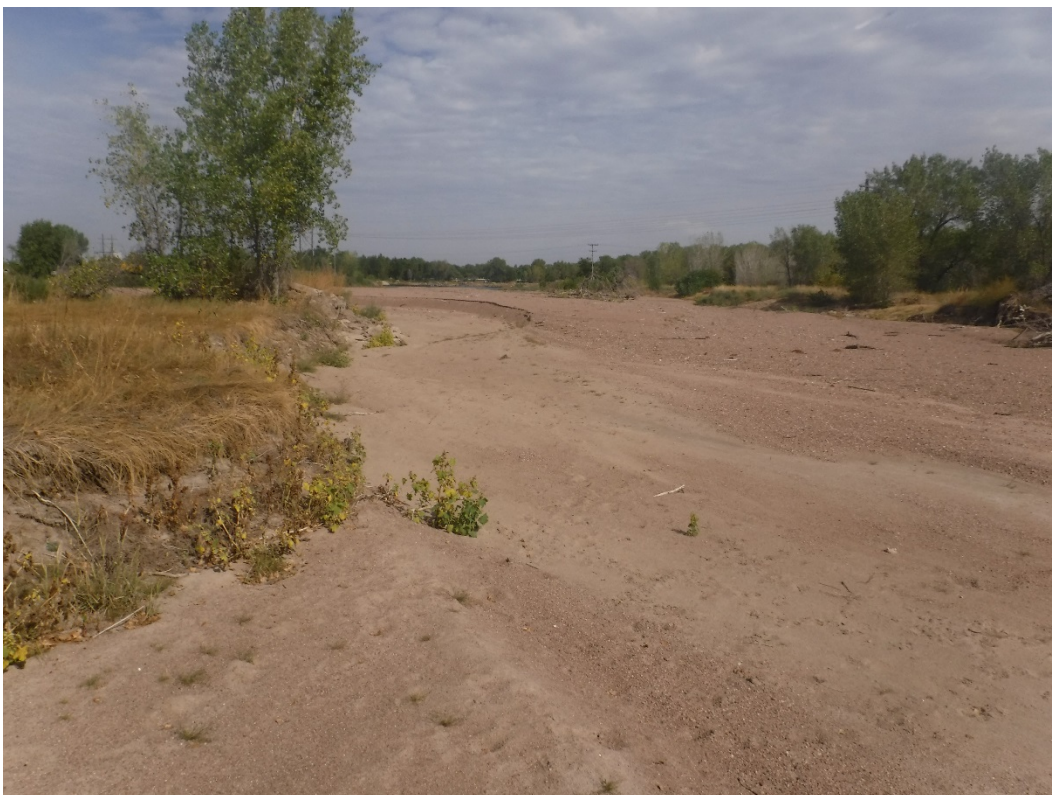
Cut channel entering Lake Robert in the southwest corner; looking north.

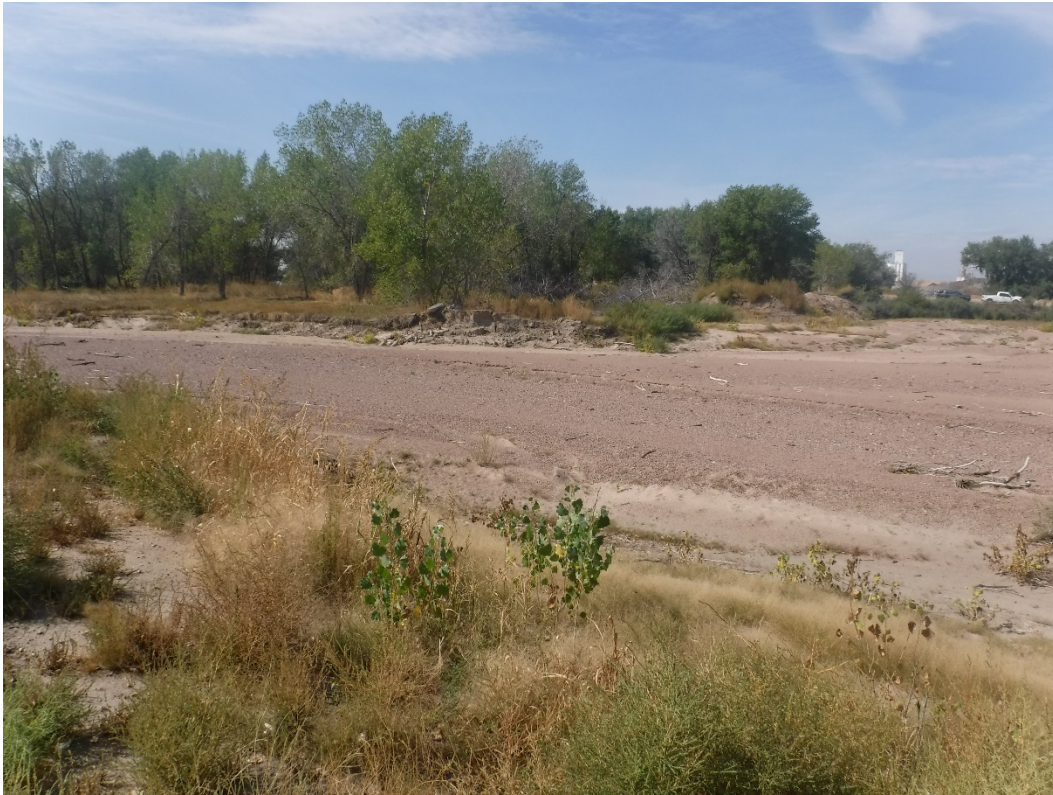
Cut channel entering Lake Robert in the southwest corner; looking southwest.

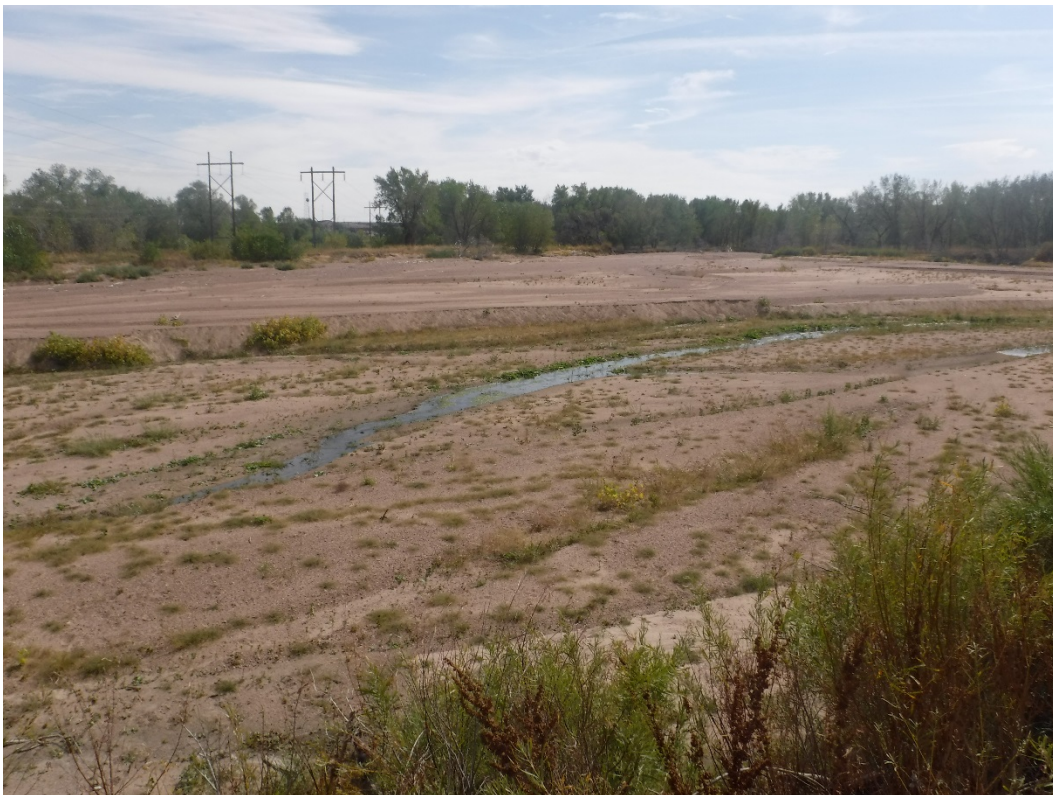
Southern portion of Lake Robert filled with sediment; looking southeast.

The Division agreed with the Operator that it would be best to establish a 5 year period to re-evaluate the Lake Robert area. This time period could possibly allow the site to stabilize on its own without requiring the Operator to do major construction activities, which may be destroyed or damaged with future spring run-off and flooding events. After this time period ends, roughly at the end of 2020, the Operator and the Division can re-evaluate the area to determine if further repair work and/or reclamation is needed.

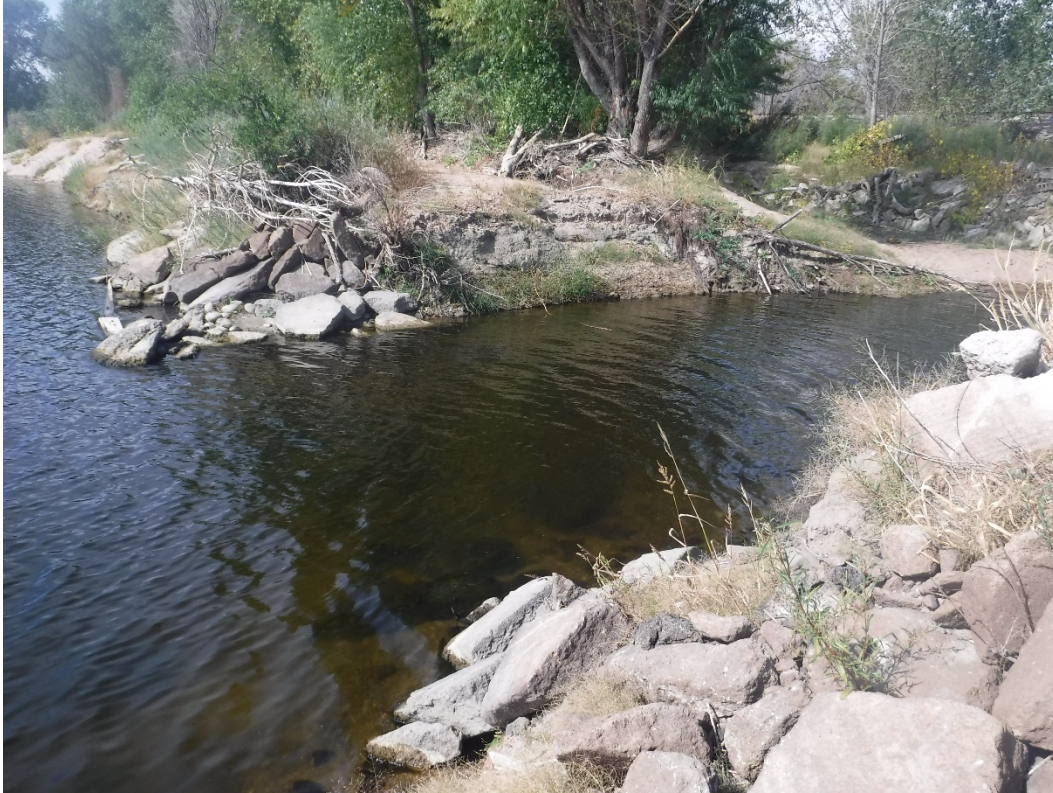
Cut outlet on the north side of Lake Robert in need of stabilization and armoring; looking northwest.

Based on observations and discussion with Mr. Gebhart and Mr. O'Brian, the best option to move forward with this situation is to stabilize and protect the outlet on the north side of Lake Robert. Constructing an armored outlet will help allow flood stage waters to leave Lake Robert and return to the South Platte, reducing the chance for causing erosion and further damage to the northern shoreline. Creating this structure would also re-establish access to the east side of Lake Robert. The Operator stated they would revise the Technical Revision and submit the information the Division. TR-04 was approved on December 31, 2015. The Operator submitted photographs of the completed work on the outlet of Lake Robert on February 23, 2016.

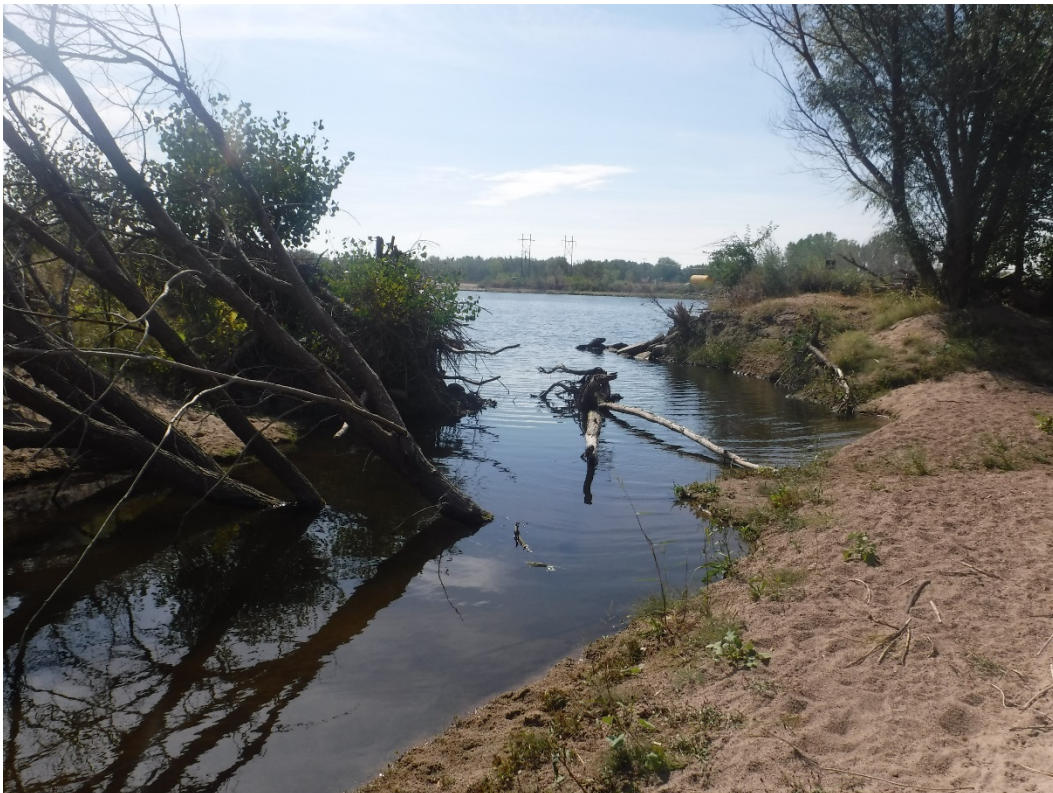
Cut outlet on the north side of Lake Robert in need of stabilization and armoring; looking south.
