MINERALS PROGRAM INSPECTION REPORT

MINE NAME: Hitch Rack Ranch	MINE/PROSPECTING ID#: P-2017-008	MINERAL: Granite, granite gneiss	COUNTY: El Paso
INSPECTION TYPE: Monitoring	INSPECTOR(S): Timothy A. Cazier, Wally Erickson	INSP. DATE: May 9, 2018	INSP. TIME: 13:20
OPERATOR: Transit Mix Concrete Co.	OPERATOR REPRESENTATIVE: Jerry Schnabel	TYPE OF OPERATION: ME – Mineral Exploration	
REASON FOR INSPECTION: Citizen Complaint	BOND CALCULATION TYPE: None	BOND AMOUNT: \$4,000.00	
DATE OF COMPLAINT: NA	POST INSP. CONTACTS: None	JOINT INSP. AGENCY: None	
WEATHER: Cloudy	INSPECTOR'S SIGNATURE:

P-2017-008 Post Complaint Inspection Map

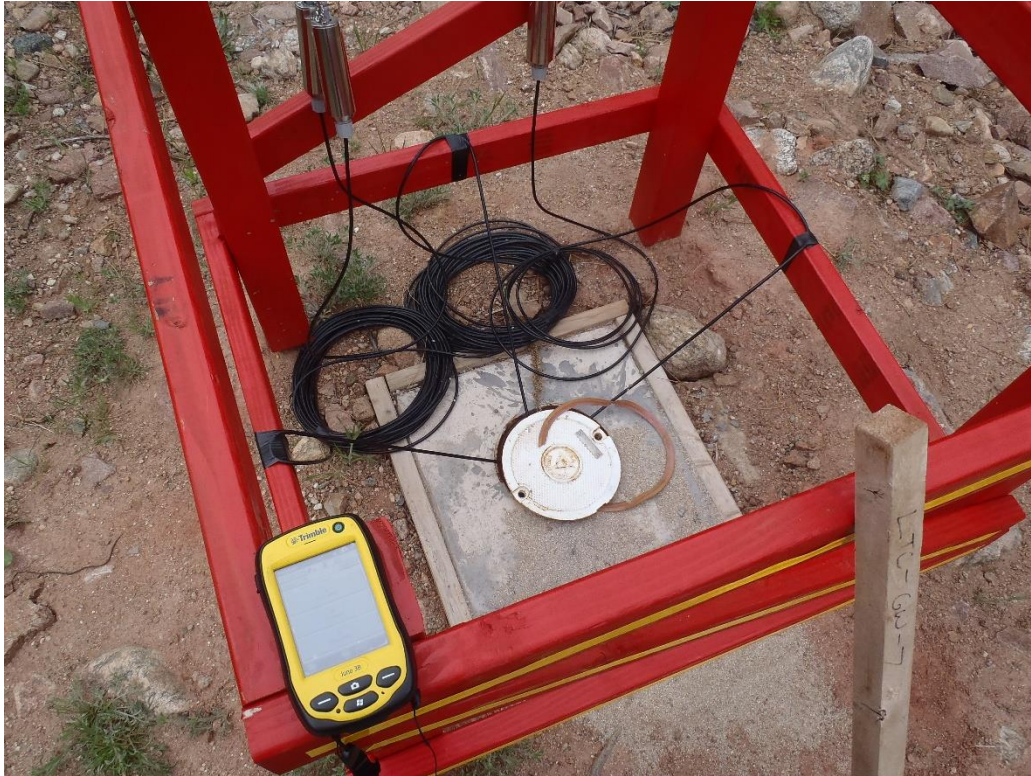
The following three monitoring wells were observed during this inspection: MW-7 (a.k.a. LTC-GW-7), MW-6 (a.k.a. LTC-GW-6), and MW-2 (a.k.a. LTC-GW-2) see **Photos 1** through **3**) and GPS coordinates of each were collected using a handheld Trimble Juno 3B (see **enclosed post-inspection map**). The locations of both the secondary (see **Photos 4** and **5**) and primary wells were also recorded with the same GPS, also shown on the post-inspection map. The investigated well was measured to be 480 feet from the closest, LTC-MW-7.

Photo 1. LTC-MW-7 (note unsecured cover and GPS unit).

Gen. Compliance with Mine Plan: The operation appeared to be in compliance with the approved NOI. However, as indicated in the complaint, the monitoring well covers were observed to be unlocked. Given the small diameter of the monitoring tubes from the wells, it would be difficult, but not impossible to introduce contamination into the monitoring wells. **The DRMS strongly recommends Transit Mix either lock or otherwise secure the monitoring wells.**

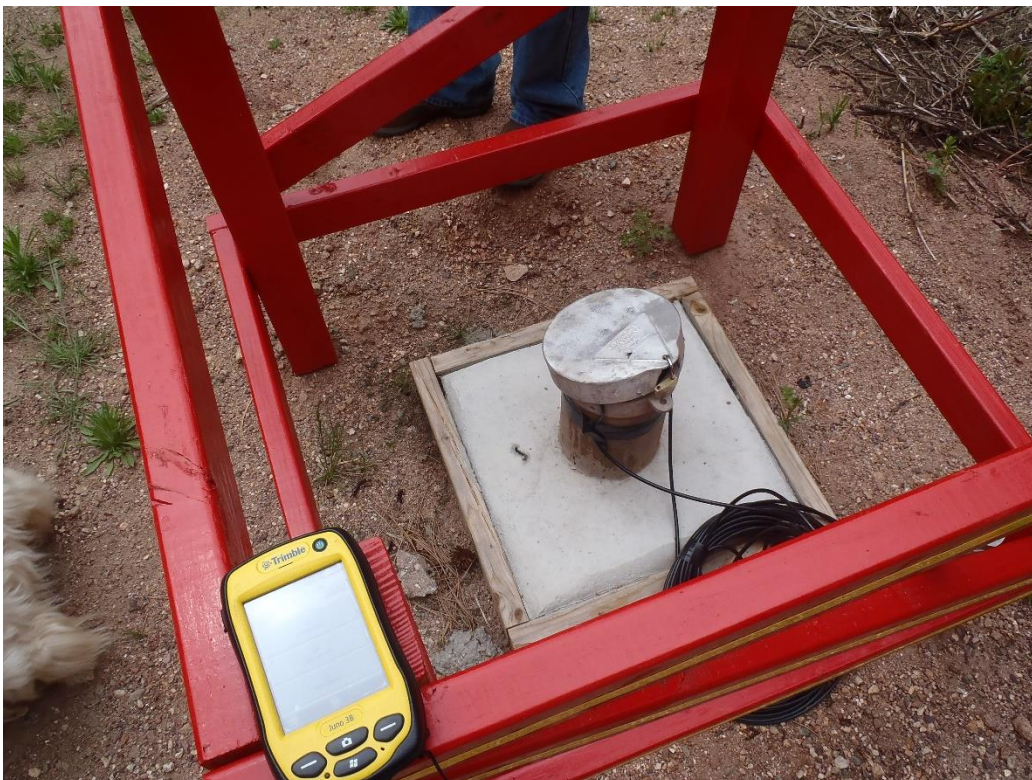
Photo 2. LTC-MW-6 (note unsecured cover and GPS unit).

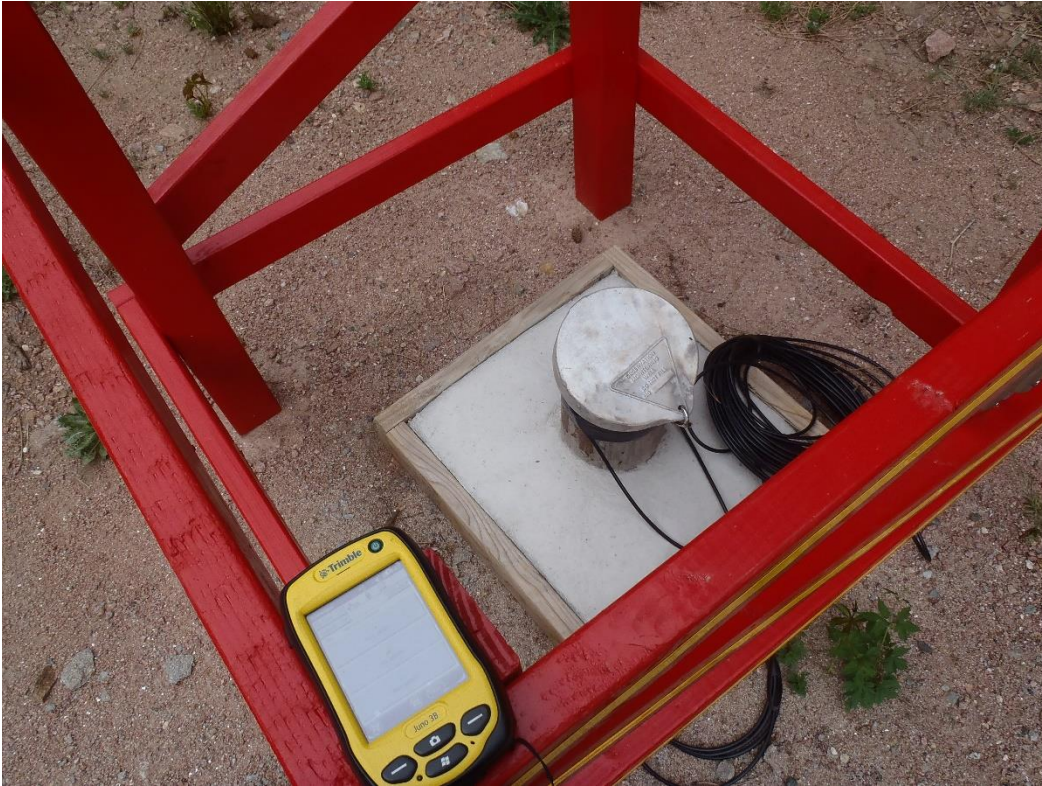
Photo 3. LTC-MW-7 (note unsecured lock on cover and GPS unit).

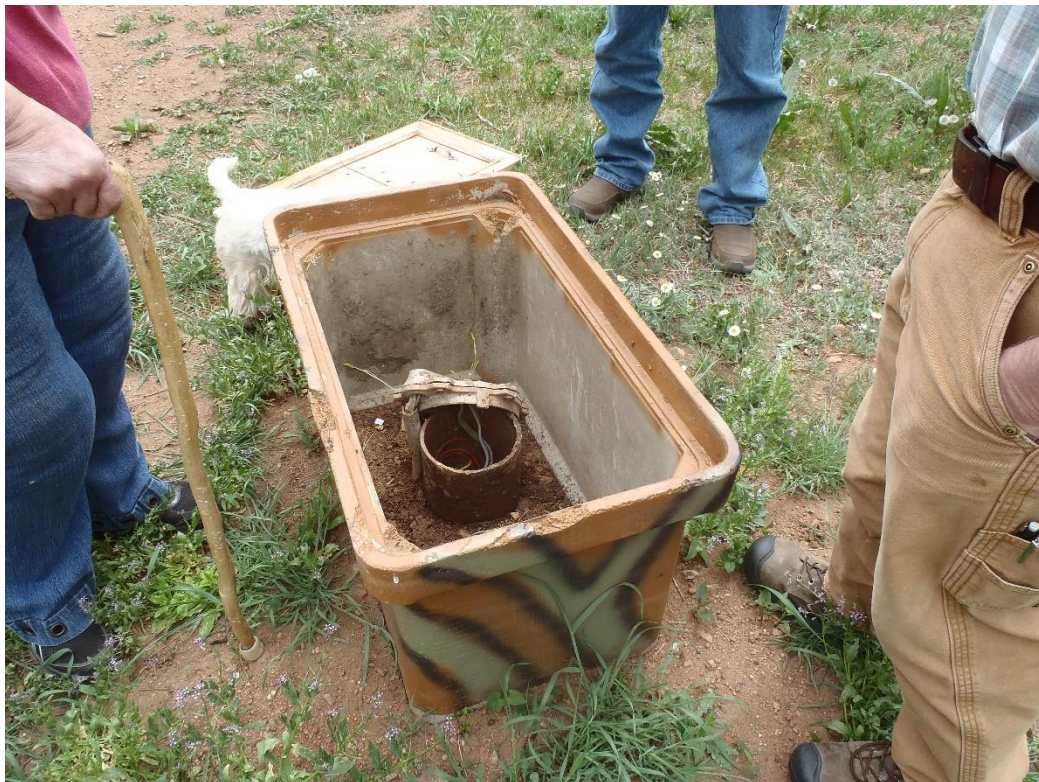
Ms. Delgado showed us the location of the inoperable well, which she indicated had not been able to supply water for about a year and a half, stating it was about the same time as the Transit Mix monitoring wells were installed. Power to the pump had been disconnected. This inspector observed water in the well, which Ms. Delgado indicated was approximately 240 feet deep. A water level meter was used to measure the depth to water which was determined to be 8.25 feet from the top of the casing. All parties considered the problem might be electrical or related to the pump. Mr. Schnabel offered to have the well contractor Transit mix used come investigate the pump and system.

Photo 4. Inoperable well enclosure.

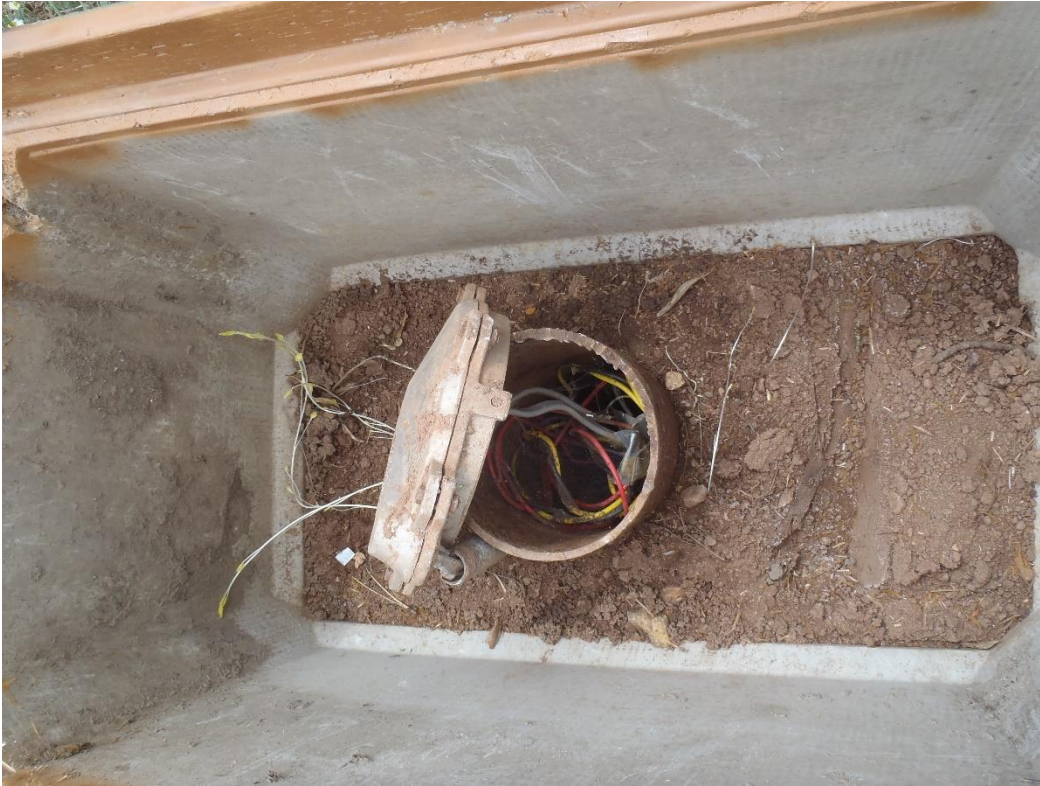
The DRMS representatives expressed interest in collecting a water sample from the subject well for the purpose of assessing the amount of suspended solids. As the pump was not working, it was decided to use a length of garden hose to syphon water from the well. Slight curvature in the hose required some up and down motion of the hose to get it to an adequate depth into the well. This action likely knocked debris loose from inside the well casing, potentially contaminating the sample. When sufficient hose submersion was reached, the hose was kinked, withdrawn from the well and emptied into a one-liter bottle. The bottle was subsequently emptied into an Imhoff cone and allowed to settle. The settleable solids were measured to be 2.5 mm from the one liter sample. The vast majority of these solids appeared to be rust, likely as a result of the method used to collect the sample.

Photo 5. Inoperable well (top of casing).

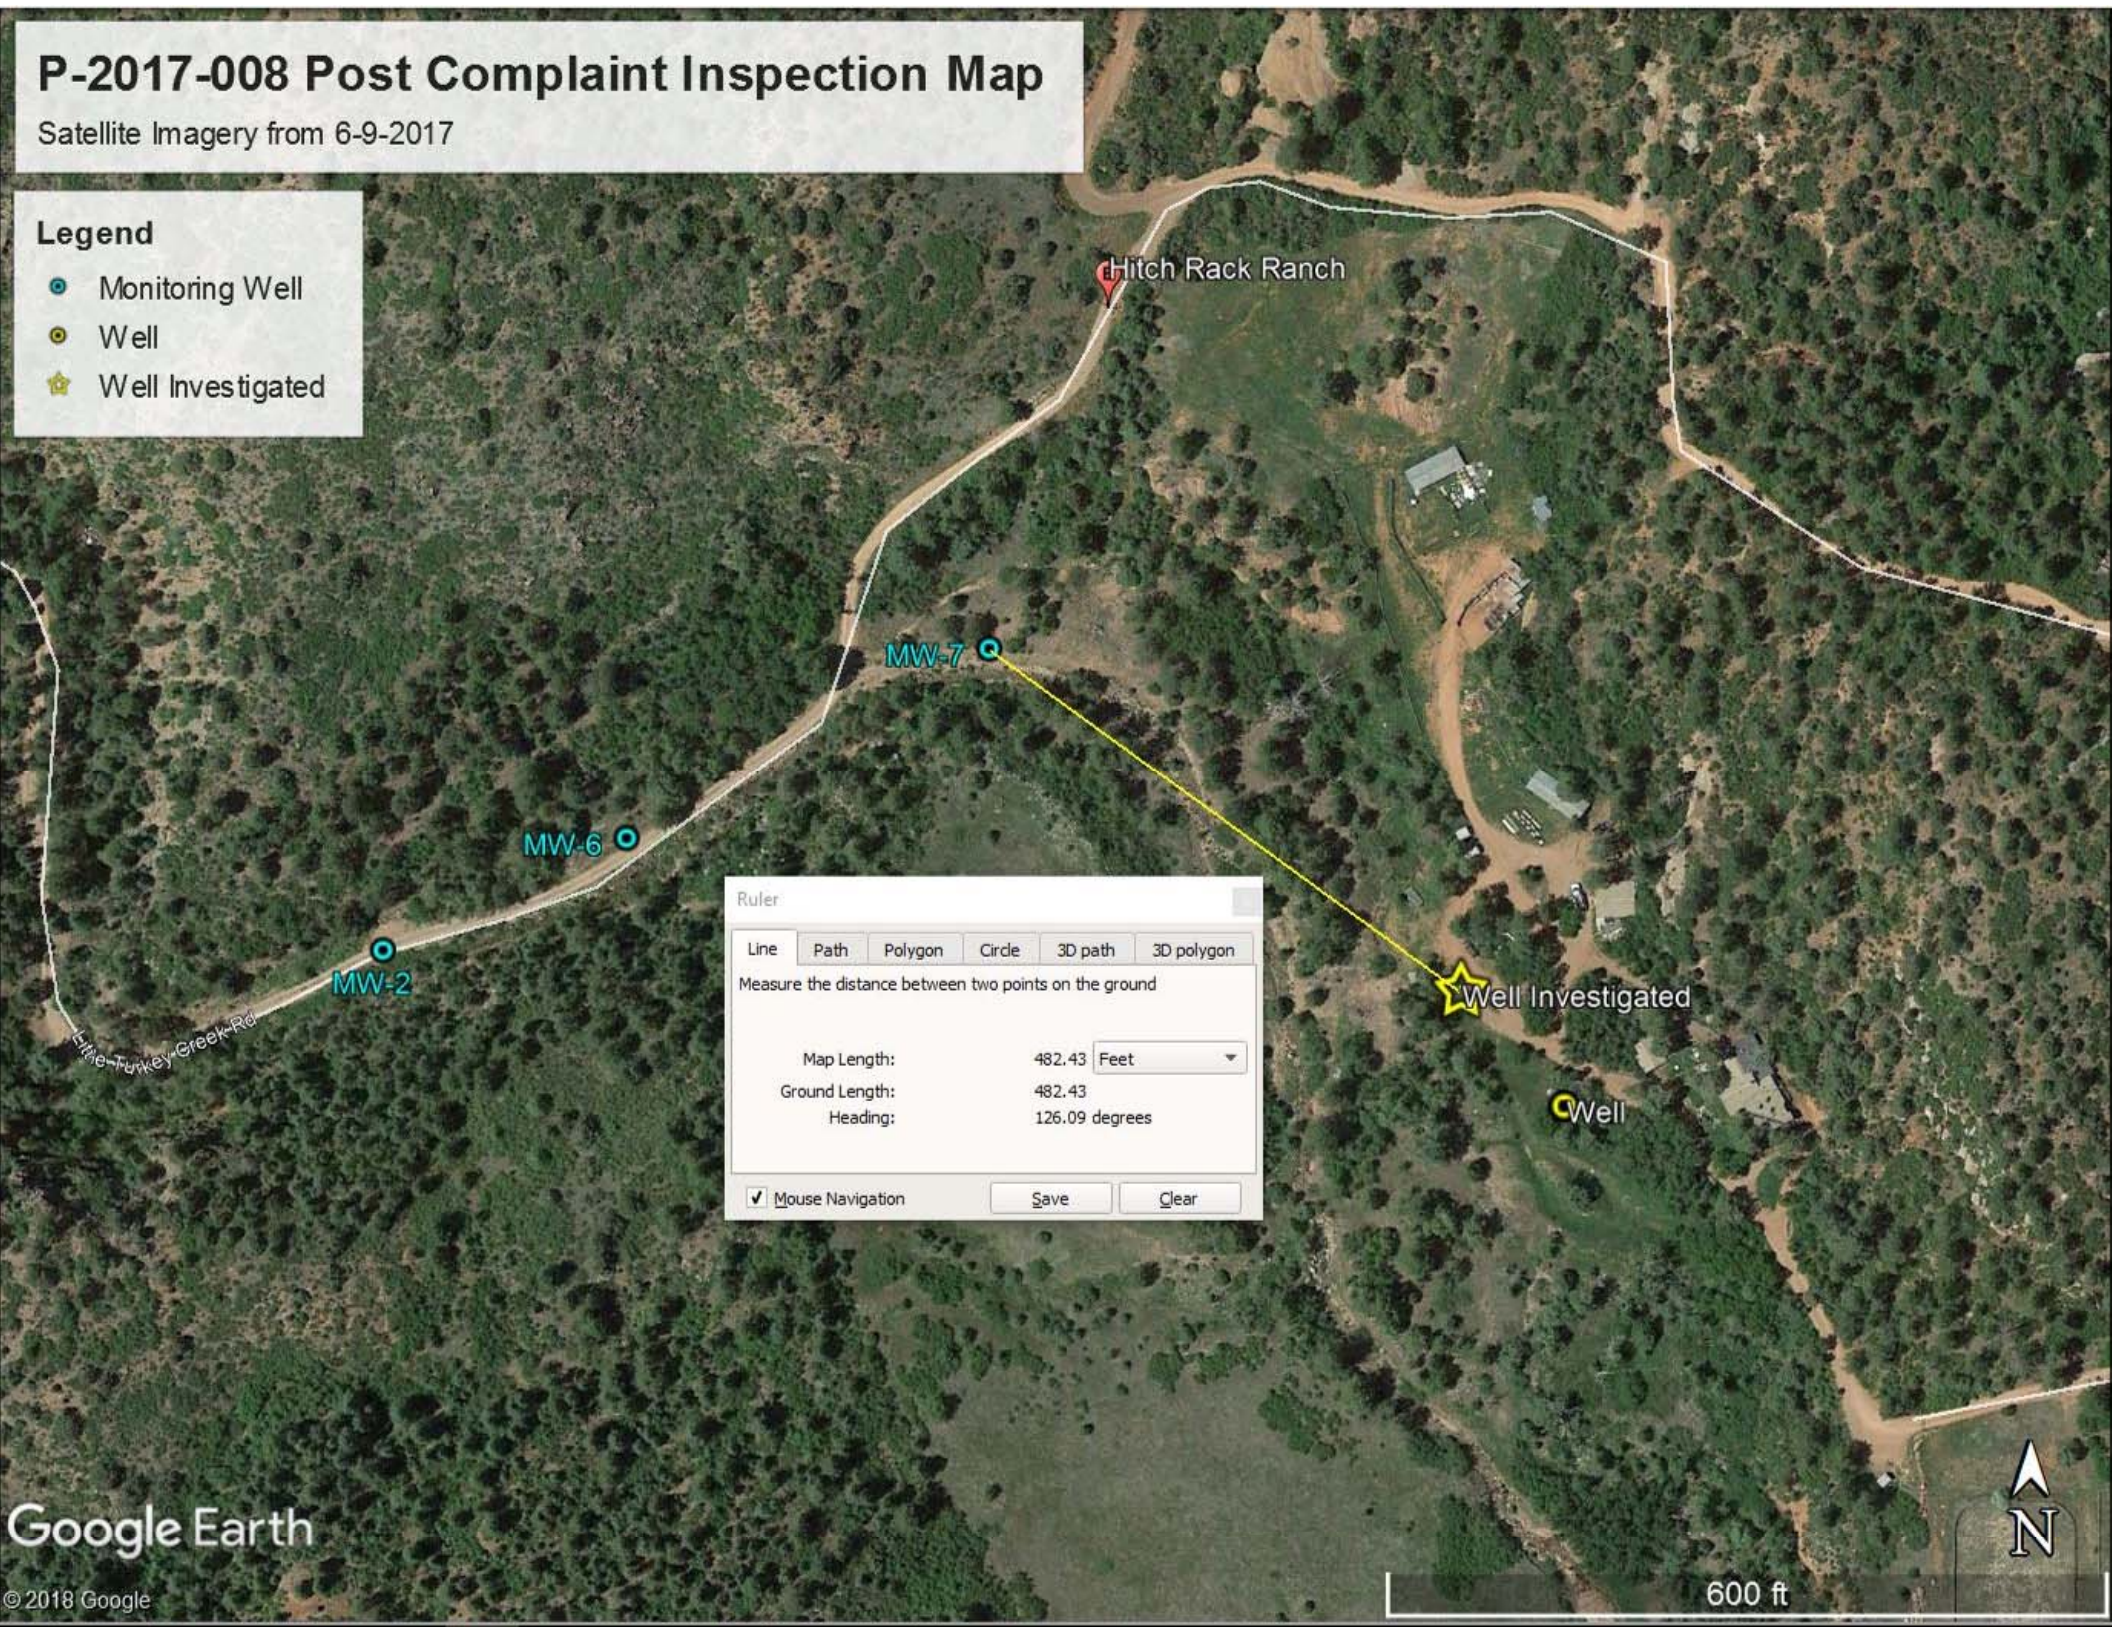
Hydrologic Balance: The site investigation related to the complaint centered on a secondary well (labeled as "Well Investigated" on the **enclosed post-inspection map**) alleging the installation of monitoring wells (photos of LTC-GW-7 and LTC-GW-2 included in the complaint email) causing this well to become inoperable.
