MINERALS PROGRAM INSPECTION REPORT
PHONE: (303) 866-3567

MINE NAME: Bates-Hunter Mine	MINE/PROSPECTING ID#: M-1990-041	MINERAL: Gold	COUNTY: Gilpin
INSPECTION TYPE: Surety-Related Inspection	INSPECTOR(S): Michael A. Cunningham	INSP. DATE: March 23, 2018	INSP. TIME: 09:30
OPERATOR: Central City Consolidated Mng	OPERATOR REPRESENTATIVE: Matt Collins	TYPE OF OPERATION: 110(2) - Hard Rock Limited Impact	
REASON FOR INSPECTION: Normal I&E Program	BOND CALCULATION TYPE: None	BOND AMOUNT: \$99,000.00	
DATE OF COMPLAINT: NA	POST INSP. CONTACTS: None	JOINT INSP. AGENCY: None	
WEATHER: Clear	INSPECTOR'S SIGNATURE:

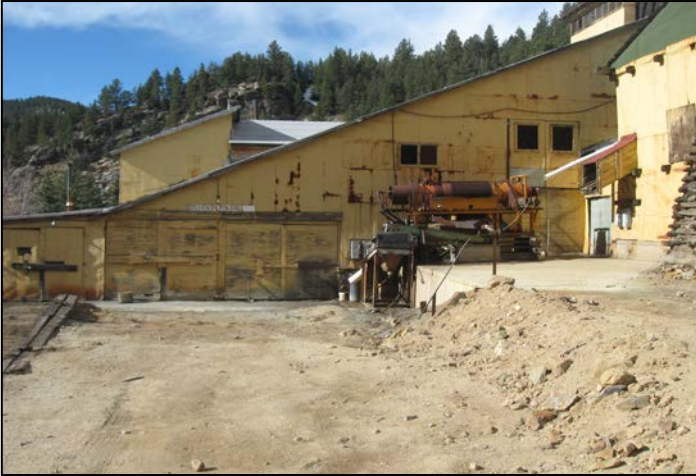
1. North side of Mill building.

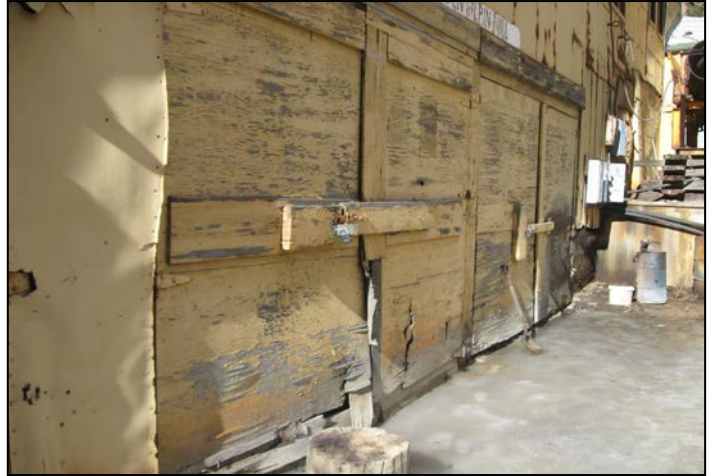
Following the inspection of the mine site, the Division proceeded to inspect the Mill facility. The Operator has installed locks on all of the doors to the Mill building and the facility is no longer accessible to the public. In addition, the Operator has removed all refuse and equipment from around the Mill building. The reagents which were stored in the Mill building and still have a use for future milling operations have been moved into a Conex container located adjacent to the Mill. All other reagents were removed from the site and were properly disposed of at a licensed waste disposal facility.

2. Locked doors on Mill building.

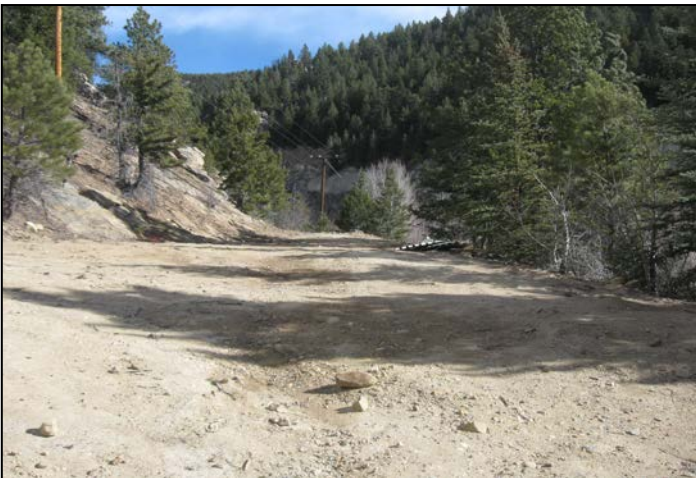
3. Area adjacent to Mill, previously used to store equipment and refuse.

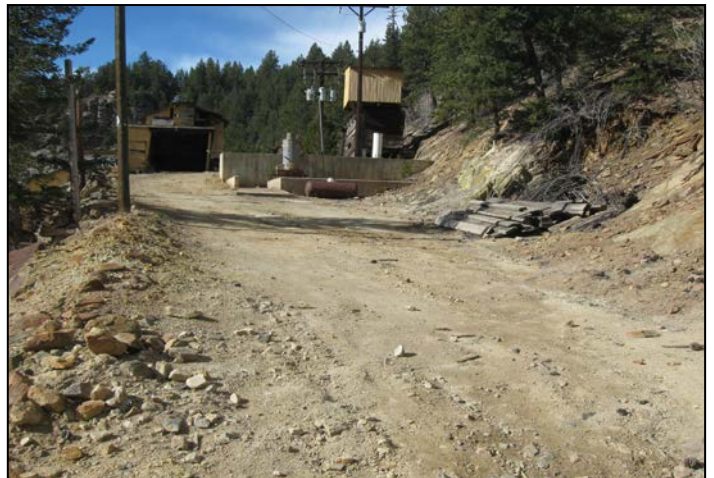
4. Area adjacent to Mill, previously used to store equipment and refuse.

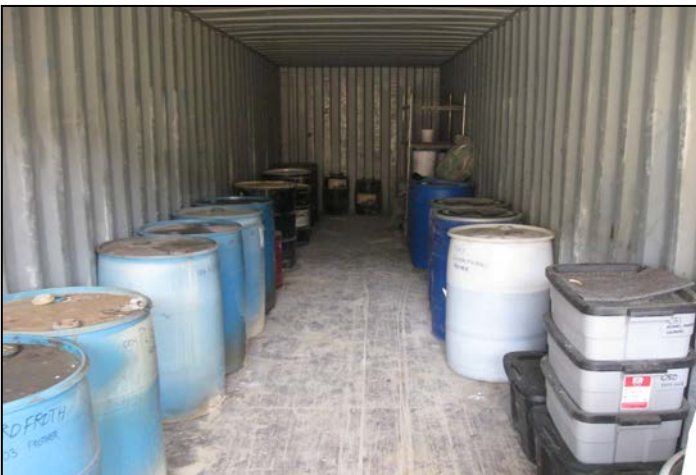
5. Conex used to store reagents.
