**MINERALS PROGRAM INSPECTION REPORT**  
**PHONE: (303) 866-3567**

<b>MINE NAME:</b> Currier Gravel Pit	<b>MINE/PROSPECTING ID#:</b> M-1980-203	<b>MINERAL:</b> Sand and gravel	<b>COUNTY:</b> Mesa
<b>INSPECTION TYPE:</b> Monitoring	<b>INSPECTOR(S):</b> Amy C. Yeldell	<b>INSP. DATE:</b> May 3, 2018	<b>INSP. TIME:</b> 08:15
<b>OPERATOR:</b> Currier Gravel Pit, Inc.	<b>OPERATOR REPRESENTATIVE:</b> George Currier	<b>TYPE OF OPERATION:</b> 110c - Construction Limited Impact	
<b>REASON FOR INSPECTION:</b> Normal I&E Program	<b>BOND CALCULATION TYPE:</b> None	<b>BOND AMOUNT:</b> \$15,879.98	
<b>DATE OF COMPLAINT:</b> NA	<b>POST INSP. CONTACTS:</b>	<b>JOINT INSP. AGENCY:</b> U.S.BLM	
<b>WEATHER:</b> Snowing	<b>INSPECTOR'S SIGNATURE:</b>

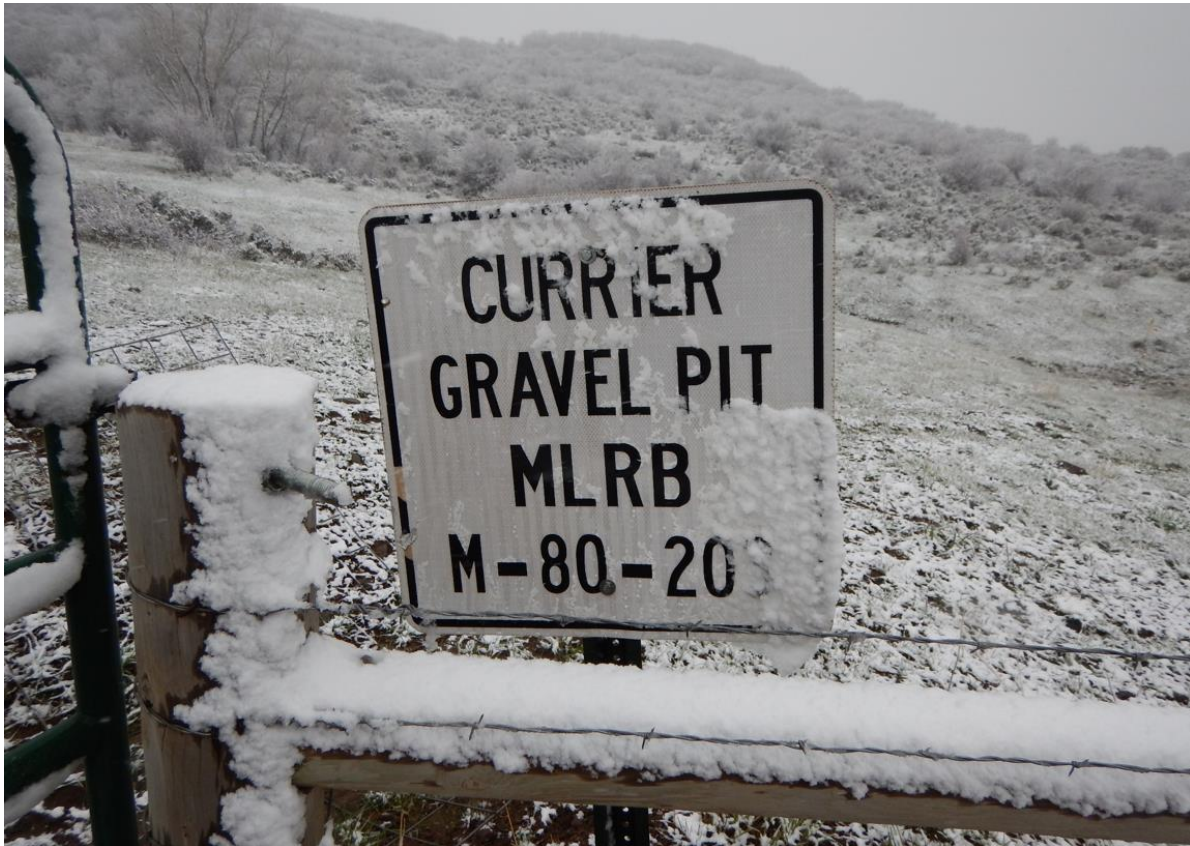
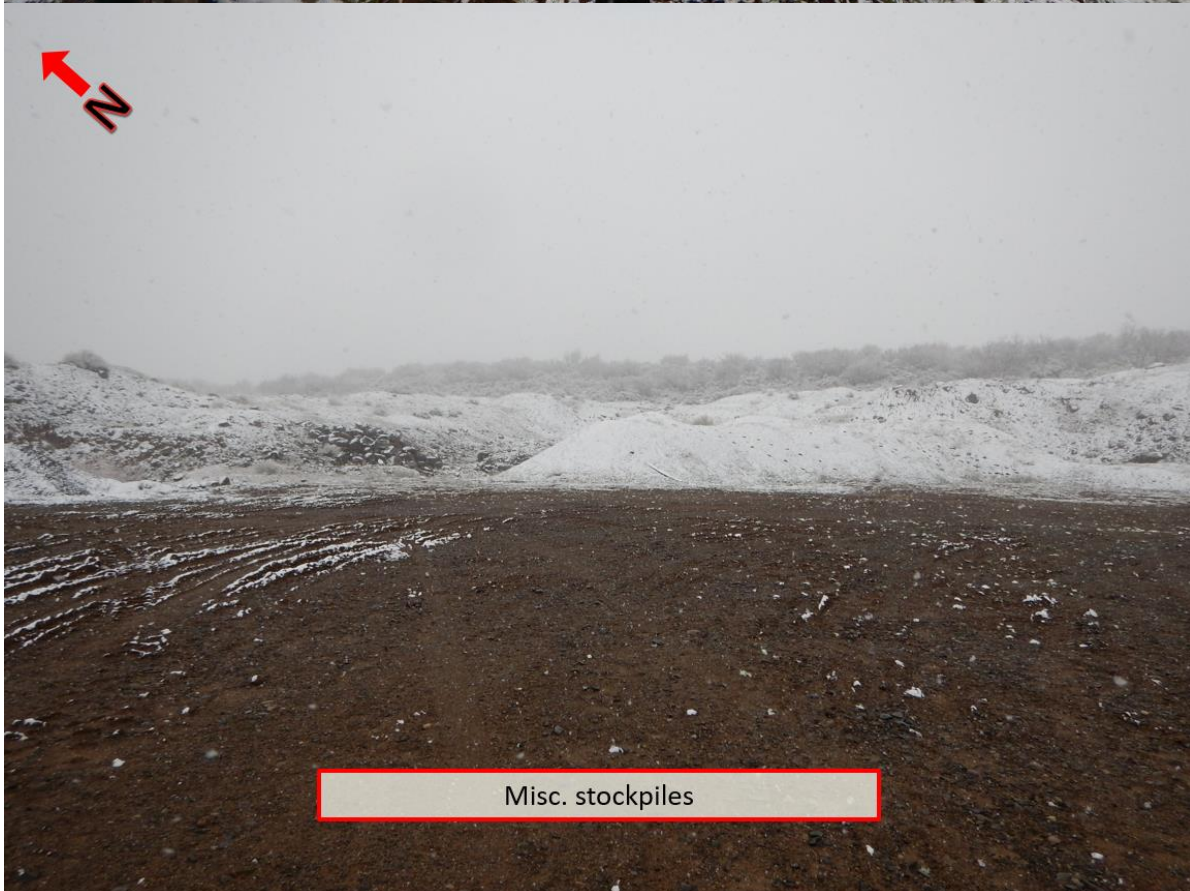
There were several stockpile of various material types neatly stored on site. A loader was on site to help load trucks out of existing stockpiles. No other equipment, fuel or buildings were present. There is an existing highwall along the northern permit boundary that is at a 1:1 slope and will need to be graded prior to reclamation.

Misc. stockpiles

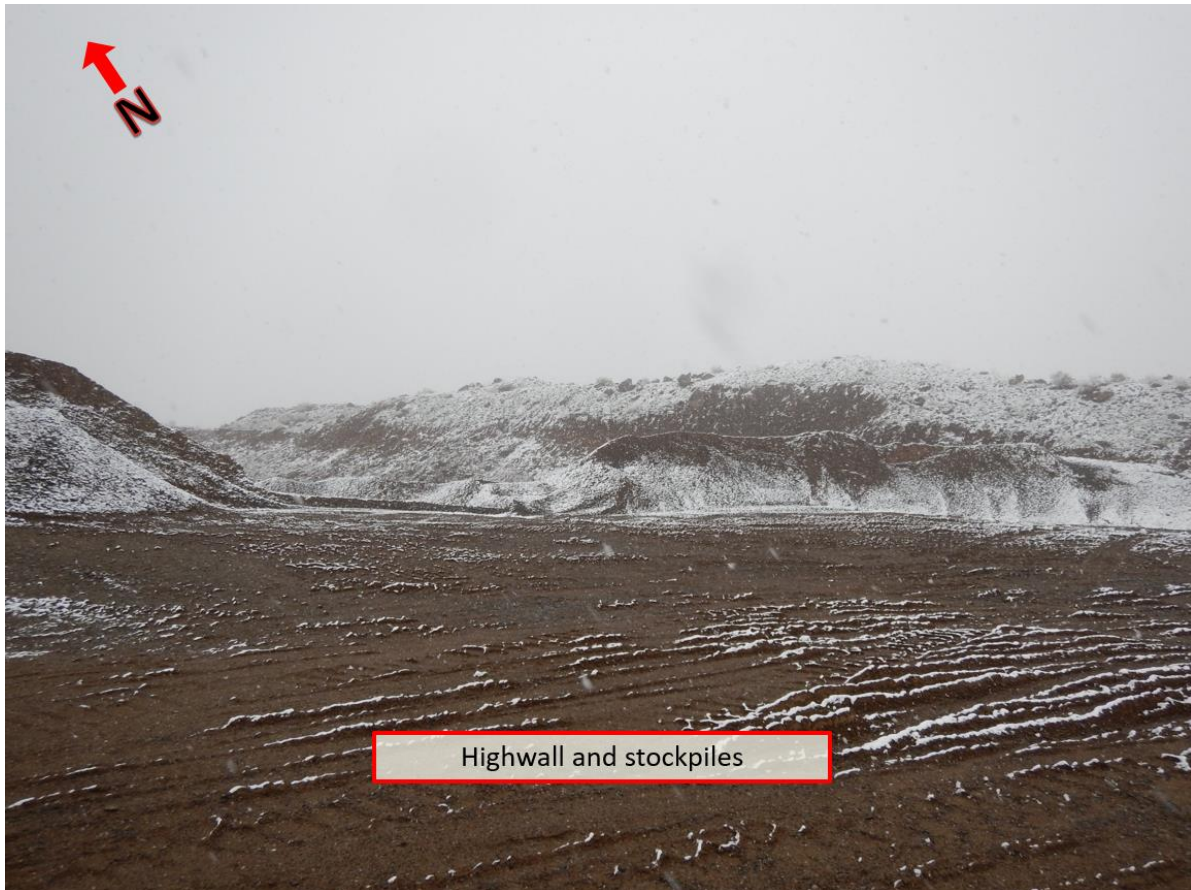
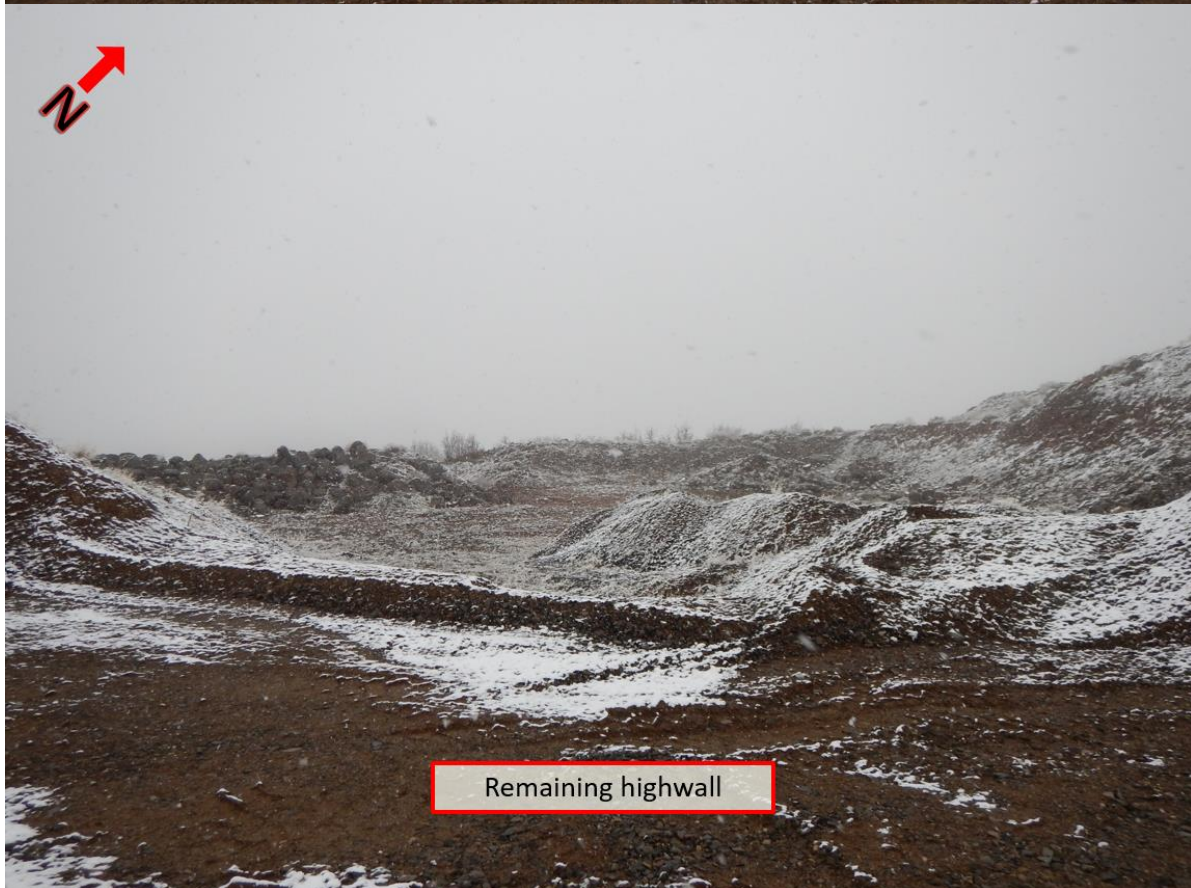
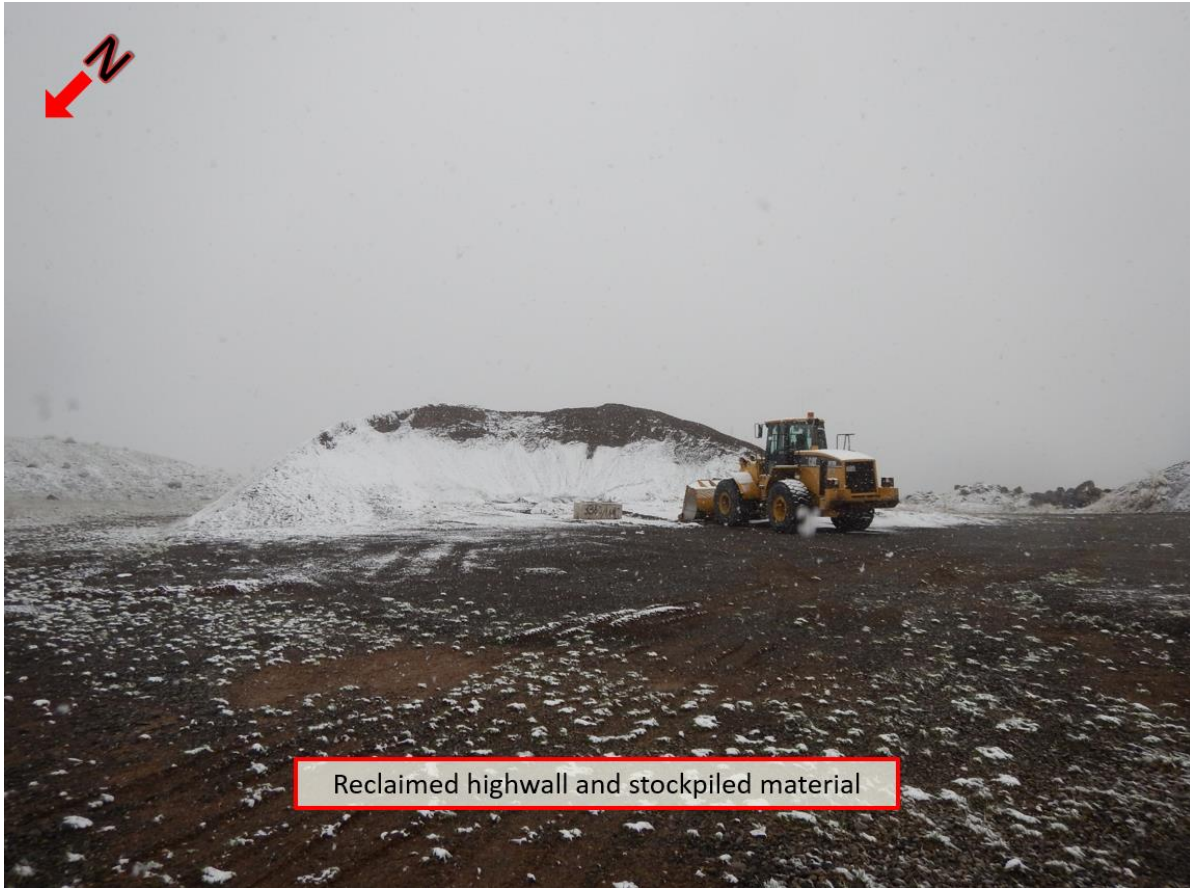
The entire 9 acre permit has been affected to date. The south and east highwalls have been completely regarded and seeded. Given the time of the inspection and the weather conditions staff was unable to evaluate reclamation success. However based on the presents of green foliage it is likely that a portion of the permit could be released since reclamation was done 4-5 years ago.

Reclaimed highwall and stockpiled material

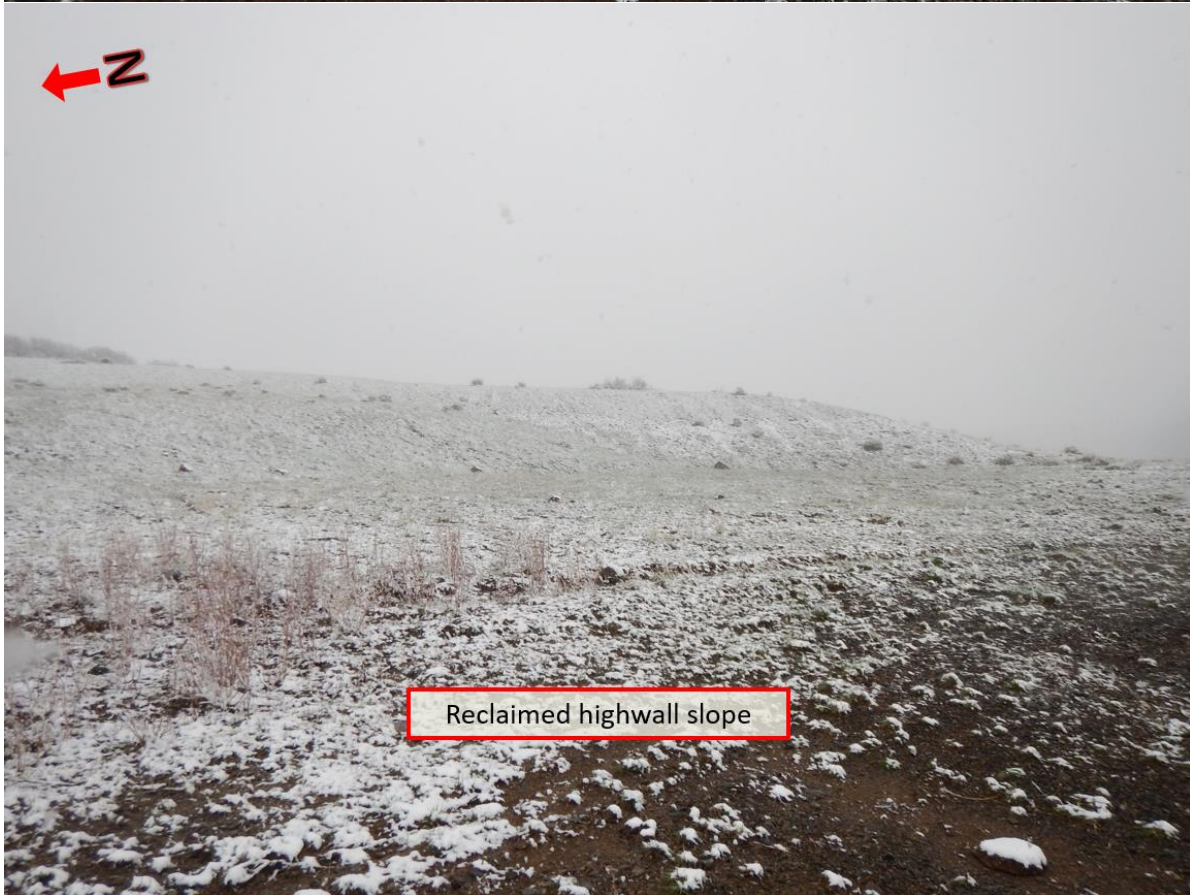
Reclaimed highwall slope
