MINERALS PROGRAM INSPECTION REPORT
PHONE: (303) 866-3567

MINE NAME: San Luis Project	MINE/PROSPECTING ID#: M-1988-112	MINERAL: Gold and silver	COUNTY: Costilla
INSPECTION TYPE: Monitoring	INSPECTOR(S): Lucas J. West	INSP. DATE: April 25, 2018	INSP. TIME: 13:45
OPERATOR: Battle Mountain Resources, Inc.	OPERATOR REPRESENTATIVE: Julio Madrid, Steve Carino, Melissa Chalona	TYPE OF OPERATION: 112d-3 - Designated Mining Operation	
REASON FOR INSPECTION: Normal I&E Program	BOND CALCULATION TYPE: None	BOND AMOUNT: \$7,400,000.00	
DATE OF COMPLAINT: NA	POST INSP. CONTACTS: None	JOINT INSP. AGENCY: None	
WEATHER: Clear	INSPECTOR'S SIGNATURE:

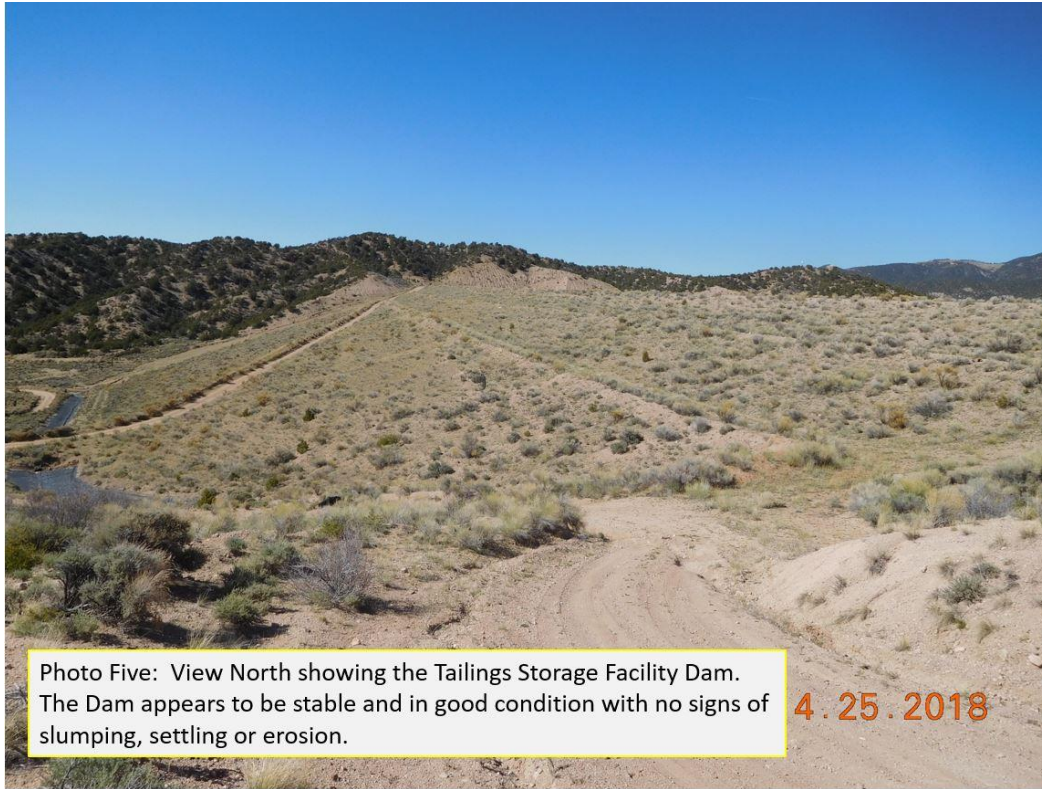
Several other areas in the Permit Area were observed during the inspection as well. The Tailings Storage Facility as well as the Tailings Dam appears to be in good condition and can be seen in Photo Five. No signs of seepage or erosion were noted on the face of the Tailings Dam after the winter snow melt. On site discussions indicate that the Operator would like to change the water and brine delivery system from a center pivot sprinkler system to an on ground gated pipe system. After further consideration and discussion the Division believes that an on ground gated pipe system would not provide sufficient evaporation of the Tailings Water. Other upgraded systems could be investigated, but the on-ground systems will not be approved. Any change to the water and brine delivery system should be addressed through the Technical Revision Process.
