**MINERALS PROGRAM INSPECTION REPORT**  
**PHONE: (303) 866-3567**

<b>MINE NAME:</b> Lamar East Pit	<b>MINE/PROSPECTING ID#:</b> M-1977-572	<b>MINERAL:</b> Sand and gravel	<b>COUNTY:</b> Prowers
<b>INSPECTION TYPE:</b> Monitoring	<b>INSPECTOR(S):</b> Amy Eschberger	<b>INSP. DATE:</b> November 27, 2017	<b>INSP. TIME:</b> 13:45
<b>OPERATOR:</b> City of Lamar	<b>OPERATOR REPRESENTATIVE:</b> John Sutherland, Jr. and Rick Ackers	<b>TYPE OF OPERATION:</b> 112c - Construction Regular Operation	
<b>REASON FOR INSPECTION:</b> Normal I&E Program	<b>BOND CALCULATION TYPE:</b> None	<b>BOND AMOUNT:</b> NA	
<b>DATE OF COMPLAINT:</b> NA	<b>POST INSP. CONTACTS:</b> None	<b>JOINT INSP. AGENCY:</b> None	
<b>WEATHER:</b> Clear	<b>INSPECTOR'S SIGNATURE:</b>

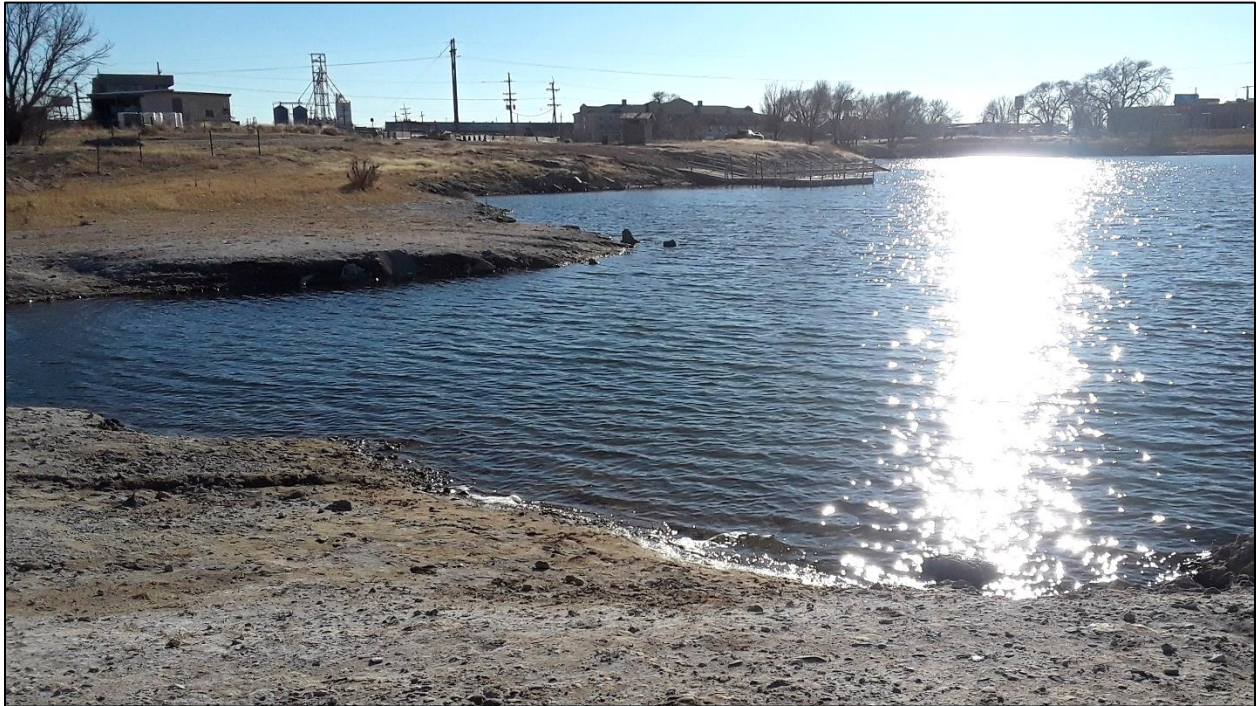
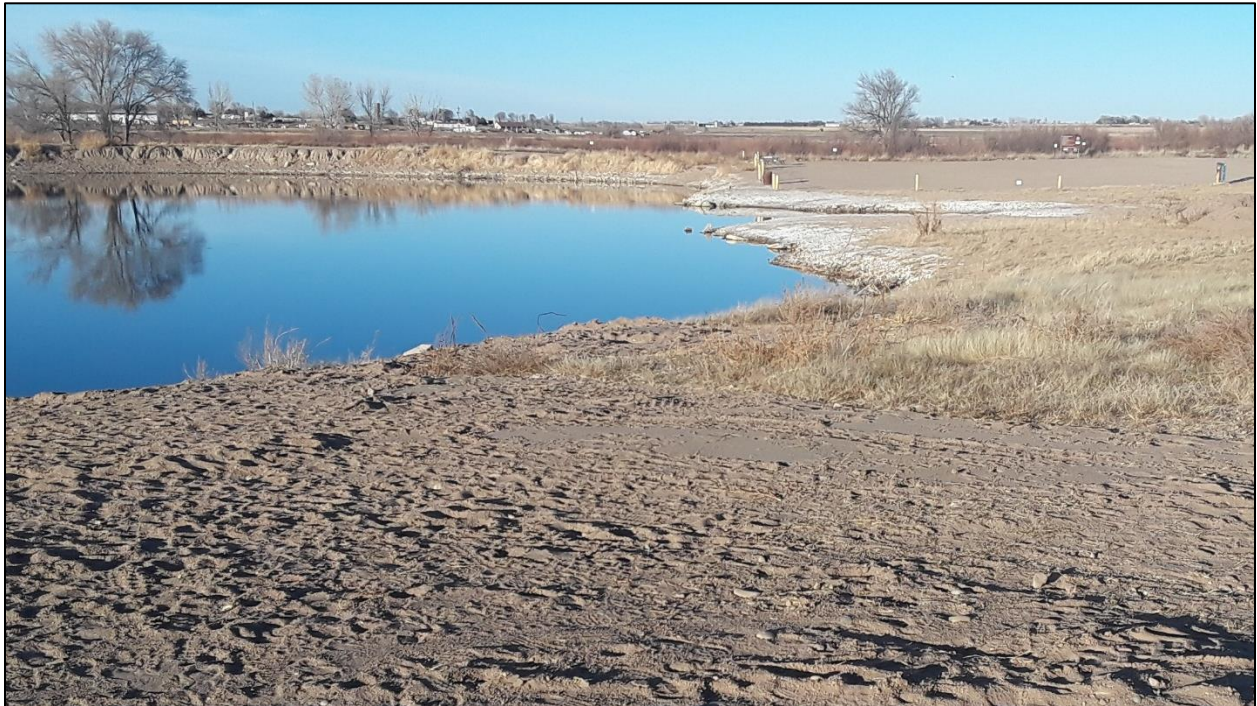
**Photo 1.** View looking southwest from eastern edge of western pond. Pond shorelines have been graded to 3H:1V or flatter.

**Photo 2.** View looking north from eastern edge of western pond. Pond shorelines have been graded to 3H:1V or flatter.

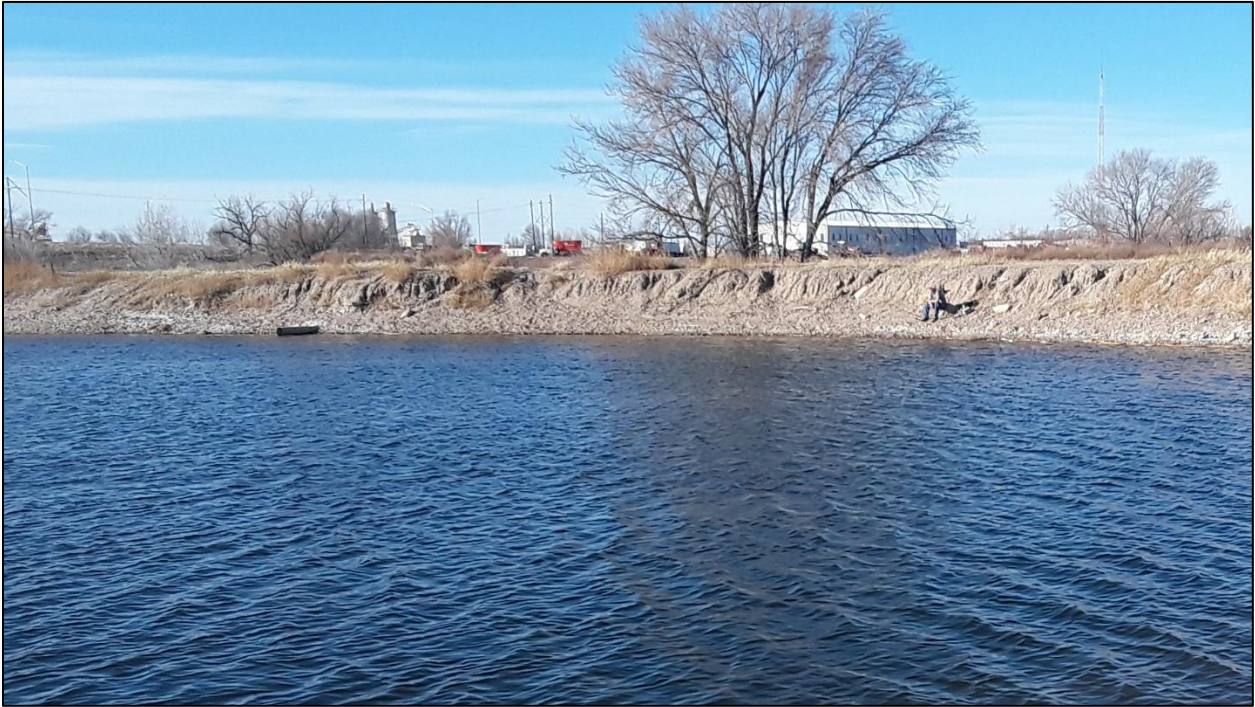
The required reclamation grading has been completed at the site, with all disturbed land, including pond shorelines, graded to 3H:1V or flatter. However, the Division did observe some erosional damage present along a portion of the northern shoreline of the western pond (**Photo 3**). This erosion was noted in the Division's last inspection report from June 28, 2013. The operator indicated it has been difficult to repair the erosional damage given the limited access to the area for trucks and equipment. The northern shoreline of the western pond consists of a berm separating the pond from the Arkansas River, which is within 50 feet of the pond edge. The top of the berm is approximately 15-20 feet in width. The Division understands the operator's concerns about accessing the area, with the limited amount of space available. However, pursuant to Rule 3.1.5(3), all grading shall be done in a manner to control erosion and siltation of the affected lands, to protect areas outside the affected land from slides and other damage. If the erosion continues, the stability of the berm may be

**Photo 3.** View looking northwest from eastern edge of western pond, showing erosion damage present on northern shoreline/berm.

compromised. Given the additional importance of the berm in flood mitigation for the site, efforts to maintain its stability should be a priority. Therefore, the Division recommends the operator find a way to repair and control the erosion along the northern shoreline of the western pond in accordance with Rule 3.1.5(3). If the erosion along the northern shoreline of the western pond has not been addressed by the next site inspection, a problem will be cited for this issue. Additionally, the operator should work to revegetate this shoreline, as its current lack of vegetative cover is most likely contributing to the erosion problem. Areas around the western pond are far less vegetated than the rest of the permit area. Part of this is due to the road, parking lots, and other park features present around the western pond. However, the northern shoreline/berm has very little vegetative cover at all.

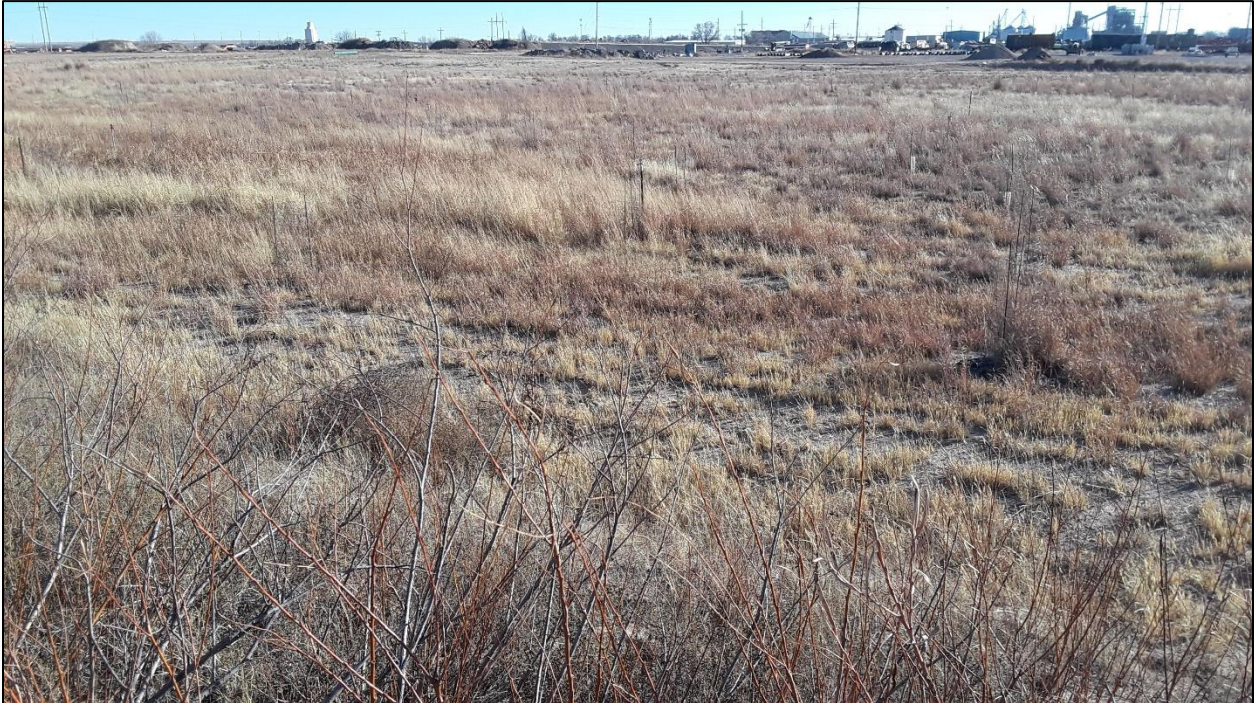
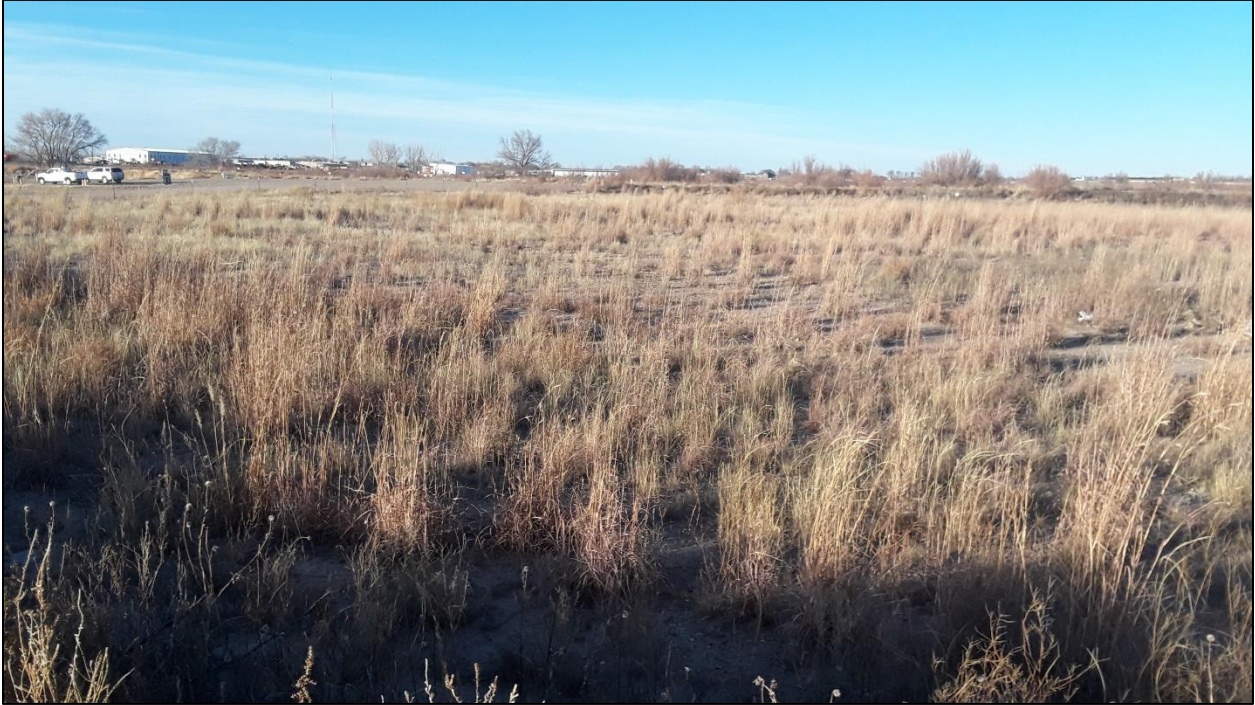
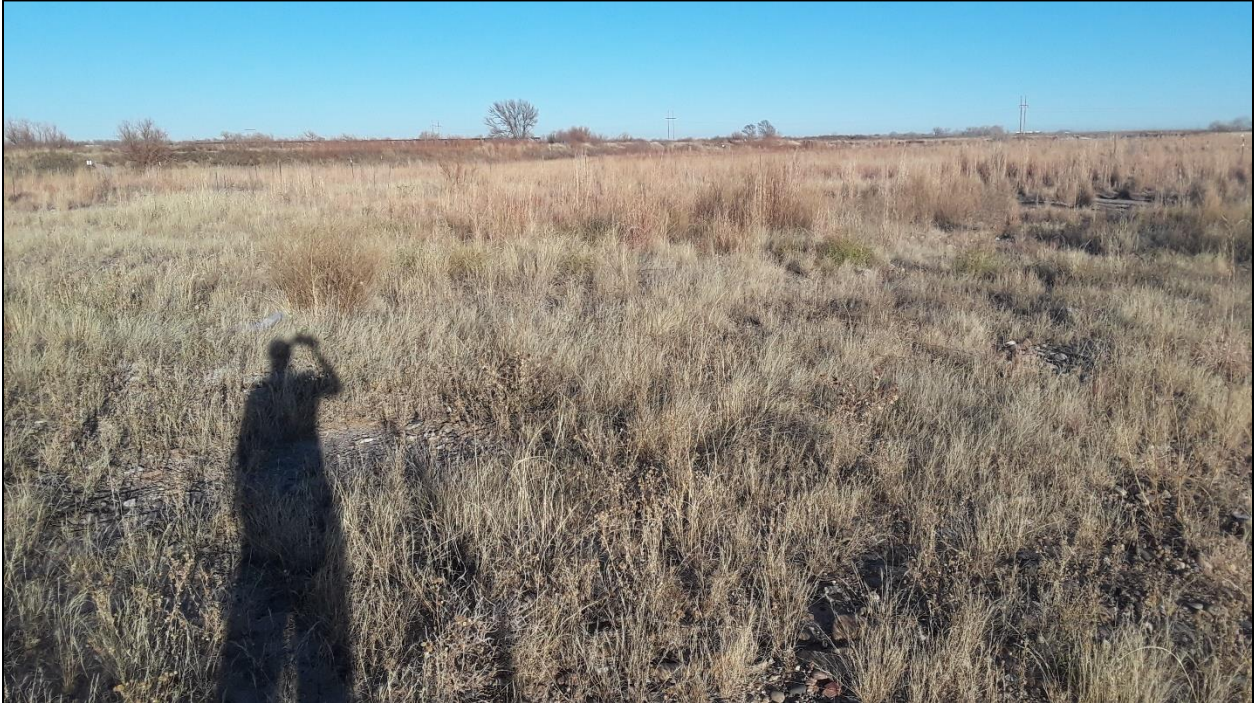
The Division observed the area between the western pond and middle pond, which was backfilled to a relatively flat surface and seeded in 2012. The Division estimates this area to be approximately 7.55 acres in size. Revegetation of this area has been very successful, with a diverse stand of grasses and forbs having established in the area (**Photos 4-6**). The area was irrigated in spring of 2014 after a planting project was conducted in conjunction with CPW and Lamar Parks and Recreation, during which almost 200 trees were planted in the area by students from Lamar schools. Unfortunately, many of the planted trees did not survive. However, the trees are not required by the approved reclamation plan. The approved revegetation plan (last revised in 2012 with Technical Revision No. 3) includes a mixture of native grasses recommended by NRCS and Habitat Construction, LLC, specifically for the sandy soils present at the site. The Division believes this portion of the site has been reclaimed in accordance with the approved reclamation plan.

**Photo 4.** View looking southeast across reclaimed area between western and middle ponds, showing establishment of diverse stand of grasses.

**Photo 5.** View looking north across reclaimed area between western and middle ponds, showing establishment of diverse stand of grasses.

**Photo 6.** View looking east across reclaimed area between western and middle ponds, showing establishment of diverse stand of grasses.

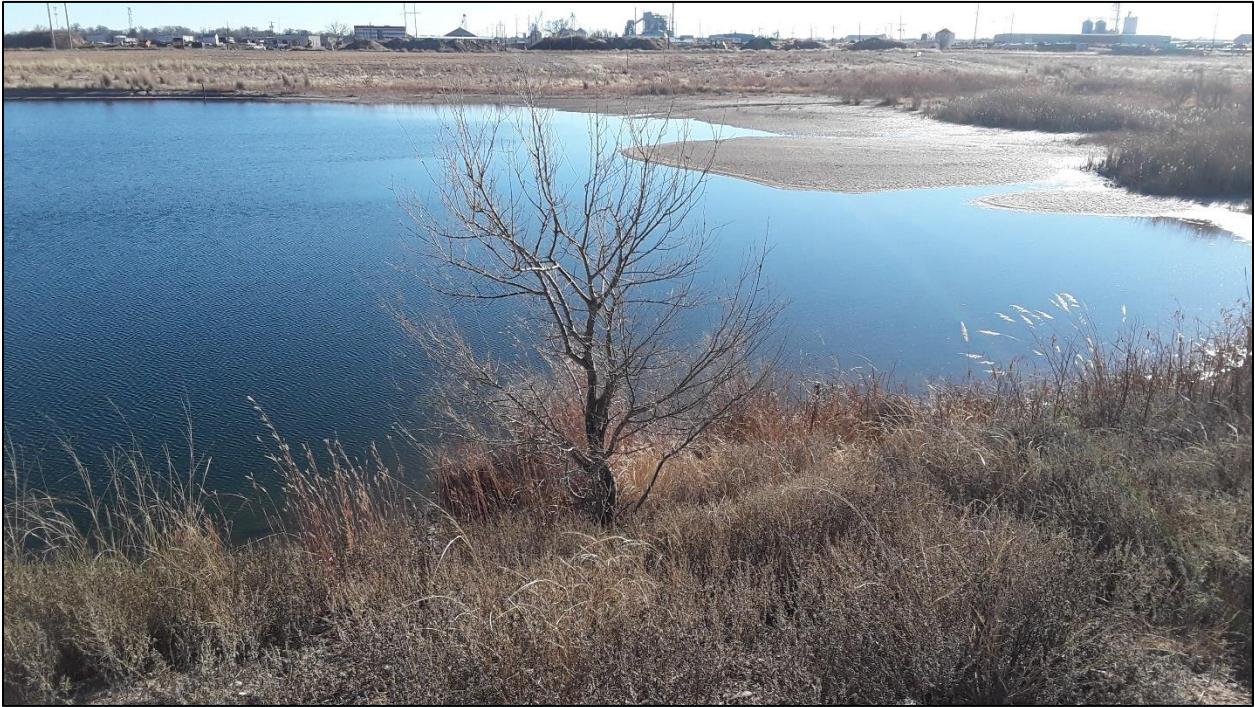
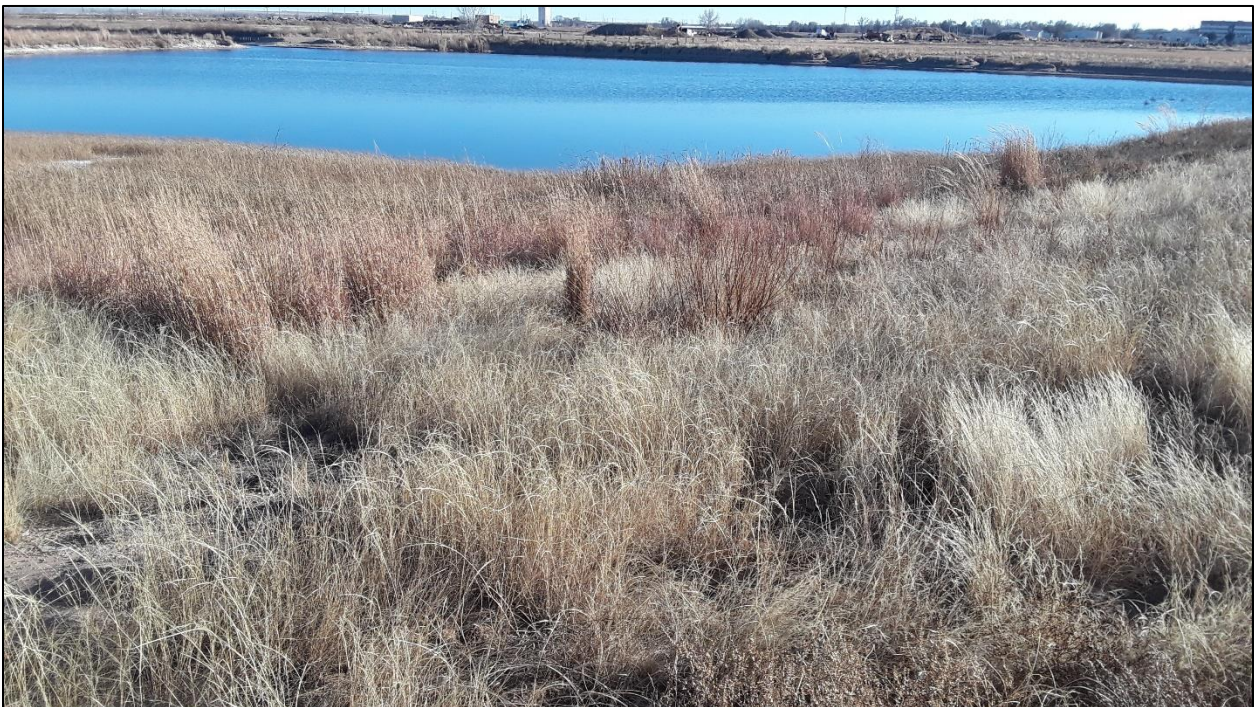
**Photo 7.** View looking southwest from north of middle pond, showing establishment of diverse stand of grasses along northern shoreline.

**Photo 8.** View looking south from north of middle pond, showing establishment of diverse stand of grasses along northern shoreline.

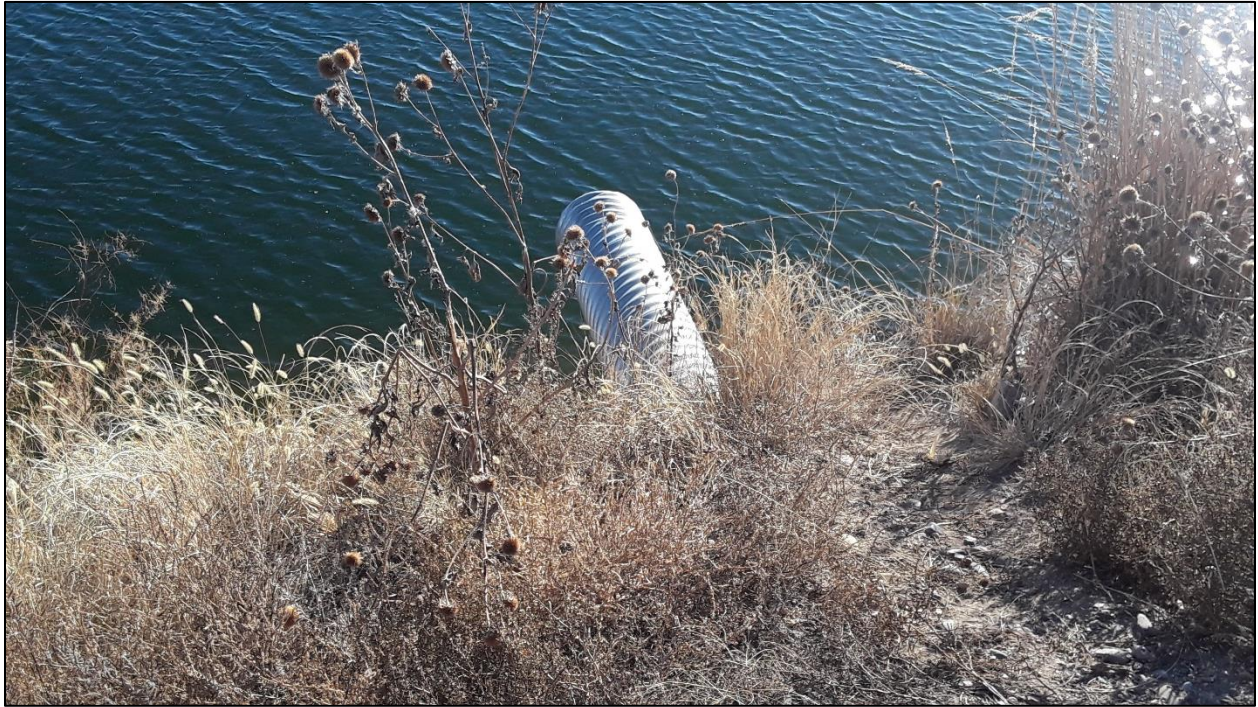
The Division observed the northern shoreline of the middle pond to also have a diverse stand of native grasses and forbs established across the slopes (**Photos 7 and 8**). The Division observed the end of the 18 inch overflow pipe installed in the berm connecting the middle pond to the Arkansas River (**Photo 9**). This pipe was installed as part of the flood mitigation plan for the site, approved in 2012 under Technical Revision No. 2. The bottom edge of the pipe appeared to be approximately 2 feet from the pond water surface. An overflow pipe was installed at each of the ponds to help control pond levels during high water conditions. The pipe diameters vary from 12 inches at the western pond, to 18 inches at the middle pond, to 24 inches at the eastern pond.

**Photo 9.** View of 18 inch overflow pipe installed in berm that separates middle pond from the Arkansas River. Installation of the pipe was part of the flood mitigation plan approved for the site. Edge of pipe was approximately 2 feet from pond water surface.

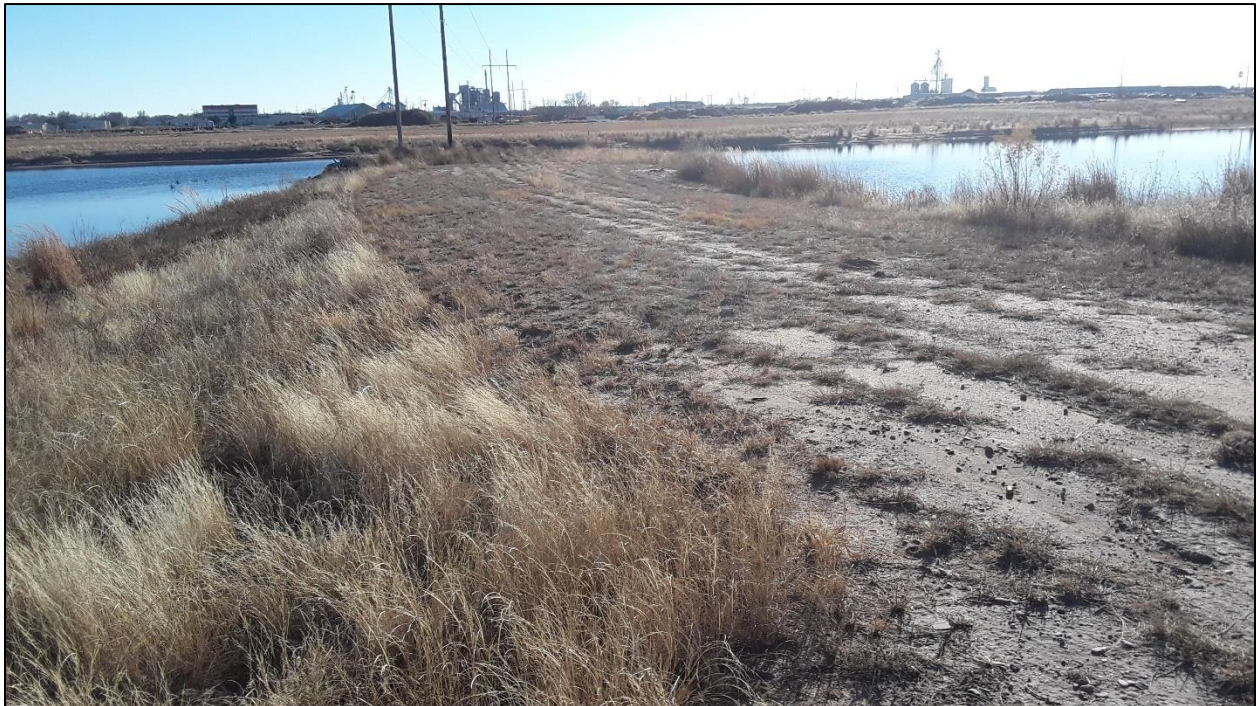
The Division observed the peninsula along the northern shoreline of the middle pond (**Photo 10**). A pair of power line distribution poles are present at the edge of the peninsula. The peninsula was well vegetated with grasses, forbs, and some annual weeds, with the middle section mowed for utility access to the power line poles. The Division observed that concrete rubble had been placed along the edge of the peninsula (**Photo 11**) in efforts to stabilize the slope against further erosion which could impact the stability of the power line poles. This may not be an effective long-term solution for the slope erosion occurring at this location. The Division recommends the operator continue to monitor the area, and revise the stabilization plan as needed.

**Photo 10.** View looking south across peninsula in northern shoreline of middle pond. A pair of power line distribution poles are present at the edge of the peninsula. The operator keeps the peninsula mowed for utility access.

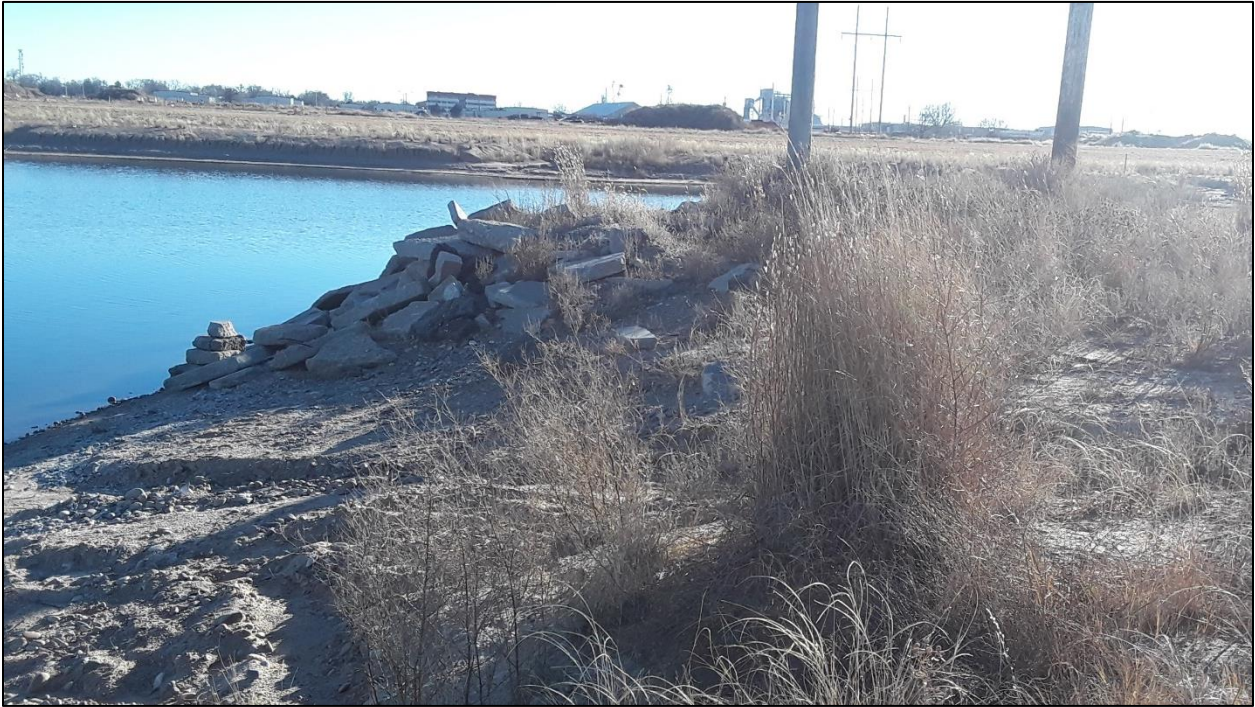
**Photo 11.** View looking south, showing concrete rubble operator has placed at edge of peninsula on northern shoreline of middle pond to help stabilize the slope against further erosion. This may not be an effective long-term solution.

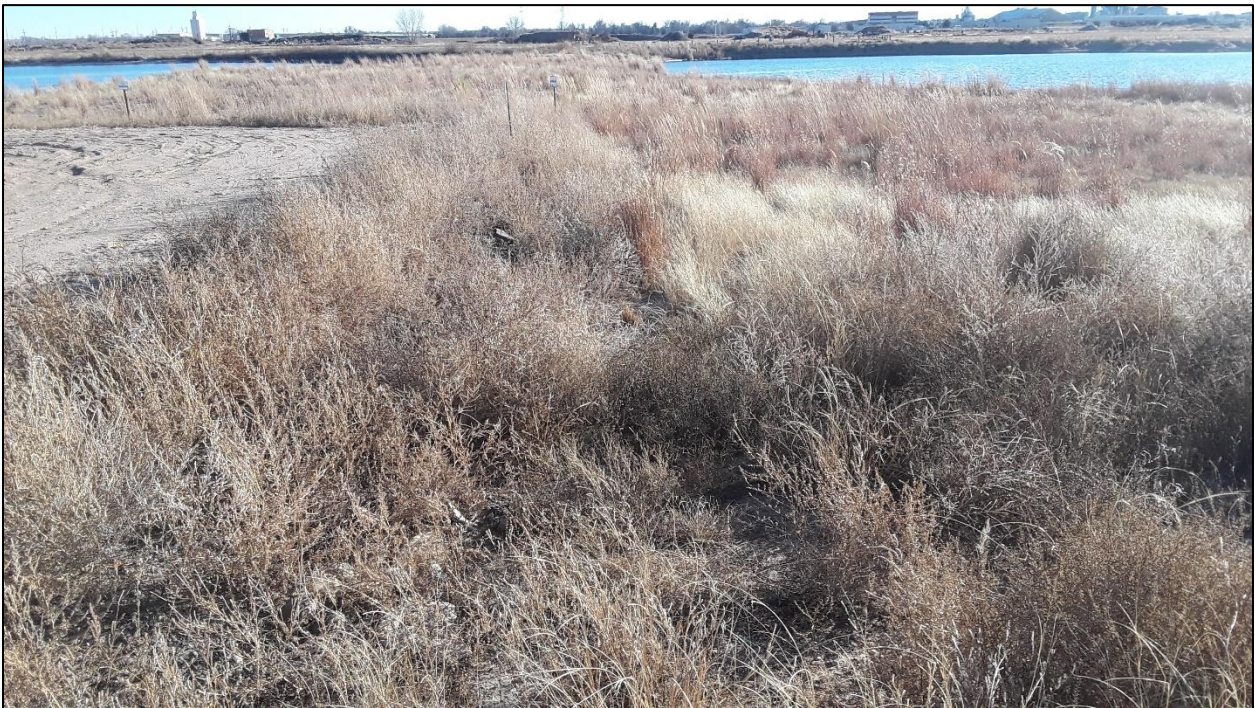
The Division observed the land separating the middle and eastern ponds, north of the channel (**Photo 12**). This area was well vegetated with a diverse stand of grasses and forbs, with some annual weeds also present. A small gravel parking lot has been constructed at the northern edge of this area. The northern shoreline of the eastern

**Photo 12.** View looking south across land between middle and eastern ponds. Note the diverse stand of grasses established across the area. Corner of parking lot is present at left.

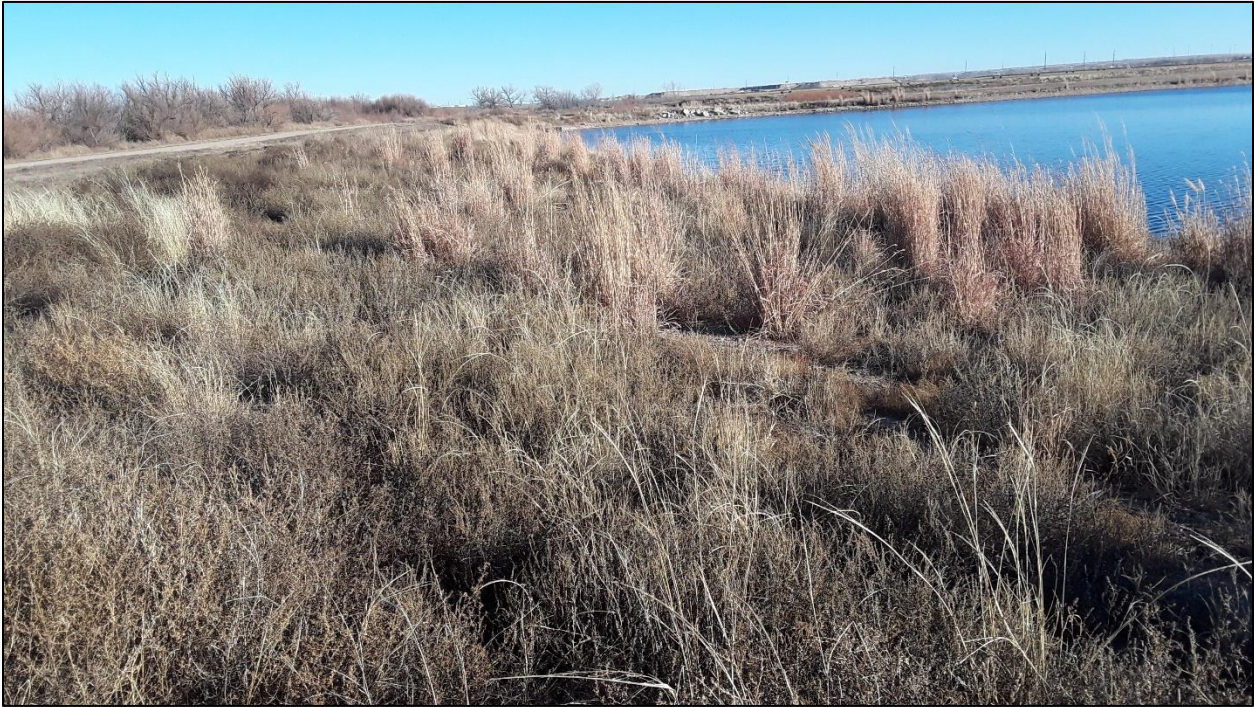
**Photo 13.** View looking east across northern shoreline of eastern pond, showing well established grasses along this shoreline.

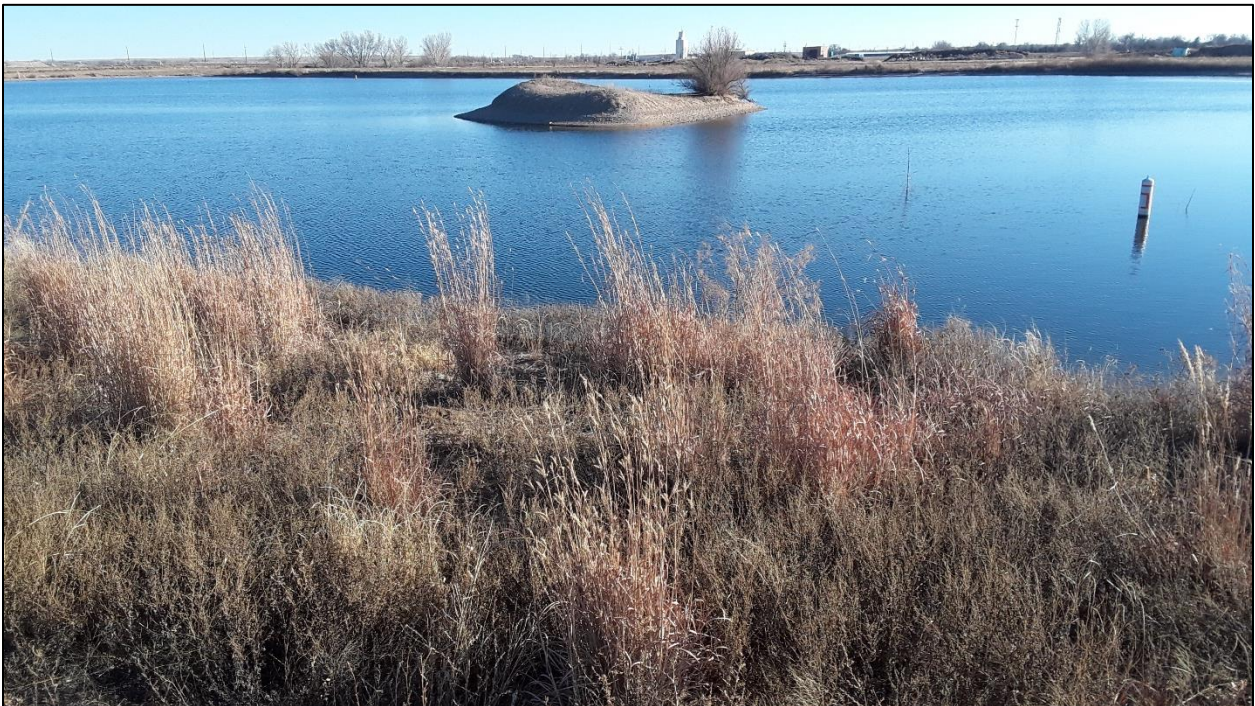
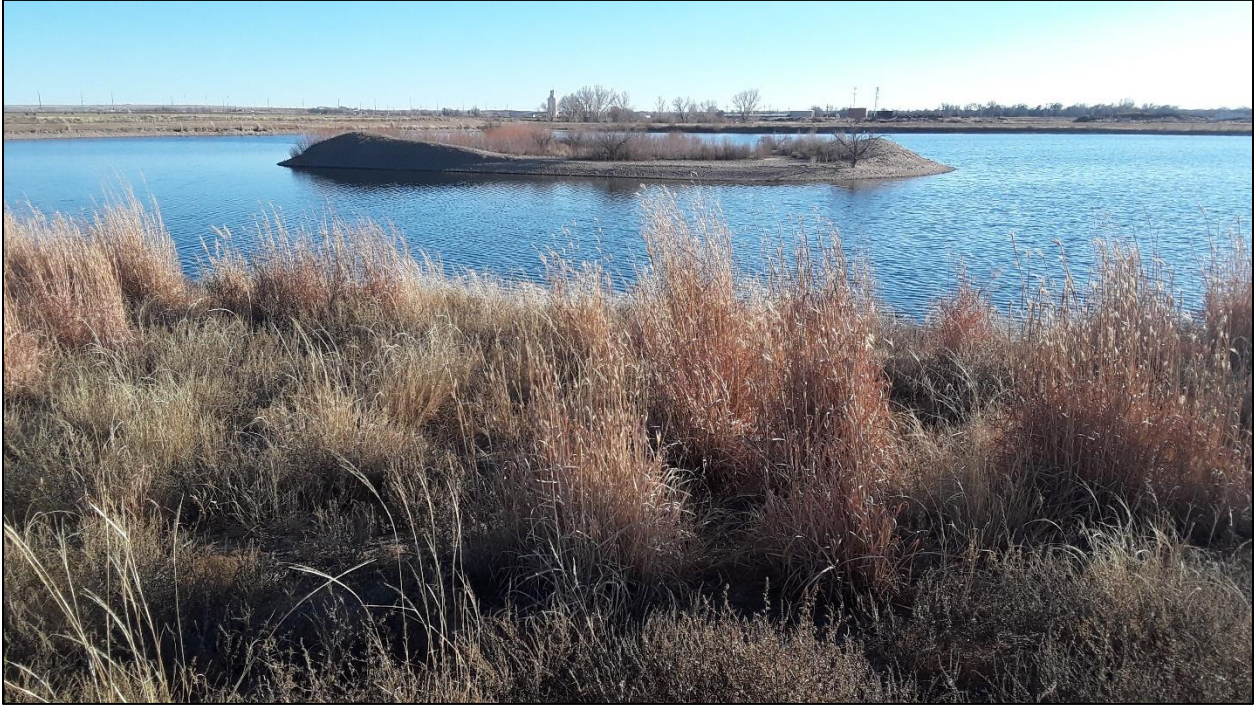
**Photo 14.** View looking south from northern shoreline of eastern pond, showing smaller of two islands present in this pond. Vegetation present on the island appeared to consist mainly of weeds.

**Photo 15.** View looking south from northern shoreline of eastern pond, showing larger of two islands present in this pond. Vegetation present on the island appeared to consist mainly of weeds.

pond was also well vegetated with native grasses (**Photo 13**). Two islands are present in the northern portion of the eastern pond (**Photos 14 and 15**), with a combined land surface of 0.54 acre. From the shoreline, it appeared that vegetative cover of the islands consists mainly of weeds. The Division recommends the operator implement the approved weed control plan on the islands, as they too are considered affected lands within the permit area.

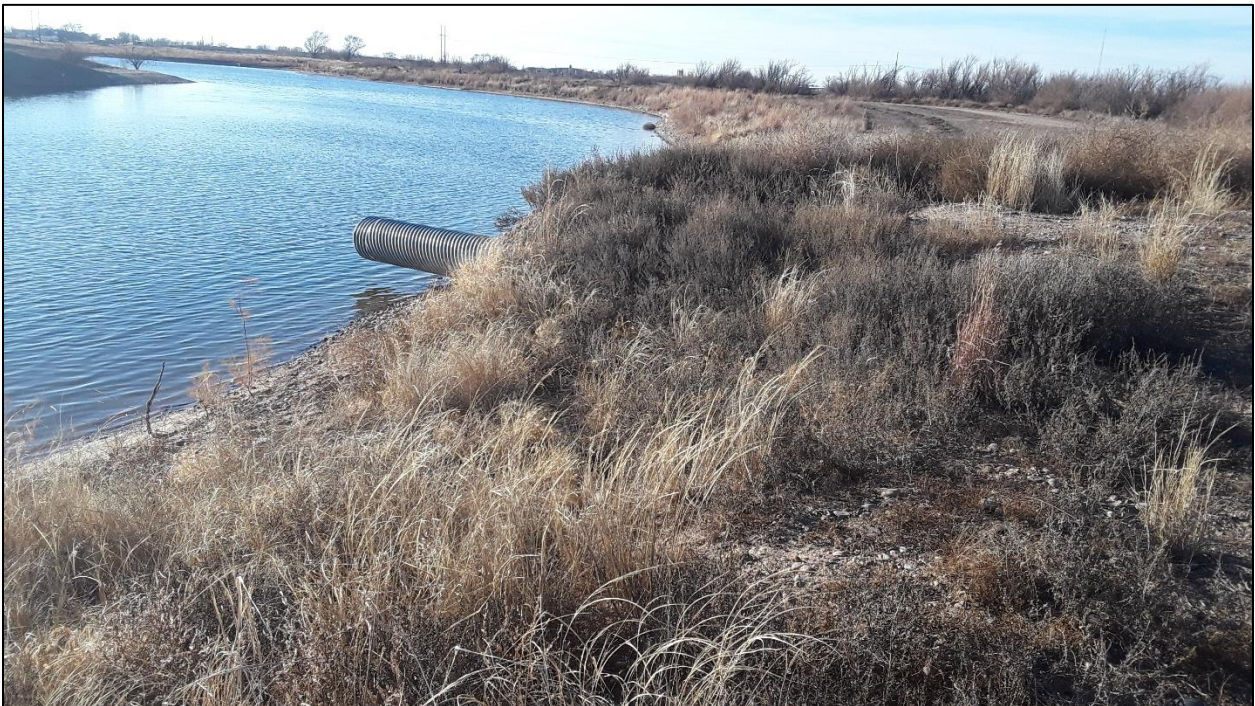
The Division observed the edge of the 24 inch overflow pipe installed in the berm separating the eastern pond from the river (**Photo 16**). The bottom edge of the pipe appeared to be approximately 1.5 feet from the pond water surface. The Division observed a well-established stand of grasses along the edge of the eastern shoreline of the eastern pond (**Photo 17**). The city mows the strip of land between the eastern pond and the gravel road (**Photos 18 and 19**). Vegetative cover across this area consists mainly of native grasses. The southern shoreline of the eastern pond was fairly well vegetated with newer grass growth than what is present along the northern shoreline (**Photos 20-25**). According to the operator, the southern and eastern shorelines of the middle and eastern ponds had experienced less revegetation success from the initial seeding completed by the previous operator in 2012. Therefore, in early summer of 2014, the city imported 6,000 tons of clean topsoil to the site and spread it across these areas. In early fall of 2014, the city reseeded these areas. The city's water department ran city water to the area from the east side, installing three fire hydrants along the southern shoreline for irrigation purposes. It is unclear how often the areas were irrigated, but the results show significant grass germination and growth along much of the southern shorelines. There are some minor patchy areas where grasses are less prevalent (**Photos 26-30**), particularly along the southeastern edge of the eastern pond, and the vegetation is less diverse than observed in other revegetated areas on site. However, overall, vegetation of the southern shorelines is off to a great start, especially west of the parking lot located between the two ponds. The Division recommends the operator continue to monitor revegetation success along the southern shorelines of the eastern ponds, and interseed and/or irrigate the area as needed.

**Photo 16.** View of 24 inch overflow pipe installed in berm that separates eastern pond from the Arkansas River. Installation of the pipe was part of the flood mitigation plan approved for the site. Edge of pipe was approximately 1.5 feet from pond water surface.

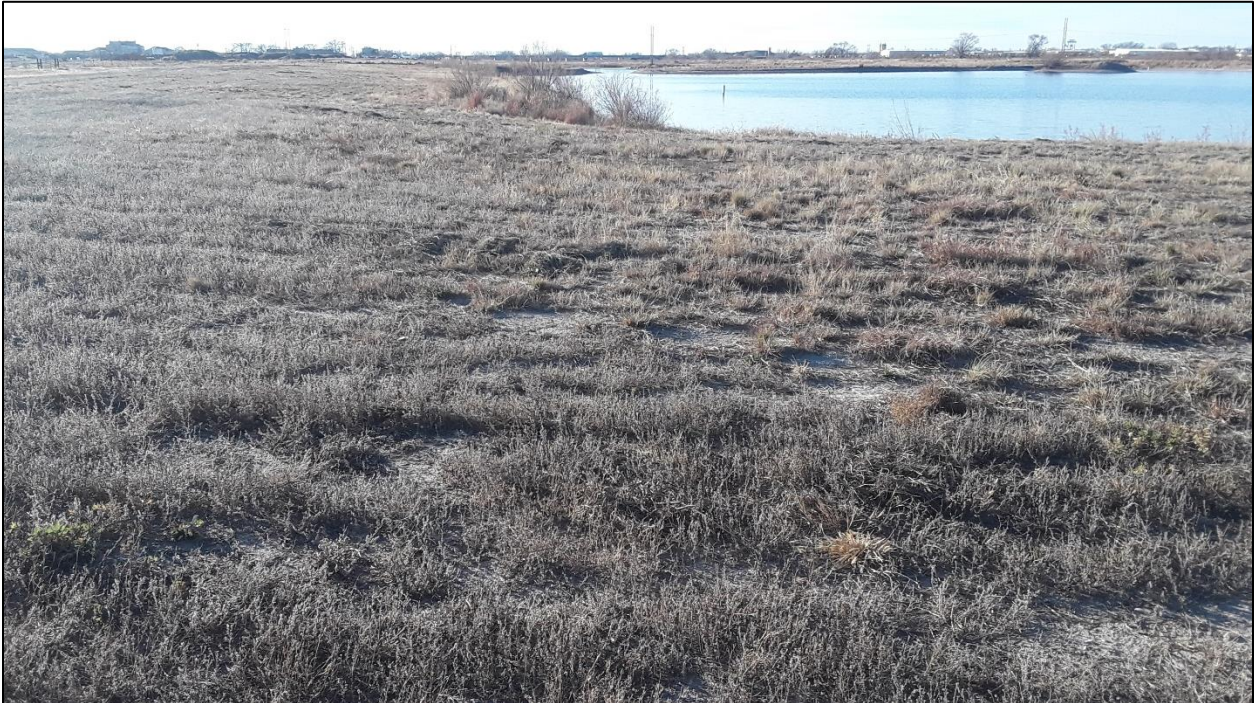
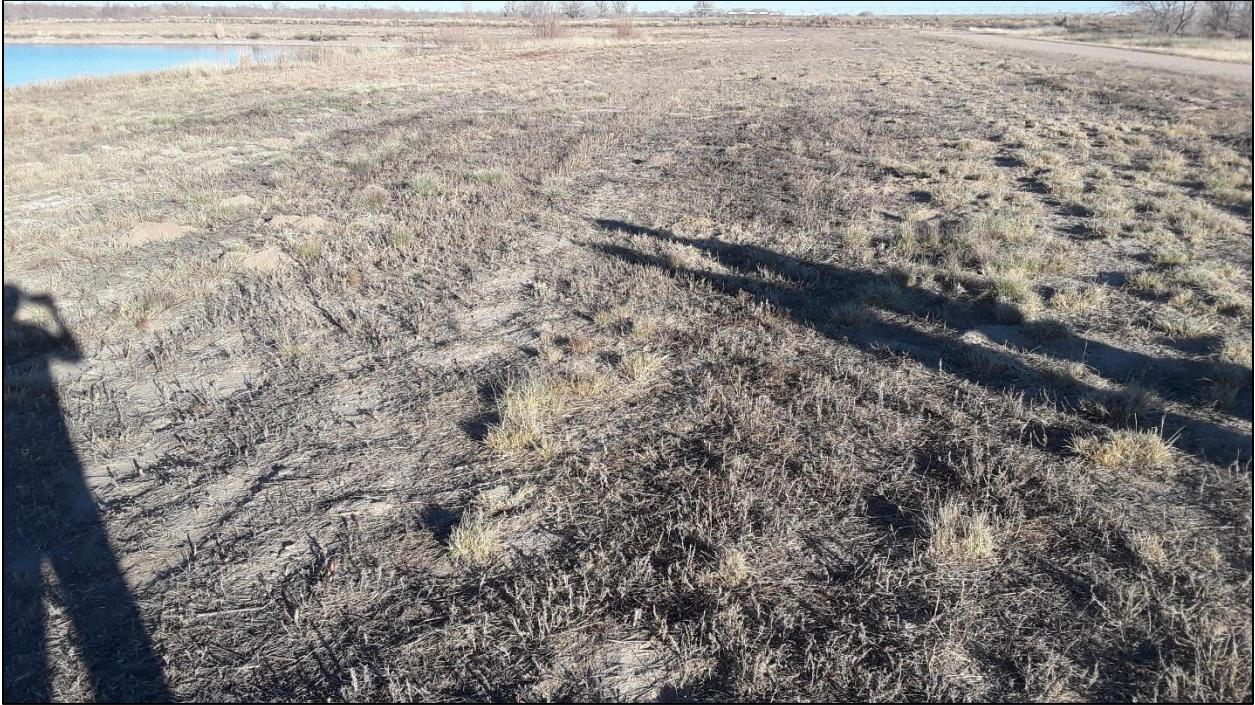
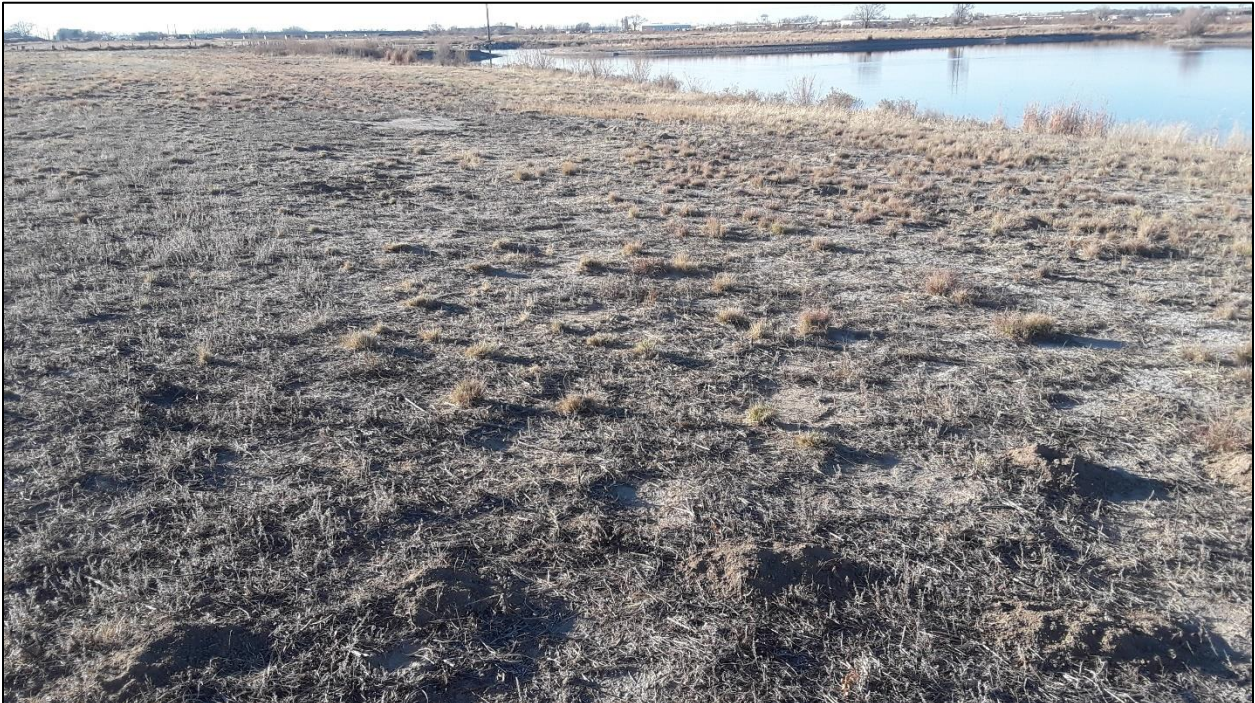
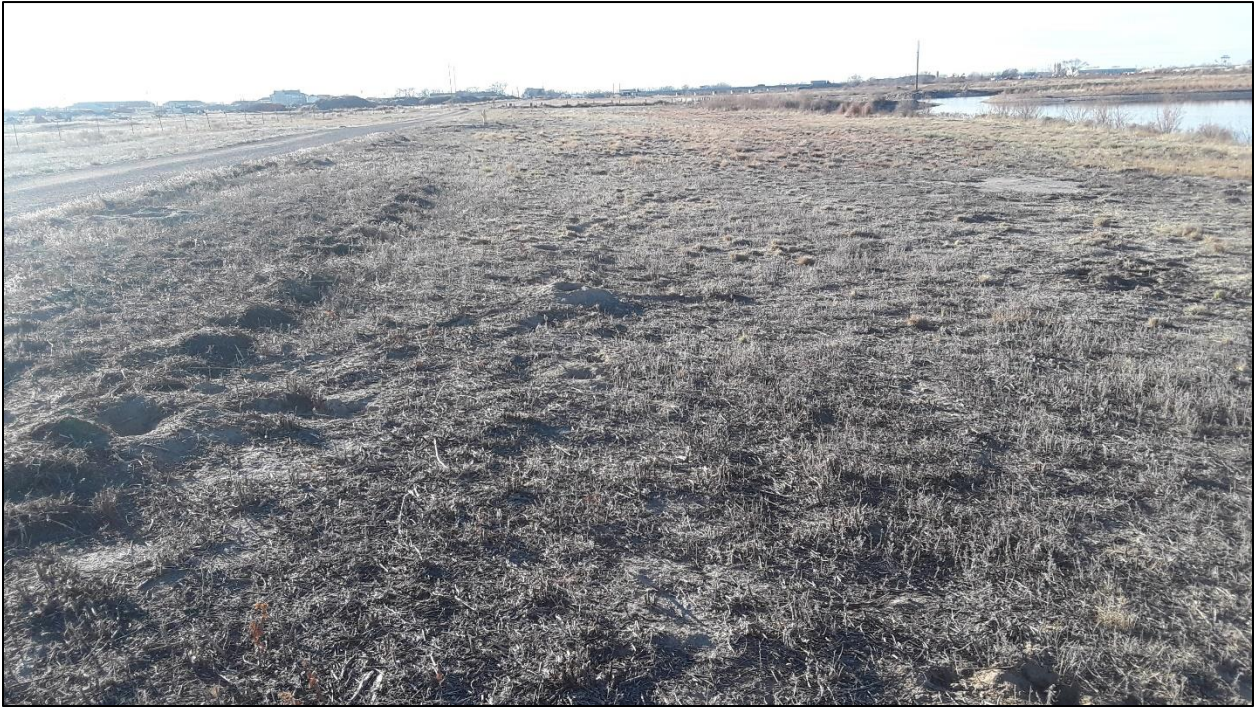
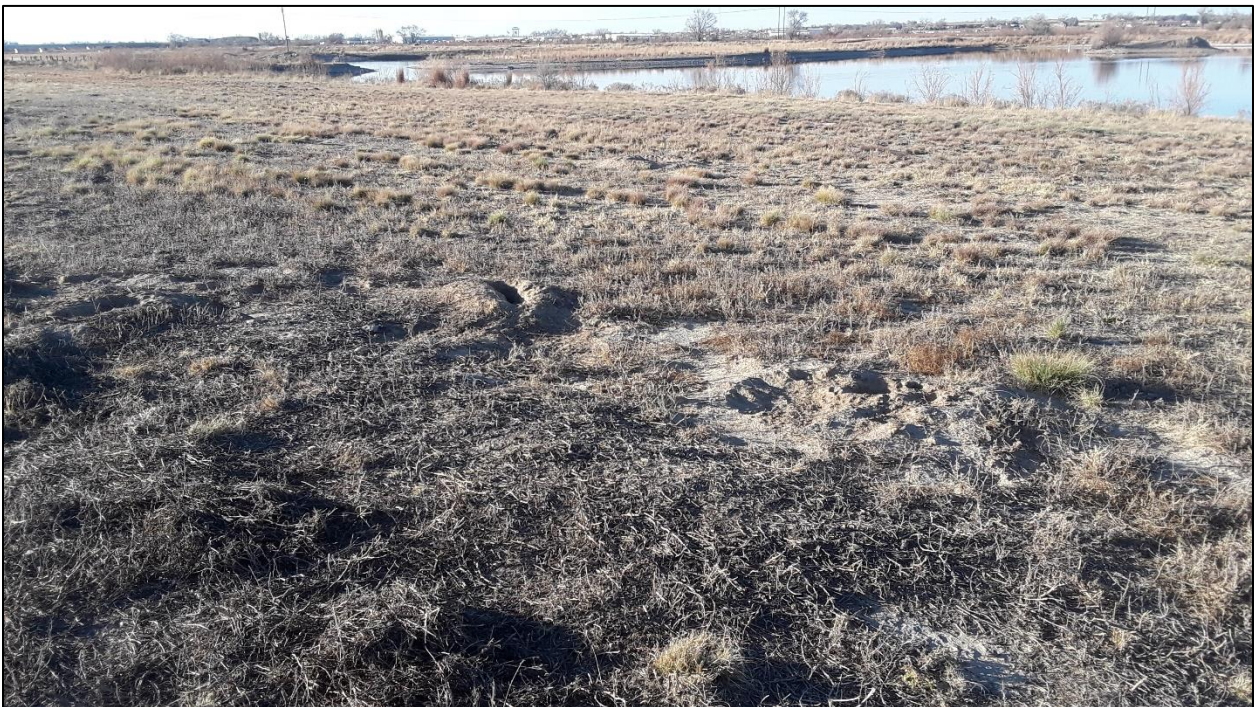
**Photo 26.** View looking west across land southeast of eastern pond, showing grasses less prevalent in some areas.

**Photo 27.** View looking east across land southeast of eastern pond, showing grasses less prevalent in some areas.

**Photo 28.** View looking west across land south of eastern pond, showing grasses less prevalent in some areas.

**Photo 29.** View looking west across land south of eastern pond, showing grasses less prevalent in some areas.

**Photo 30.** View looking northwest across land south of eastern pond, showing grasses less prevalent in some areas (foreground).
