MINERALS PROGRAM INSPECTION REPORT PHONE: (303) 866-3567

MINE NAME:		MINE/PROSPECTING ID#:	MINERAL:	COUNTY:		
May Day Idaho Mine Complex		M-1981-185	Gold and silver	La Plata		
INSPECTION TYPE:		INSPECTOR(S):	INSP. DATE:	INSP. TIME:		
Monitoring		Lucas J. West	April 27, 2018	10:30		
OPERATOR:		OPERATOR REPRESENTATIVE:	TYPE OF OPERATION:			
Sunrise Mining LLC		Sarah Glinatsis, Jack Nielson	112d-2 - Designated Mining Operation			
REASON FOR INSPECTION:		BOND CALCULATION TYPE:	BOND AMOUNT:			
Normal I&E Program		None	\$204,562.00			
DATE OF COMPLAINT:		POST INSP. CONTACTS:	JOINT INSP. AGENCY:			
NA		None	None			
WEATHER:	INSPECTOR'S SIGNATURE:		SIGNATURE DATE:			
Clear	and we		May 17, 2018

PERMIT #: M-1981-185 INSPECTOR'S INITIALS: LJW INSPECTION DATE: April 27, 2018

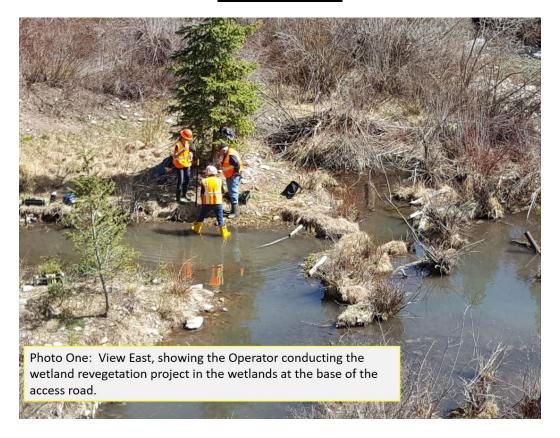
This inspection was conducted as part of the normal monitoring program established by the Colorado Division of Reclamation Mining and Safety. The Mayday Idaho Mine Complex is listed as an active 112d-2 permit consisting of 274 permitted acres and 56 acres of affected lands. The site lies approximately fifteen miles northwest of Durango at 8,700 feet in elevation. Public access is controlled by a locked gate. The Division currently holds \$204,562.00 in financial warranty for the site. A reclamation cost estimate was not performed at this time. Two Photos accompany this report to illustrate the current site conditions.

The overall footprint of the site was in good condition and free from excessive trash and debris. No significant erosion, settling or slumping was observed throughout the observed areas of the site. All access roads were in good condition and appear to be stable. No noxious weeds were noted during the inspection. No problems or possible violations were observed during the inspection. All responses to this report should be directed to Lucas West at the Colorado Division of Reclamation, Mining and Safety at 1313 Sherman Street, Room 215, Denver CO, 80203, by phone at (970)-243-6368 or by email at lucas.west@state.co.us.
