## MINERALS PROGRAM INSPECTION REPORT

<b>MINE NAME:</b> Candelas	<b>MINE/PROSPECTING ID#:</b> M-2018-024	<b>MINERAL:</b> Sand and Gravel	<b>COUNTY:</b> Jefferson
<b>INSPECTION TYPE:</b> Illegal(Unpermitted Operation)	<b>INSPECTOR(S):</b> Michael A. Cunningham	<b>INSP. DATE:</b> April 13, 2018	<b>INSP. TIME:</b> 13:30
<b>OPERATOR:</b> Premiere Earthwork and Infrastructures	<b>OPERATOR REPRESENTATIVE:</b> Aldo Mendoza	<b>TYPE OF OPERATION:</b> NM - Not Mining	
<b>REASON FOR INSPECTION:</b> Citizen Complaint	<b>BOND CALCULATION TYPE:</b> None	<b>BOND AMOUNT:</b> No Bond Held	
<b>DATE OF COMPLAINT:</b> NA	<b>POST INSP. CONTACTS:</b> None	<b>JOINT INSP. AGENCY:</b> None	
<b>WEATHER:</b> Windy	<b>INSPECTOR'S SIGNATURE:</b>

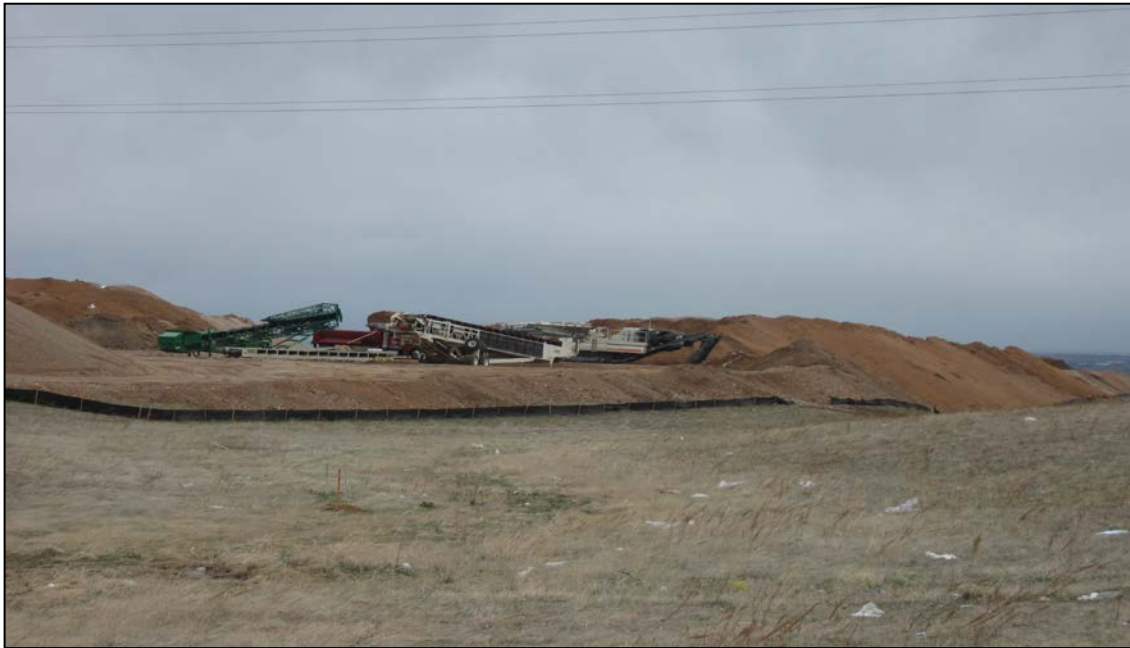
1. View of the affected lands, photo taken facing south.

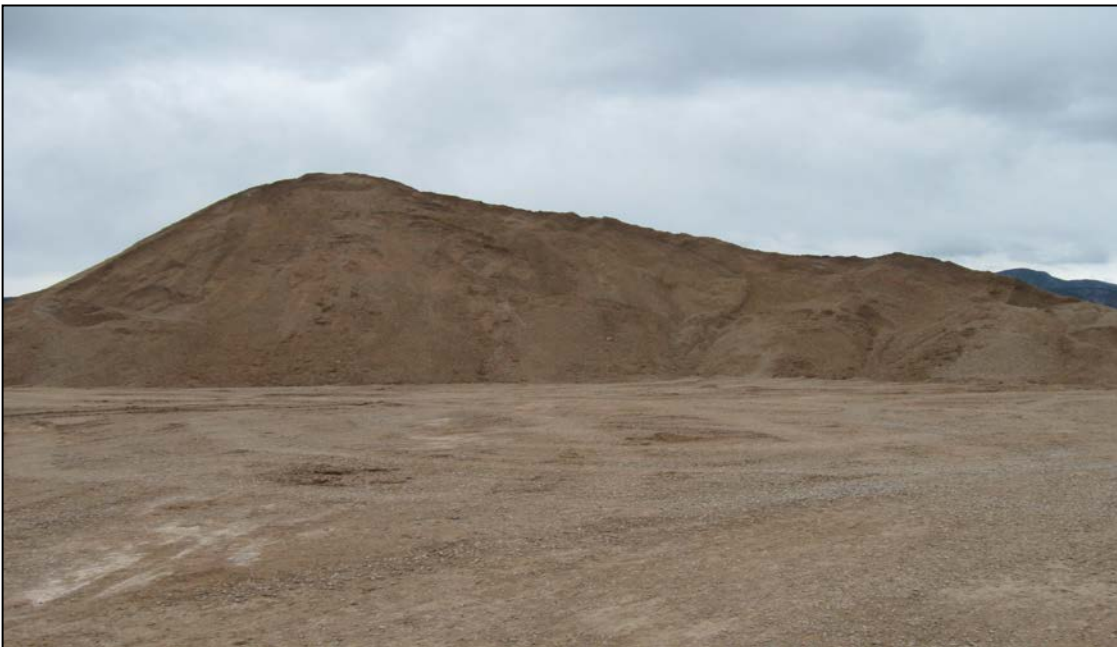
2. Screened product stockpiles.

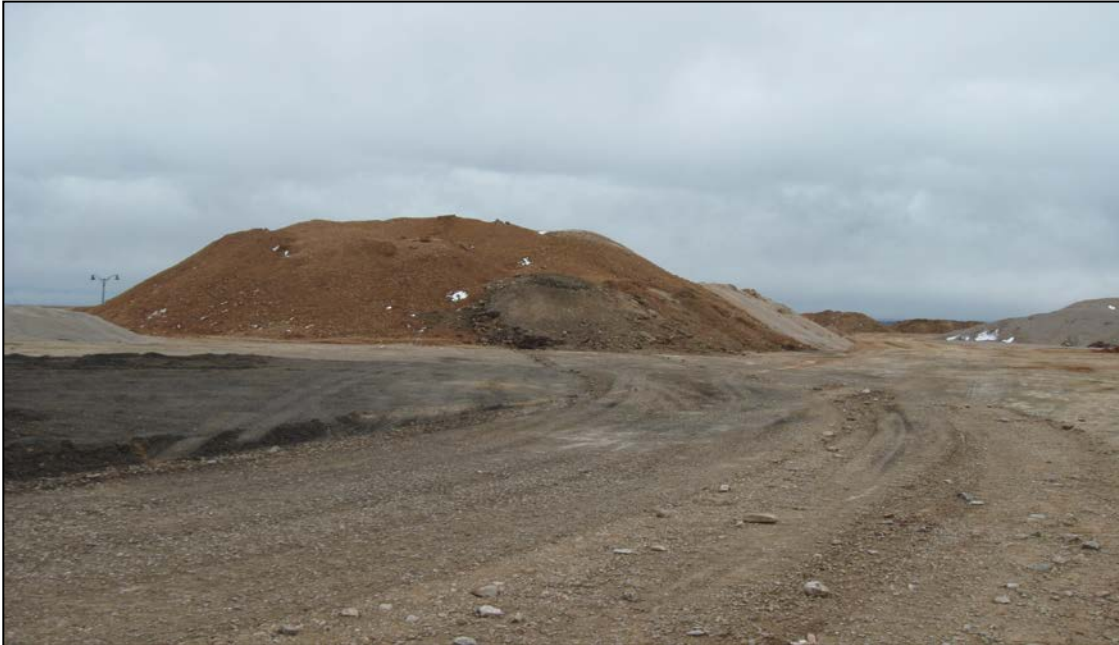
3. Screened product stockpiles.

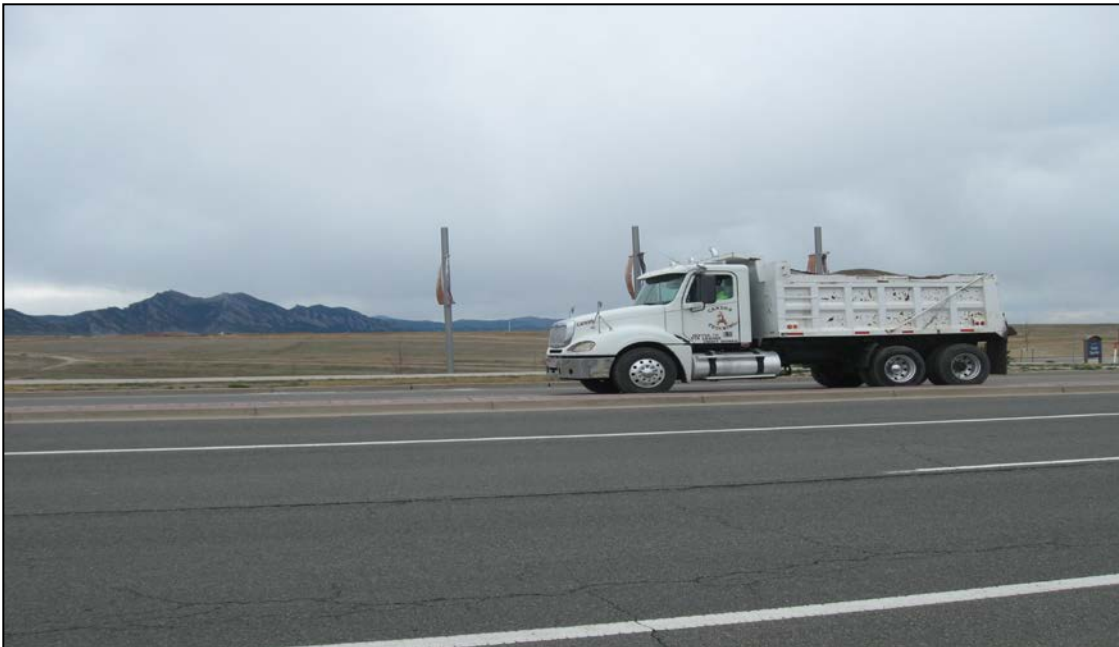
4. Haul truck transporting material from the site.

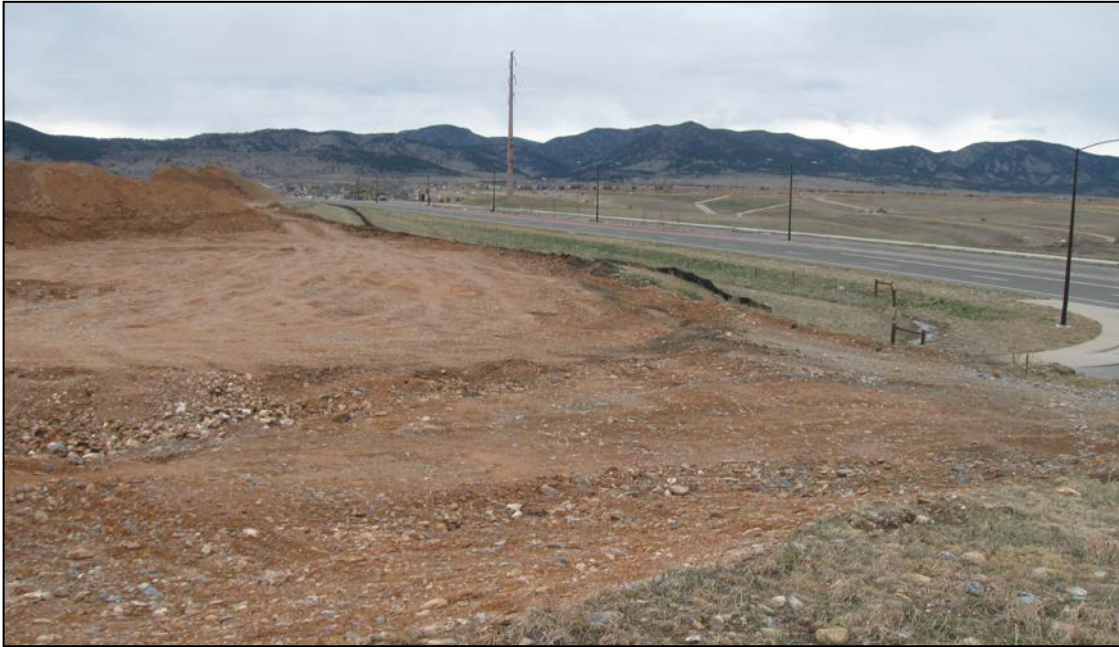
5. View of the affected lands, photo taken facing west.
