MINERALS PROGRAM INSPECTION REPORT
PHONE: (303) 866-3567

MINE NAME: Hertzog Pit	MINE/PROSPECTING ID#: M-1981-276	MINERAL: Sand and gravel	COUNTY: Moffat
INSPECTION TYPE: Surety-Related Inspection	INSPECTOR(S): Amy C. Yeldell	INSP. DATE: May 7, 2018	INSP. TIME: 11:45
OPERATOR: Bower Brothers Construction, Inc.	OPERATOR REPRESENTATIVE: Bud Bower	TYPE OF OPERATION: 112c - Construction Regular Operation	
REASON FOR INSPECTION: Priority	BOND CALCULATION TYPE: None	BOND AMOUNT: \$36,650.00	
DATE OF COMPLAINT: NA	POST INSP. CONTACTS: None	JOINT INSP. AGENCY: None	
WEATHER: Windy	INSPECTOR'S SIGNATURE:

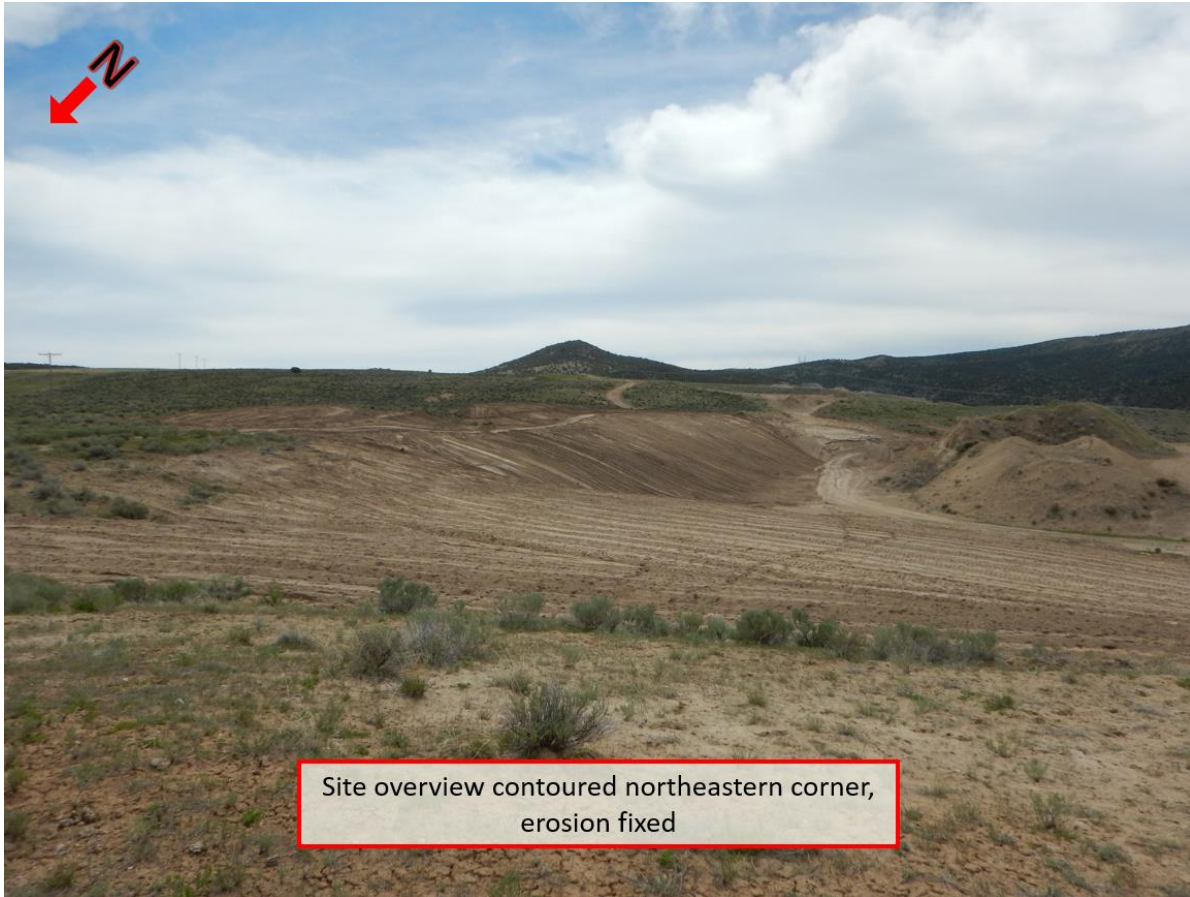
Site overview contoured northeastern corner,
erosion fixed

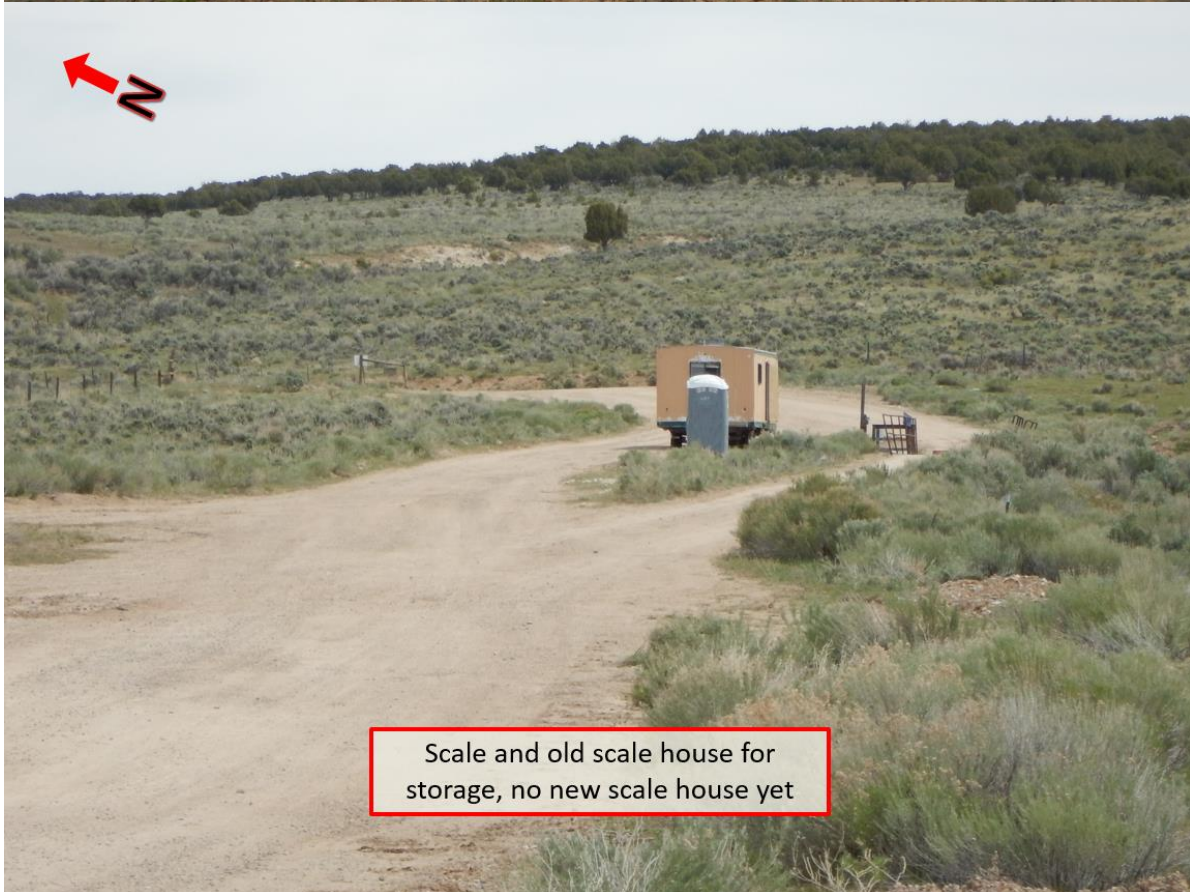
The mine identification sign and affected area boundary markers are in place and in compliance with Rule 3.1.12. The sign is located at the entrance to the permit boundary. The scale and scale house remain on site. A new scale house is being brought in and the old building will serve as storage. Both buildings are trailers and do not require a TR or affect the bond.

Scale and old scale house for
storage, no new scale house yet

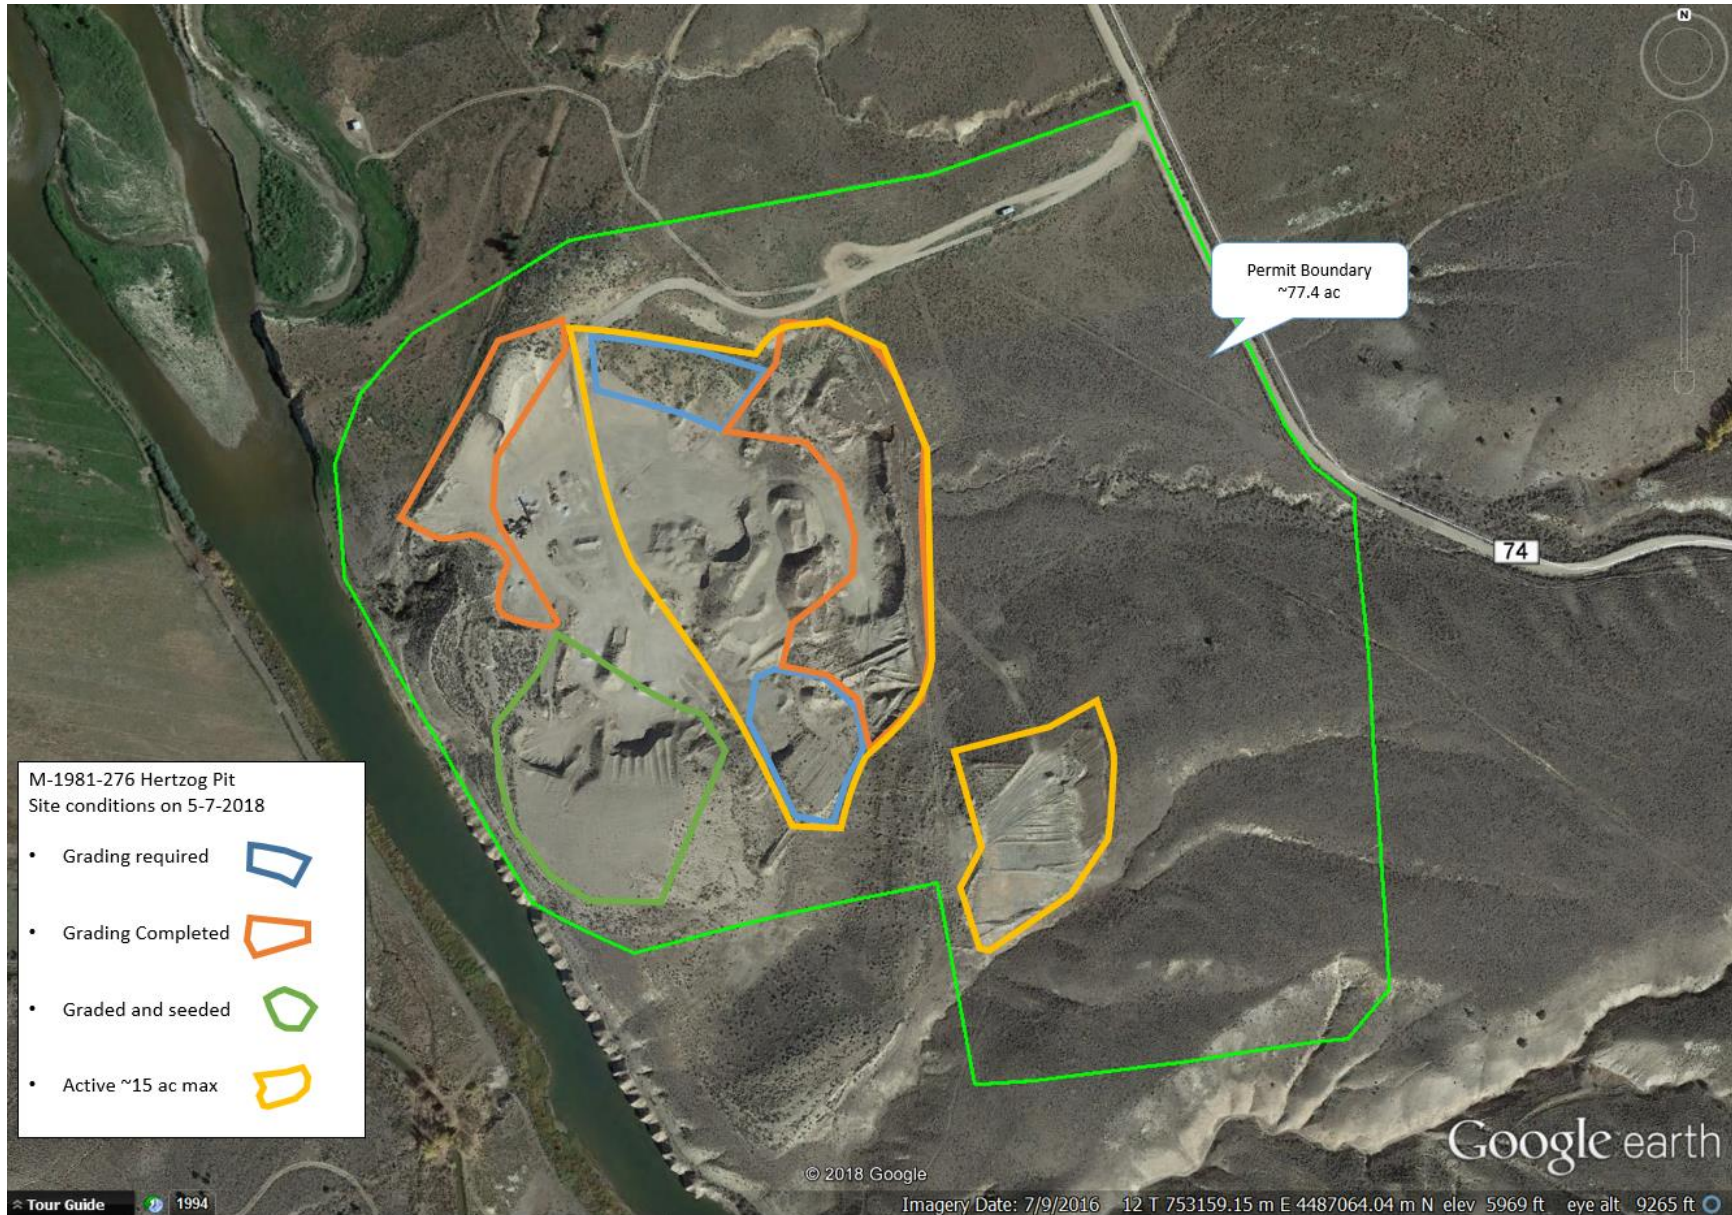
With regards to seeding only the southwestern portion (5.3 ac) has been seeded. The remainder of the western side of the pit will be seeded this fall. See attached map.
