MINERALS PROGRAM INSPECTION REPORT
PHONE: (303) 866-3567

MINE NAME: Cañon Dolomite Quarry	MINE/PROSPECTING ID#: M-1977-376	MINERAL: Dolomite	COUNTY: Fremont
INSPECTION TYPE: Monitoring	INSPECTOR(S): Timothy A. Cazier	INSP. DATE: March 28, 2018	INSP. TIME: 13:30
OPERATOR: Continental Materials Corporation	OPERATOR REPRESENTATIVE: Andre Laroché	TYPE OF OPERATION: 112c - Construction Regular Operation	
REASON FOR INSPECTION: Normal I&E Program	BOND CALCULATION TYPE: Partial Bond	BOND AMOUNT: \$232,000.00	
DATE OF COMPLAINT: NA	POST INSP. CONTACTS: None	JOINT INSP. AGENCY: None	
WEATHER: Cloudy	INSPECTOR'S SIGNATURE:

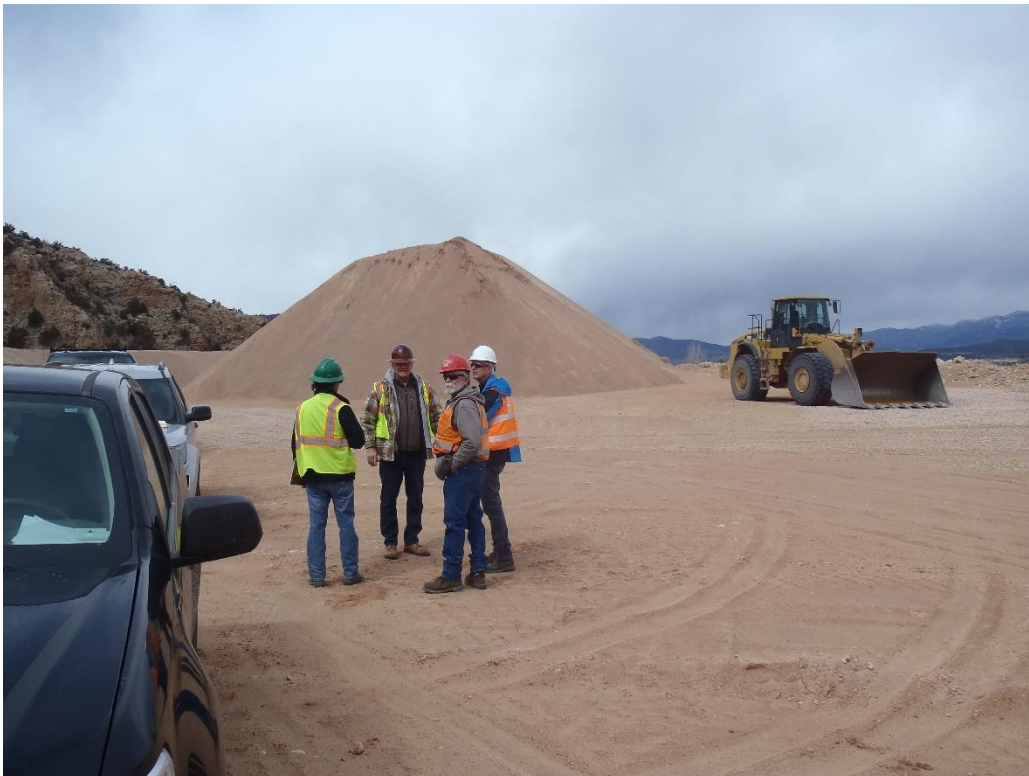
Backfilling and Grading: Based on the approval of TR-02, the benches (roughly 30 ft high by 60 ft wide) are to be reclaimed by backfilling at a 4H:1V slope using unmarketable fines. Fines stockpiles were observed on site on the pit floor (see **Photo 1**). Mr. Laroche explained the pit is leased out to a landscaping company. I asked if the landscaping company was aware of the permit conditions, especially the need to retain sufficient fines for backfilling. [Mr. Laroche indicated it was probably addressed in the leasing contract, but that he would have Mr. Pope confirm this.](#)

Photo 1. Fines stockpile were observed on pit floor (looking north).

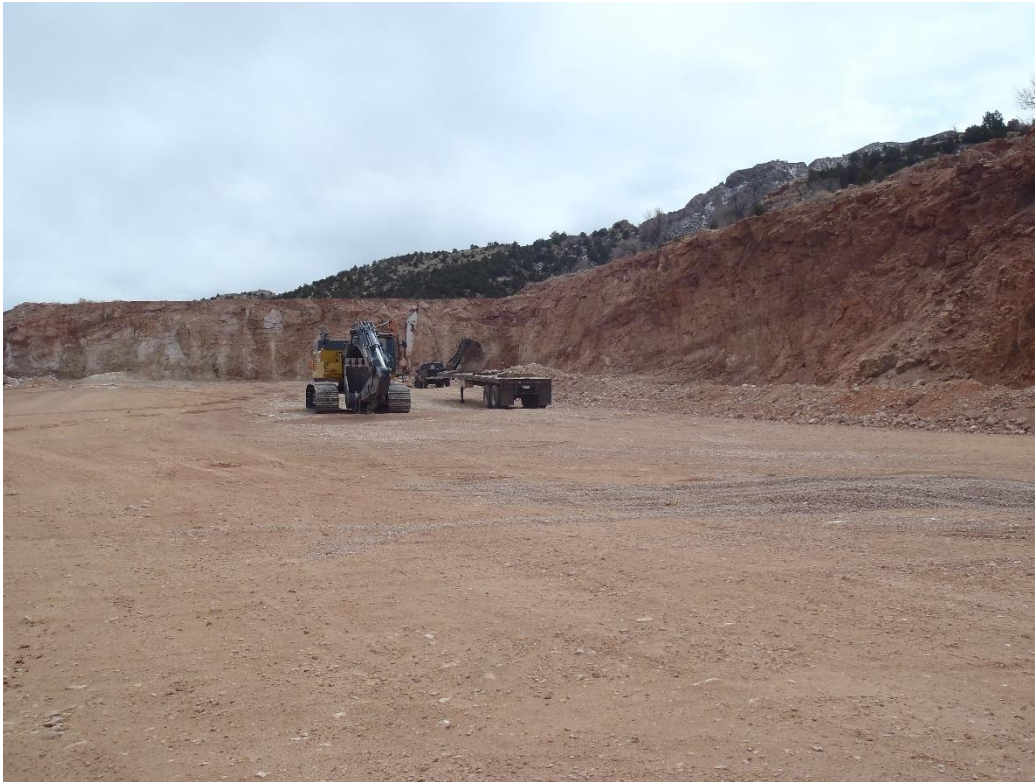
Gen. Compliance with Mine Plan: The operation appeared to be in compliance with the approved mine plan. Google Earth was used to measure the disturbed area, which was estimated to be just over 25 acres, based on 2016 imagery. Highwalls were estimated to vary between 20 and 30 feet in height and appeared stable (see **Photo 2**).

Photo 2. Pit highwall, south end & west side (looking SSW).

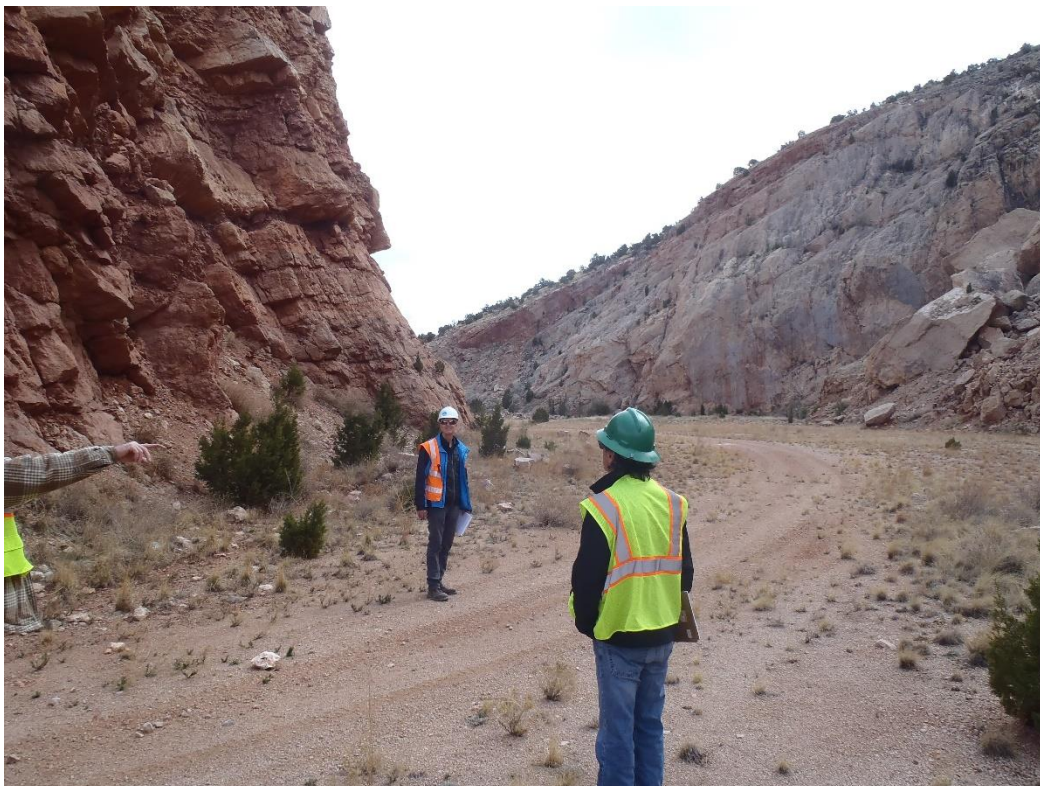
Photo 3. Old Quarry area entrance off access road (looking SSW).

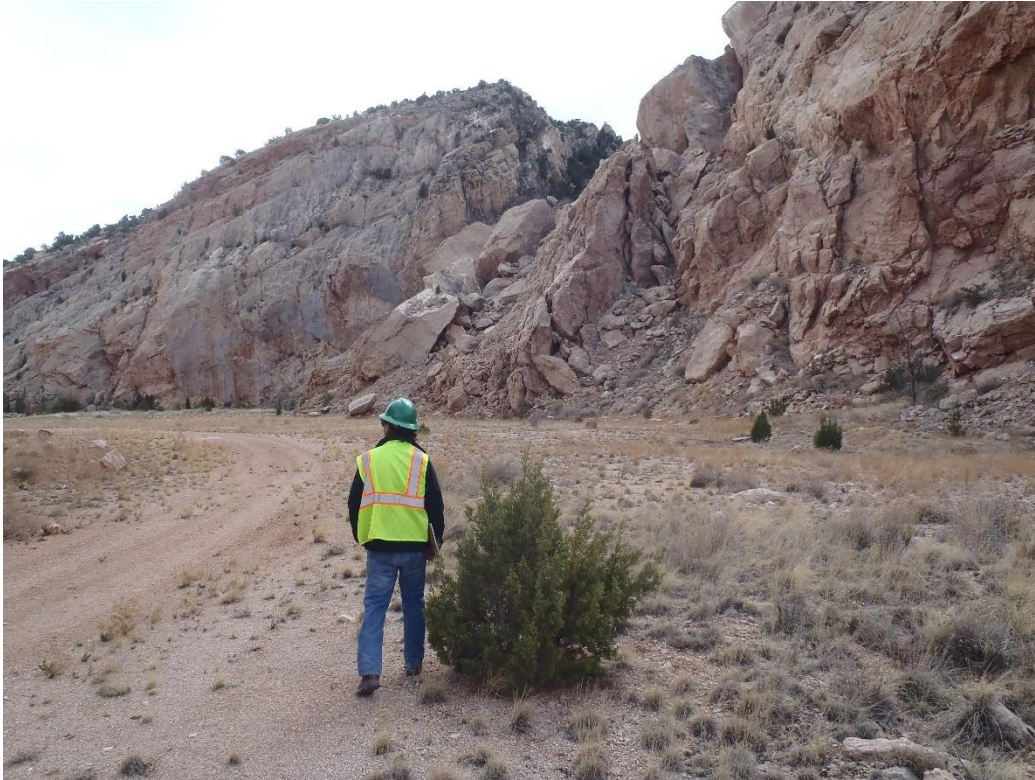
Processing Waste: Based on the approval of TR-02, approximately half the fines are to be moved to the Old Quarry area (see **Photos 3 and 4**), the rest will remain at the quarry for backfill on the benches. Concrete slabs and some rebar were observed in the Old Quarry area (see **Photo 5**). The concrete may remain if it is buried with the fines. However, the rebar must be cut away and disposed of properly in a landfill or other acceptable disposal facility.

Photo 4. Old Quarry fines disposal area, to left (looking south).

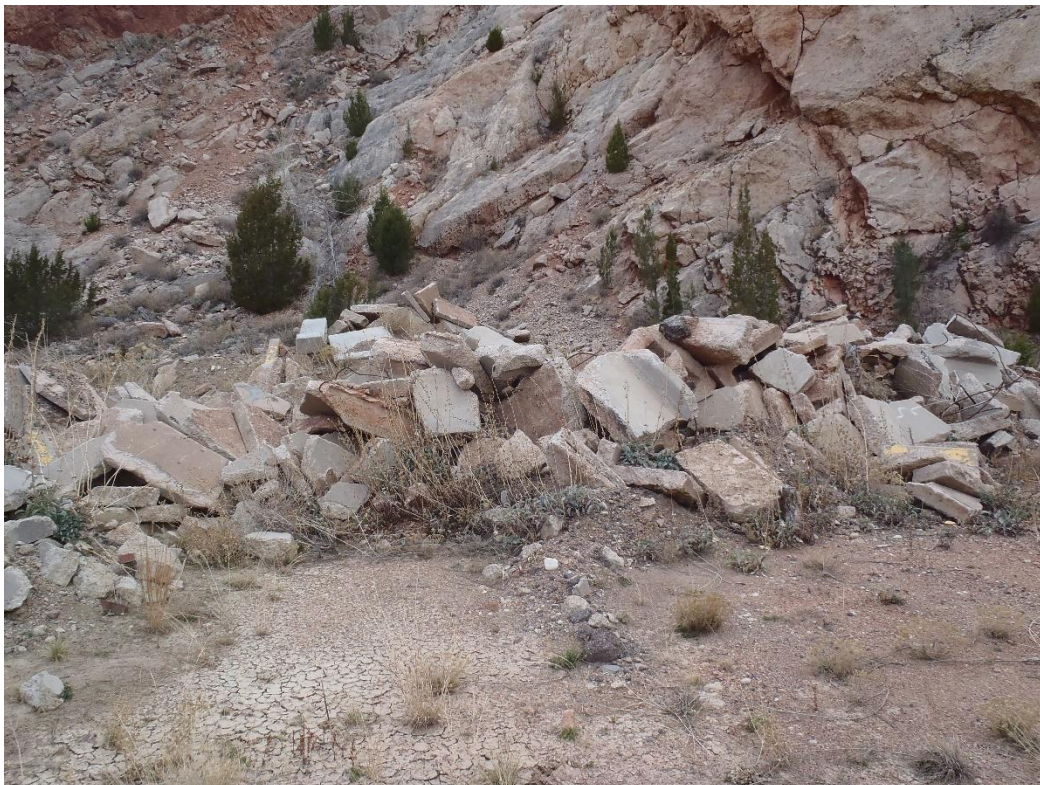
Photo 5. Concrete slabs and rebar observed in Old Quarry area.

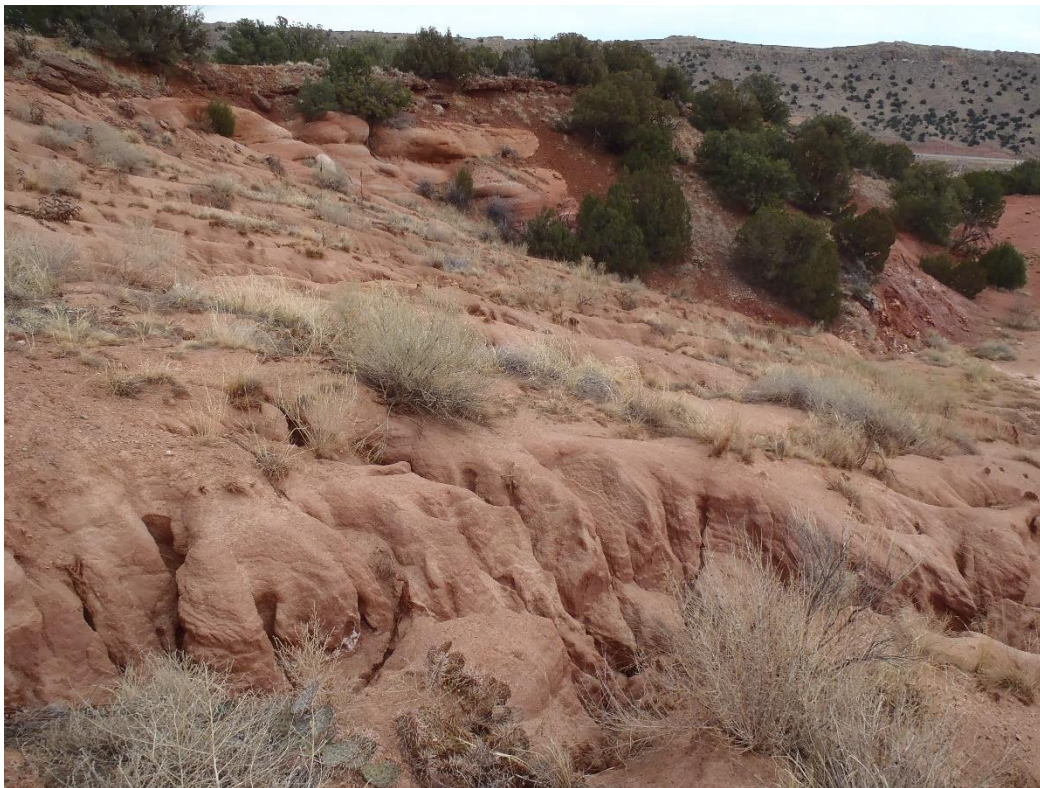
Sediment Control: Other than the large erosion gullies in the lower fines disposal area (not currently planned to be used for fines disposal), no erosion concerns were observed. As this lower fines disposal area is in the affected area, Mr. Humphries discussed a plan for reclaiming the steeper slope in the lower previously permitted fines disposal area. This slope is highly eroded in an area that may or may not have been disturbed by mining activity. The material is slightly cemented weathered rock (see **Photo 6**). The plan is to terrace this slope with likely three terraces having a back slope to convey runoff towards the side into the natural drainage (see **Photo 7**).

Photo 6. Highly eroded lower fines disposal area (looking NE).

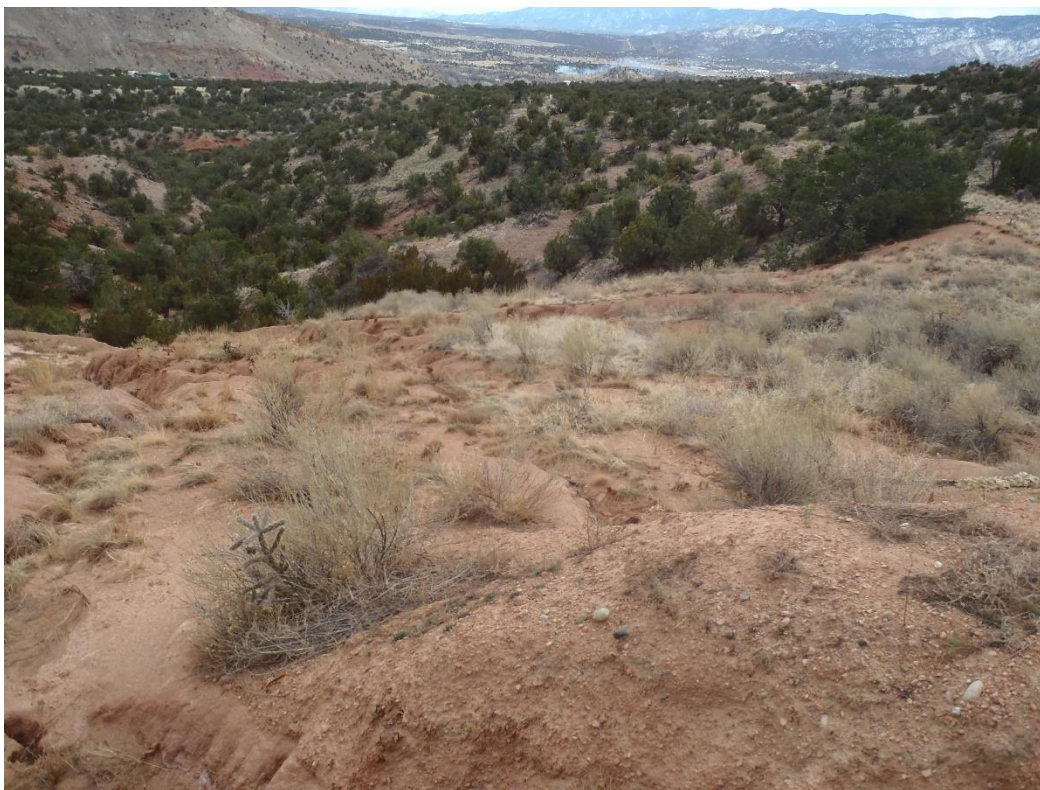
Photo 7. Natural drainage south of highly eroded lower fines disposal area (looking SE).

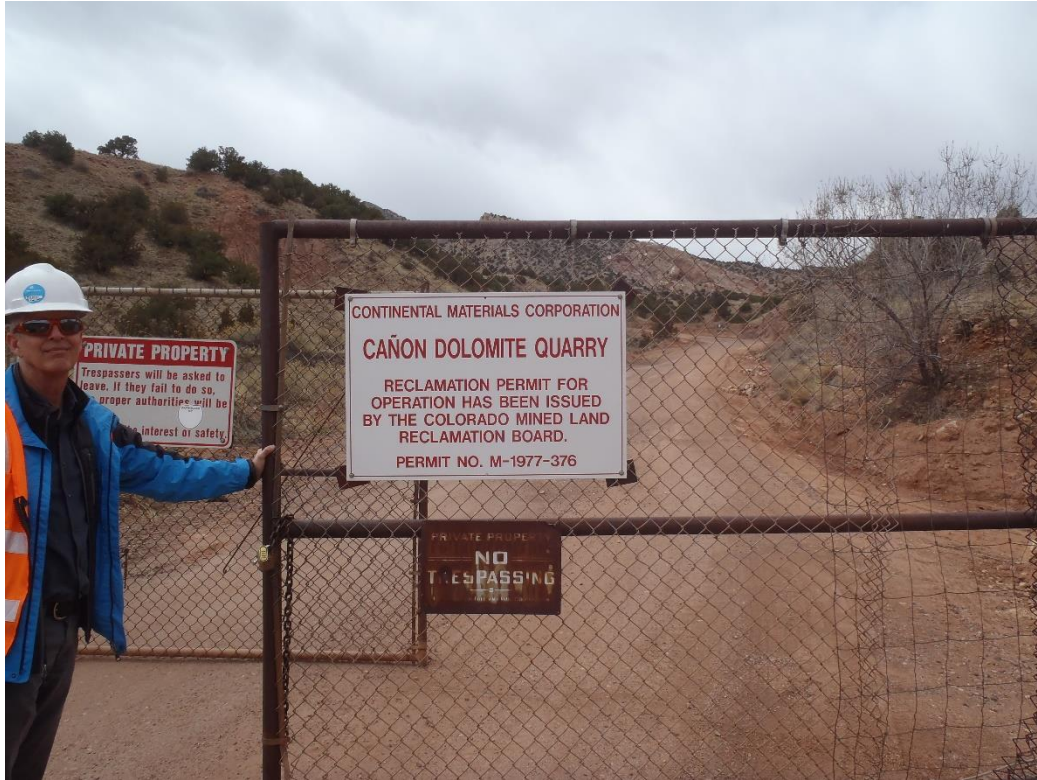
Signs and Markers: The permit sign was properly posted (see **Photo 8**) and boundary markers were observed to delineate the permit boundary (see **Photo 9**).

Photo 8. Permit sign at entrance.

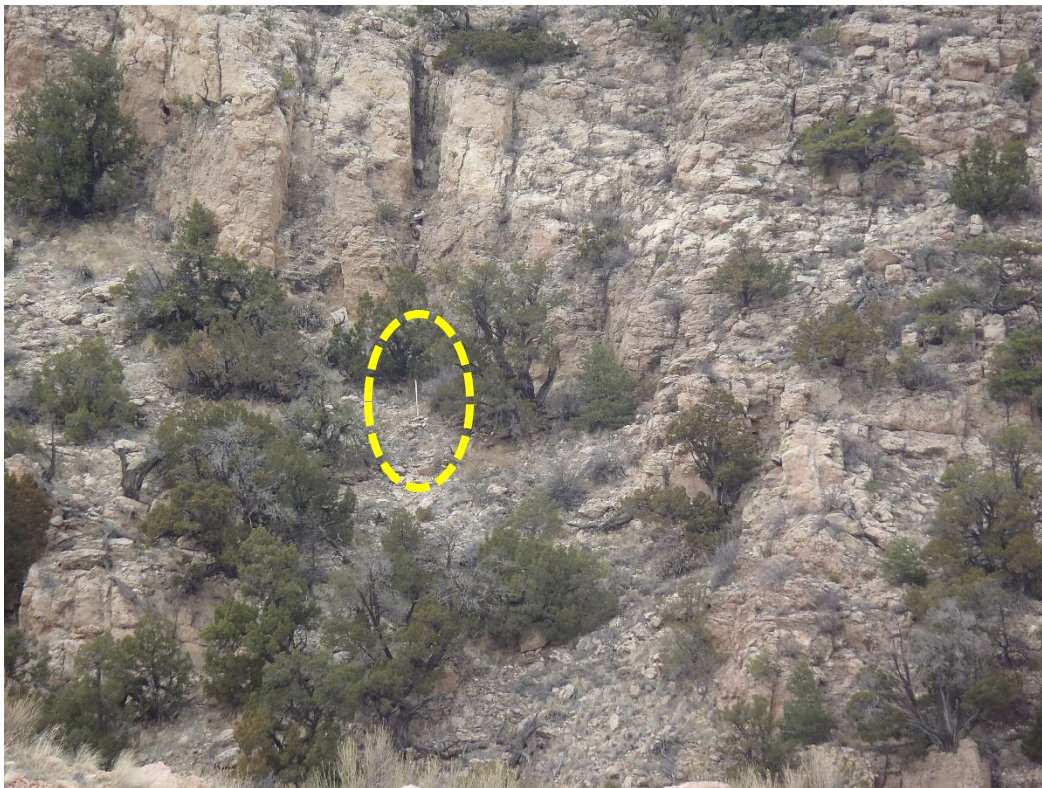
Photo 9. Permit boundary marker (on northwest corner, looking NW).

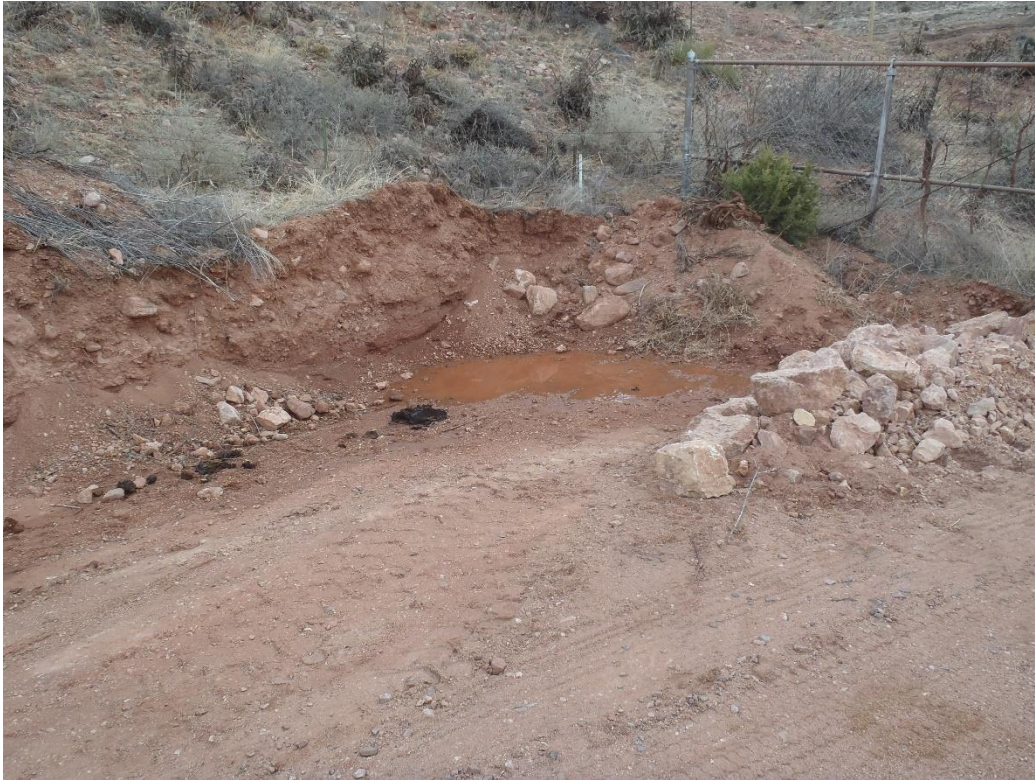
Storm Water MGT Plan: No oil or fuel spills observed. Pit area stormwater drains to the pit and infiltrates. Rock check dams and sediment traps (see **Photo 10**) were observed along the haul road for sediment control along access to the pit.

Photo 10. Sediment trap along access road (near entrance, looking east).
