**MINERALS PROGRAM INSPECTION REPORT**  
**PHONE: (303) 866-3567**

<b>MINE NAME:</b> Climax Mine	<b>MINE/PROSPECTING ID#:</b> M-1977-493	<b>MINERAL:</b> Molybdenum	<b>COUNTY:</b> Summit
<b>INSPECTION TYPE:</b> Monitoring	<b>INSPECTOR(S):</b> Jared L. Ebert	<b>INSP. DATE:</b> May 9, 2018	<b>INSP. TIME:</b> 10:00
<b>OPERATOR:</b> Climax Molybdenum Company	<b>OPERATOR REPRESENTATIVE:</b> James Haag and Diana Kelts	<b>TYPE OF OPERATION:</b> 112d-3 - Designated Mining Operation	
<b>REASON FOR INSPECTION:</b> Normal I&E Program	<b>BOND CALCULATION TYPE:</b> None	<b>BOND AMOUNT:</b> \$78,246,088.00	
<b>DATE OF COMPLAINT:</b> NA	<b>POST INSP. CONTACTS:</b> None	<b>JOINT INSP. AGENCY:</b> None	
<b>WEATHER:</b> Clear	<b>INSPECTOR'S SIGNATURE:</b>

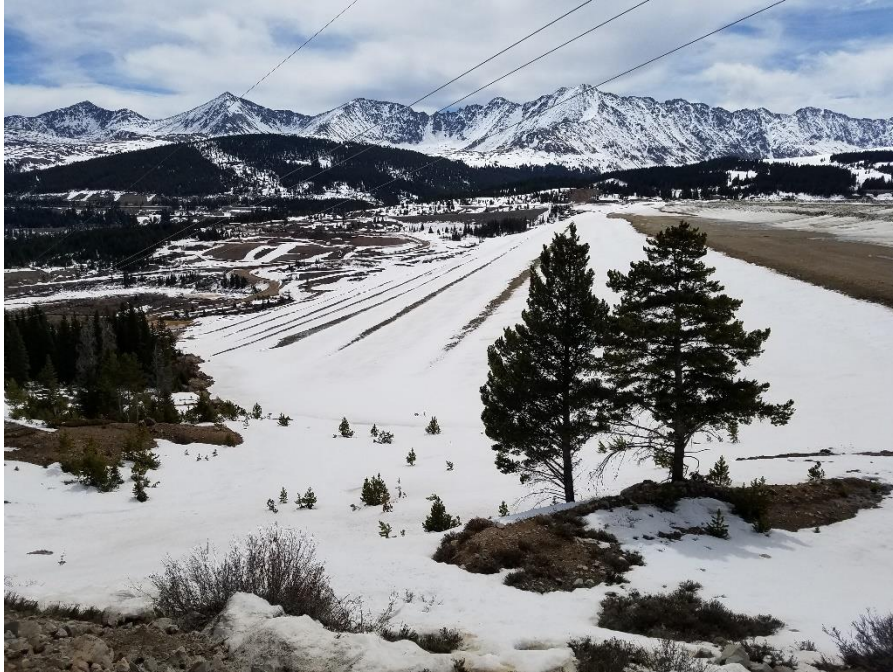
Figure 1. From the West side of 3 Dam looking southeast.

The face of Tailings Dams 1, 2, 3 and the Robinson Dam were covered with snow but overall appeared stable.

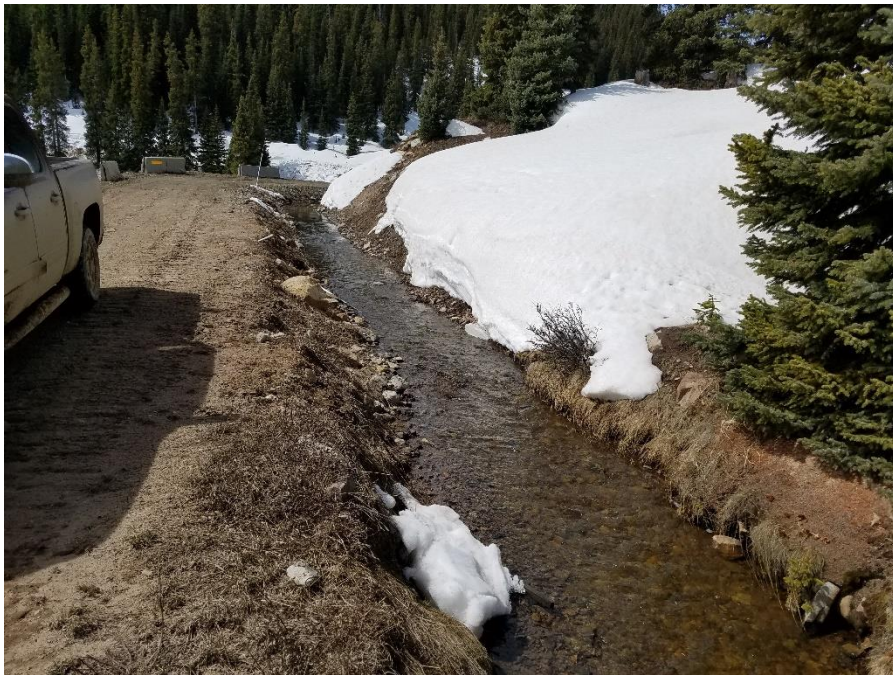
Figure 2. West Interceptor channel.

The West Interceptor ditch/pipe was observed. According to Mr. Haag, Climax intends to replace sections of the West Interceptor pipe this year. The West Interceptor consists of an open ditch in places and underground piping. Snow was observed in sections of the open ditch but overall the ditch sections appeared functional. A pipeline was installed for a large portion of the interceptor and surface water flows into the pipe in fairly closely spaced drainage grates. Climax clears snow from the grates to allow surface water to flow into them.

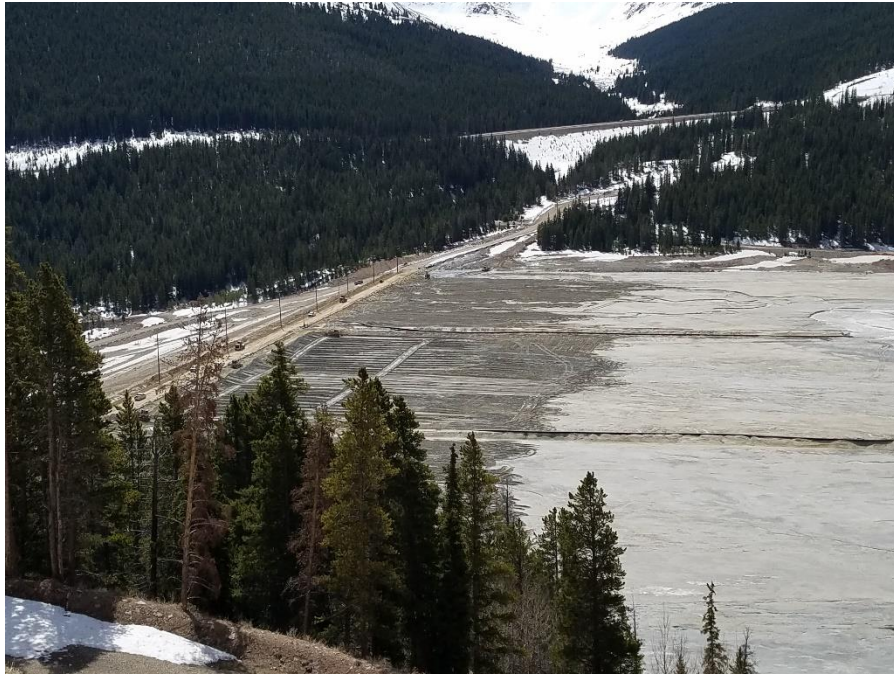
Figure 3. From the west side of 5 Dam looking southeast.

Climax was actively preparing 5 Dam for spigot tailings deposition. Equipment was observed grading the top bench of the dam and clearing snow and ice. Climax was discharging tailings at the Clinton Cut-Out. The beach width appeared greater than 1,000 feet.

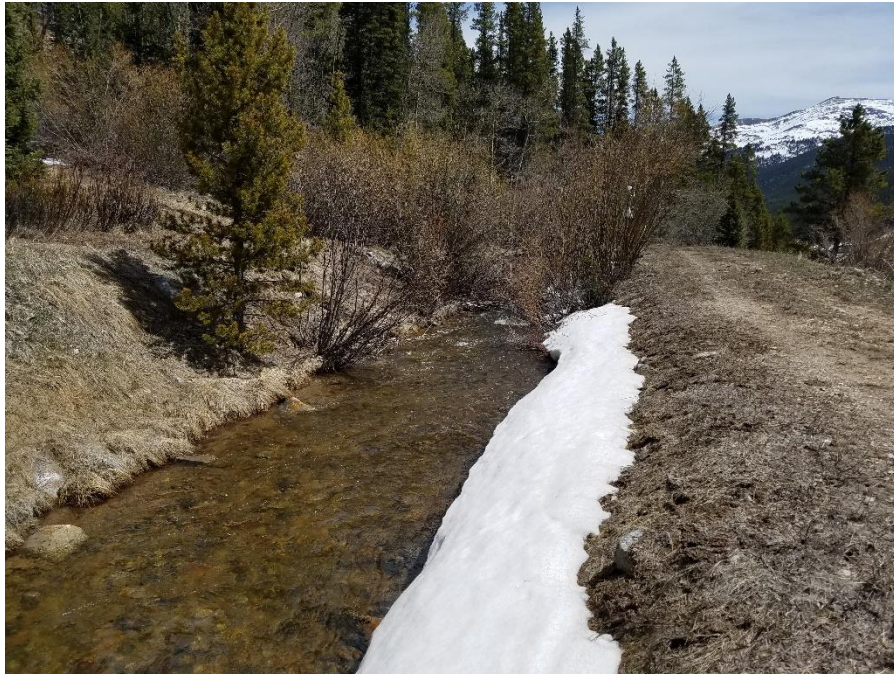
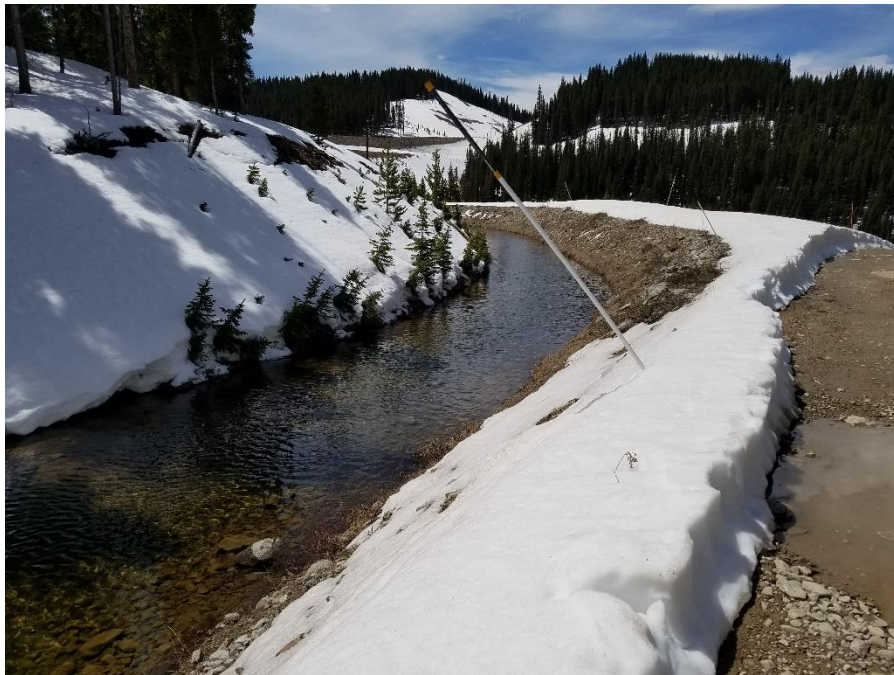
**Figure 5. East Interceptor**

Portions of the East Interceptor/Clinton Canal was observed. The drainage downstream from the Drop Tower #15 of the Tailings Delivery Line (TDL), was inaccessible due to snow conditions. The sections of the drainage observed were clear and functional. Water was flowing through the drainage.

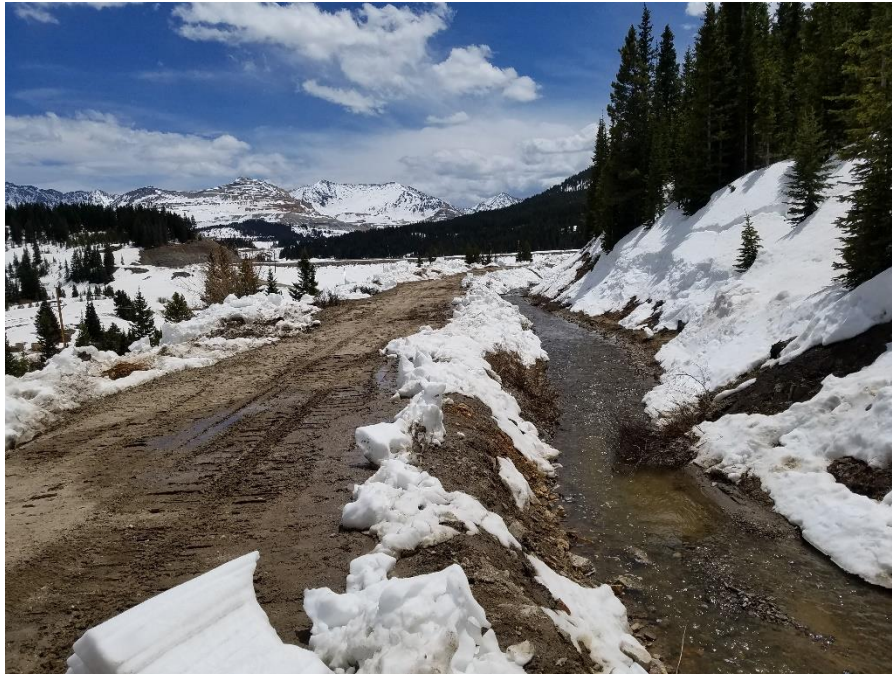
**Figure 7. Chalk Mountain Interceptor.**

The Chalk Mountain Interceptor was observed. This channel appears to have been recently cleaned out in places. The channel was flowing with water and appeared functional.
