**MINERALS PROGRAM INSPECTION REPORT**  
**PHONE: (303) 866-3567**

| <b>MINE NAME:</b><br>Wagner/Kauffman Pit #3 | <b>MINE/PROSPECTING ID#:</b><br>M-1999-069 | <b>MINERAL:</b><br>Sand and gravel | <b>COUNTY:</b><br>Larimer |
| <b>INSPECTION TYPE:</b><br>Surety-Related Inspection | <b>INSPECTOR(S):</b><br>Amy Eschberger | <b>INSP. DATE:</b><br>May 22, 2018 | <b>INSP. TIME:</b><br>10:00 |

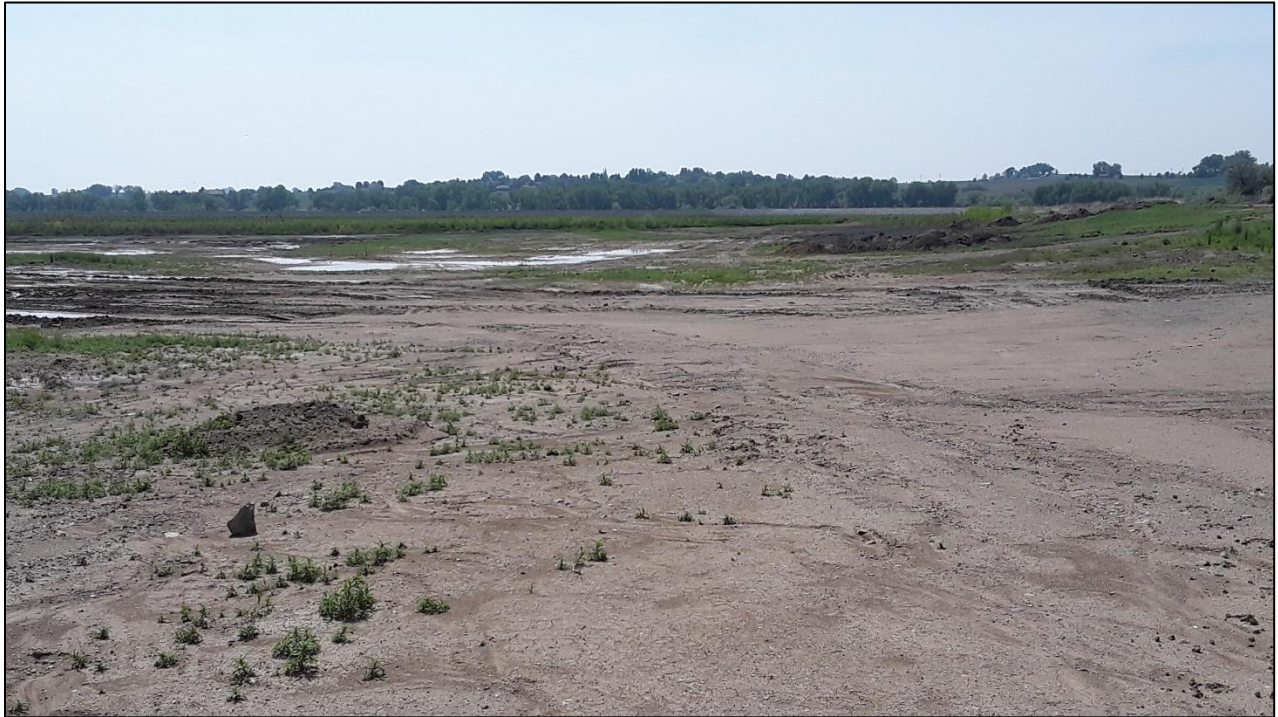
The Division observed the triangular area located between the outlet ditch and the embankment (**Photos 1-4**). This area was observed to be holding approximately 5.8 acres of groundwater during the Division's 4/14/2017 inspection of the site. The water was estimated to be no more than approximately two feet in depth. The Division was not clear during the last inspection whether the operation had the appropriate water rights in place for the amount of groundwater exposed on site. In further communications with the operator and the Division of Water Resources (DWR), it was determined the operation did not have the appropriate water rights for the exposed groundwater. Therefore, the operator backfilled the pit to a minimum of two feet above the static groundwater level, and submitted drone imagery to the Division on January 16, 2018 demonstrating this project had been completed. According to the operator, the portion of the pit that was holding groundwater was backfilled with 6-8 feet of dirt, which would be approximately 4-6 feet above the observed groundwater level. The Division observed no evidence of exposed groundwater in the triangular area during the current inspection. However, there were some puddles present due to a recent storm event. The Division observed topsoil stored along the northern edge of the triangular area, which was hauled in from the East Reservoir stockpile. The operator intends to spread the topsoil across the northern portion of the pit. A small stockpile of concrete rubble was stored at the northwestern corner of the triangular area. The operator intends to move this material to the

**Photo 1.** View looking south across western half of backfilled triangular area located between embankment and outfall ditch.

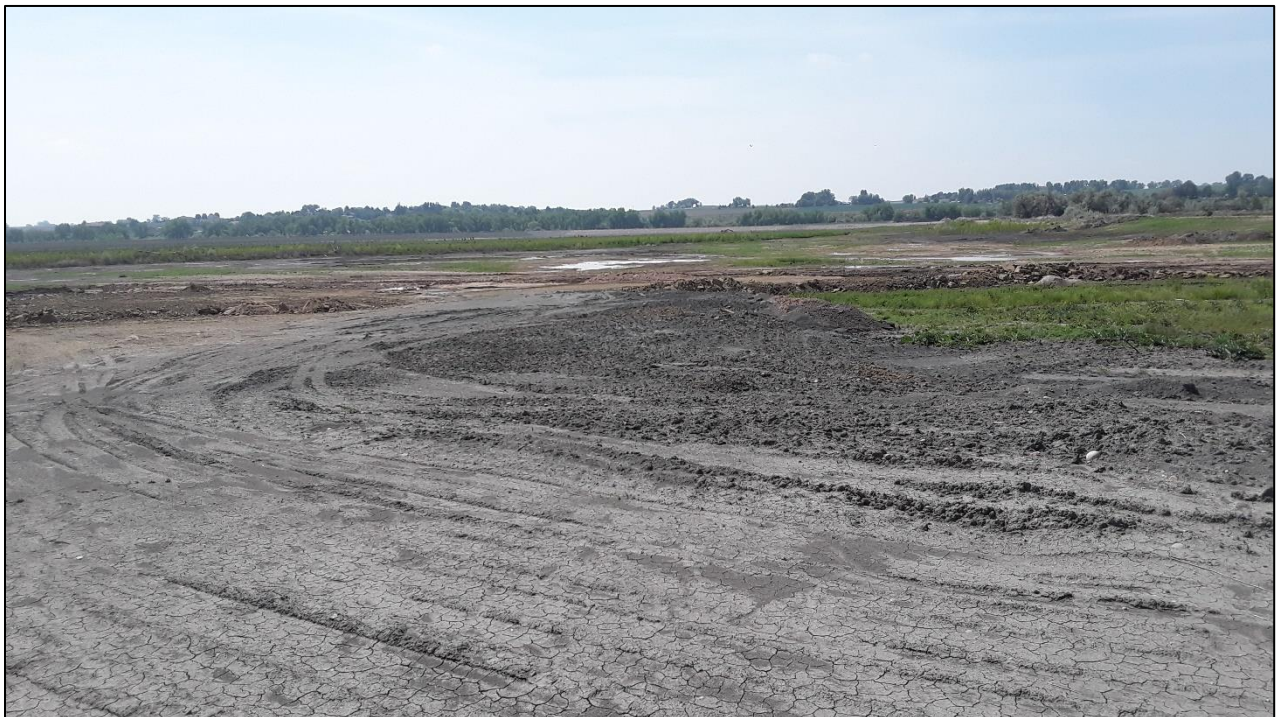
**Photo 2.** View looking south across eastern half of backfilled triangular area located between embankment and outfall ditch.

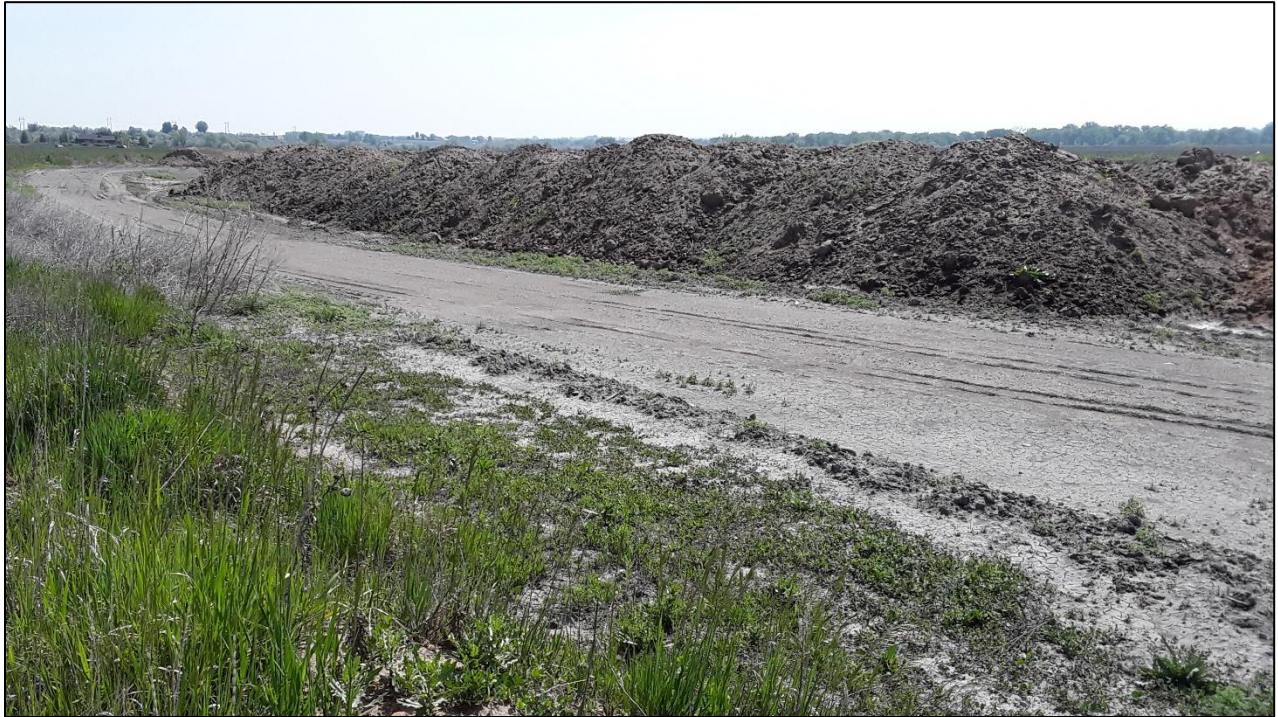
**Photo 3.** View looking south from outside of triangular area, showing topsoil stockpiled along northern edge of pit.

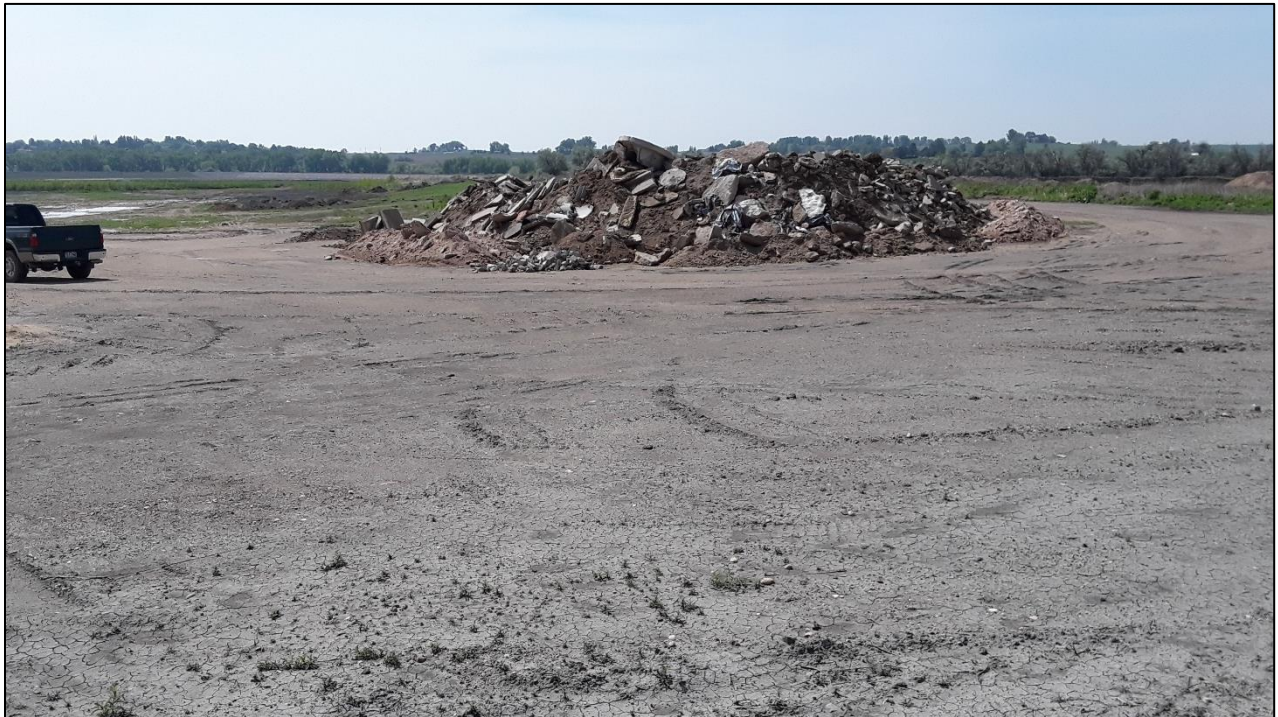
recycling plant in the Kauffman Pit permit area, so it can be crushed into rip rap. The operator inquired about submitting an additional Acreage Reduction request to release the triangular area from the permit area. The Division believes this area will meet the requirements of its approved post-mining land use as an outdoor storage area once the topsoil stockpiles have been spread out. The undisturbed strip of land located north of the triangular area (**Photo 5**) is releasable at this time. Additionally, the City of Loveland embankment could be released, as it has been constructed as approved, and is well vegetated with native grasses.

**Photo 4.** View looking southwest from northern edge of triangular area, showing small stockpile of concrete rubble stored at northwestern corner of pit.

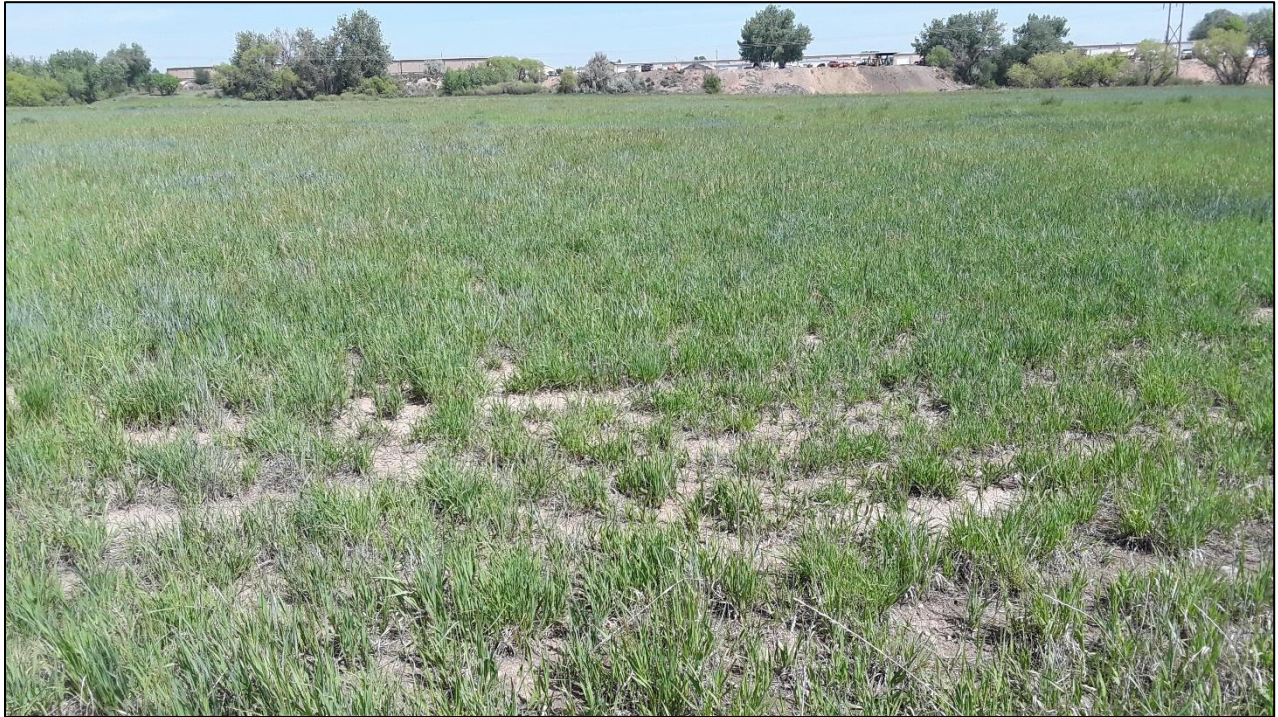
**Photo 5.** View looking north across strip of land located north of triangular area that was undisturbed by the operation and is therefore, eligible for release.

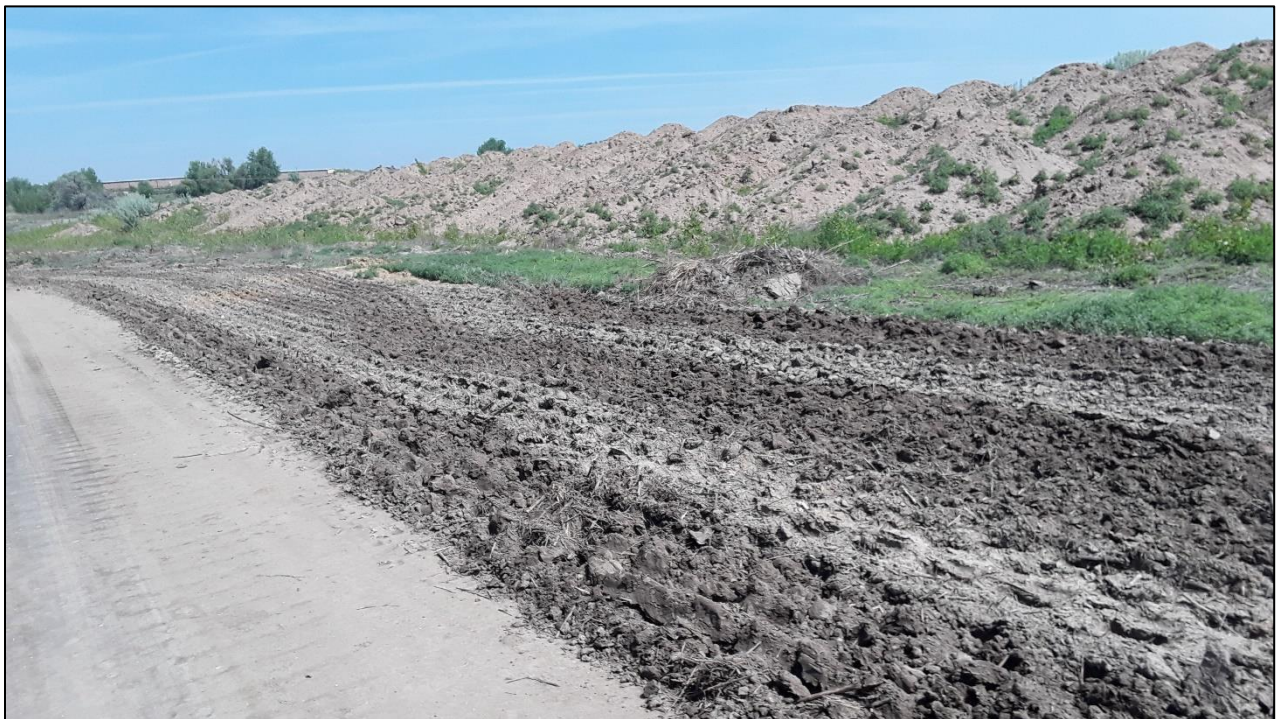
The Division observed the West Reservoir pit located west of the outfall ditch (**Photos 6-13**). This pit was dry during the inspection, besides some puddles left by a recent storm event. The pit is approximately 15 feet deep, and covers approximately 33 acres. Topsoil from the East Reservoir was also hauled to this pit for storage. Several stockpiles were stored along the eastern and northern edges of the pit and on the pit floor. The Division observed a truck dumping material on the pit floor during the inspection. The western pit slope that was seeded last spring now shows good grass growth. However, the operator intends to completely backfill this pit prior to using it as outdoor storage. The Division observed the top of the berm that separates the West Reservoir pit from an unlined pond located in the Kauffman Pit permit area. The operator had to repair this portion of the berm after it was breached in the September 2013 flooding. The berm appeared to be stable. The operator continues to pump water from a small dewatering trench present along the southern edge of the West Reservoir and discharge the water to the Kauffman Pit pond. According to the SWSP for the site, this activity has been authorized by the DWR, with any associated depletions accounted for in the plan.

**Photo 6.** View looking north, showing topsoil stockpiles stored along eastern slope of West Reservoir.

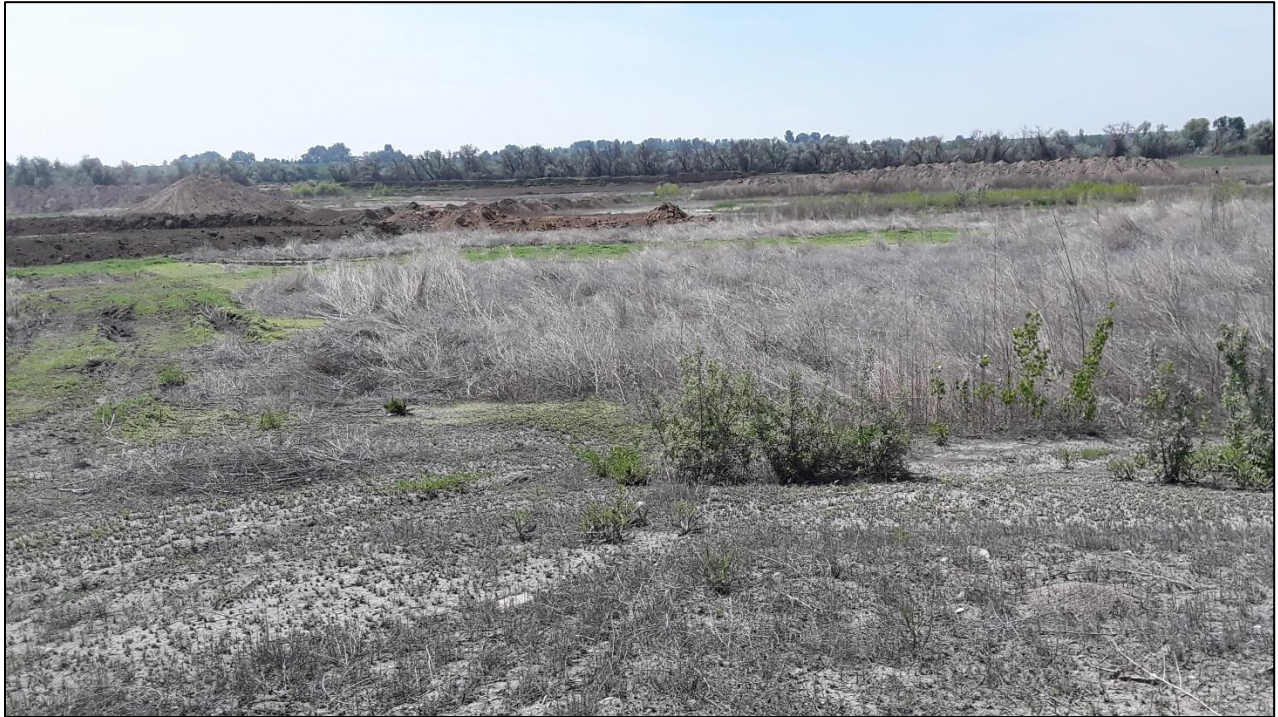
**Photo 7.** View looking south across floor of West Reservoir, from its northern edge.

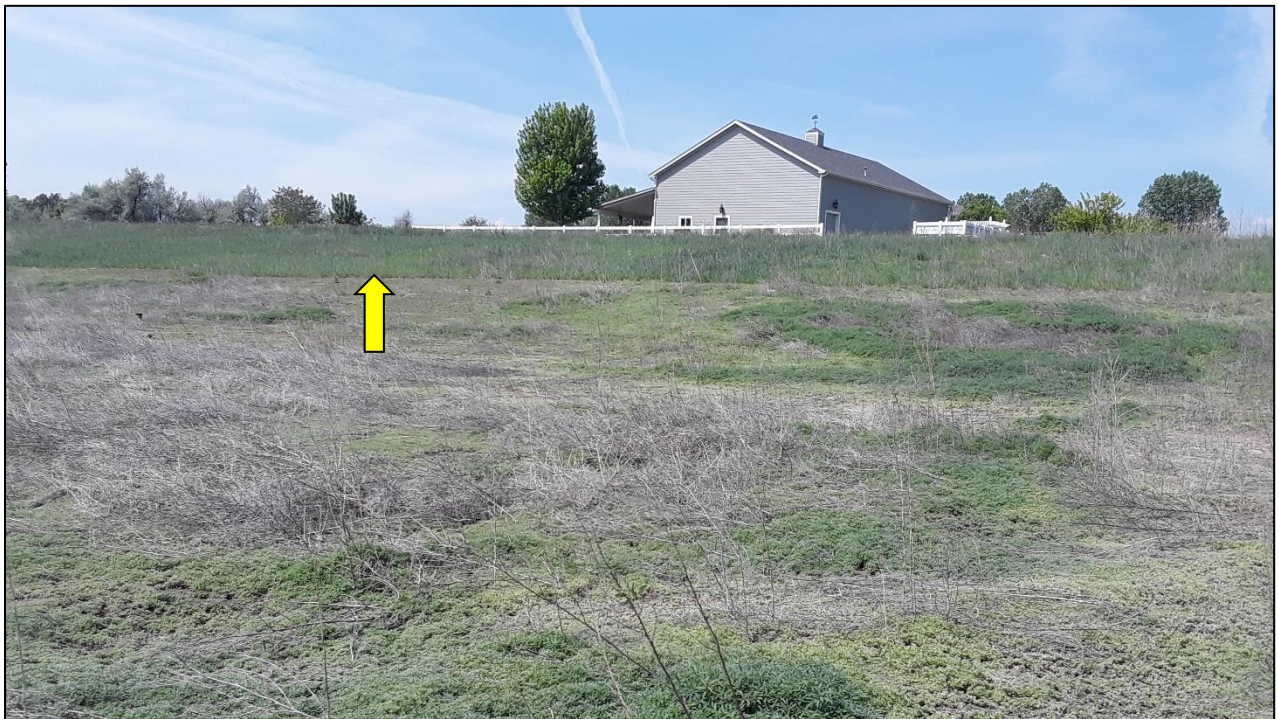
**Photo 8.** View looking west across floor of West Reservoir, showing portion of western slope (in background; indicated with arrow) that shows good grass growth.

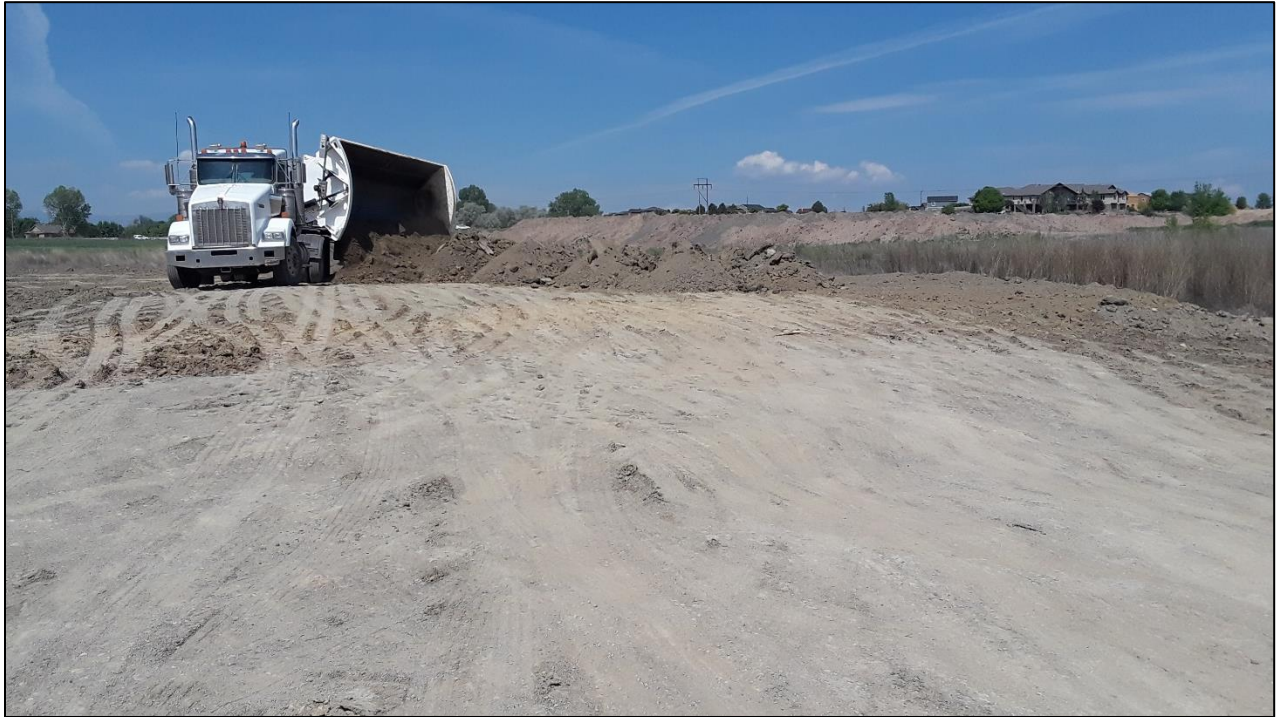
**Photo 9.** View of truck dumping dirt in the West Reservoir pit during the inspection. TR-4, approved in 2017, allows the operator to backfill pits west of the embankment with inert materials.

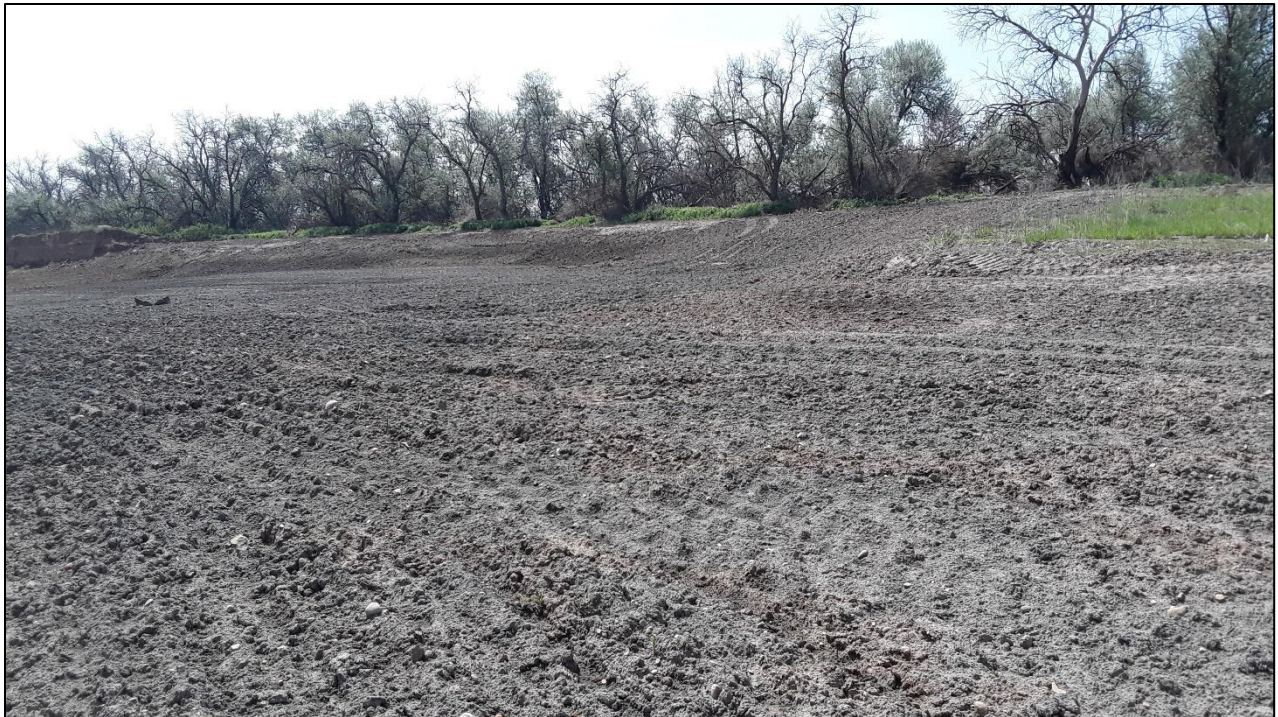
**Photo 10.** View looking southwest across floor of West Reservoir. Tree-lined berm in background separates this pit from an unlined pond in the Kauffman Pit permit area.

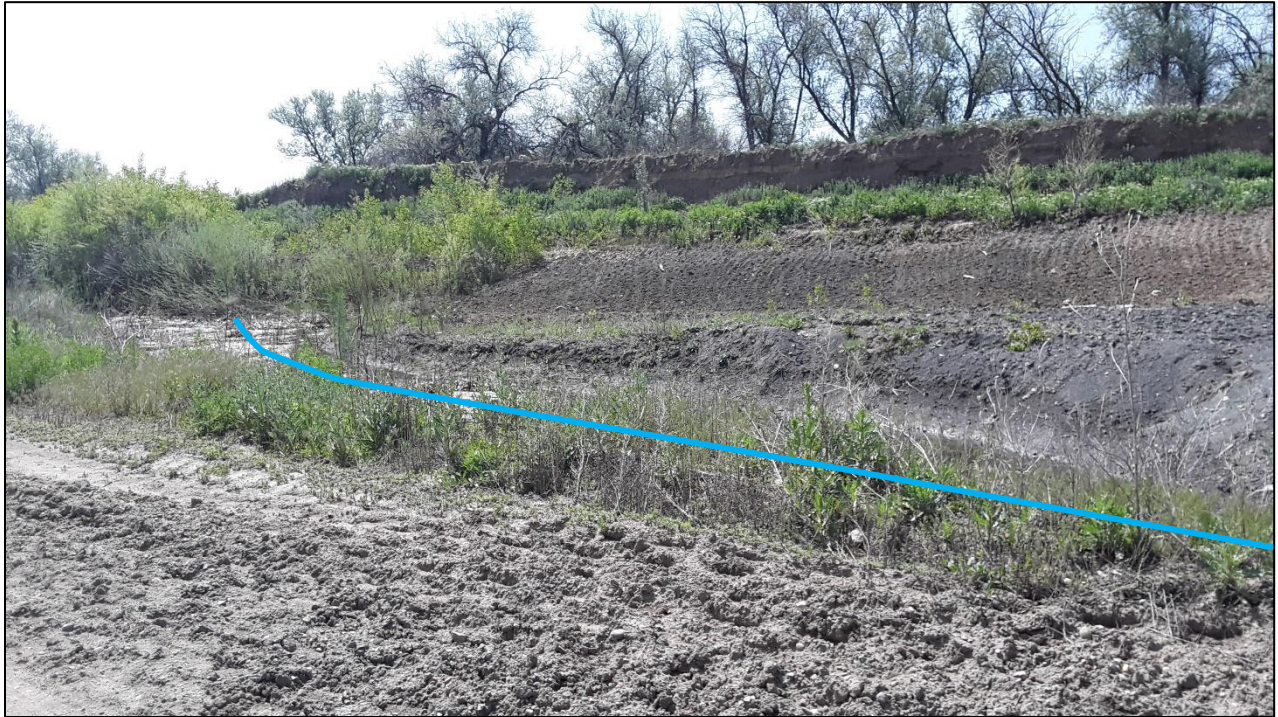
**Photo 11.** View looking south at southern edge of West Reservoir pit, with location of dewatering trench indicated by blue line. Tree-lined berm in background separates this pit from an unlined pond in the Kauffman Pit permit area. Water from the dewatering trench is pumped to the Kauffman Pit pond.

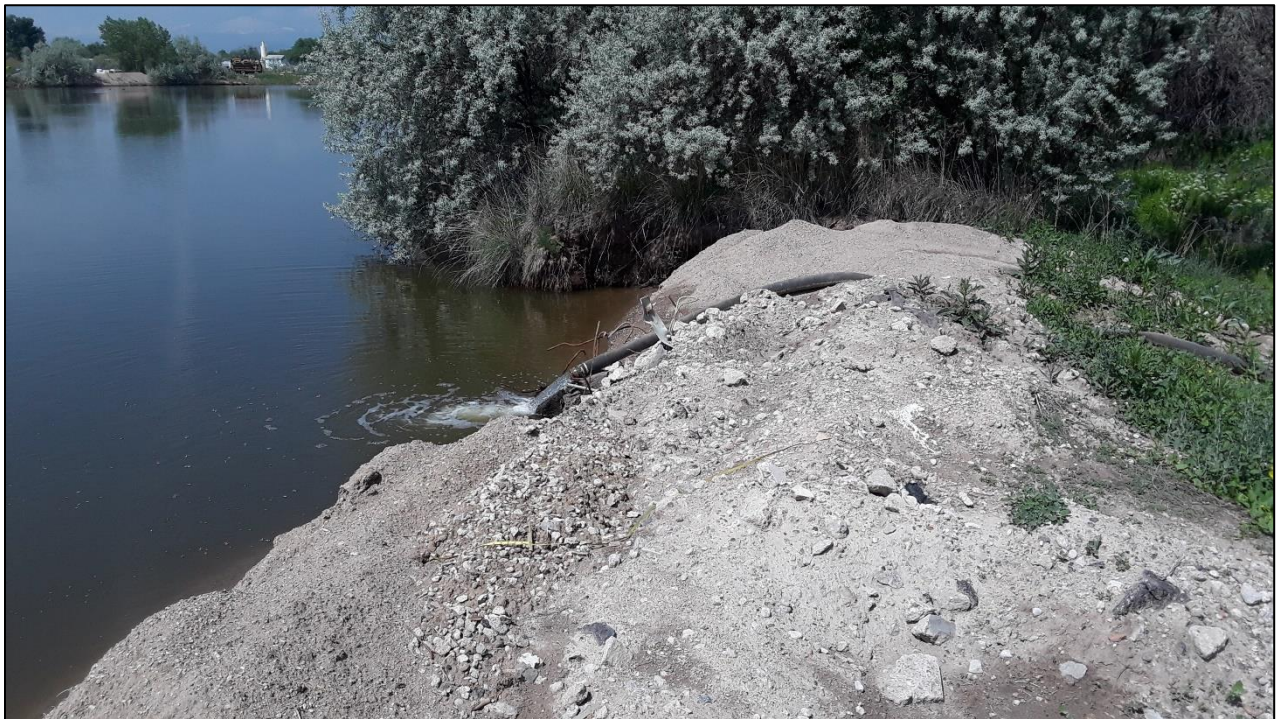
**Photo 12.** View from top of berm separating West Reservoir from unlined pond in Kauffman Pit permit area, showing hose discharging water to pond from dewatering trench in West Reservoir.

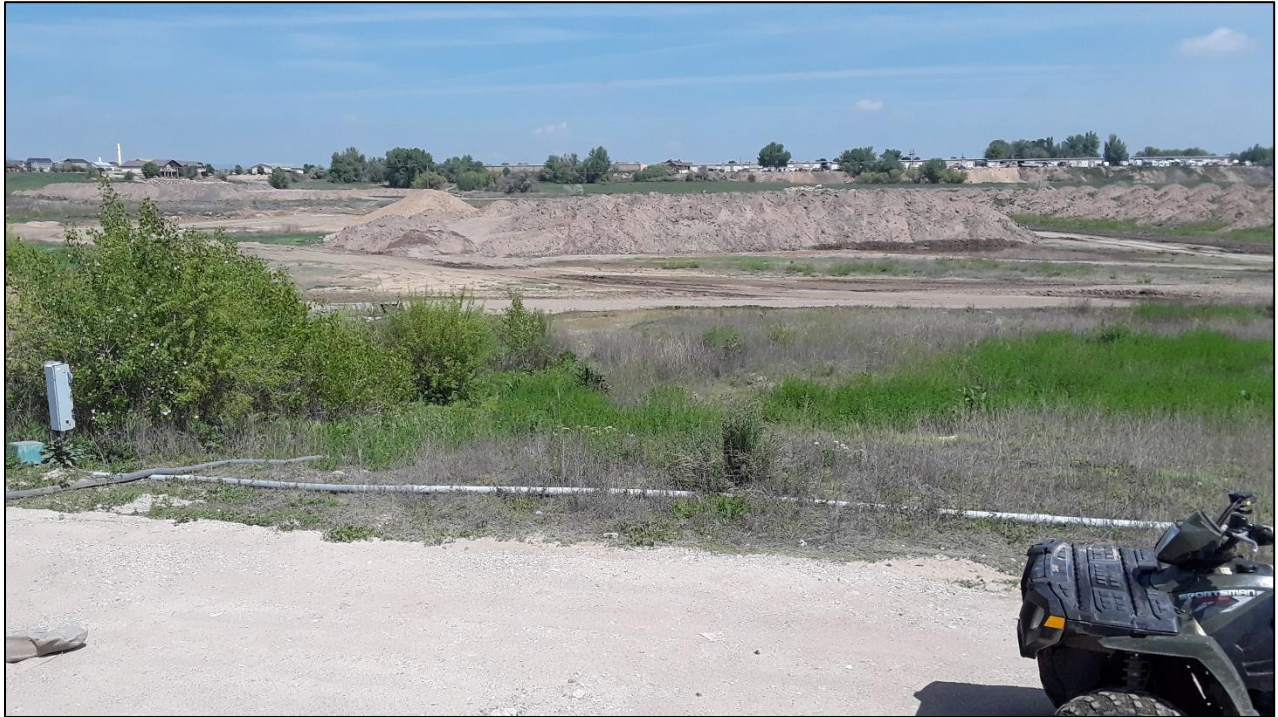
**Photo 13.** View looking north across West Reservoir pit from top of berm separating pit from pond in Kauffman Pit permit area. Note material stockpiles present on pit floor.

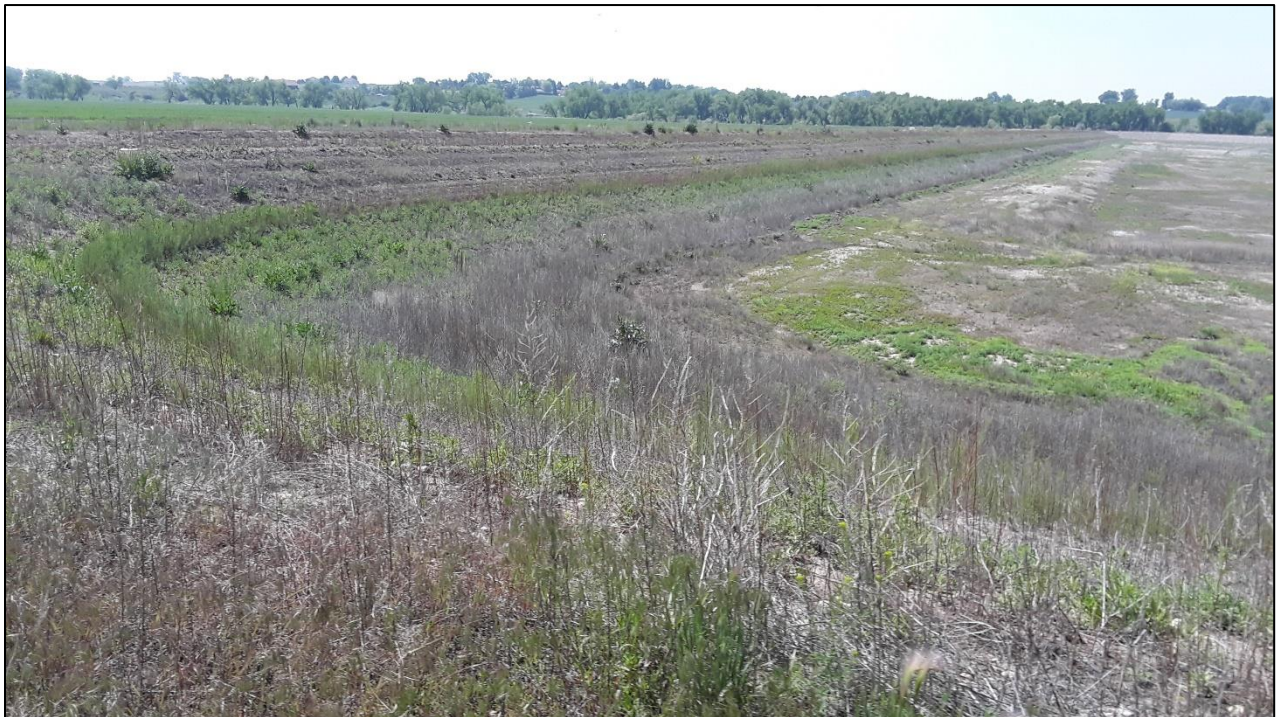
The Division observed the East Reservoir proposed for release in AR-8 (**Photos 14-19**). The reservoir was dry besides some puddles left from a recent storm event. The large topsoil stockpile that was present on the reservoir floor during the 4/14/2017 inspection had been almost completely removed. Only a few feet of the stockpile remains, with the top surface graded flat. As previously mentioned, the topsoil was moved to the two pits located west of the embankment. This was done after the Division informed the operator last year the reservoir could not be released with a large topsoil stockpile stored in the area. The slopes of the reservoir were graded to 3H:1V and seeded many years ago. The reservoir slopes appeared to be stable with decent vegetative growth on slopes that have not yet received rip rap placement. The approved reclamation plan does not require rip rap placement along the slopes of the East Reservoir. This project is being funded by the City of Loveland. The timing for this project is controlled by city budgeting, thus, only the western and southern slopes have had rip rap placement at this time. The clay liner constructed around the East Reservoir was approved by DWR as having met the design standard in a letter dated January 17, 2017. The DWR submitted comments on May 8, 2018 in response to AR-8, which further confirm the pit has been classified as a lined reservoir.

**Photo 14.** View looking southeast across eastern slope of East Reservoir, showing slope at 3H:1V gradient and stable with vegetative cover. This slope will be covered with rip rap, per City of Loveland.

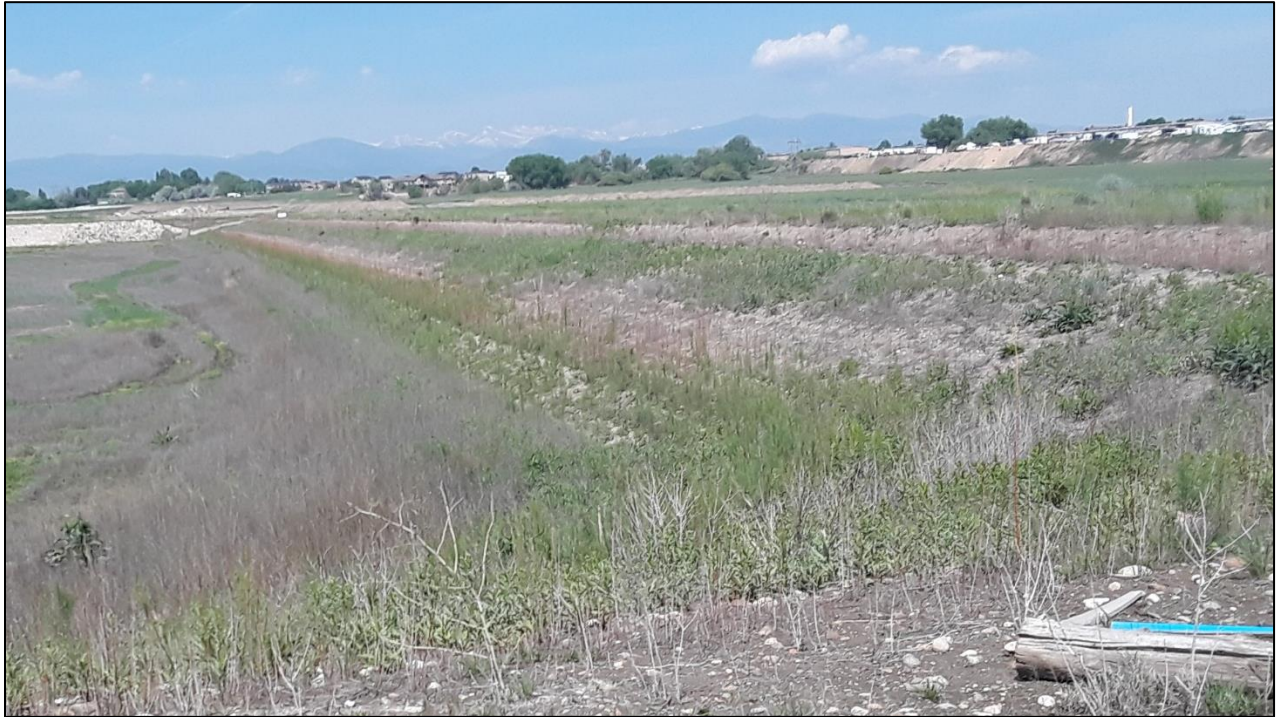
**Photo 15.** View looking northwest across northern slope of East Reservoir, showing slope at 3H:1V gradient and stable with vegetative cover. This slope will be covered with rip rap, per City of Loveland.

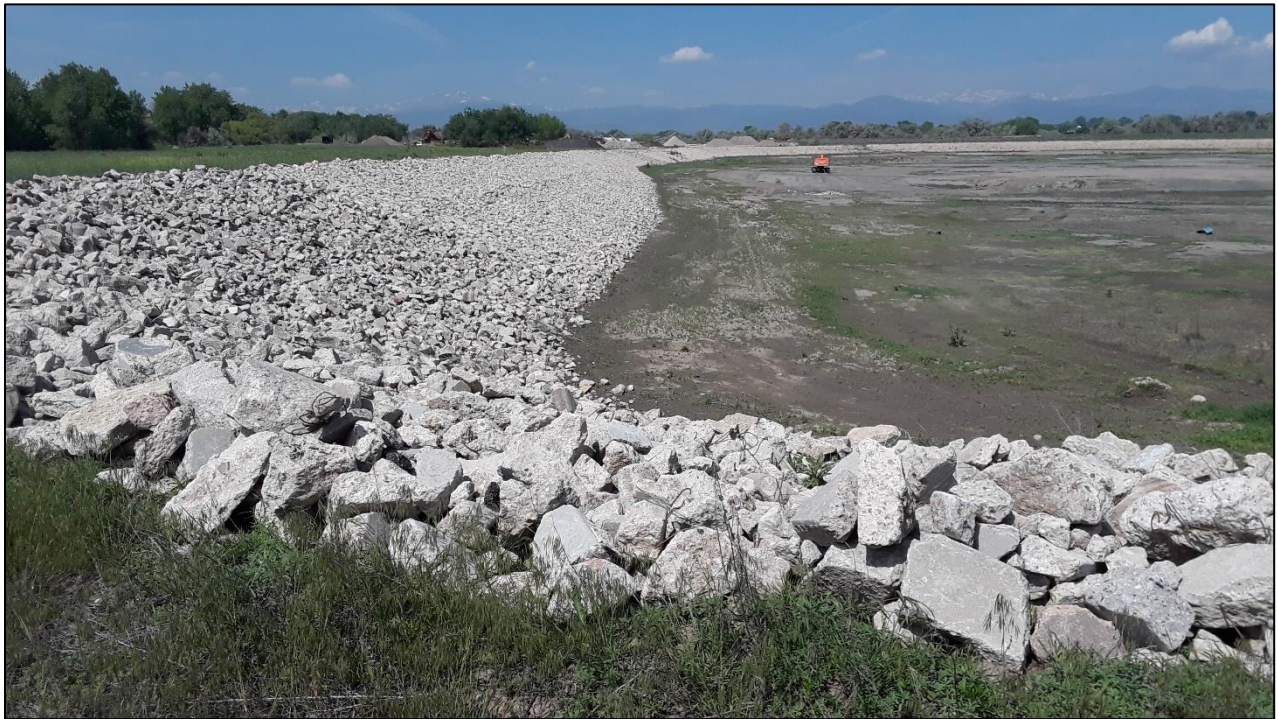
**Photo 16.** View looking west across southern slope of East Reservoir, showing slope at 3H:1V gradient and covered with rip rap composed of crushed concrete.

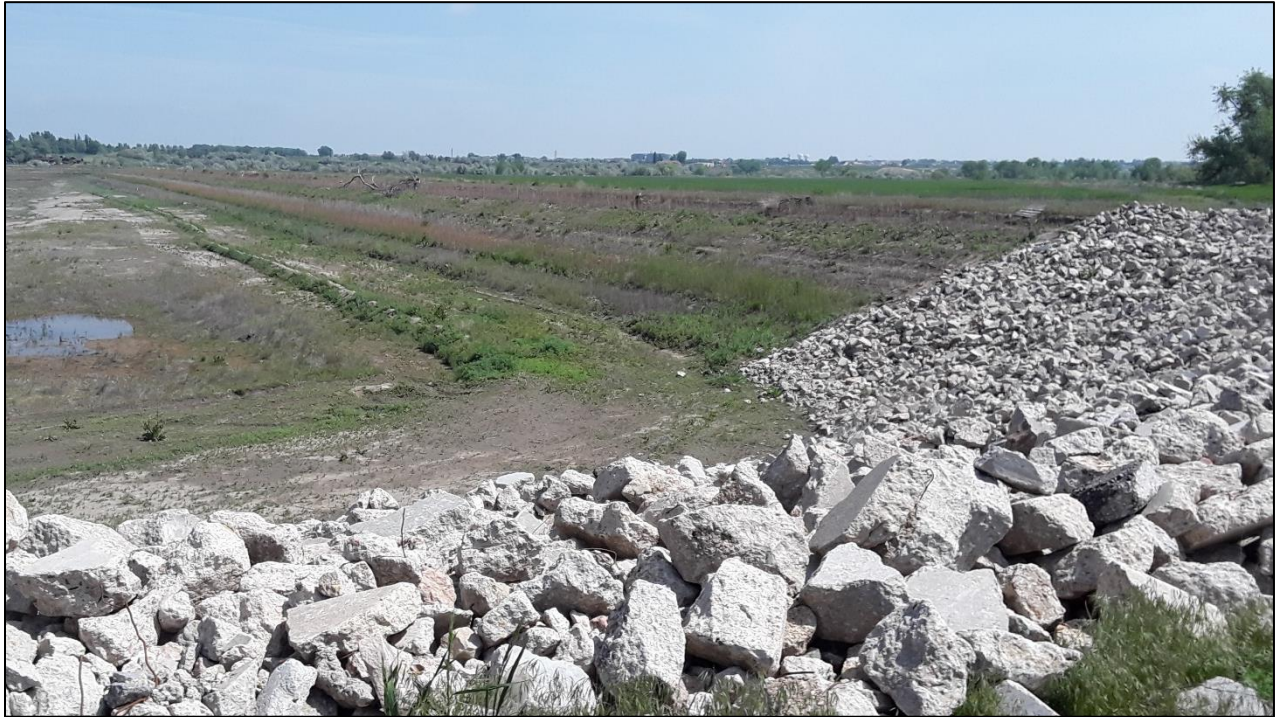
**Photo 17.** View looking northeast across eastern slope of East Reservoir, showing slope at 3H:1V gradient and stable with vegetative cover. This slope will be covered with rip rap, per City of Loveland, as was done with southern slope (shown in foreground).

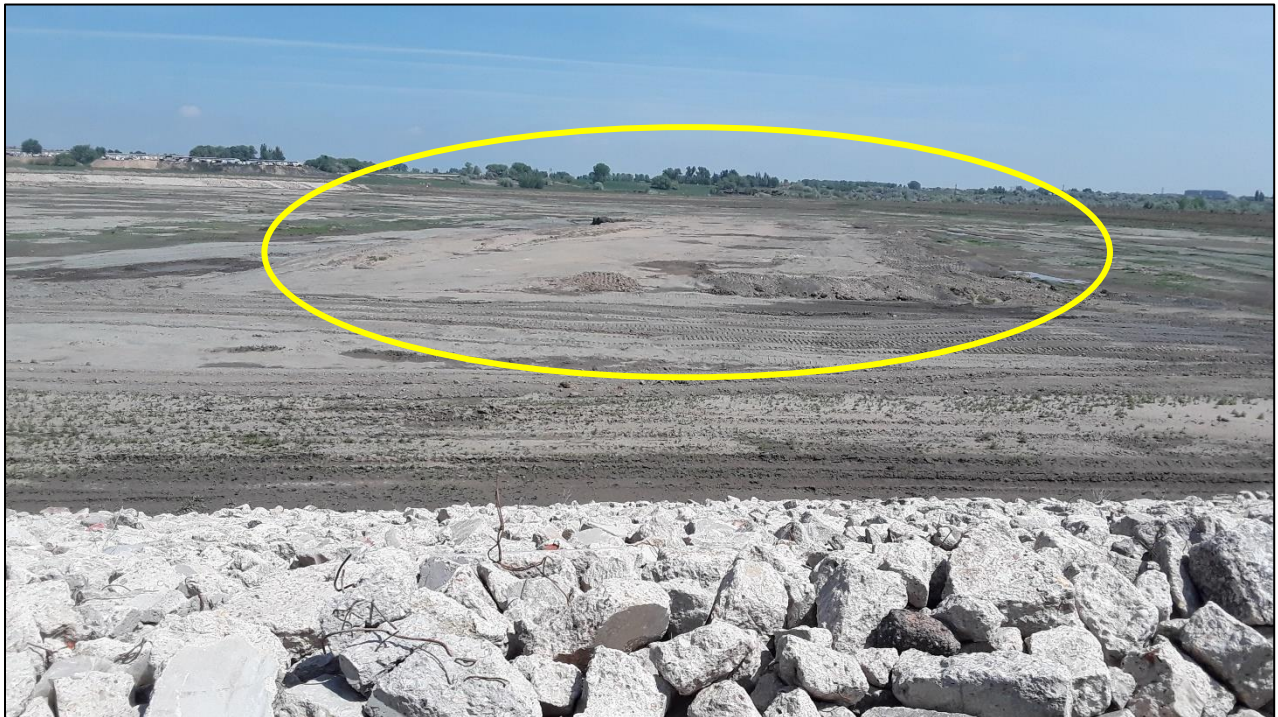
**Photo 18.** View looking north from southern edge of East Reservoir, showing area where large topsoil stockpile was present during last inspection (indicated with circle). Note stockpile has been almost completely removed from the pit floor.

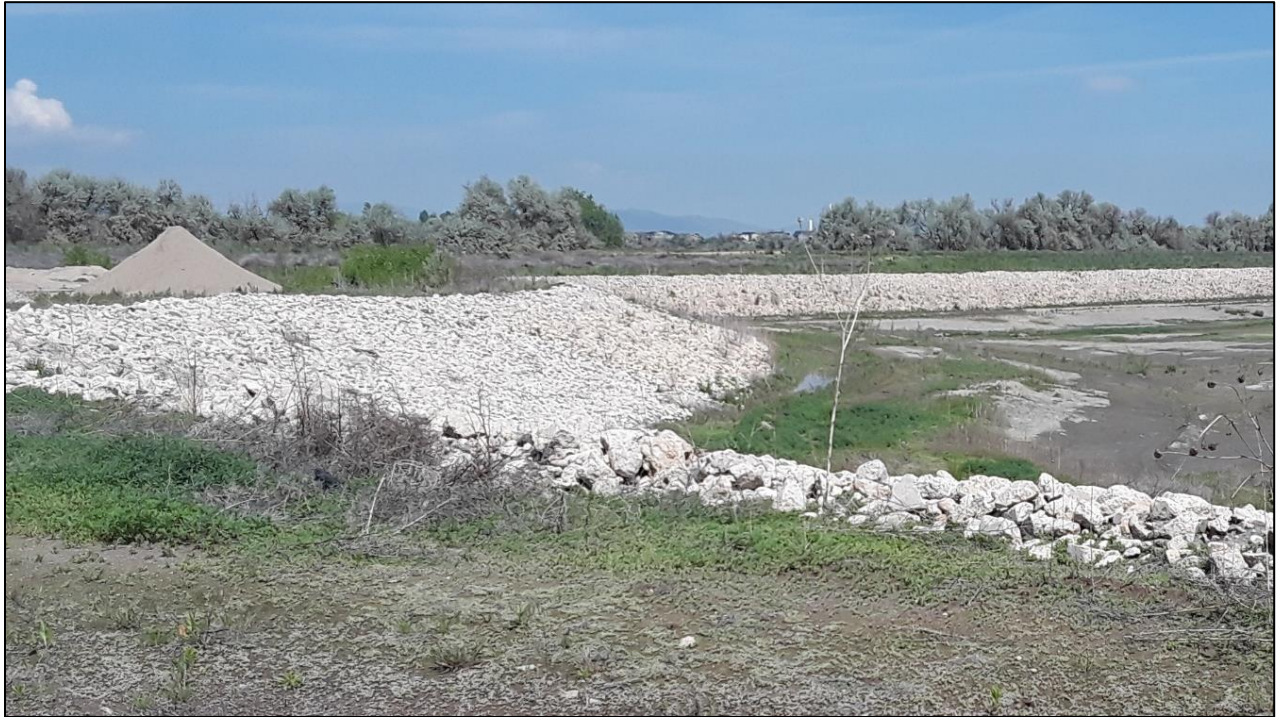
**Photo 19.** View looking northwest across southwest corner and south slope of East Reservoir, showing slope at 3H:1V gradient and covered with rip rap composed of crushed concrete. Stockpiles visible at left are part of Kauffman pit permit area.
