MINERALS PROGRAM INSPECTION REPORT
PHONE: (303) 866-3567

MINE NAME: Kauffman Pit	MINE/PROSPECTING ID#: M-1978-327	MINERAL: Sand and gravel	COUNTY: Larimer
INSPECTION TYPE: Monitoring	INSPECTOR(S): Amy Eschberger	INSP. DATE: May 22, 2018	INSP. TIME: 11:00
OPERATOR: Jake Kauffman & Son, Inc.	OPERATOR REPRESENTATIVE: Dan Giroux, Frank Kauffman, Troy Kauffman	TYPE OF OPERATION: 112c - Construction Regular Operation	
REASON FOR INSPECTION: Normal I&E Program	BOND CALCULATION TYPE: Complete Bond	BOND AMOUNT: \$84,440.00	
DATE OF COMPLAINT: NA	POST INSP. CONTACTS: None	JOINT INSP. AGENCY: None	
WEATHER: Clear	INSPECTOR'S SIGNATURE:

M-1978-327 / Kauffman Pit / Jake Kauffman & Son, Inc.

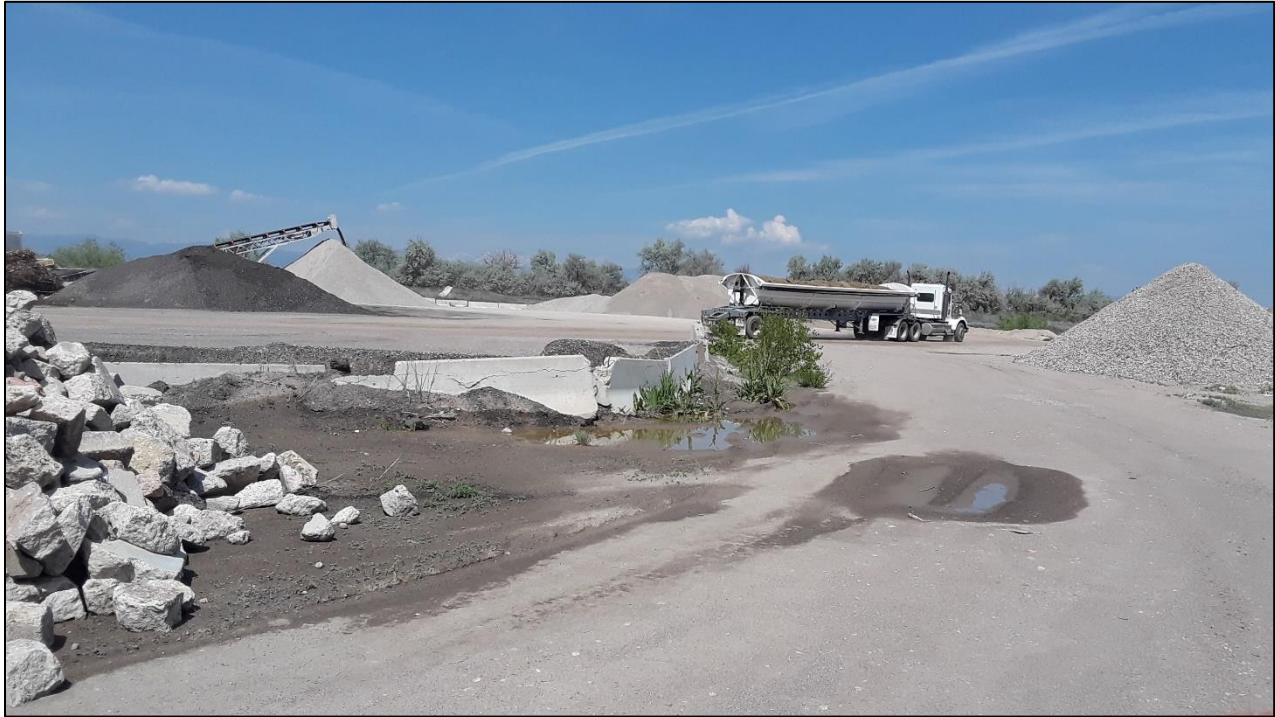
During the inspection, the recycled materials plant was in operation (**Photos 1-3**). Several material stockpiles are stored in this area. The Division observed no evidence of spills or improper storage of fuel. The two ponds appear to be reclaimed in accordance with the approved reclamation plan, as their shorelines have been graded to the approved final slope configuration and are stable. The north pond (**Photos 4 and 5**) appears to have been undisturbed for some time, as its shorelines have very good vegetative cover, including several mature trees. The south pond (**Photo 6**) has good vegetative cover around all but the eastern shoreline, which the operator continues to backfill. This shoreline has slopes of 4H:1V or flatter. Because the area east of the south pond has been designated for industrial/commercial use, it will not require revegetation for final release. This storage area is currently being used for stockpile storage in support of the operator's commercial yard (**Photo 7**). The designated storage area south of the north pond is currently being used for industrial/commercial purposes (**Photos 8 and 9**).

Photo 1. View looking northwest across northern portion of material recycling plant that operates at eastern edge of permit area.

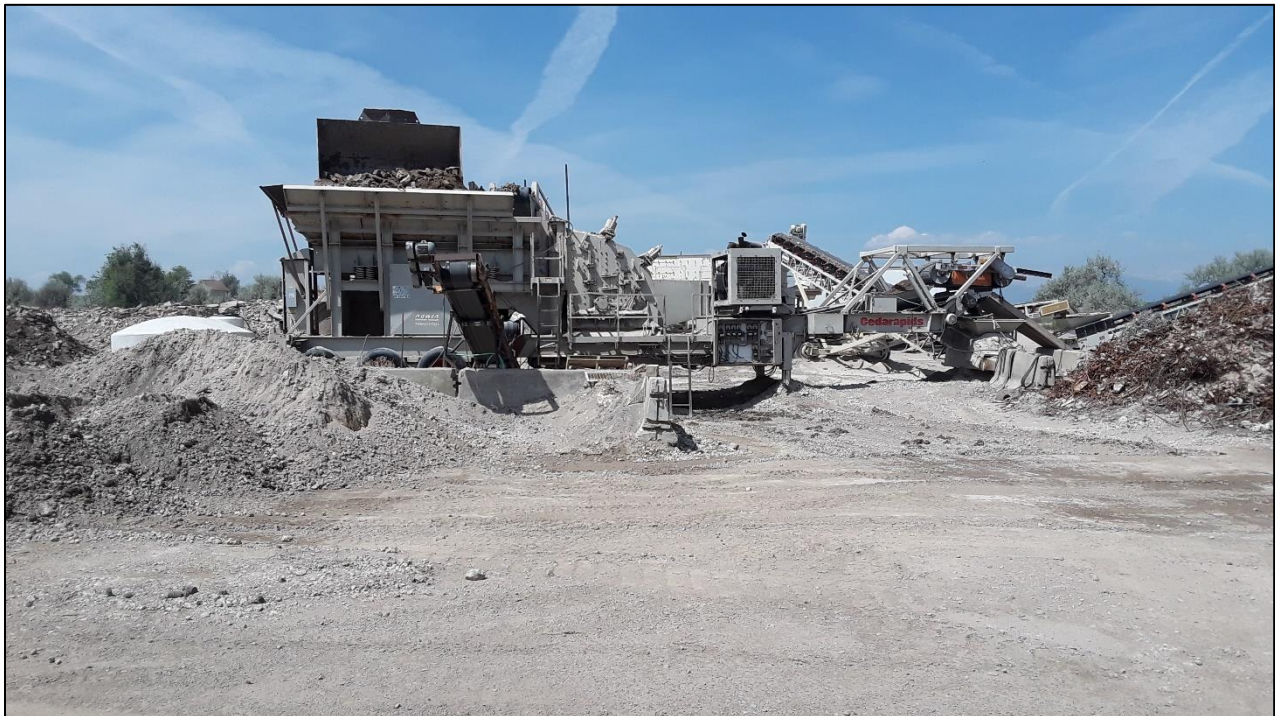
Photo 2. View looking west across material recycling plant that operates at eastern edge of permit area.

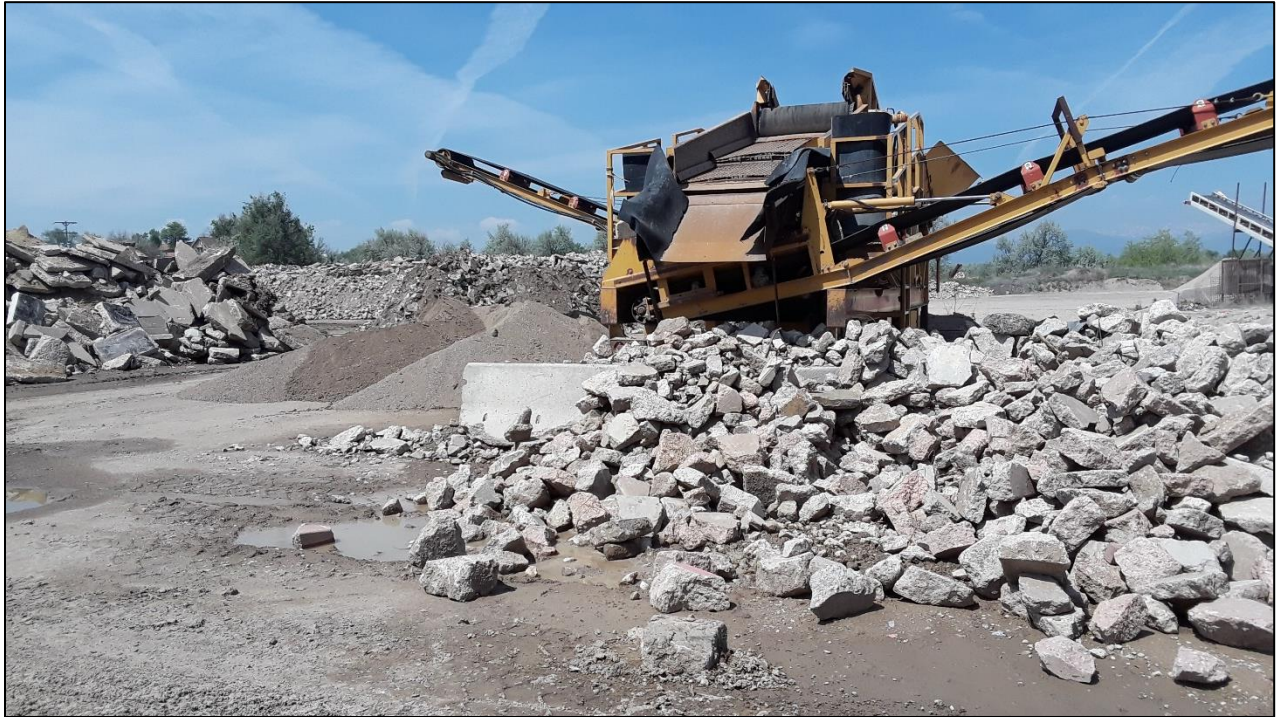
Photo 3. View looking southwest across material recycling plant that operates at eastern edge of permit area.

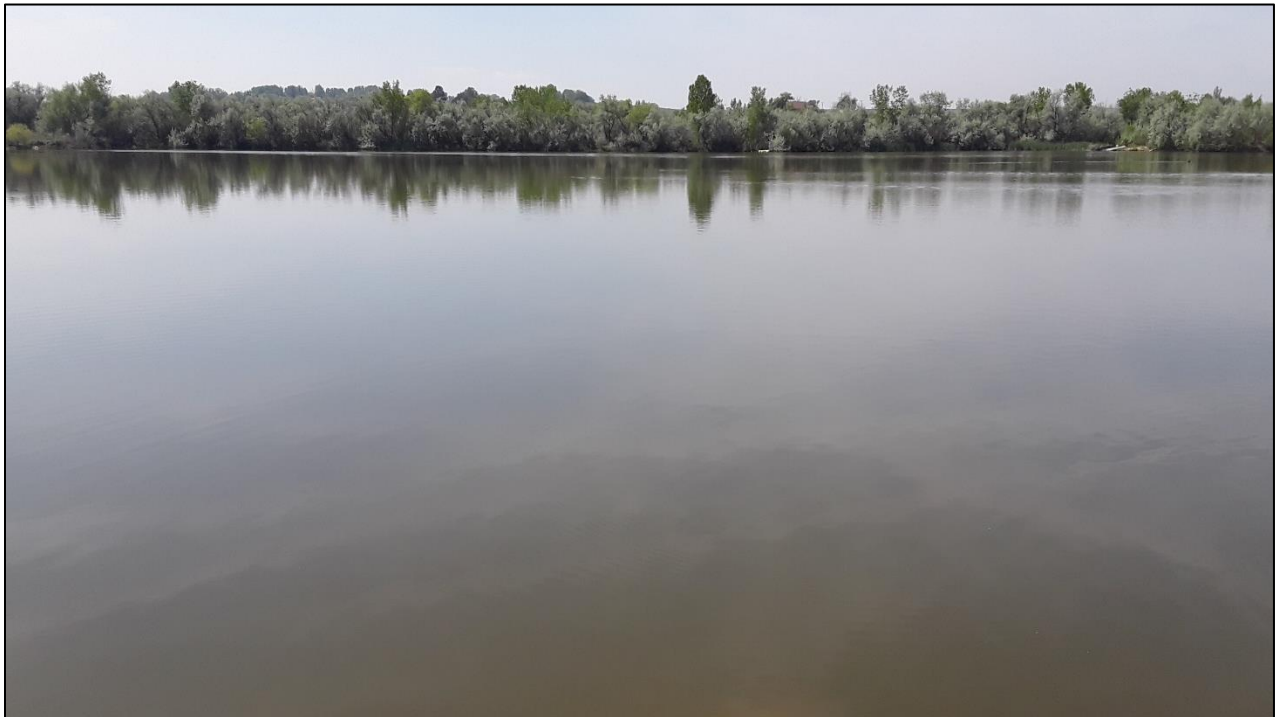
Photo 4. View looking south across reclaimed north pond. Note established vegetation across shoreline, including several mature trees.

No problems were observed during the inspection. However, the Division recommends the operator implement the approved weed control plan for the site, especially for any state-listed noxious weed species. Additionally, because the site is considered releasable at this time, the Division strongly encourages the operator to submit a

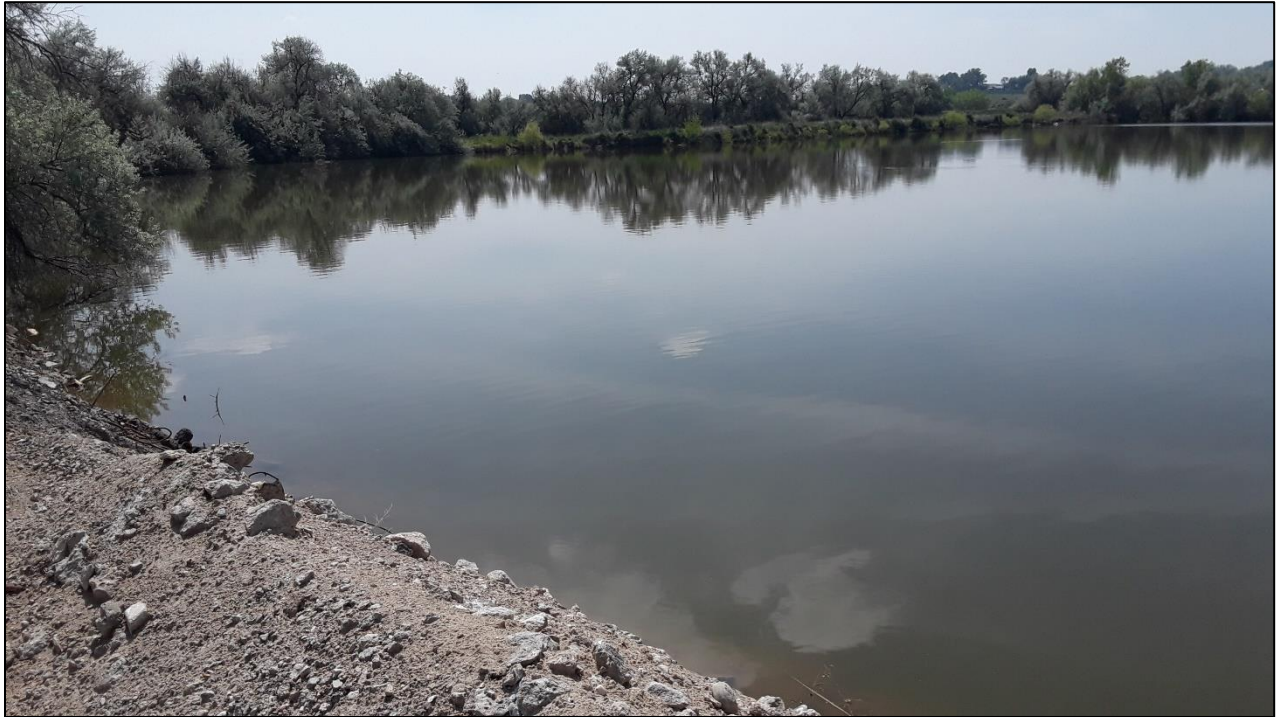
Photo 5. View looking southeast across reclaimed north pond. Note established vegetation across shoreline, including several mature trees. Bare ground in foreground is part of repaired berm separating the pond from a pit in the Wagner/Kauffman Pit #3 permit area.

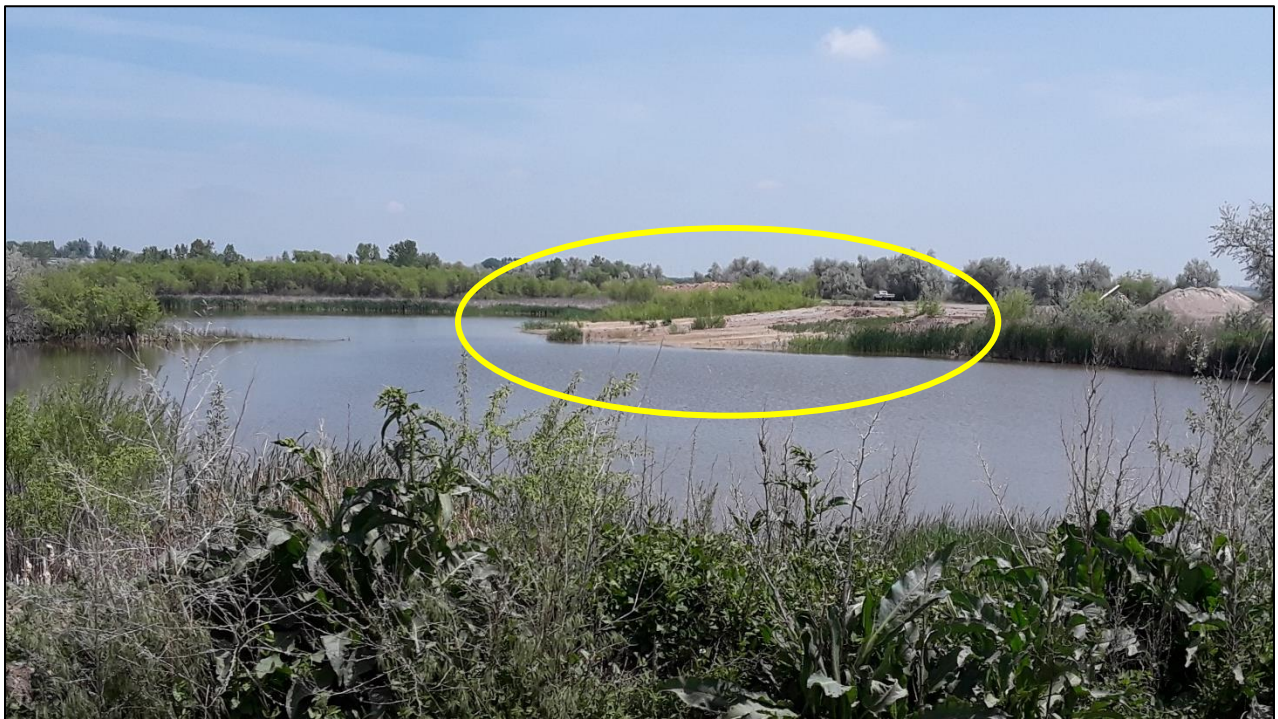
Photo 6. View looking northeast across reclaimed south pond. Note shorelines have good vegetative cover, except for portion of eastern shoreline where pond continues to be backfilled (circled).

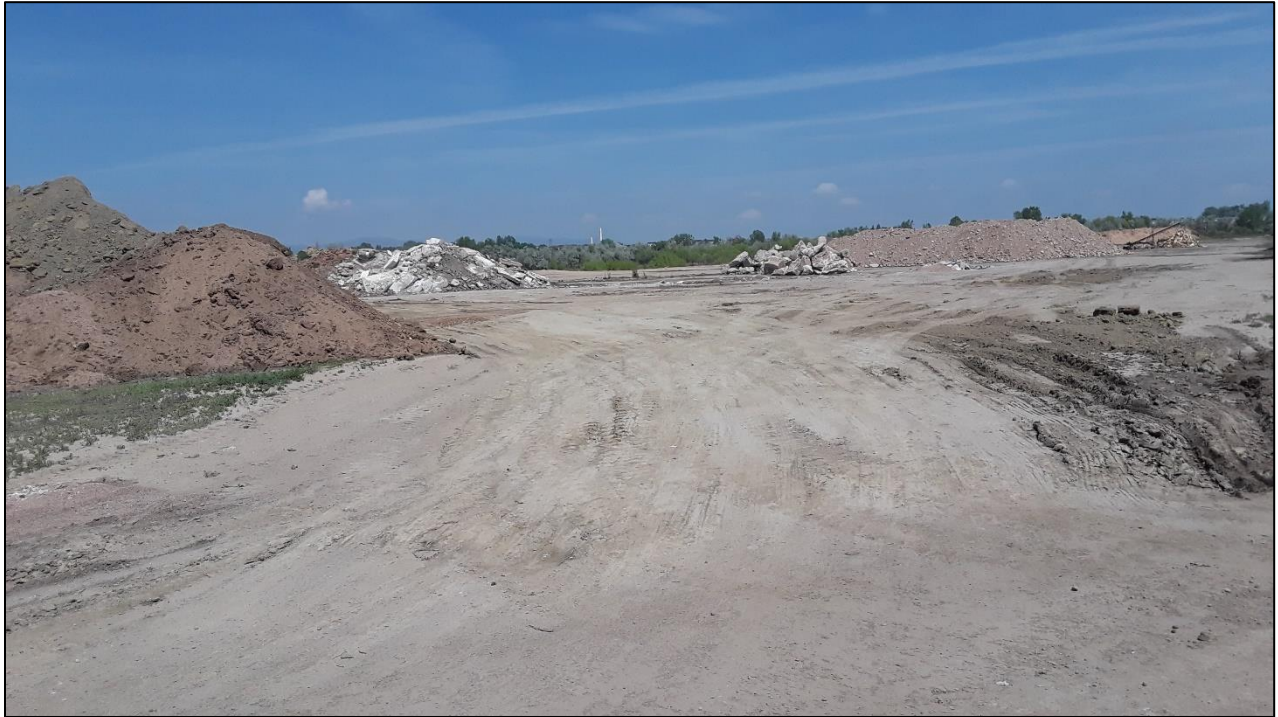
Photo 7. View looking north across designated storage area located east of south pond, where operator stores material and equipment in support of the adjacent commercial yard.

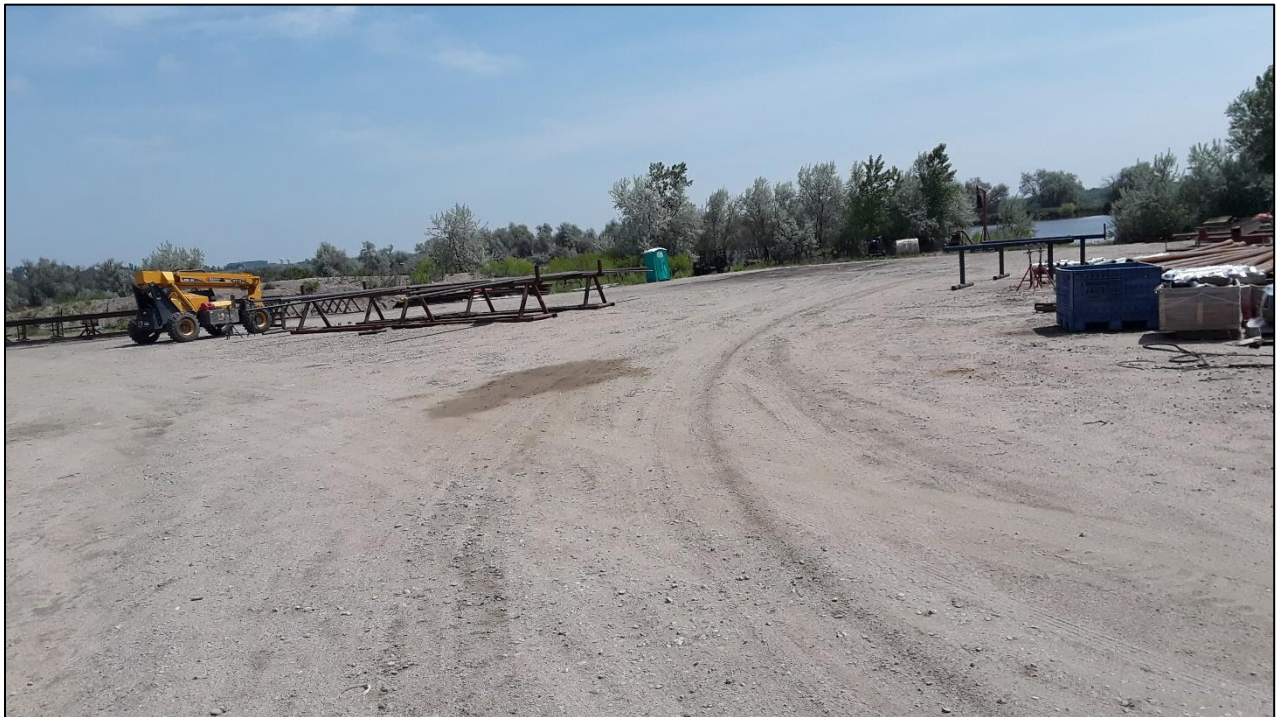
Photo 8. View looking northeast across designated storage area located south of north pond, which operator leases out for commercial/industrial use.

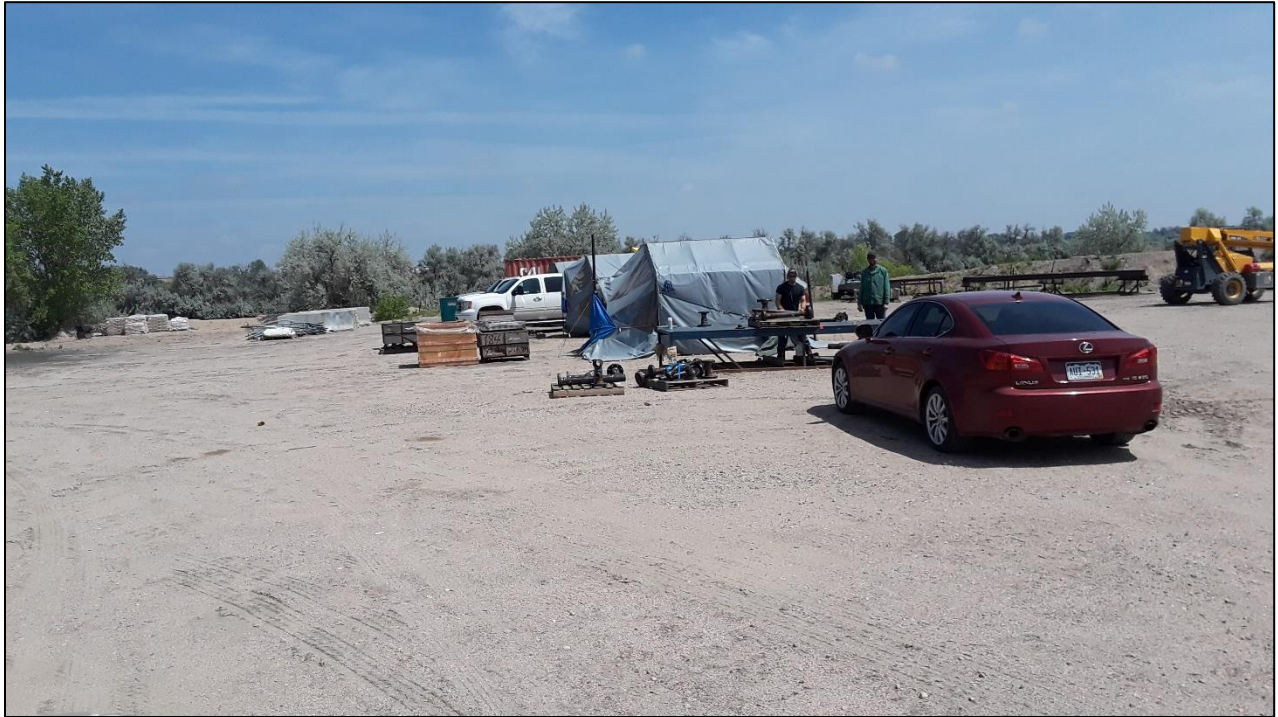
Photo 9. View looking northwest across designated storage area located south of north pond, which operator leases out for commercial/industrial use.
