MINERALS PROGRAM INSPECTION REPORT
PHONE: (303) 866-3567

MINE NAME: Cottonwood Quarry	MINE/PROSPECTING ID#: M-2004-061	MINERAL: Aggregate	COUNTY: Grand
INSPECTION TYPE: Surety-Related Inspection	INSPECTOR(S): Peter S. Hays	INSP. DATE: May 22, 2018	INSP. TIME: 12:00
OPERATOR: Kilgore Companies, LLC dba Peak Materials	OPERATOR REPRESENTATIVE: Jon Mueller	TYPE OF OPERATION: 112c - Construction Regular Operation

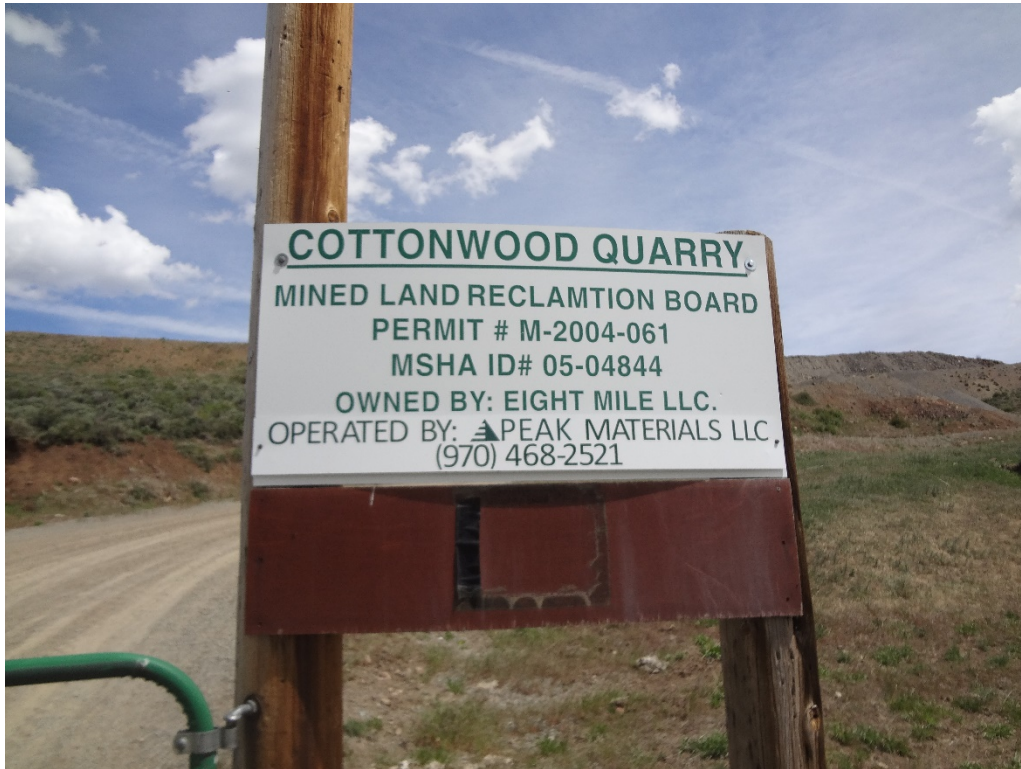
An entrance sign was posted as required by Rule 3.1.12. The mining disturbance, haul road between the scale house bench and the processing bench, appears to be very close to the western boundary of the site and possibly within the required 25 foot offset from the permit boundary based on the t-post installed near the haul road. It is unknown if the t-post indicates the permit boundary or the 25 foot offset buffer location. As cited as a problem, the Division will require the Operator to survey the site to verify all mining disturbances are located within the permit boundary and install permit boundary markers as required by Rule 1.1.12, as needed. The survey results must be submitted to the Division.

Cottonwood Quarry mine sign

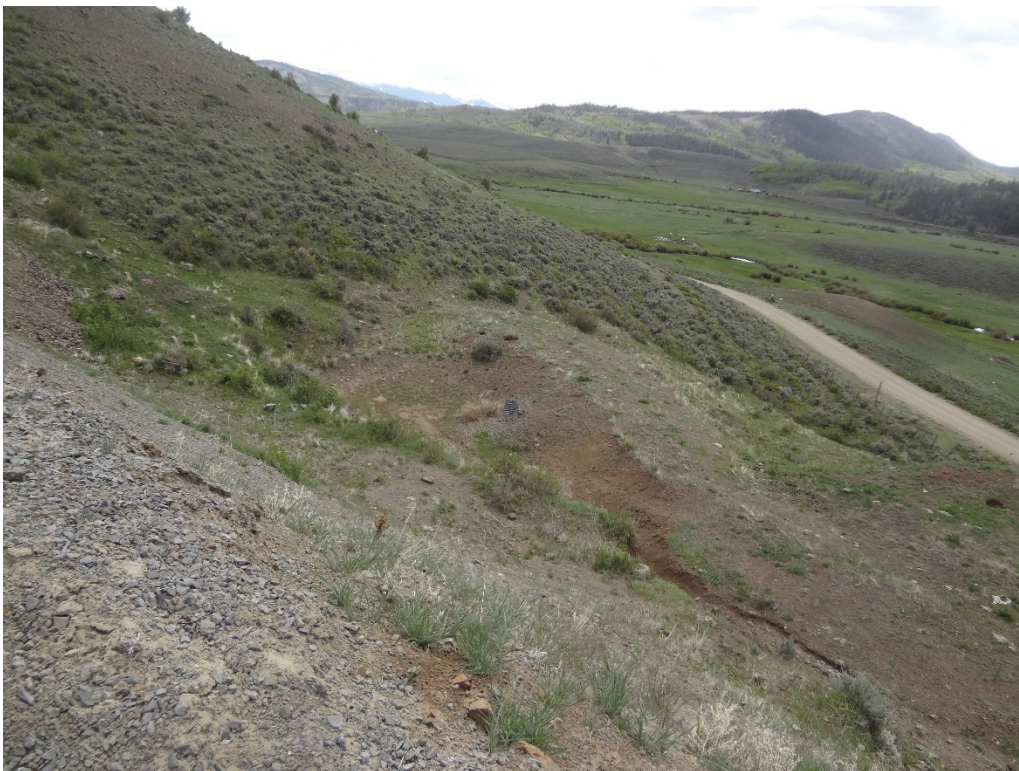
A stormwater retention pond was located in the southeast corner of the site as required by the Mining Plan. Concrete and asphalt stockpiles and debris were observed north of the mining bench. The Operator stated the debris would be removed and the stockpiles would be transported off-site.

View of the stormwater detention basin located in the southwest corner of the site

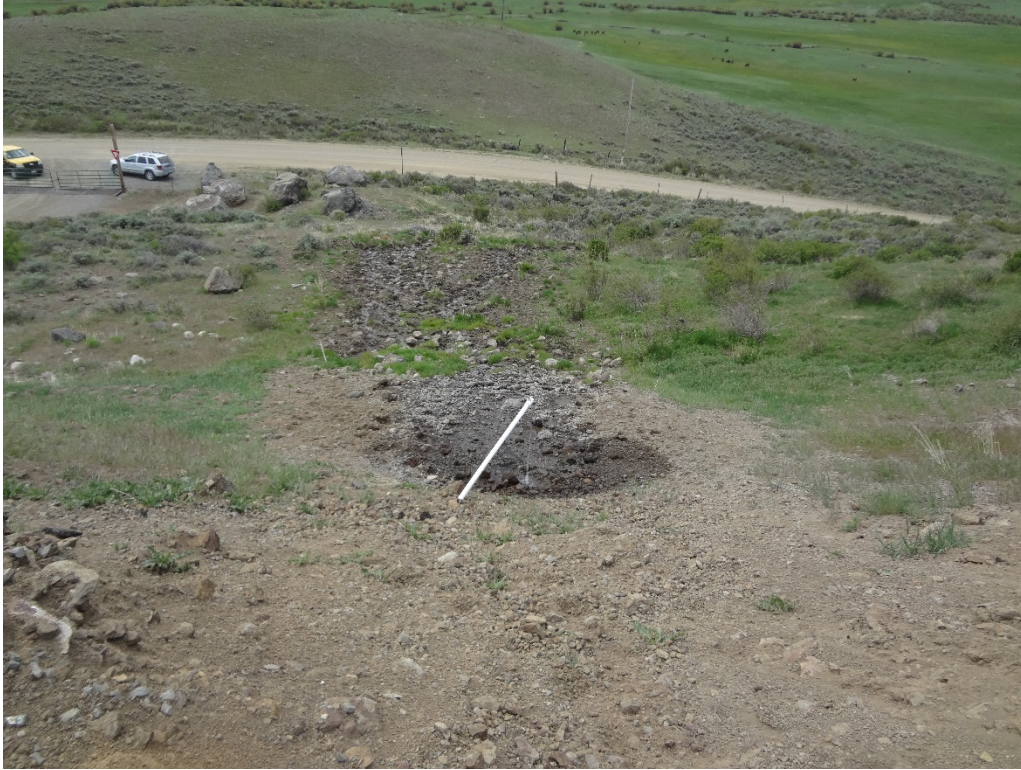
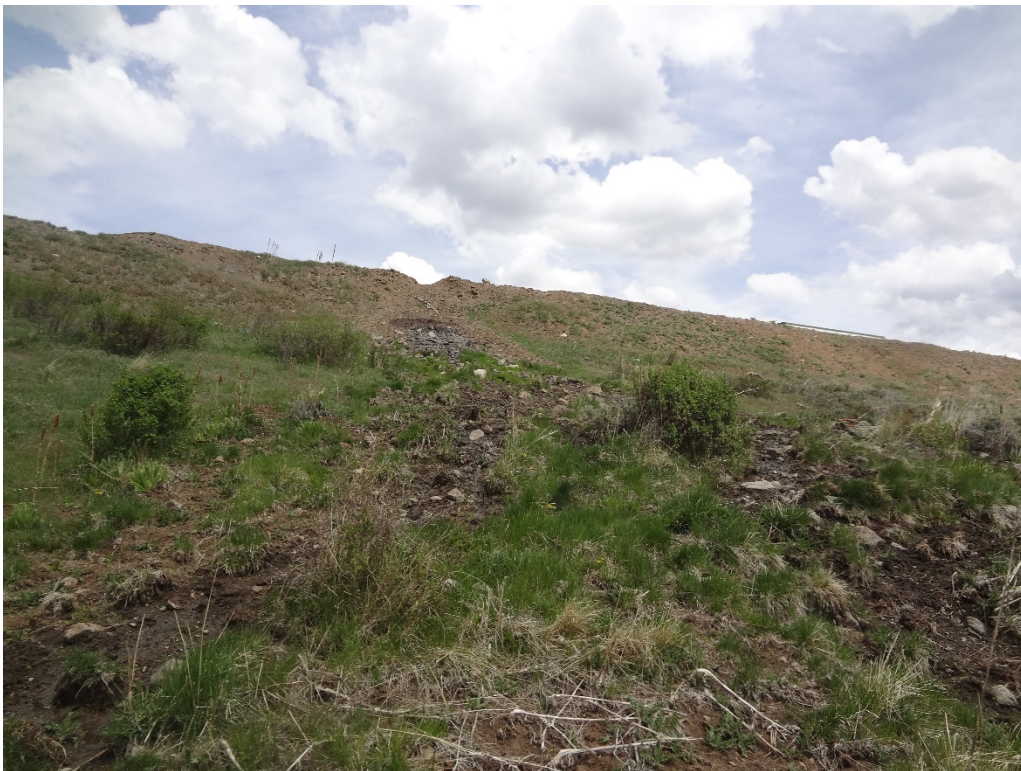
PROBLEM: A 1" diameter PVC pipe was observed protruding from the lower bench southwest of the scale house during the inspection. The pipe was discharging water at an approximate rate of 2-5 gallons per minute. The source of the water and the purpose of the pipe are not included in the approved Mine Plan for the site.

A 1" diameter PVC pipe was observed protruding from the lower bench southwest of the scale house during the inspection. The pipe was discharging water at an approximate rate of 2-5 gallons per minute. The source of the water and the purpose of the pipe are not included in the approved Mine Plan for the site. As cited as a problem, the Division will require the Operator to investigate the purpose of the pipe and the source of the water and provide the Division with an explanation for the pipe and water. The discharged water was infiltrating into the hillside before reaching the permit boundary. A small erosion feature was observed south of the pipe on the hillside.

View of the 1" PVC exiting the scale house bench looking south

View of the 1" PVC exiting the scale house bench looking north

CORRECTIVE ACTIONS: The Operator must investigate the purpose of the pipe and the source of the water and provide the Division with an explanation for the pipe and water.

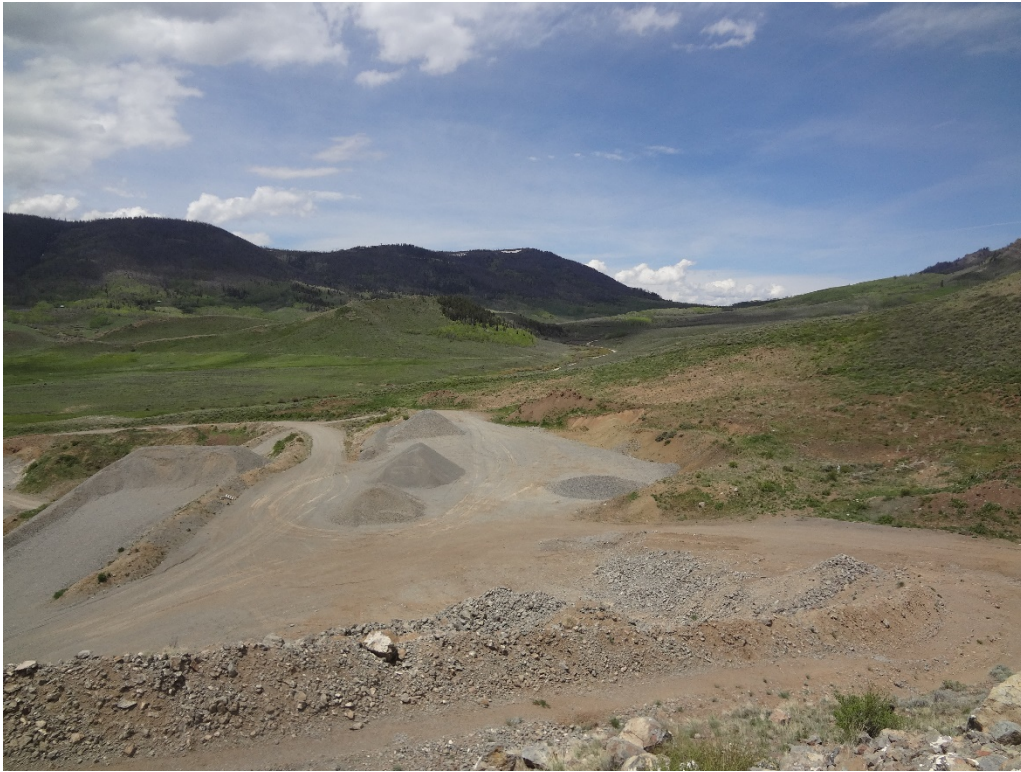
View of the upper stockpile benches from the mining bench looking west

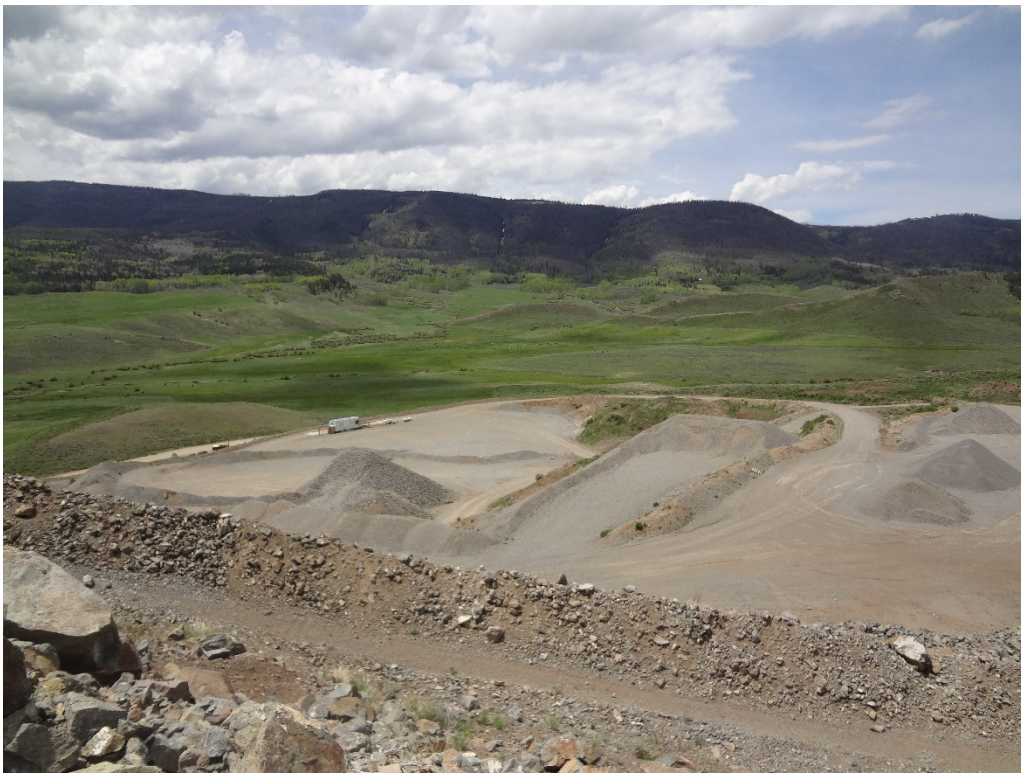
View of the stockpile and scale house benches from the mining bench looking southwest

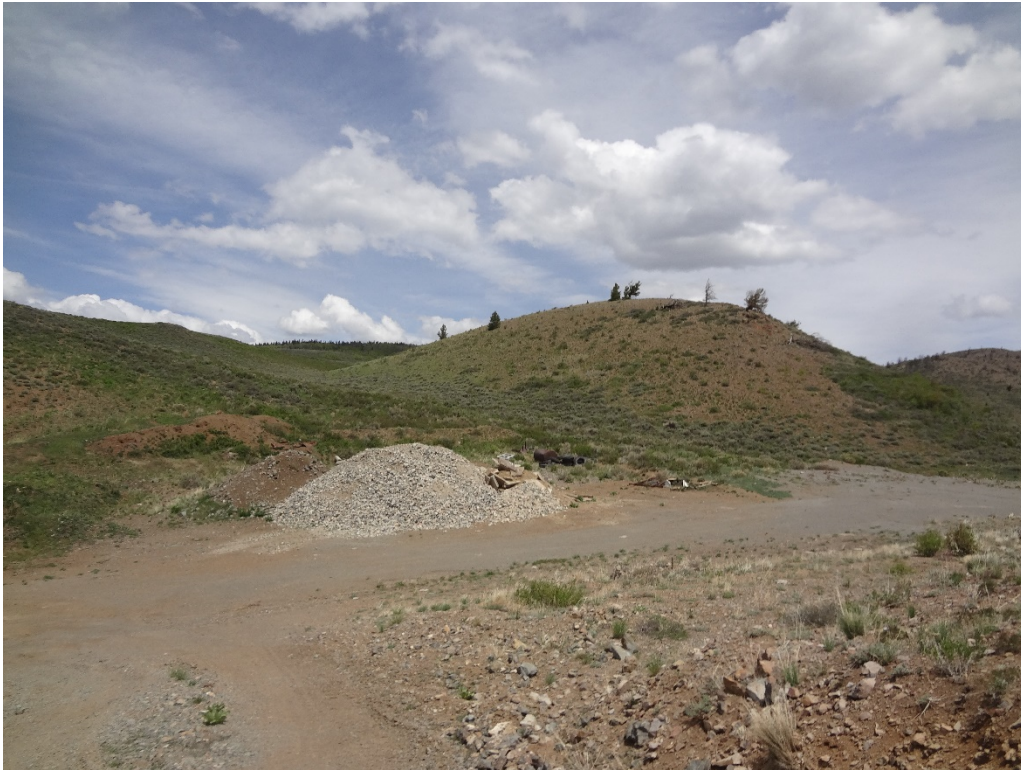
View of concrete stockpile and debris located north of the mining bench

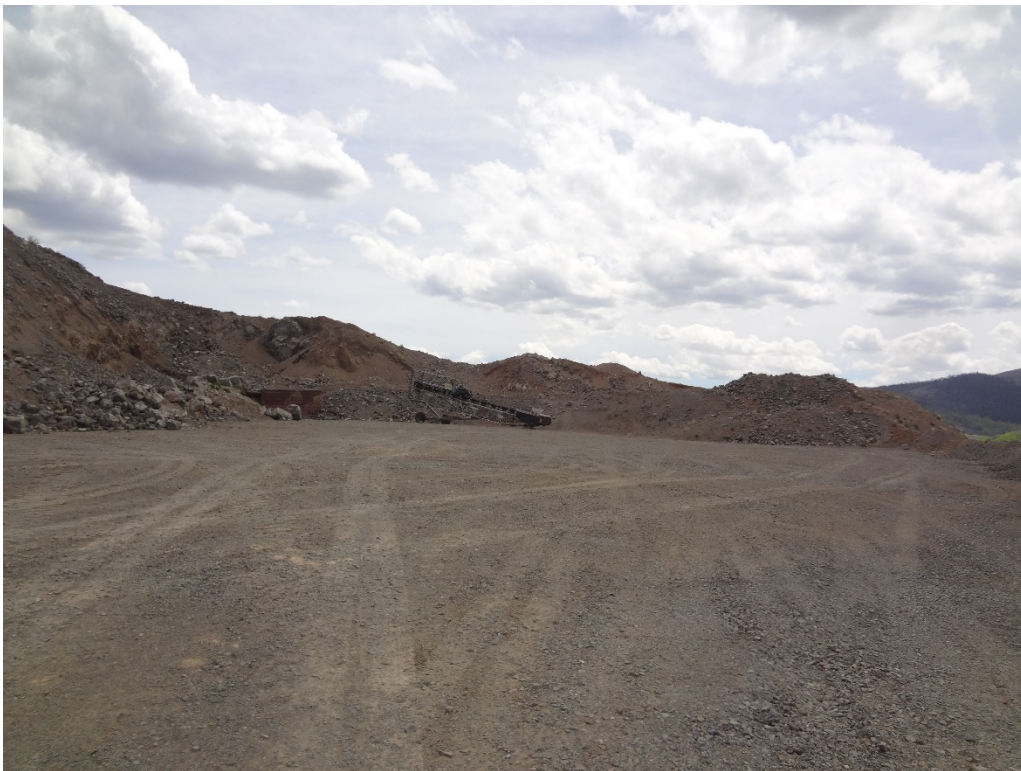
View of the processing plant bench looking east
