MINERALS PROGRAM INSPECTION REPORT
PHONE: (303) 866-3567

MINE NAME: Morrow/Murphy Gravel Pit	MINE/PROSPECTING ID#: M-1979-187	MINERAL: Sand and gravel	COUNTY: Grand
INSPECTION TYPE: Surety-Related Inspection	INSPECTOR(S): Peter S. Hays	INSP. DATE: May 22, 2018	INSP. TIME: 12:30
OPERATOR: Kilgore Companies, LLC dba Peak Materials	OPERATOR REPRESENTATIVE: Jon Mueller	TYPE OF OPERATION: 112c - Construction Regular Operation	
REASON FOR INSPECTION: Surety Related	BOND CALCULATION TYPE: Complete Bond	BOND AMOUNT: \$132,600.00	
DATE OF COMPLAINT: NA	POST INSP. CONTACTS: None	JOINT INSP. AGENCY: None	
WEATHER: Clear	INSPECTOR'S SIGNATURE:

SIGNATURE DATE: May 29, 2018

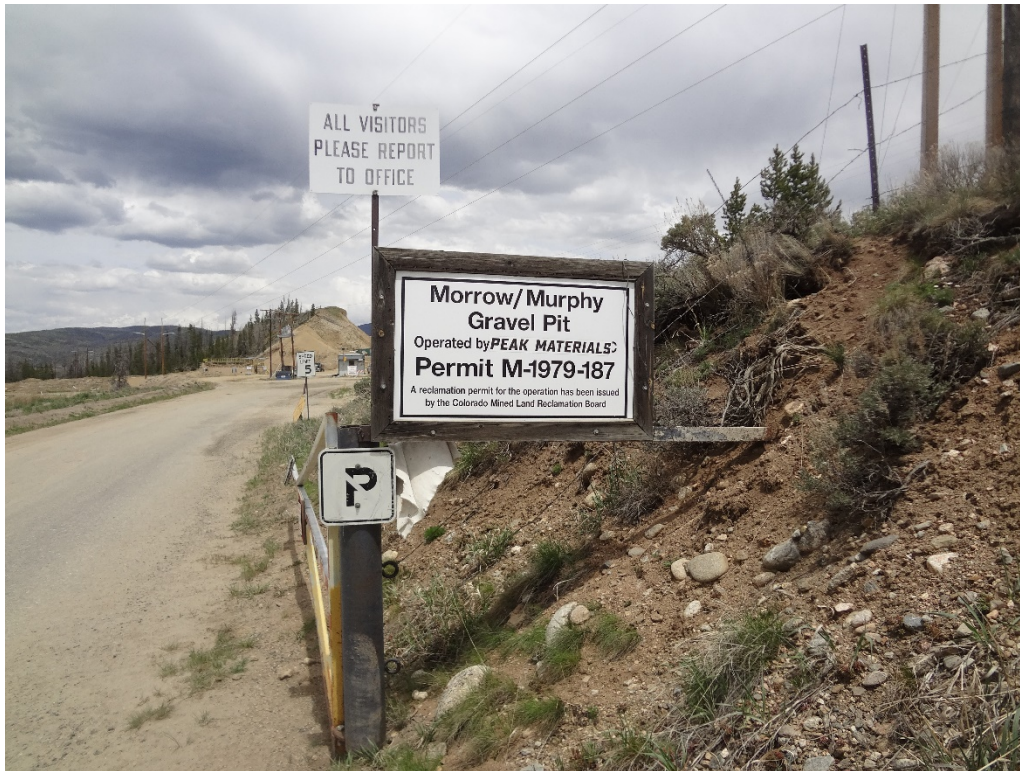
An entrance sign was posted as required by Rule 3.1.12 and all mining disturbance appeared to be contained within the approved permit boundary.

Morrow/Murphy mine sign

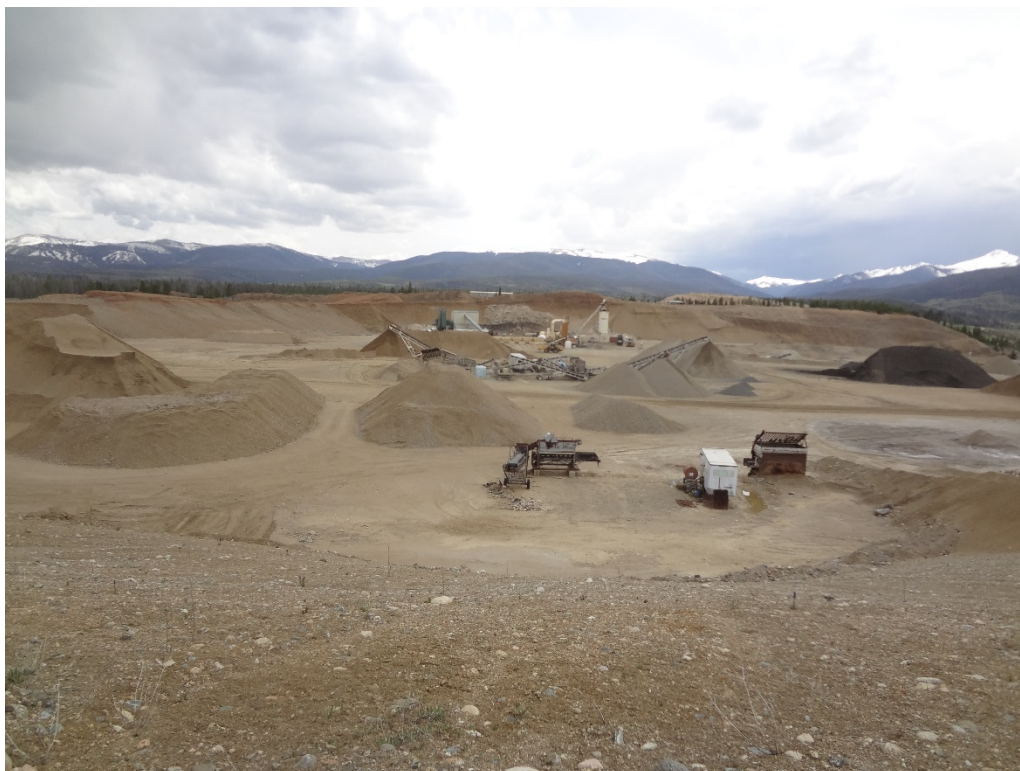
View of site from the north highwall looking south at batch and processing plants

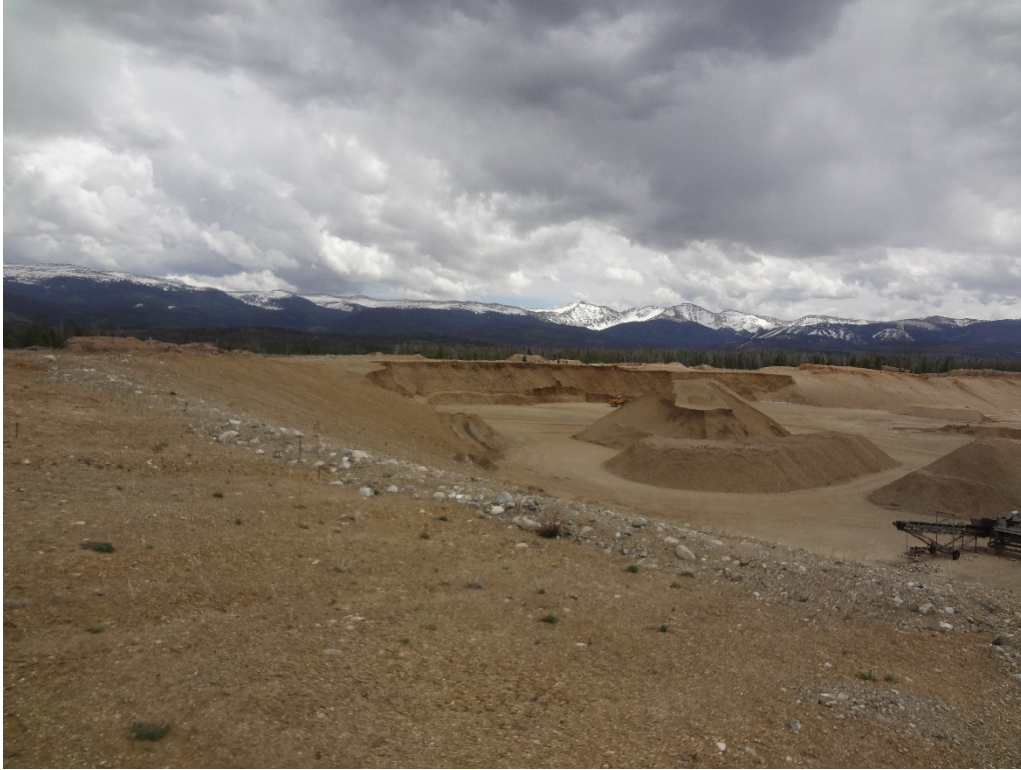
View of site from the north highwall looking southeast at highwall and stockpiles

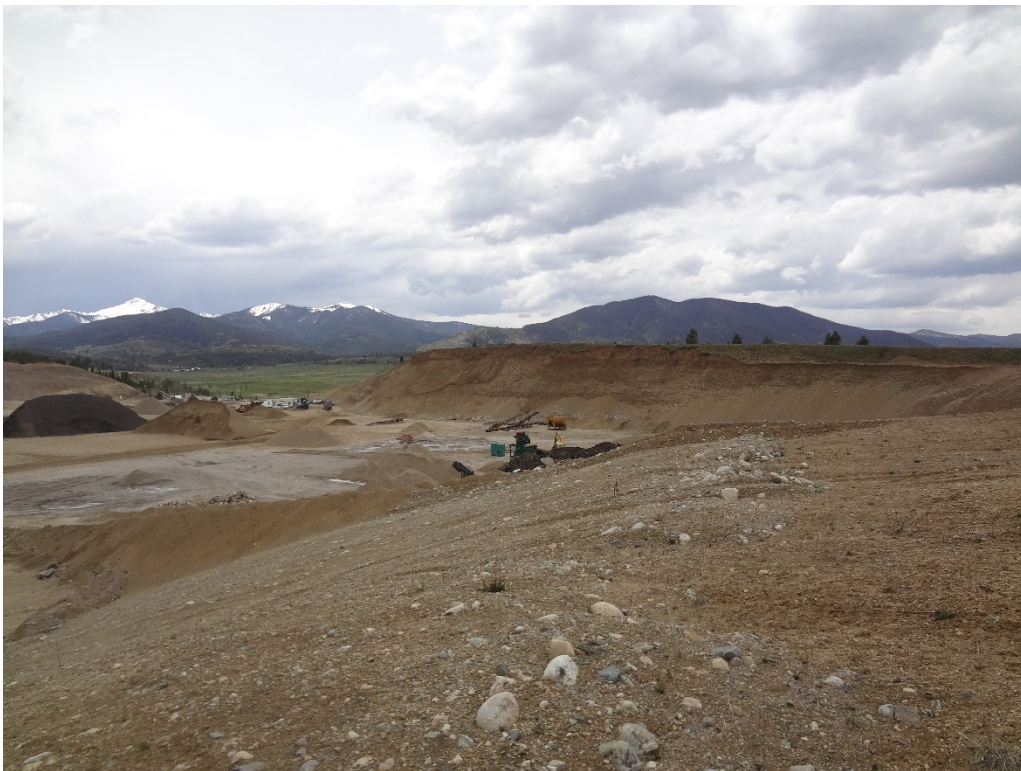
View of site from the north highwall looking southwest

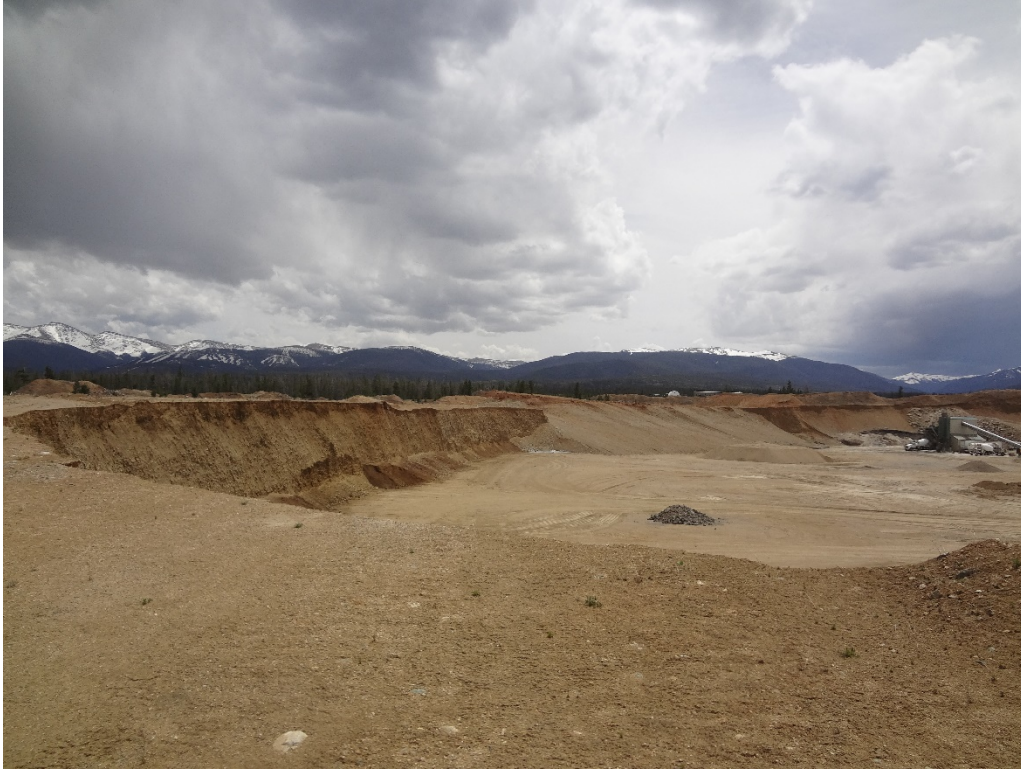
During the 1998 permit amendment, the Operator committed to a maximum of 4700 lineal feet of working extraction face (highwall) with approximately 1000 feet of total vertical face and the remaining area sloped between 2H:1V to 3H:1V. The Division estimated the amount of vertical highwall at 997 feet and sloped highwall at 3,394 feet. The Operator is in compliance with the highwall length and grading requirements of the permit.

View of the current highwall and graded section of highwall looking south

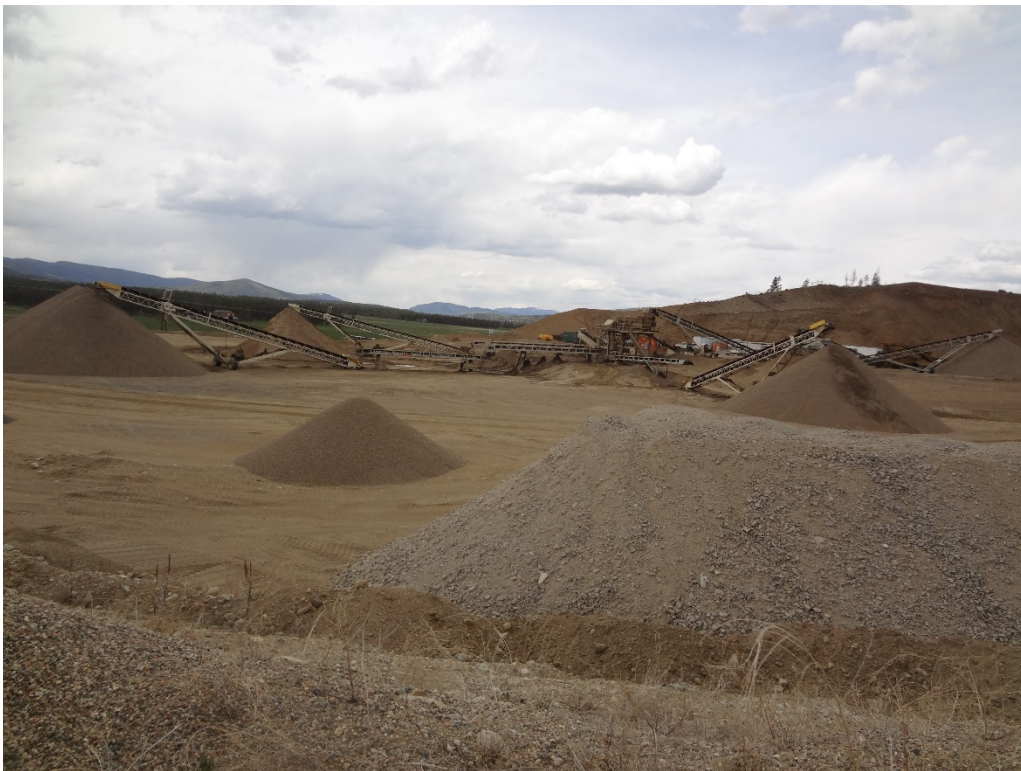
View of wash plant looking north from pit floor
