## RE: P-2008-052, Lucky Jack Project Weather Station

To follow up on your inspection of May 7, 2018:

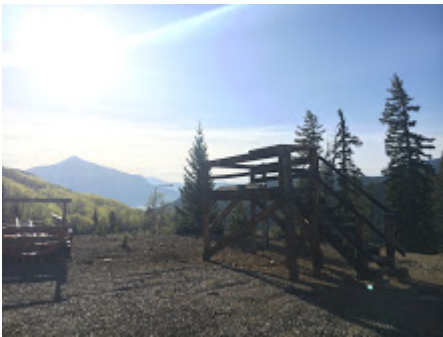
**weather station current location.jpg**  
2320K

The weather station platform was relocated from adjacent to tailing pond #1 (the location shown on the figure you attached), to its current location in the lay-down area adjacent to the core shed. Only the timber platform exists, there is no weather monitoring equipment thereon. See attached.

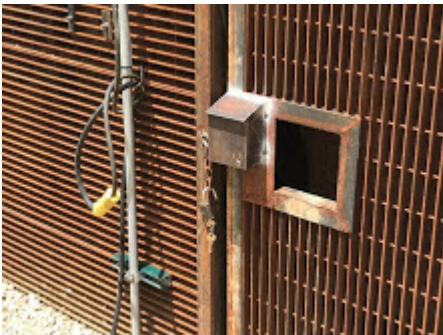
**2000 portal gate lock a.jpeg**  
158K

A hood has been welded over the lock on the portal gate. See attached.

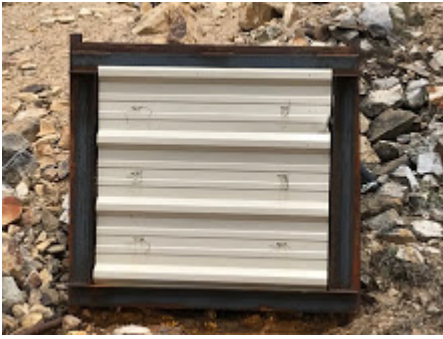
**1370 portal a.jpeg**  
125K

A hinged steel gate has been welded to the portal. The gate lock is on the inside of the gate. Metal sheeting has been wire-tied to the metal gate to limit air flow.
