MINERALS PROGRAM INSPECTION REPORT PHONE: (303) 866-3567

MINE NAME:		MINE/PROSPECTING ID#:	MINERAL:	COUNTY:	
Pay Dirt		P-2010-019	Gold	Montrose	
INSPECTION TYPE:		INSPECTOR(S):	INSP. DATE:	INSP. TIME:	
Monitoring		Dustin M. Czapla	May 22, 2018	10:00	
OPERATOR:		OPERATOR REPRESENTATIVE:	TYPE OF OPERATION:		
Paul Allred		Paul Allred	MP - Mineral Prospecting		
REASON FOR INSPECTION:		BOND CALCULATION TYPE:	BOND AMOUNT:		
Normal I&e Program		Complete Bond	\$3,150.00		
DATE OF COMPLAINT:		POST INSP. CONTACTS:	JOINT INSP. AGENCY:		
NA		None	None		
WEATHER:	INSPECTOR'S SIGNATURE:		SIGNATURE DAT	E:	
Clear	R		May 30, 2018

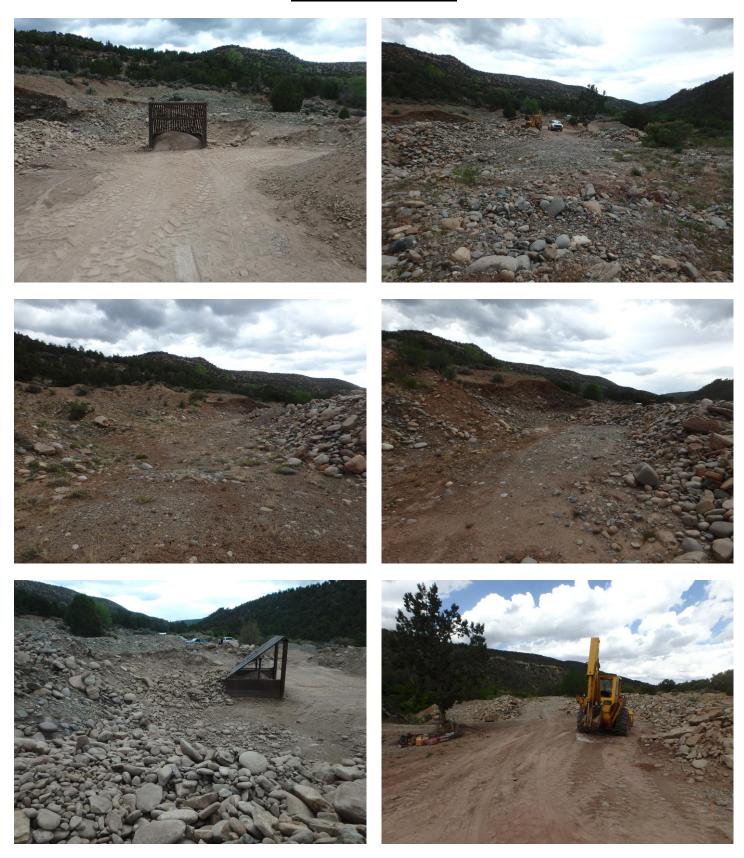
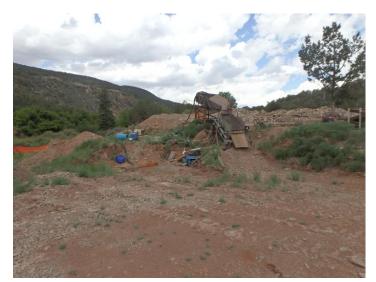
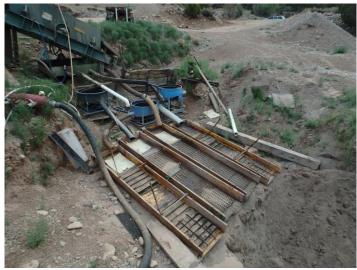
PHOTOGRAPHS

The prospecting takes place on pre-disturbed lands. The operation consists of screening river gravels through a Grizzly, and then running the sands through a sluice plant. The operation appeared to be following the plan proposed in the NOI. No problems or violations were noted during this inspection.
