Weekly VLF2 Update

The geomembrane liner integrity investigation has continued to make steady progress with Newfields overseeing Ames Construction as they continue to remove material from the investigation area. Utilizing several pieces of equipment including; a CAT 321C L excavator, a CAT D6T LGP dozer and a CAT D9T dozer, material has been removed between the 9850' elevation and the 9650' bench.

Cripple Creek and Victor Gold Mining Co.

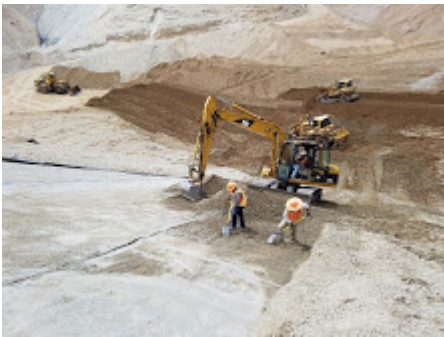
Geomembrane Exposure and DCF removal.jpg
254K

Currently, material has been removed and the liner exposed from approximately the 9660' elevation to the 9850' bench. Approximately 50' of liner has been exposed to the north of the liner tear, and 40' to the south of the liner tear.

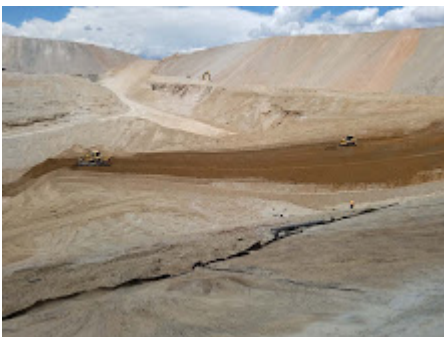
Ore Removal.jpg
162K

While removing material between the 9650' and 9750' benches, the equipment was operated at a minimum of 4' above the geomembrane cover. Additionally, two feet of material remains on the 9750' bench to protect the geomembrane cover during equipment operation in that area.
