MINERALS PROGRAM INSPECTION REPORT
PHONE: (303) 866-3567

MINE NAME: Henderson Mine	MINE/PROSPECTING ID#: M-1977-342	MINERAL: Molybdenum	COUNTY: Clear Creek, Grand
INSPECTION TYPE: Monitoring	INSPECTOR(S): Peter S. Hays	INSP. DATE: May 24, 2018	INSP. TIME: 09:00
OPERATOR: Climax Molybdenum Company	OPERATOR REPRESENTATIVE: Miguel Hamarat, Geoff Nigler	TYPE OF OPERATION: 112d-3 - Designated Mining Operation	
REASON FOR INSPECTION: Normal I&E Program	BOND CALCULATION TYPE: None	BOND AMOUNT: \$37,993,785.00	
DATE OF COMPLAINT: NA	POST INSP. CONTACTS: None	JOINT INSP. AGENCY: None	
WEATHER: Clear	INSPECTOR'S SIGNATURE:

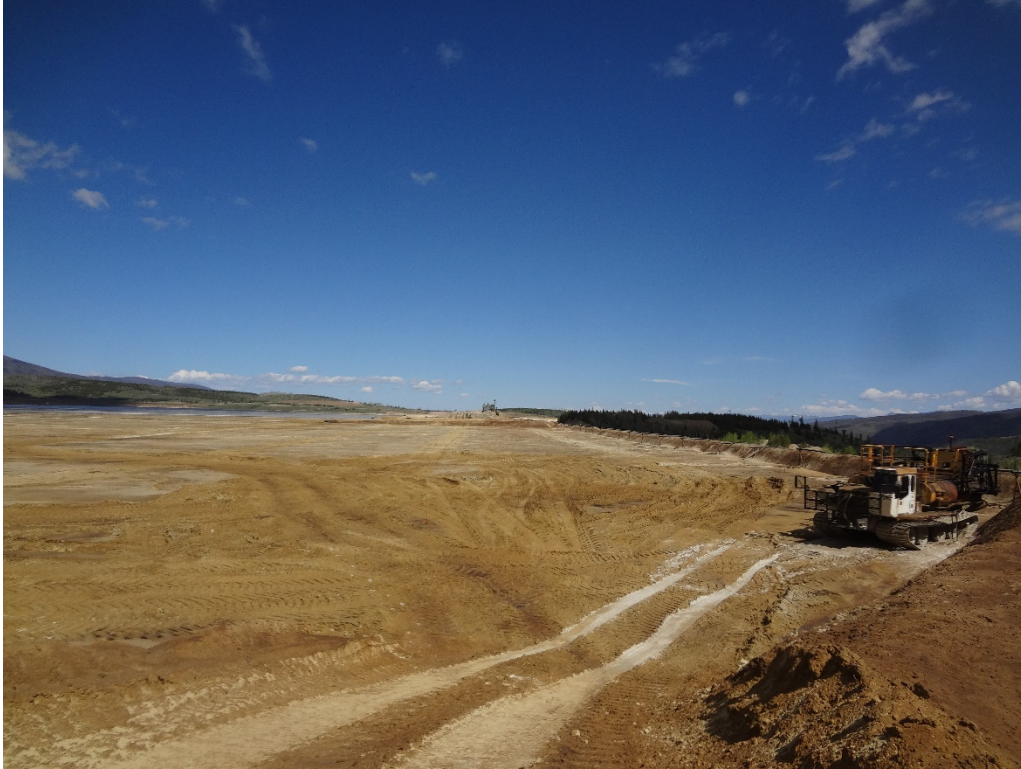
View of 3-Dam Impoundment from the south end looking north

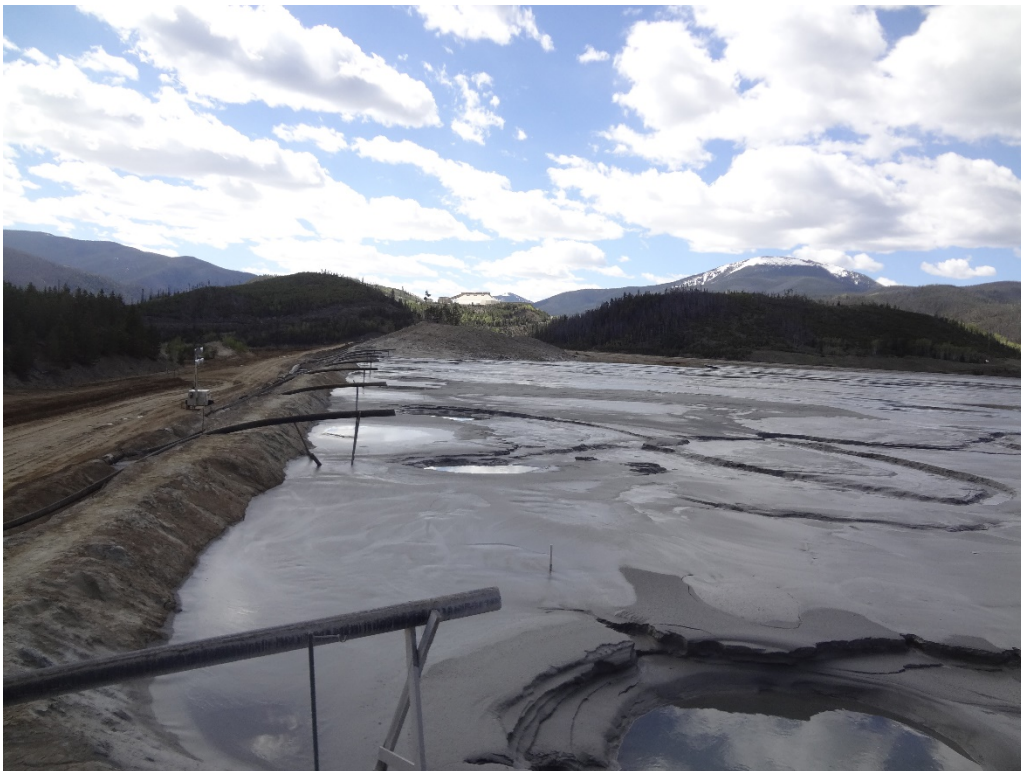
Tailings deposition in the 3-Dam cells is scheduled for the fall of this year and will consist of one deposition. Tailings deposition in the 1-Dam cells is scheduled to occur from south to north. The recent deposition in the abutment cell between 3-Dam and 1-Dam and Cell 1 in 1-Dam were observed during the inspection. Deposition in Cell 2 in 1-Dam is scheduled to occur next week according to the Operator. The remaining cells in 1-Dam have been prepared for deposition this year. Cells 8 and 9 were observed during the inspection. The initial Coherex application on the tailings impoundment is completed for the year.

View of tailings deposition in the abutment cell between 1-Dam and 3-Dam looking south

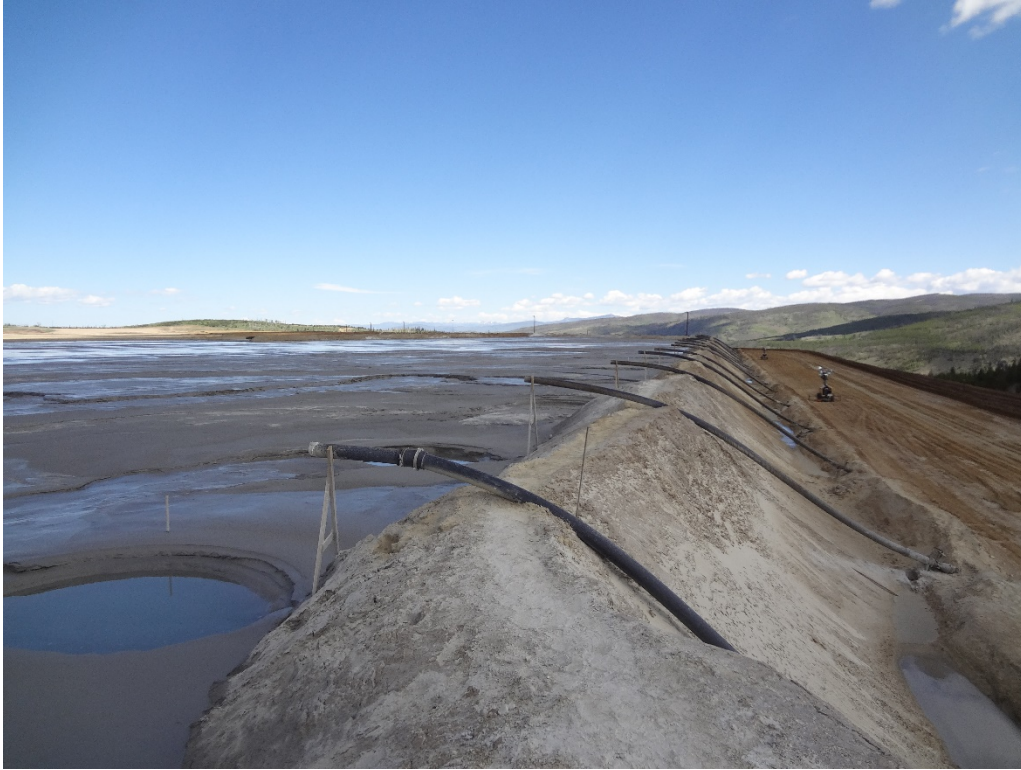
View of 1-Dam Cell 1 tailings deposition looking north

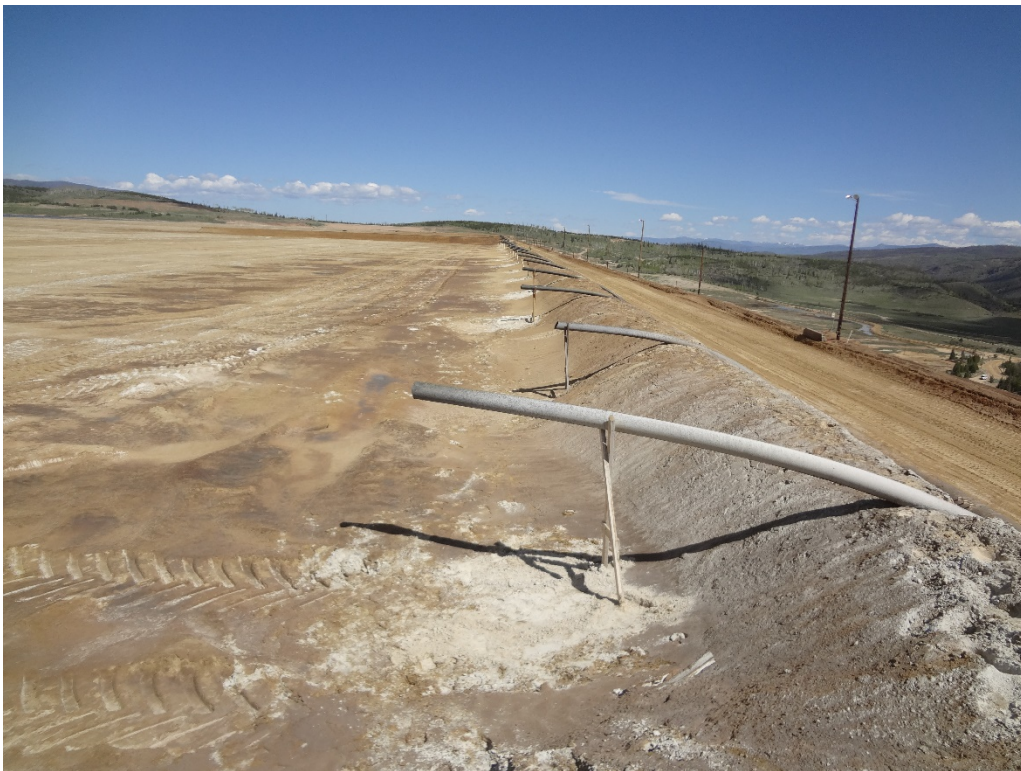
View of 1-Dam Cell 2 looking north

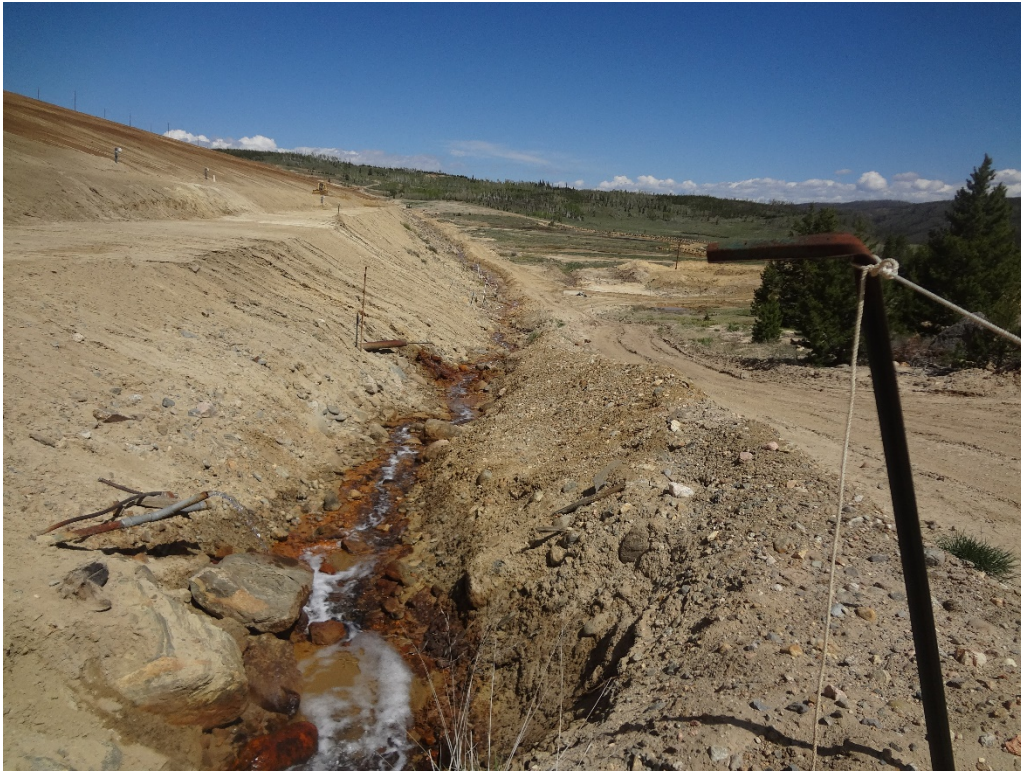
The toe of 1-Dam was observed to evaluate the seepage collection system. Henderson stated horizontal drain cleaning is completed for the year and p-trap maintenance will begin soon. The foundation drains under the impoundments were discussed and several of the active drains were observed.

View of the 1-Dam toe drains and channel from the south end looking north

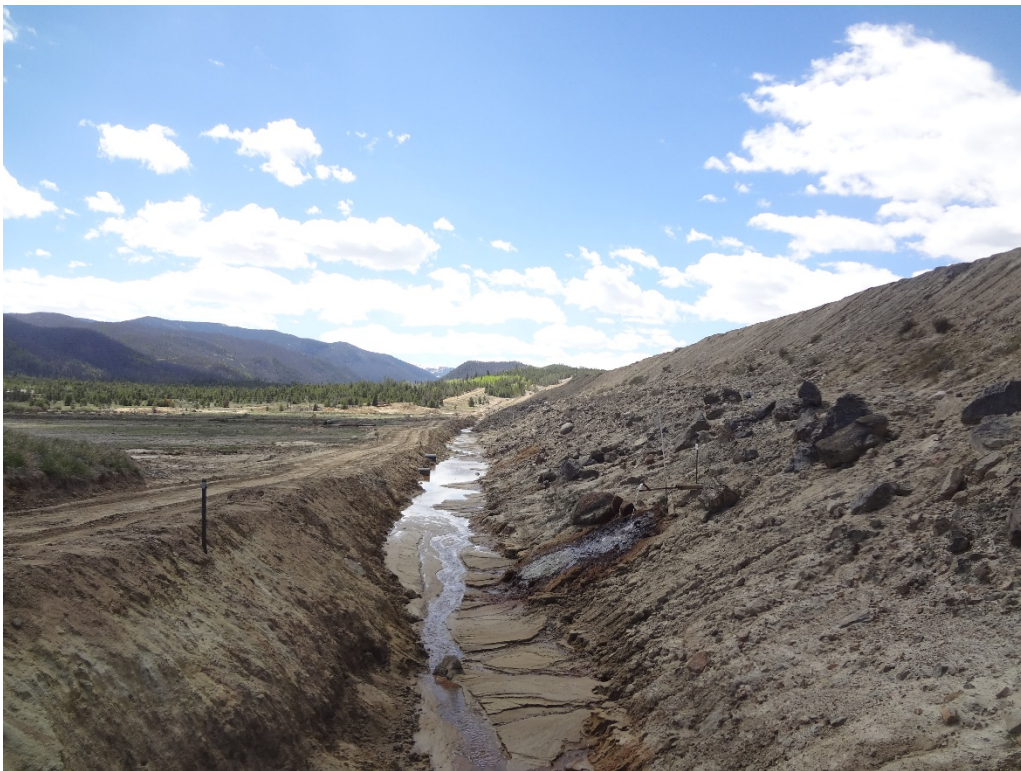
View of the 1-Dam toe drains and channel from north end looking south

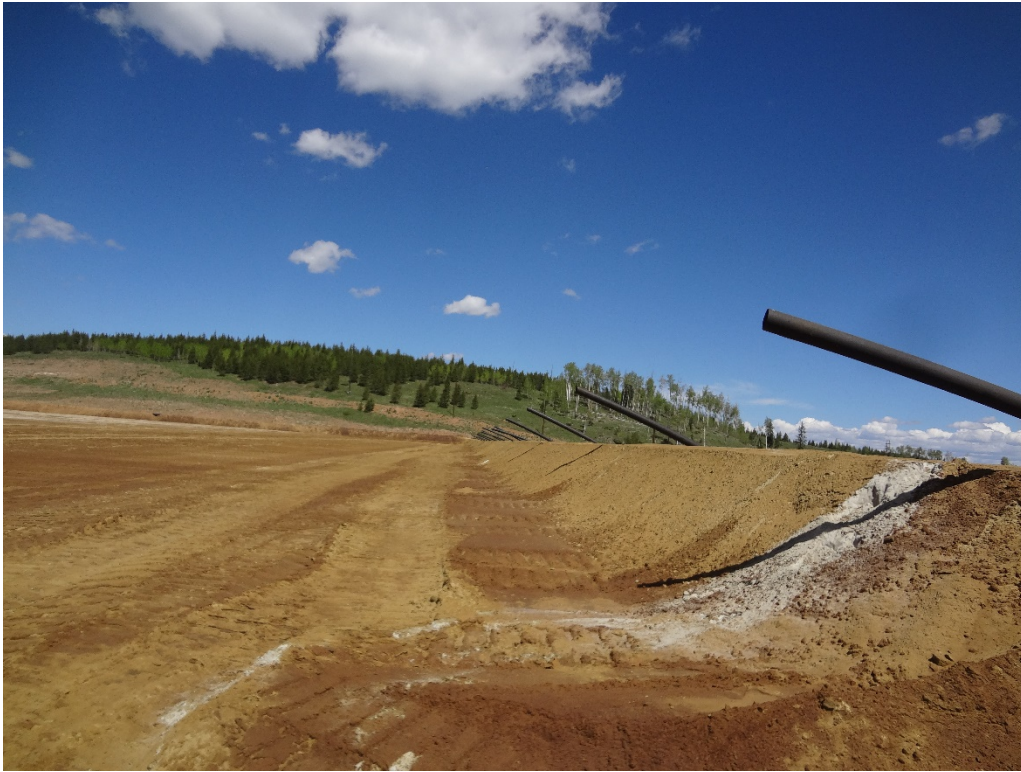
View of 1-Dam Cell 9 looking north

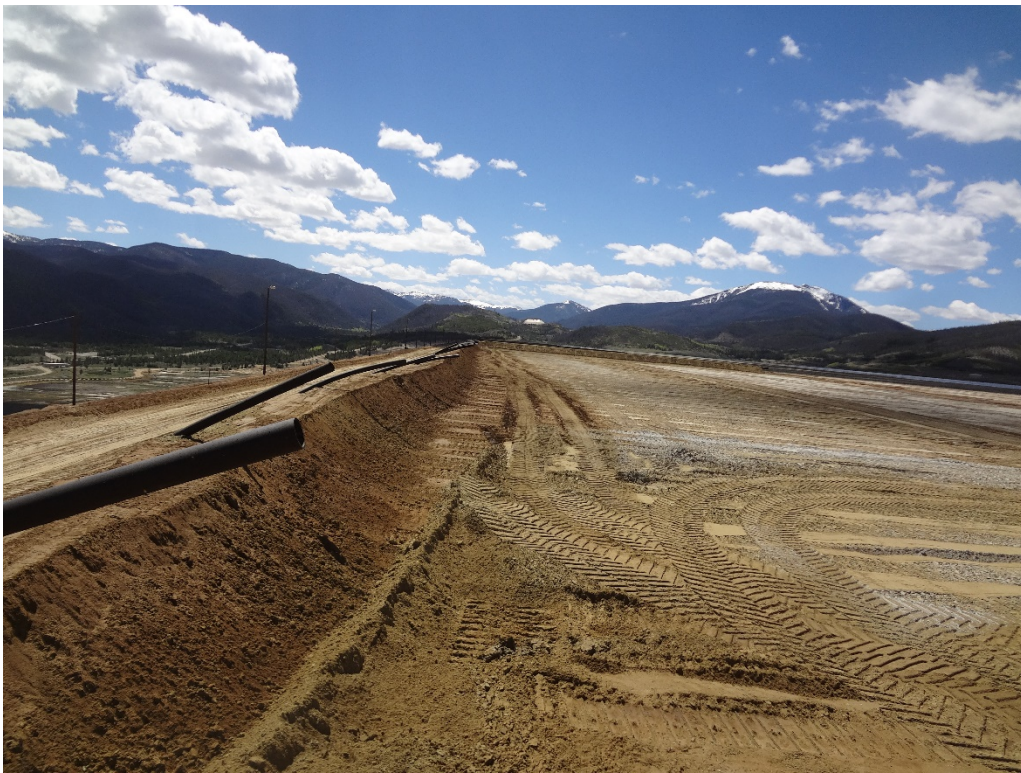
View of 1-Dam Cell 8 looking south

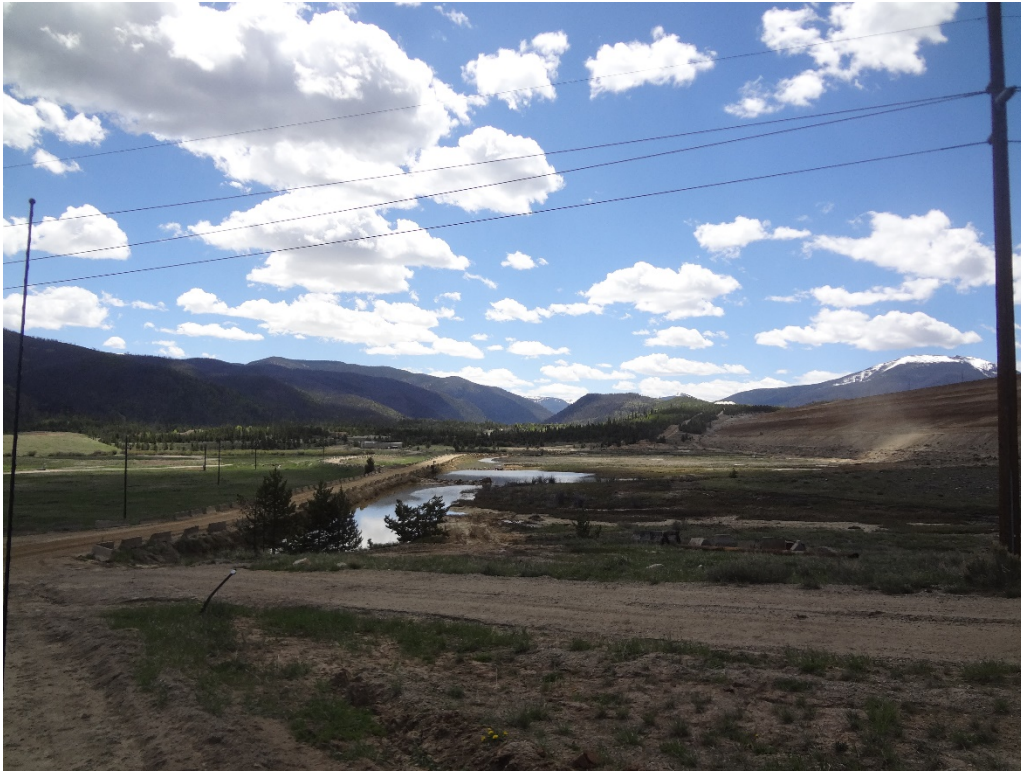
View of the seepage collection area below 1-Dam looking south

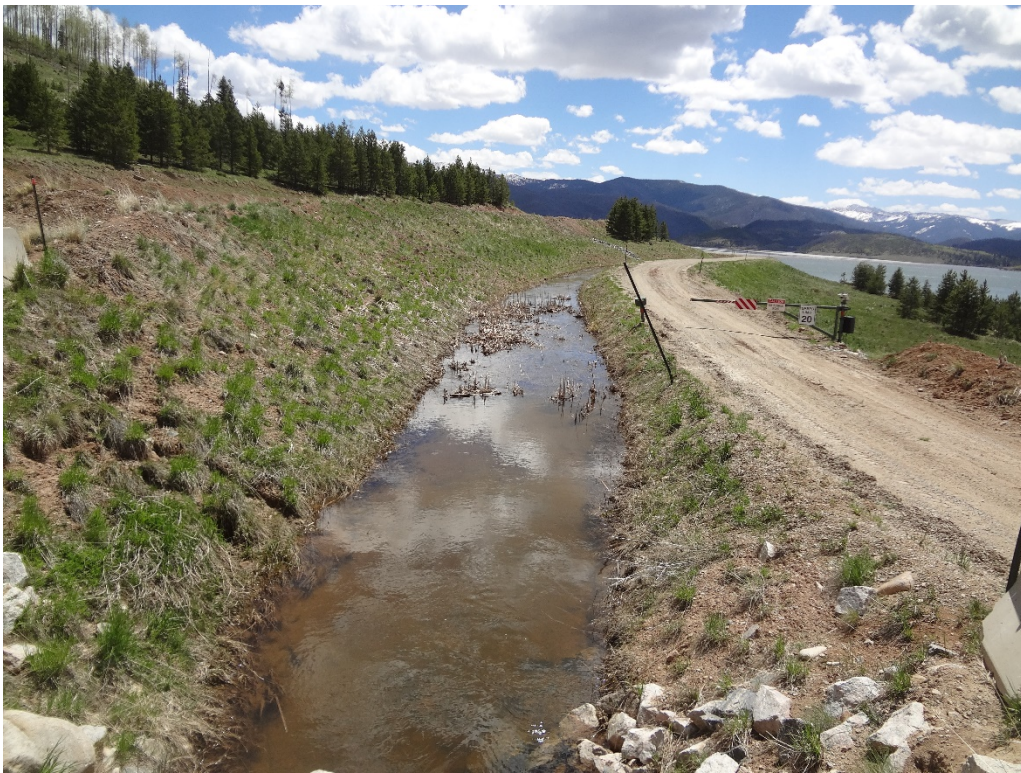
The return water system was observed to verify the pond elevation and the pumping flow rate. The Ultimate Canal was inspected from north to south during the inspection. Henderson has identified several areas of cattails in the canal which will require mechanical removal to maintain the proper function of the canal. The cattail removal work is scheduled to occur this year. The pond elevation is surveyed quarterly to determine the elevation.

View of cattails in the Ultimate Canal near the Ranger Gulch junction
